TECHNICAL REPORT ARCCB-TR-00008

**EVIDENCE AGAINST HYDROGEN
CRACKING IN GUN BORES: A REPLY**

PAUL J. COTE

MAY 2000

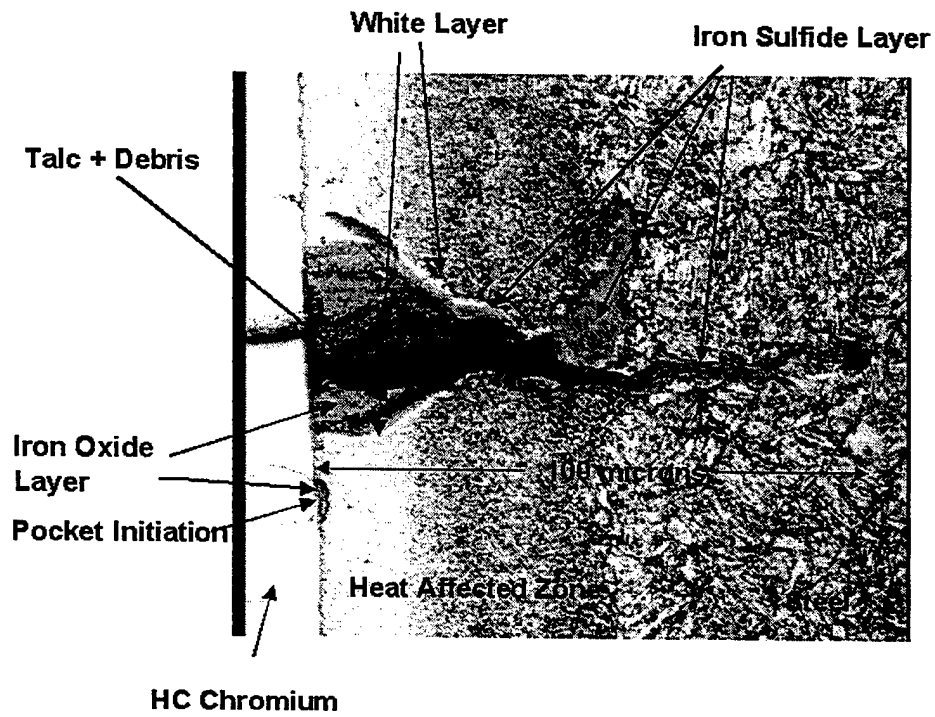
Because of the relatively isotropic nature of the corrosion at the chromium crack tips, and the relatively high volume of steel consumed at that site, it is concluded that fracture in uncorroded steel is not central to damage initiation beneath the chromium. The micrographs in Reference 1 offer straightforward illustrations of the dominant role of chemical attack. Figure 1 is reproduced from that report as an example. The image is from specimen 2, which is a tube that had experienced 220 conventional rounds and 80 experimental high-temperature rounds. The undermining of the chromium coating is clearly shown. Evidence of sulfur, oxygen, and carbon attack (white layer) are all present in this figure. The entire length of the extended erosion pit is coated with a gray layer (iron sulfide).

Finally, the specific issue here is our conclusion (ref 1) that the hydrogen-cracking mechanism proposed by Underwood and Parker (ref 4) is inconsistent with the observed progression of high-temperature corrosion into the steel at the chromium crack tips. Hydrogen cracking is expected to occur at or near room temperature and at atmospheric pressure. Thus, such cracks should be manifested as corrosion-free and debris-free narrow cracks. The proposed hydrogen-cracking mechanism involves interaction of the tensile stress layer (estimated at 500 microns deep), formed on cooling in the heat-affected layer of steel, with the hydrogen supplied by earlier exposure to the high-temperature propellant gas. The distinguishing feature of this proposed mechanism is that the hydrogen cracks ought to be substantially developed (several hundred microns deep) after the first few rounds since the stress layer and the hydrogen are both present after the first few rounds. Such rapid, early fracture is inconsistent with the general observations (ref 1) of relatively slow, gradual progression of corrosion damage into the steel (e.g., Figure 1).

The view (ref 2) that rapid fracture *must* play a role in propagation of damage into the steel is addressed next. It was suggested in Reference 1 that fracture through corroded grain boundaries or through mechanical fatigue and fracture (where there is no corrosion) can also contribute to damage propagation. Hydrogen cracking is considered unlikely, however, for the reasons cited above. It is not clear that fracture into uncorroded steel *must* play a role in the early stages of damage propagation, especially where corrosion rates are high. Consider the results in Figure 1, which has the deep corrosion pits with only 300 total rounds. Assuming the empirically-determined 0.4 micron per round rate of iron sulfide layer formation in propellant environments, and assuming a film rupture process with fresh metal exposure through the sulfide fissures with each firing, one estimates corrosion pit depths of 120 microns. (The estimate is conservative because it ignores the observed diffusion enrichment of the steel by sulfur beneath the scale (~0.3 micron per round)). The estimate is in accordance with the corrosion pit depth of 100 microns in Figure 1, so that rapid fracture of steel is not essential to explain the shape of extended corrosion pits.

Figure 1. Initiation and propagation of high-temperature corrosion into the gun bore surface beneath the chromium coating.

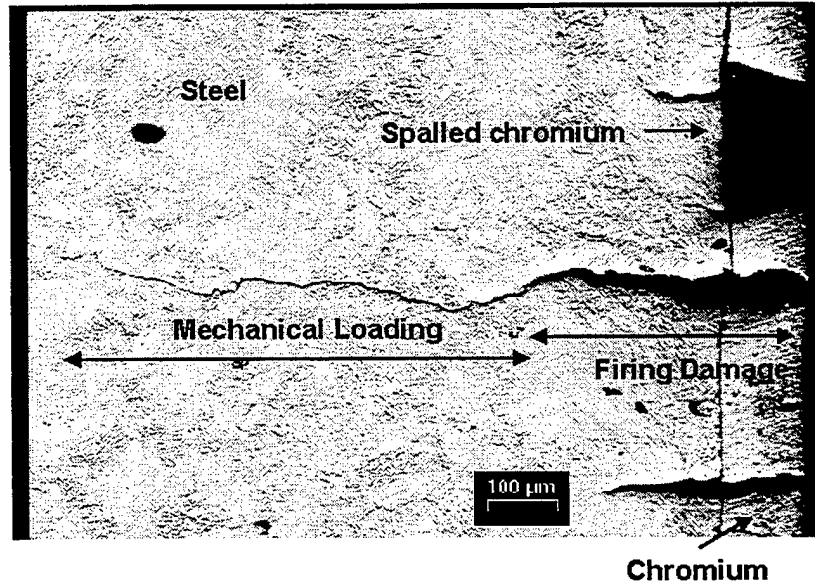
Given the reliance on a meandering crack shape and branching to establish hydrogen cracking, it is useful to examine the shape of fatigue cracks that are produced by pure mechanical loading in a simulated fatigue test using hydraulic pressure. Figure 2 shows results on a 120-mm specimen that had developed significant erosion pits by firing 1246 conventional rounds prior to mechanical testing, where 6593 cycles were applied at 97,600 psi. Hydraulic pressure cycling was applied to develop fatigue cracks for the purpose of establishing safe service lives of eroded tubes. In these specimens, such cracks are easily distinguished from those due to firing because of their narrow widths, long lengths, and absence of corrosion products and firing debris. It can be seen that the fatigue crack grown under purely mechanical cycling has all the features

attributed to classic hydrogen cracks. The longest crack in this specimen was approximately 1-cm in length and exhibits all the features associated with environmental cracking, including branching all the way to the crack tip. This is twenty times deeper than the estimated tensile stress zone (ref 3), so it cannot be attributed to the proposed hydrogen-cracking mechanism. The mean crack growth rate for this mechanically driven crack is over one micron per cycle. Thus, rapid cracking and crack shape are insufficient to establish hydrogen-cracking mechanisms in gun tubes. The usual mechanical fatigue cracks may easily be mistaken for hydrogen cracks with those criteria.

Figure 2 also shows a spalled section of chromium that is typical of what is observed in the survey study (ref 1). In general, the spallation is at or near the chromium/steel interface and as can be seen in this figure, there is no joining of cracks in the steel beneath the chromium.

Figure 2. Portion of the fatigue crack generated by mechanical loading seen to have the same meandering, branching nature usually attributed to classic hydrogen cracking.

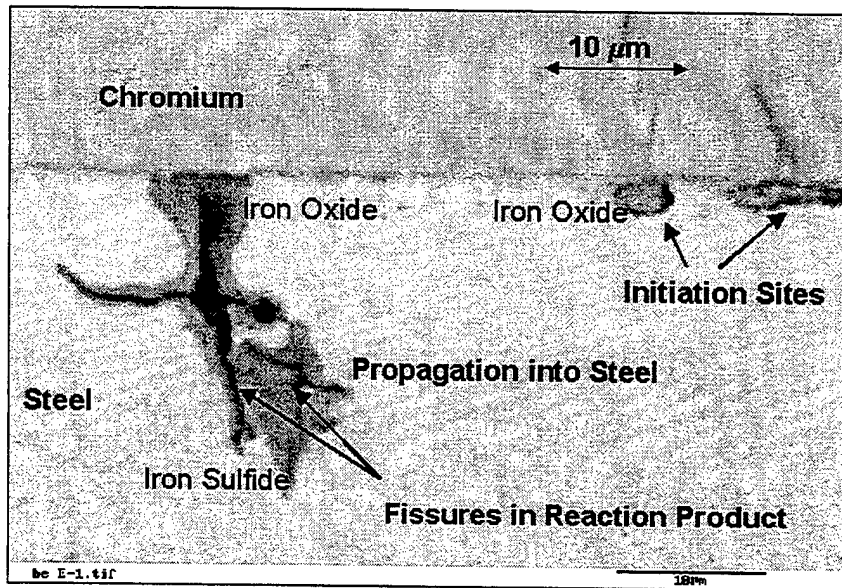
Figure 3 is a scanning electron micrograph (SEM) of typical reaction products that form at the tips of the cracks in the chromium coating for the same specimen as in Figure 1. The fractures in the SEM images are better defined than in optical micrographs. This is the typical result, which provides a straightforward illustration that fracture into uncorroded steel is not observed in early stages of damage. Thus, as illustrated by this figure and by the data in Reference 1, there is no evidence for the predicted incremental hydrogen cracks that are supposed to form at room temperature and pressure (according to the slow mode scenario) after the last round. The only observed fractures are in the form of fissures in the brittle reaction products (sulfides and oxides); these serve to direct the progress of the gas-metal attack into the steel.

Figure 3. SEM illustrating that fracture into uncorroded steel does not occur during initiation of damage beneath the chromium coating.

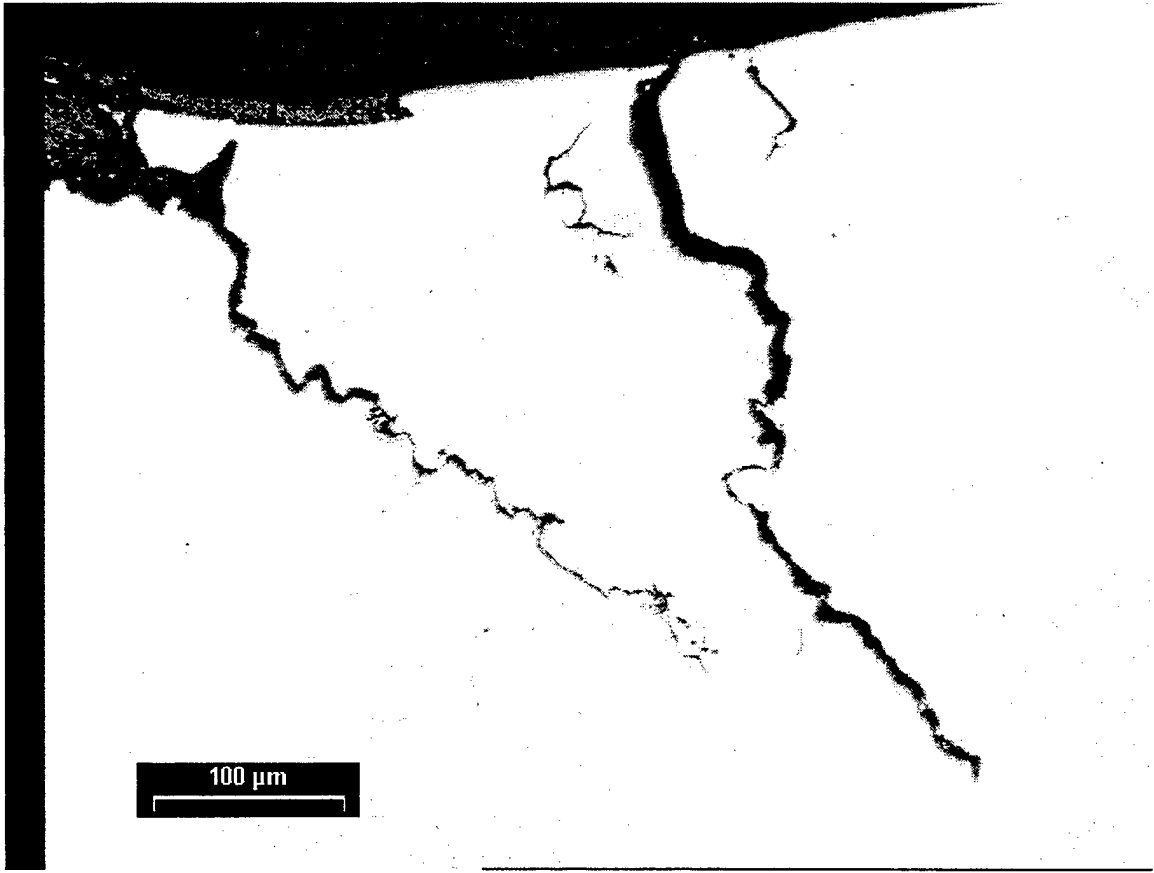
All earlier discussions focused on damage initiation. Figure 4 shows the opposite extreme, that is, several of the deepest fractures in specimen 2. These fractures occurred in a section where the chromium coating and several millimeters of steel had been eroded away. Cracks resembling the one at the left in the figure are used to show that hydrogen cracking may be present since it is assumed (ref 2) that mechanical fatigue alone cannot produce cracks of this length (in 300 rounds). As illustrated in Figure 2, however, this deep, branching, crack pattern is, in fact, consistent with mechanical cracking.

The majority of the deep cracks in this sample resemble the crack at the right in Figure 4 with its blunt crack tip. Crack blunting in deep cracks is probably not due to ductile fracture, since the irregular surface morphologies at the tips do not give the appearance of plastic flow. Regarding the hydrogen cracks that are supposed to form after each firing, one never observes the sharp debris-free hydrogen cracks emanating from any of the numerous blunt cracks in these specimens.

Another notable feature is the general widths of the cracks. Comparison of cracks in Figure 4 with the room-temperature cracks from mechanical loading in Figure 2 show crack widths are, in most cases, roughly a factor of five larger when produced under firing conditions. This suggests a high rate of material removal via gas-metal attack, even for deep cracks in fired tubes. While there are no observable reaction products (gray layers) in the steel at the tips of

Figure 4. Micrograph showing examples of the most severe fractures in specimen 2.
