# National Transportation Safety Board

## Safety Recommendation

Date: June 16, 2000

In reply refer to: A-00-32 through -40

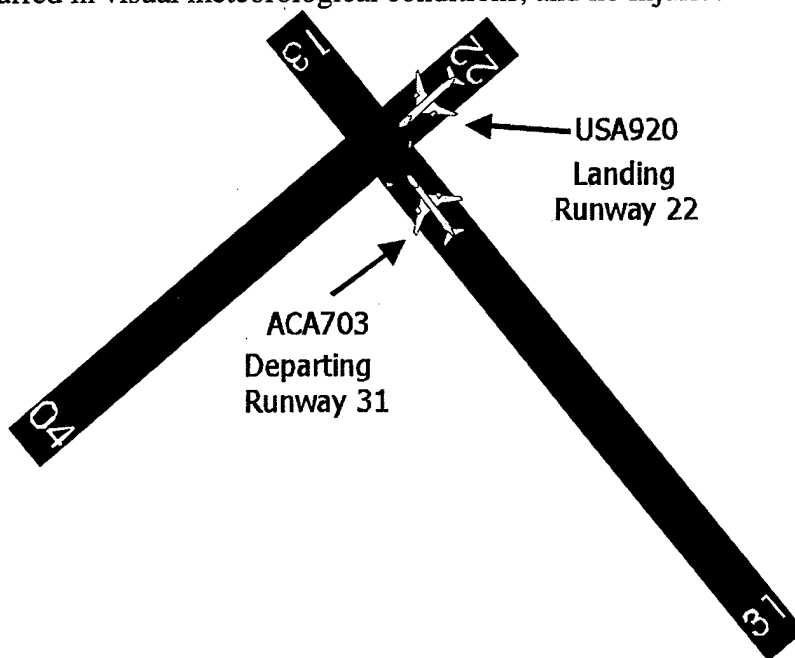
Figure 1. Approximate aircraft orientation for April 3, 1998, near midair collision (NMAC) at LGA

At the time of the incident, aircraft landing at LGA were using runway 22 and departing aircraft were using runway 31. Runway 22 intersects runway 31 approximately 5,300 feet from the threshold of runway 31. According to the LGA tower local controller, USA920 was executing a visual approach to runway 22 and had been cleared to land. The local controller then cleared ACA703 for takeoff from runway 31. Approximately 30 seconds later, he reassessed the traffic situation and decided that ACA703 would not clear the intersection before USA920 crossed the threshold of runway 22.<sup>1</sup> The local controller then instructed USA920 to go around.<sup>2</sup> ACA703 was airborne and climbing before it reached the intersection with runway 22; consequently, USA920 and ACA703 were in the air when their paths crossed. The captain of USA920 saw ACA703 on his left and alerted the first officer, who was flying the airplane. The first officer immediately took evasive action to avoid a collision. Radar data were not available because both airplanes were below radar coverage at the time of the incident; however, in the NMAC report he filed with the FAA, the captain of USA920 estimated that his aircraft passed 85 feet below ACA703 with horizontal separation of 75 feet. The local controller estimated the separation distance at 20 feet.

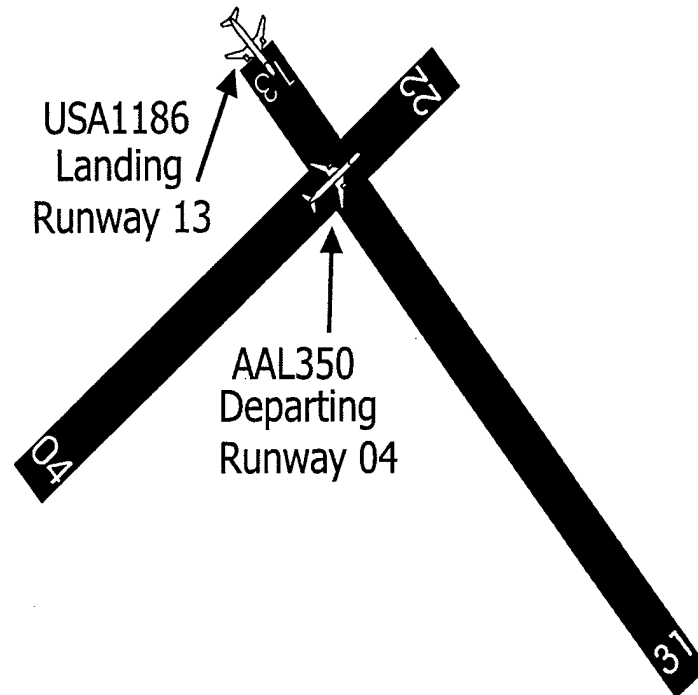
Figure 2. Approximate aircraft orientation for January 23, 1998, NMAC at LGA

The captain of AAL350 stated that he looked to his left as his aircraft passed through the runway 4/13 intersection and saw USA1186 approximately over the runway 13 threshold. Recorded air traffic control (ATC) communications indicate that after departure, one of the pilots of AAL350 said to the local controller, "that was close."

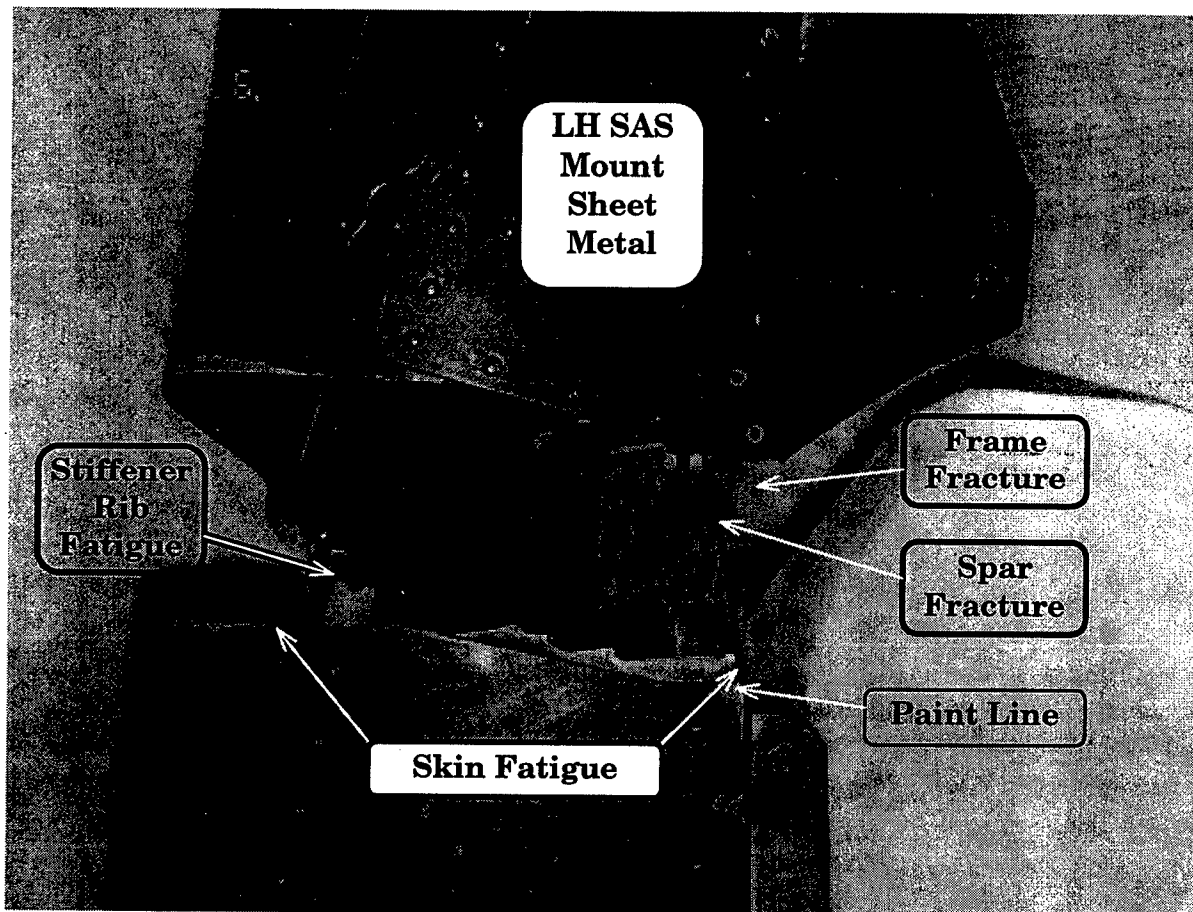
Metallurgical examination of the wreckage established that the separation was caused by fatigue cracking in multiple components of the vertical fin structure, including the skin and spar. Fatigue cracking was discovered at five locations in the vertical fin skin beneath the lower edge of the left-hand yaw stability augmentation system (SAS) servo mount support.<sup>3</sup> Fatigue cracks were also discovered in the vertical fin spar, which in effect partially severed the spar immediately adjacent to the noted skin cracks. The fatigue cracking in the skin originated at rivet holes common to the yaw SAS servo mount support and grew undetected to a length of approximately 5 1/2 inches before the ultimate separation of the vertical fin. The fatigue crack propagation in the skin was concealed by the installation of the yaw SAS servo mount support (see figures 1 and 2).

Figure 1. A left-side view of the fatigue area with the individual component fractures denoted. "Paint Line" arrow denotes the original position of the lower edge of the left-hand sheet.

Perform a fatigue evaluation/damage tolerance analysis of the Eurocopter BK117 vertical fin structure to ensure that the inspection requirements of Airworthiness Directive (AD) 98-24-13 are adequate to detect crack growth in the underlying areas of the modified spar and leading-edge skin and to verify that the BK117 vertical fin spar is not susceptible to fatigue failure beyond those areas specifically identified by AD 98-24-13. If the susceptibility is not so limited or the inspection requirements are not adequate, the AD should be superseded to ensure that all fatigue cracks will be detected. (A-00-46)

Issue a maintenance alert to all certificated airframe mechanics and inspectors to notify them of the circumstances of this accident and to inform them of the hazards associated with the installation of blind rivets. (A-00-47)

Revise 14 Code of Federal Regulations Part 43, Appendix A to state that repairs involving the substitution of fastener types are considered major repairs. (A-00-48)

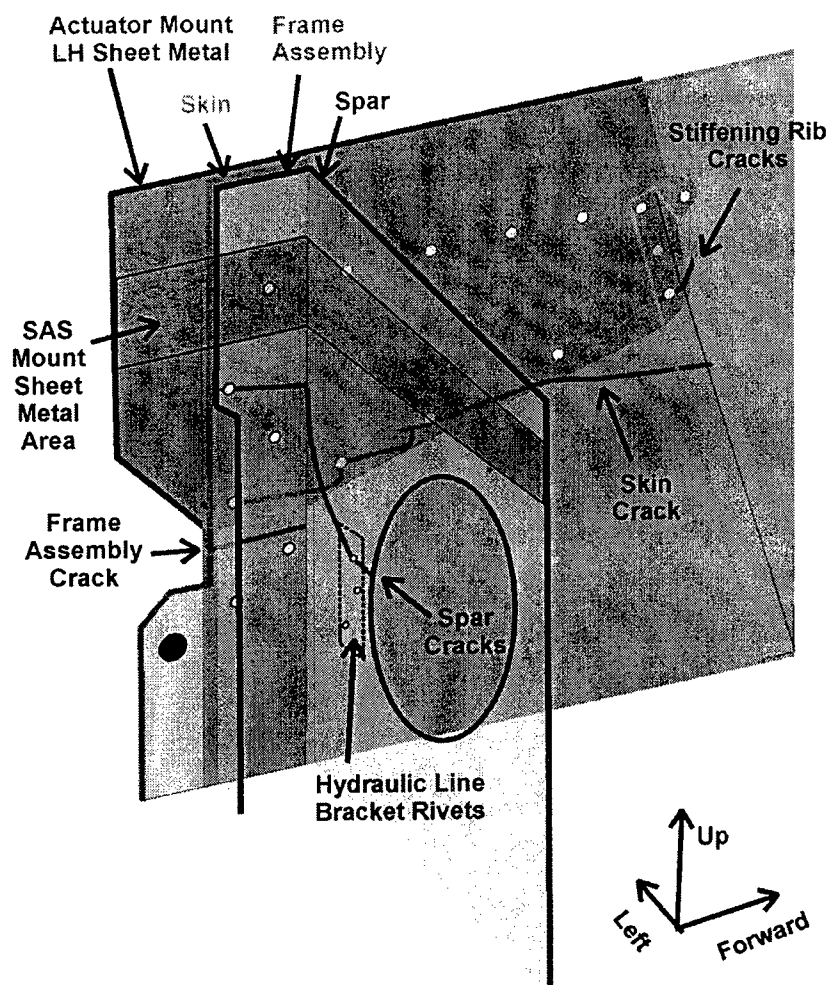
Figure 2. An illustration of the fin components in the area of the preexisting cracks. Of particular interest are the relative positions of the cracks in each member. Overlapping members are shown partially transparent to expose hidden detail. (Not to scale.)
