ERDC/CERL TR-00-24

## **Condition Assessment of Building 6237, Old Hospital Complex, Fort Carson, CO**

August 2000

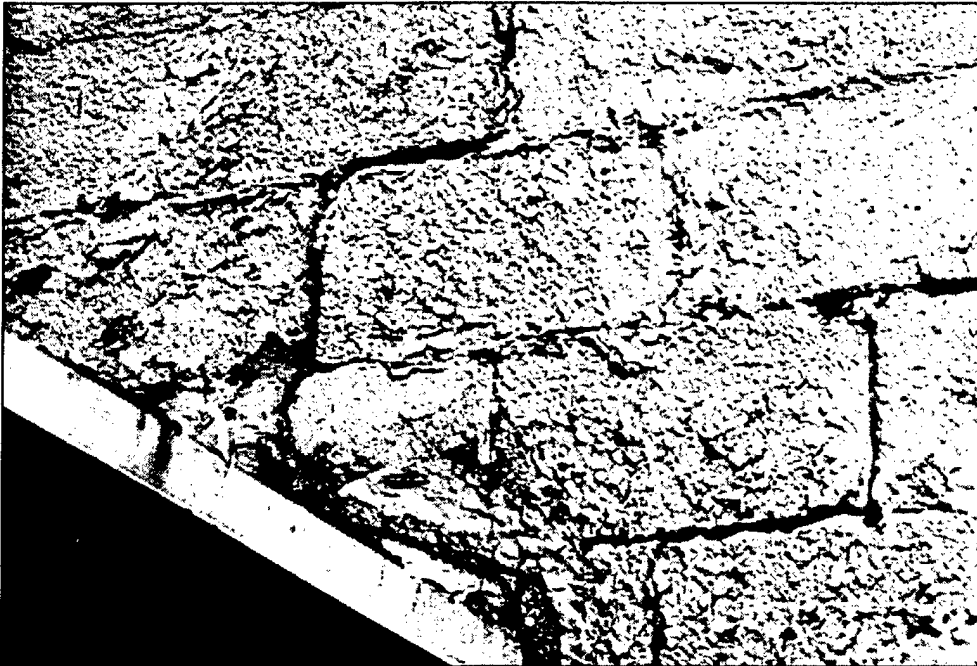
There were two locations in the west exterior wall where cracking was serious: one at the south center entry door (Point A and Figure 3-5), and one adjacent to the ninth\* window from the north (Point B and Figure 3-6). However, no cracking or settling was observed in the exterior foundation wall at these locations.

Figure 3-5. Detail of cracking.

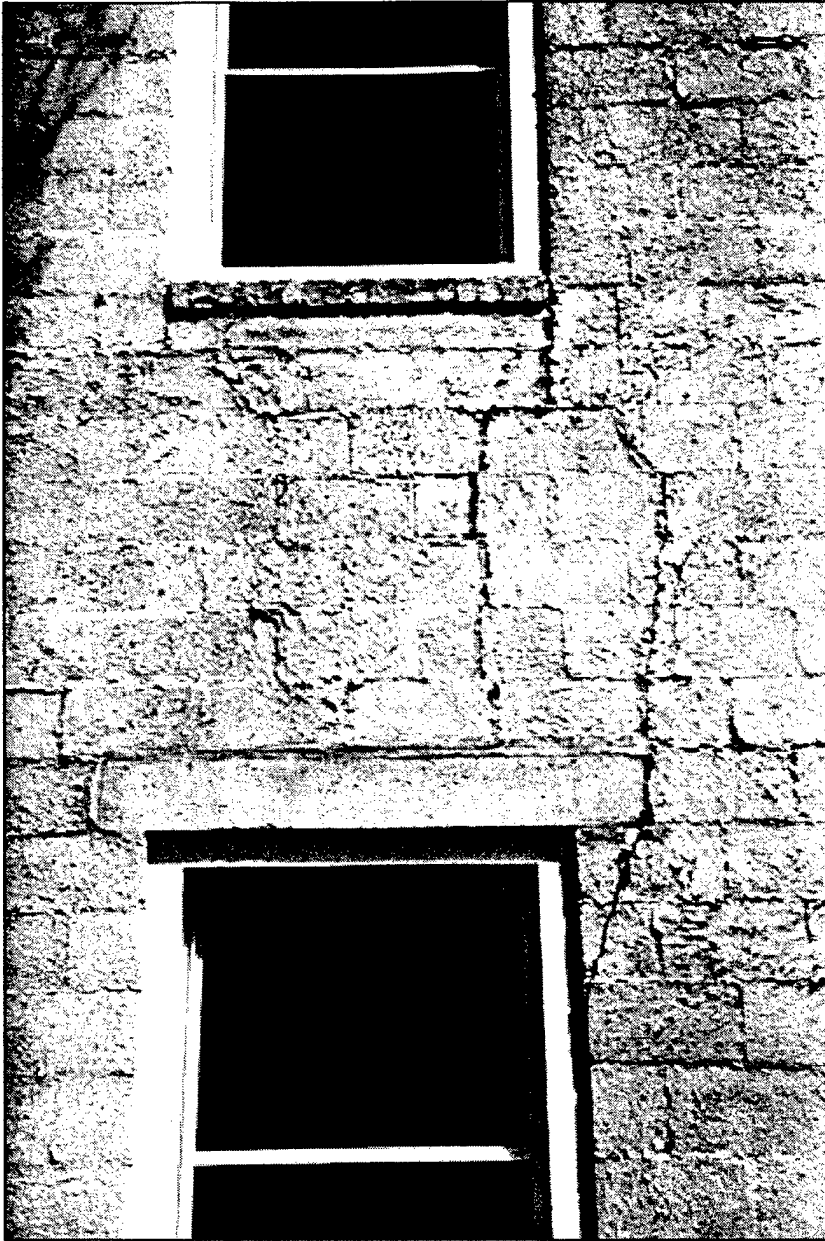
Figure 3-6. Detail of cracking adjacent to ninth window from north.

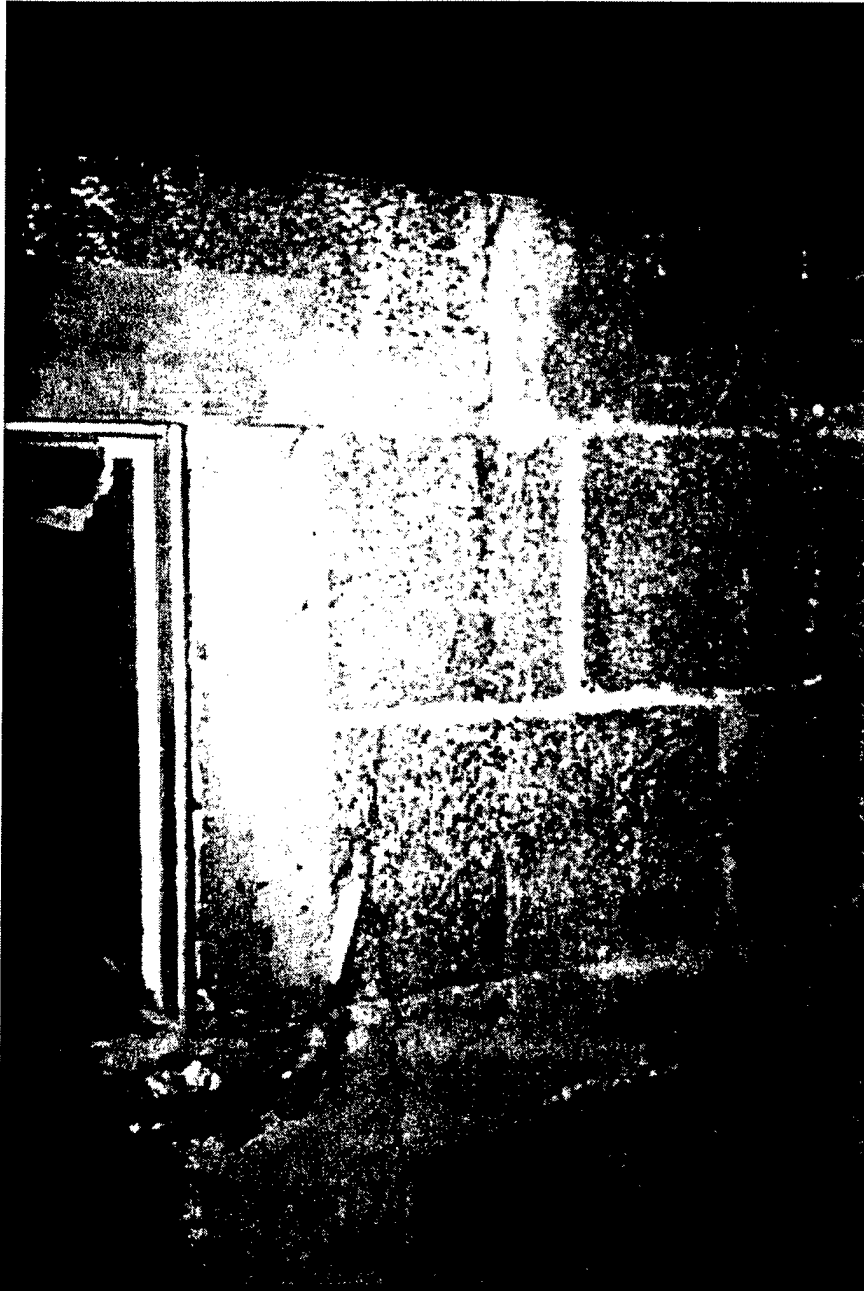
No cracking or deformations were observed in the interior foundation walls, with one exception. One crack was observed in the base of the firewall between the south stairwell and the south ward bay, immediately to the east of the access panel, but not at the pilaster (Point D). This crack did continue into the foundation wall. However, it was approximately 1/16 in. at its widest, and no differential movement was observed on either side of this crack (Figure 3-7).

**Figure 3-7. Crack adjacent to access panel.**

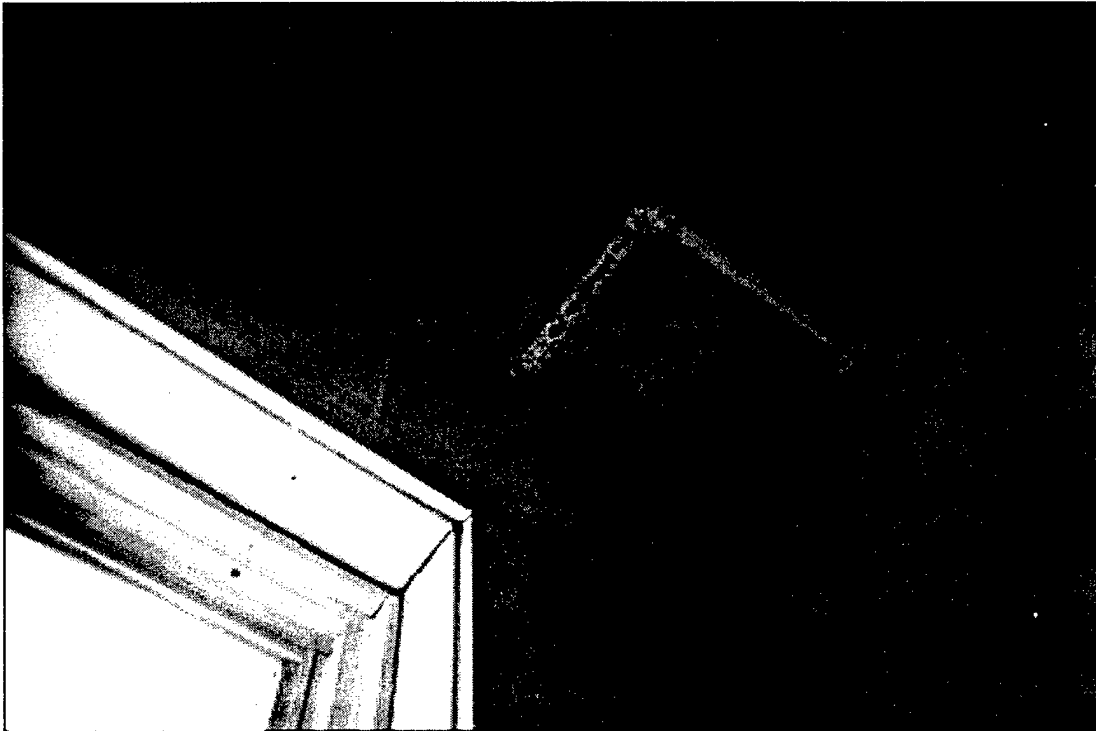
Very little cracking was observed in first floor ceilings, except in the added bathroom at the east side of the former south ward (Point I and Figure 3-10). A severe crack occurs in the east wall and ceiling adjacent to a window. However, no extraordinary deflection or slope is detected in the second floor above. The condition at this window is discussed under Load-Bearing Exterior Walls (p 42).

Figure 3-10. Cracking in southwest bathroom above the window, first floor.

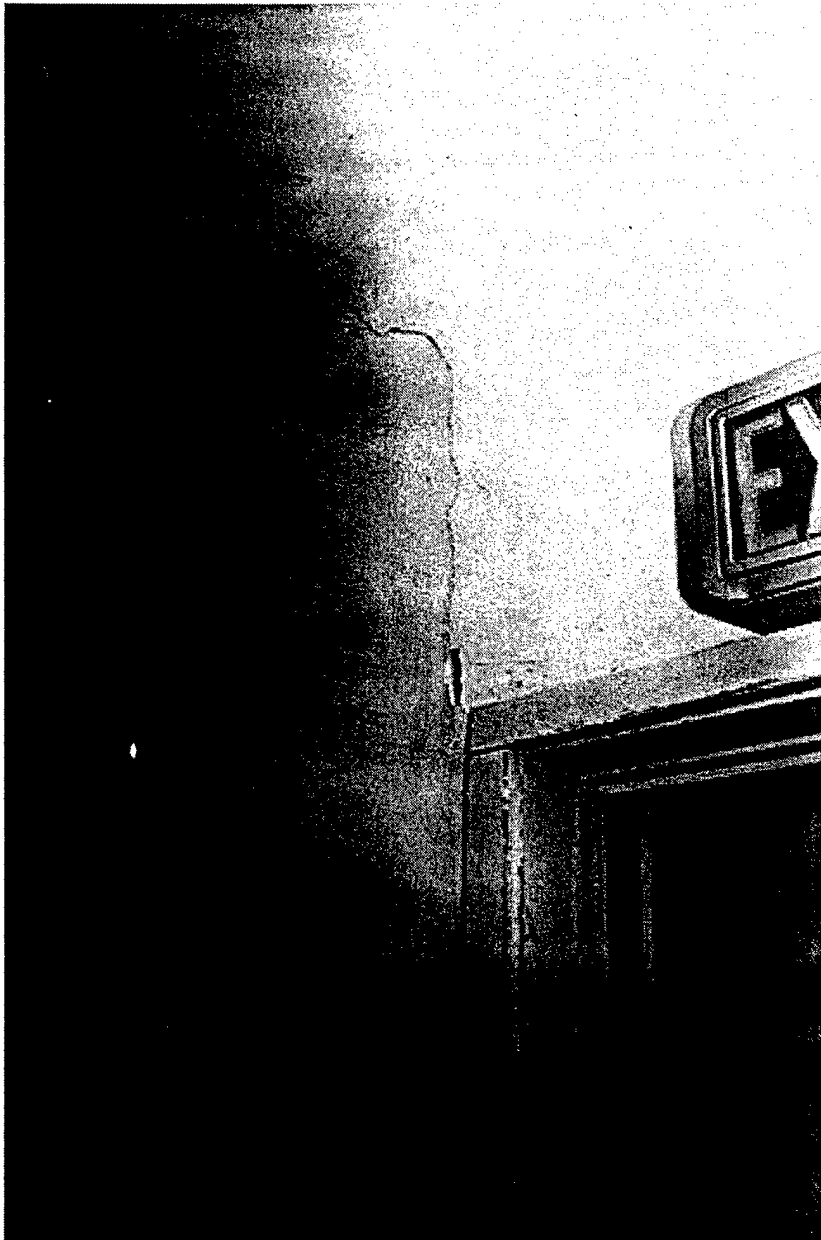
Figure 3-11. Cracking in wall of center stairs.

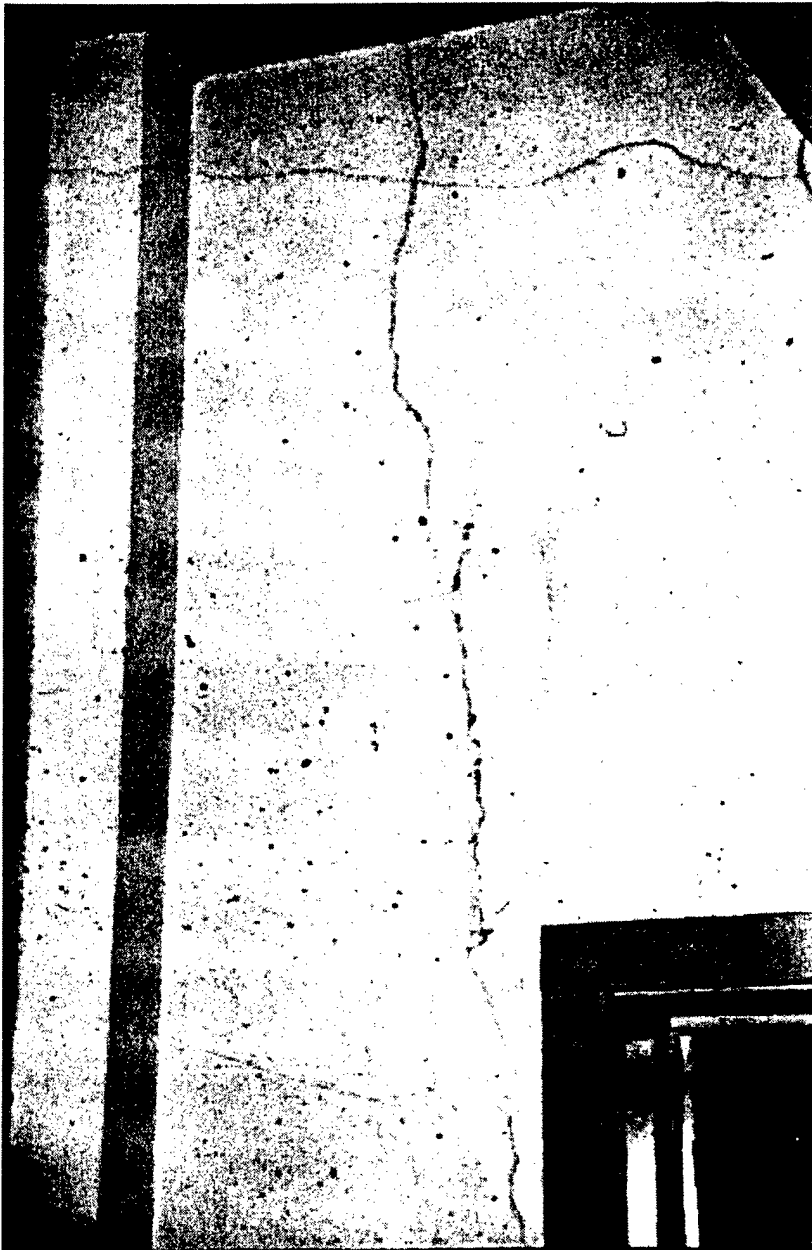
Figure 3-12. Vertical crack in firewall, first floor north ward.

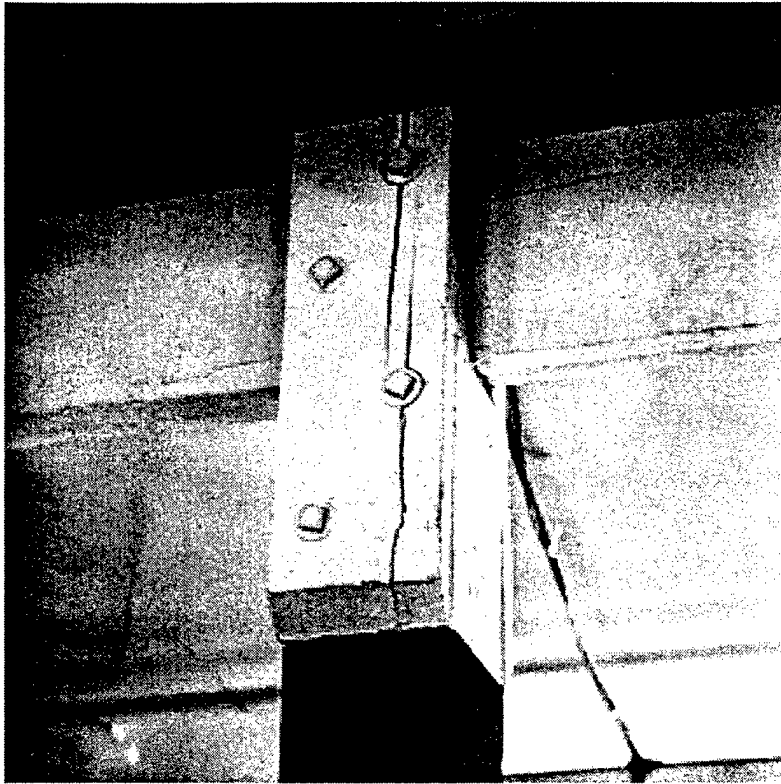
Vertical splitting had occurred at the “beam pockets” at the tops of the columns at the bolts (Figure 3-17). These pieces do not carry vertical loads, and no lateral dislocation of the beams was observed. Paint was evident within these splits, suggesting that they had been stable for quite some time.

Figure 3-17. Splitting at beam pocket.

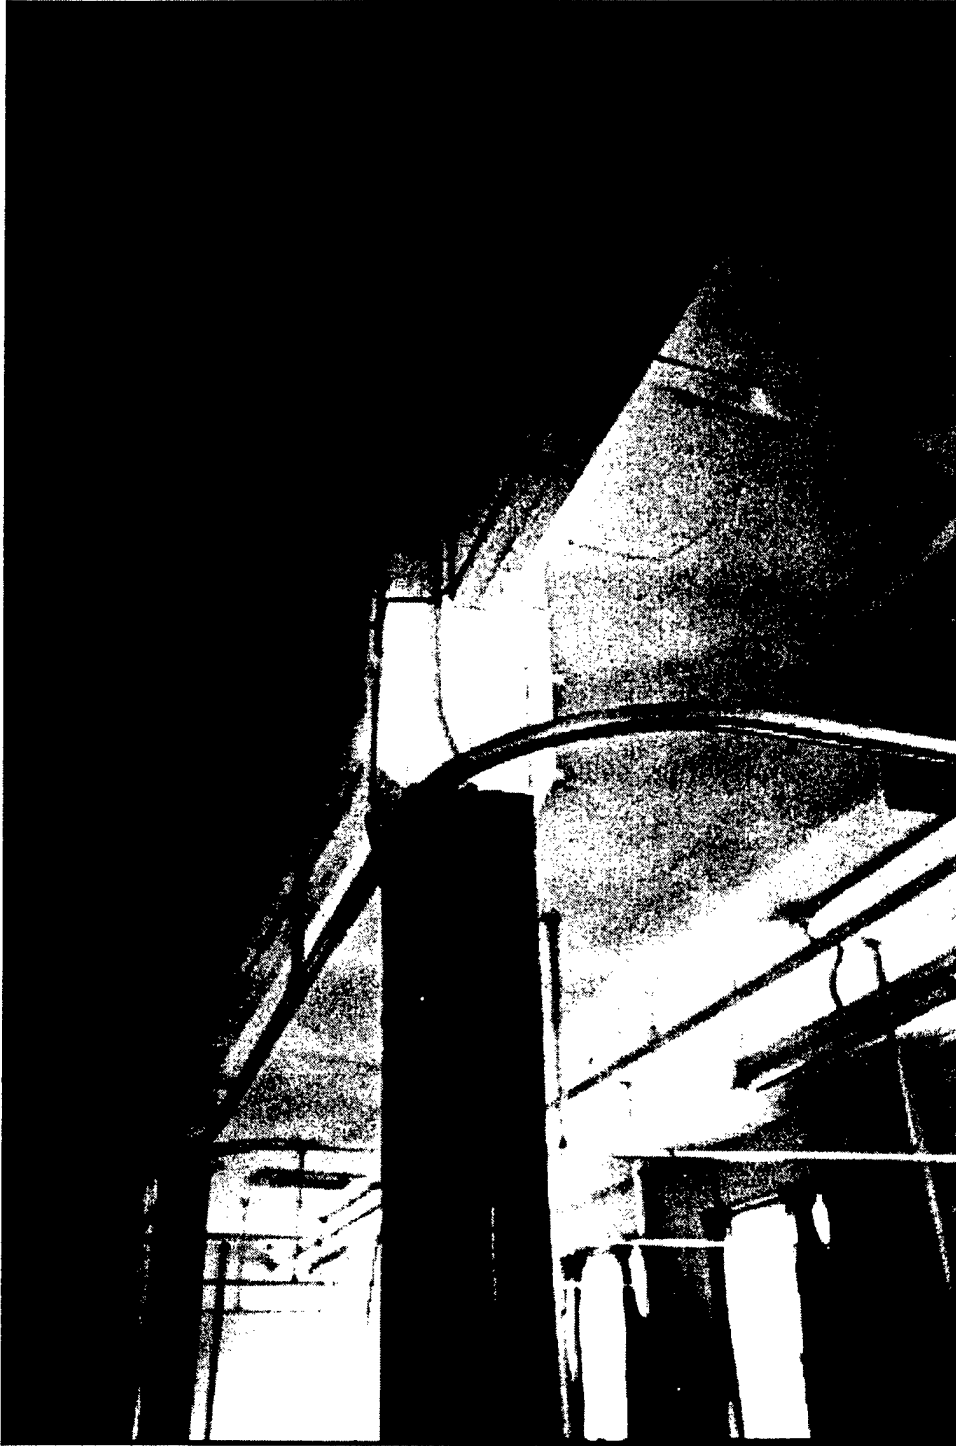
In the south open ward, the third column from the south on the west side was clearly twisted, although it was still plumb (Point M and Figure 3-18). There appeared to be no other deformations because of the twist. Again, this may be more a lumber curing problem than evidence of structural movement.

Figure 3-18. Twisted column in open ward.

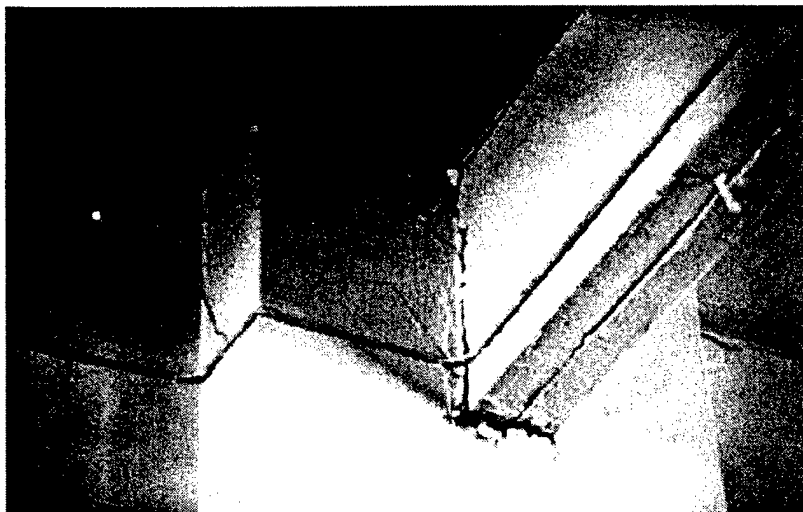
The north end of the beam on the west side of the south open ward is carried by a pilaster in the firewall (Point N). Cracking in the plaster below this beam was observed (Figure 3-19). There was a space of approximately  $\frac{1}{2}$  in. under the beam, suggesting that the beam may not be bearing flush on the pilaster. Apparently this allowed the beam to settle slightly and crush the plaster finish. However, there was no other evidence of structural movement (Figure 3-20).

Figure 3-19. Cracking at beam/pilaster connection.

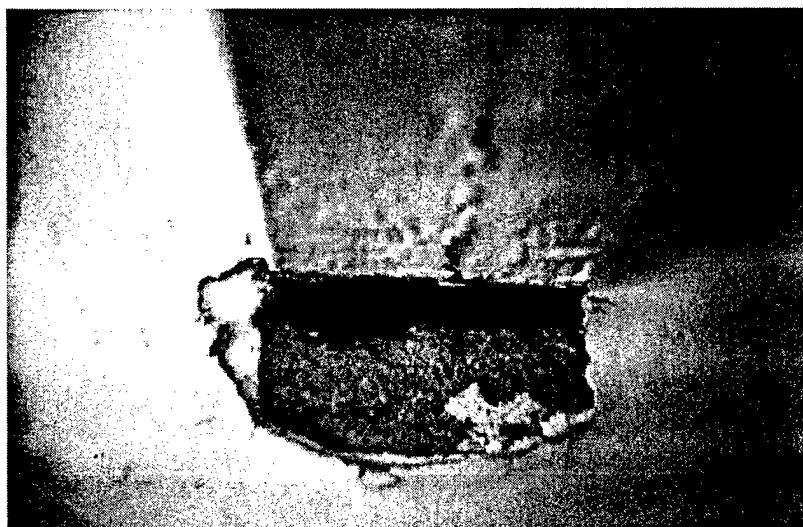
Figure 3-20. Gap below beam.

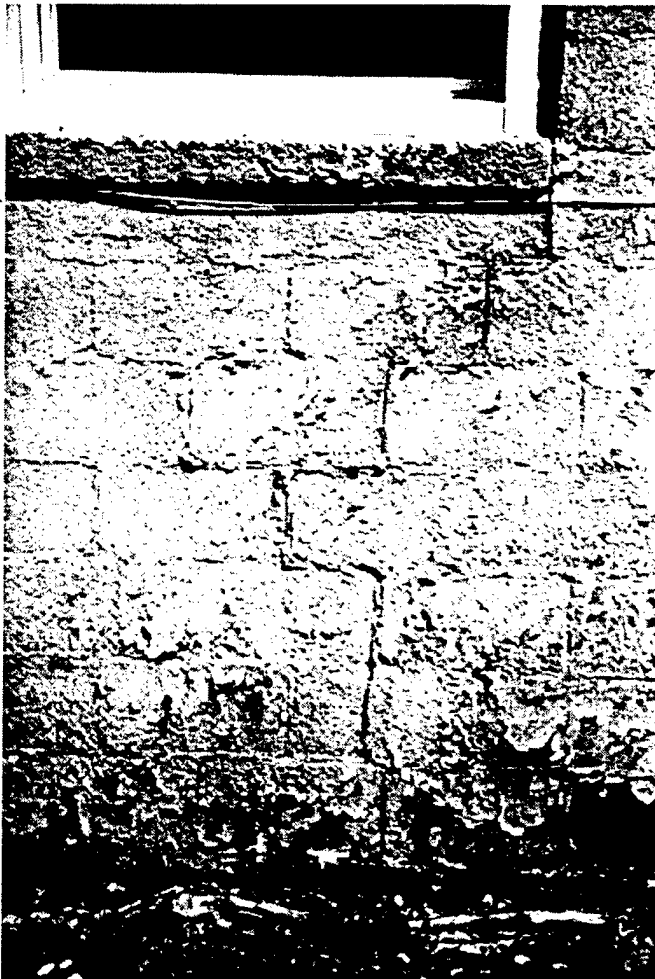
Cracking was observed throughout the exterior cinder block walls. Cracks typically radiated from the corners of window openings, and followed the stair-step pattern of the mortar joints (Figure 3-21). Occasionally cracks would split blocks vertically. Cracks were generally minor, 1/8 in. or less, although larger gaps occurred where mortar was deteriorated or absent (Figure 3-22). Exterior walls showed no evidence of vertical displacement. Framed assemblies carried by exterior walls were found to be level. Windows could be opened and closed without binding. No signs of bowing in either a vertical or horizontal direction were observed at any exterior wall; they were straight and plumb.

Figure 3-21. Stair-step cracking.

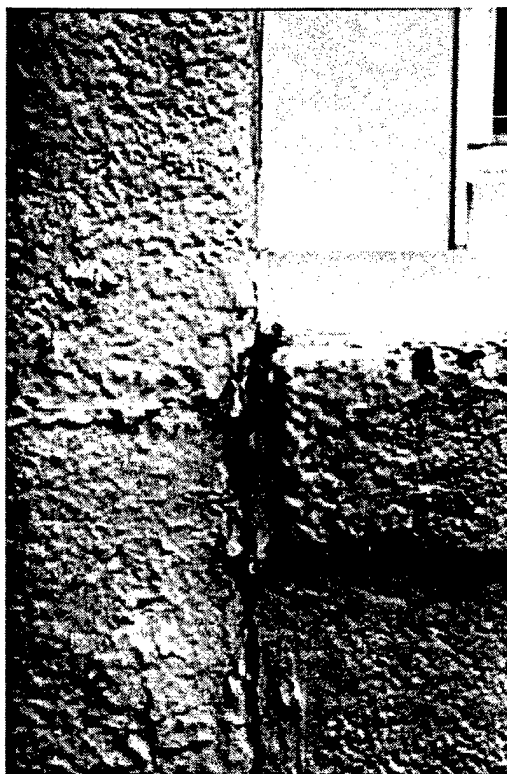
Figure 3-22. Mortar gaps at window sills.

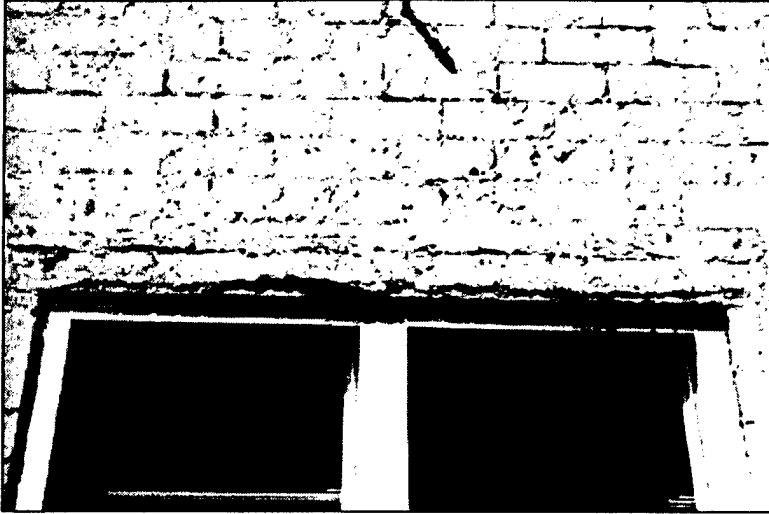
Serious distress was observed at some lintels. Lintels on the end walls (north and south walls) apparently had been parged several times, and were bulging noticeably (Point Q and Figure 3-23). On the west wall, first floor lintels had been replaced with concrete lintels, presumably reinforced (Figure 3-24). The second floor lintels appeared to be intact and exhibited no cracking. On the east wall, all the cinder block lintels remained, and most first floor lintels were seriously cracked (Figure 3-25). The most severely cracked was in the east wall, at the southernmost window of the former open ward (Point R and Figure 3-26). Deformation of almost an inch was seen in the interior trim at that window's head. Severe cracking has occurred in the interior wall and ceiling immediately adjacent to that window. Ceiling cracking was also observed adjacent to the center window in the south endwall. The lintel over that opening had apparently been cracked, and had been parged over. Water penetration through this lintel may have contributed to the ceiling cracking.

Figure 3-23. Parged and bulging lintel.

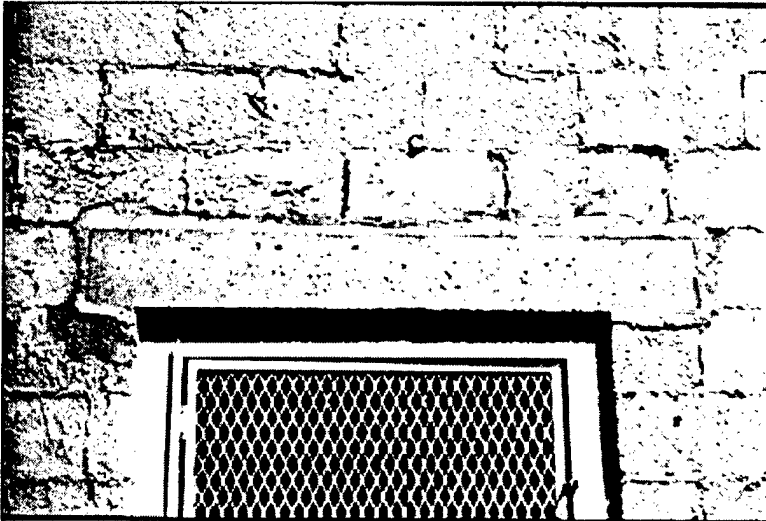
Figure 3-24. Concrete lintel replacement.

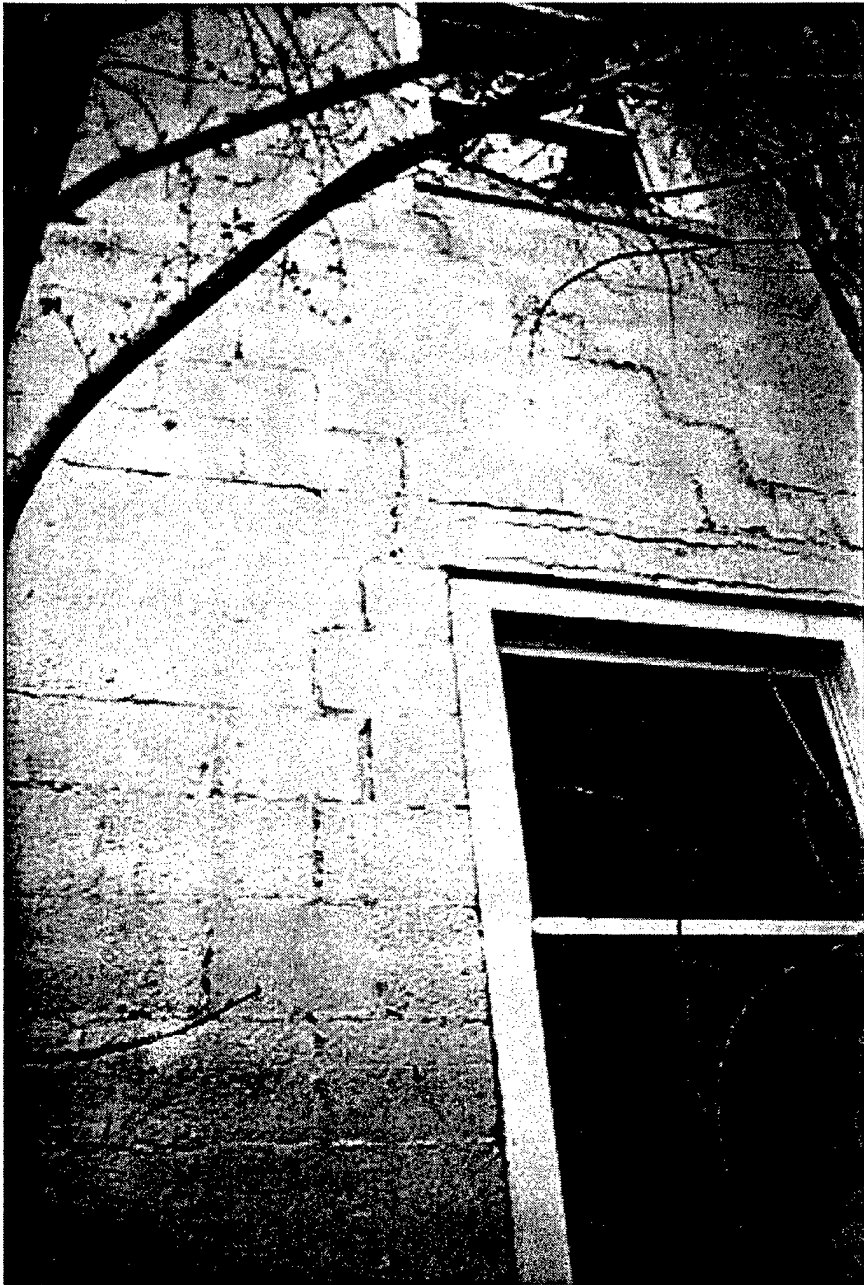
Figure 3-26. Most severe cracking at southeast window.

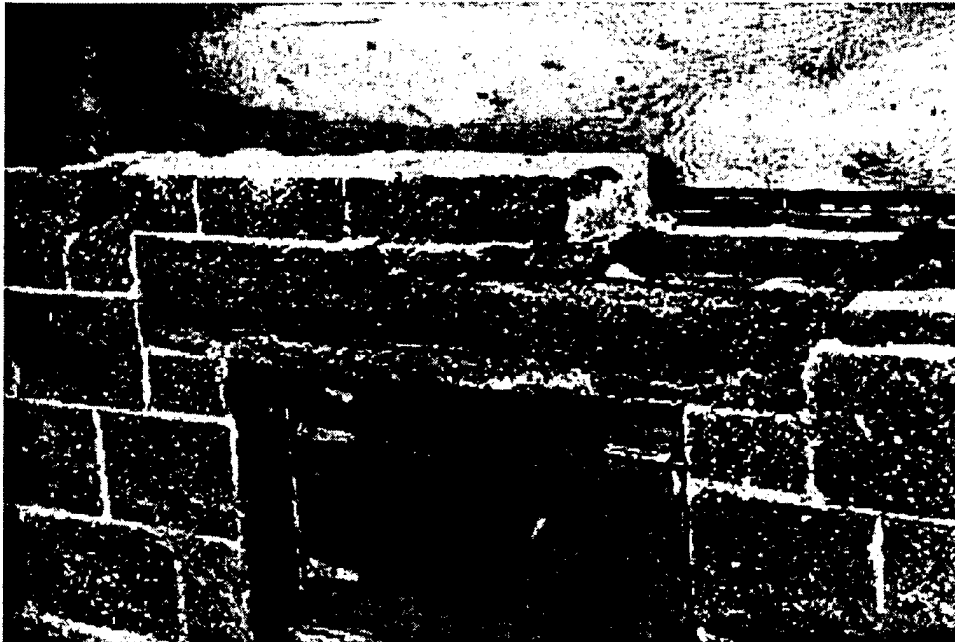
Cracked lintels were observed in Buildings 6240 and 6241, where the exterior paint and interior finishes were removed. It was clear that the reinforcing had become rusted, flaked, and spalled the cinder block cover, exposing the reinforcing (Figure 3-27). It is not apparent whether the cracks were originally caused by loading forces, or whether water penetration caused corrosion of the reinforcing, and weakened the lintels.

Figure 3-27. Exposed reinforcing in lintel (adjacent building).

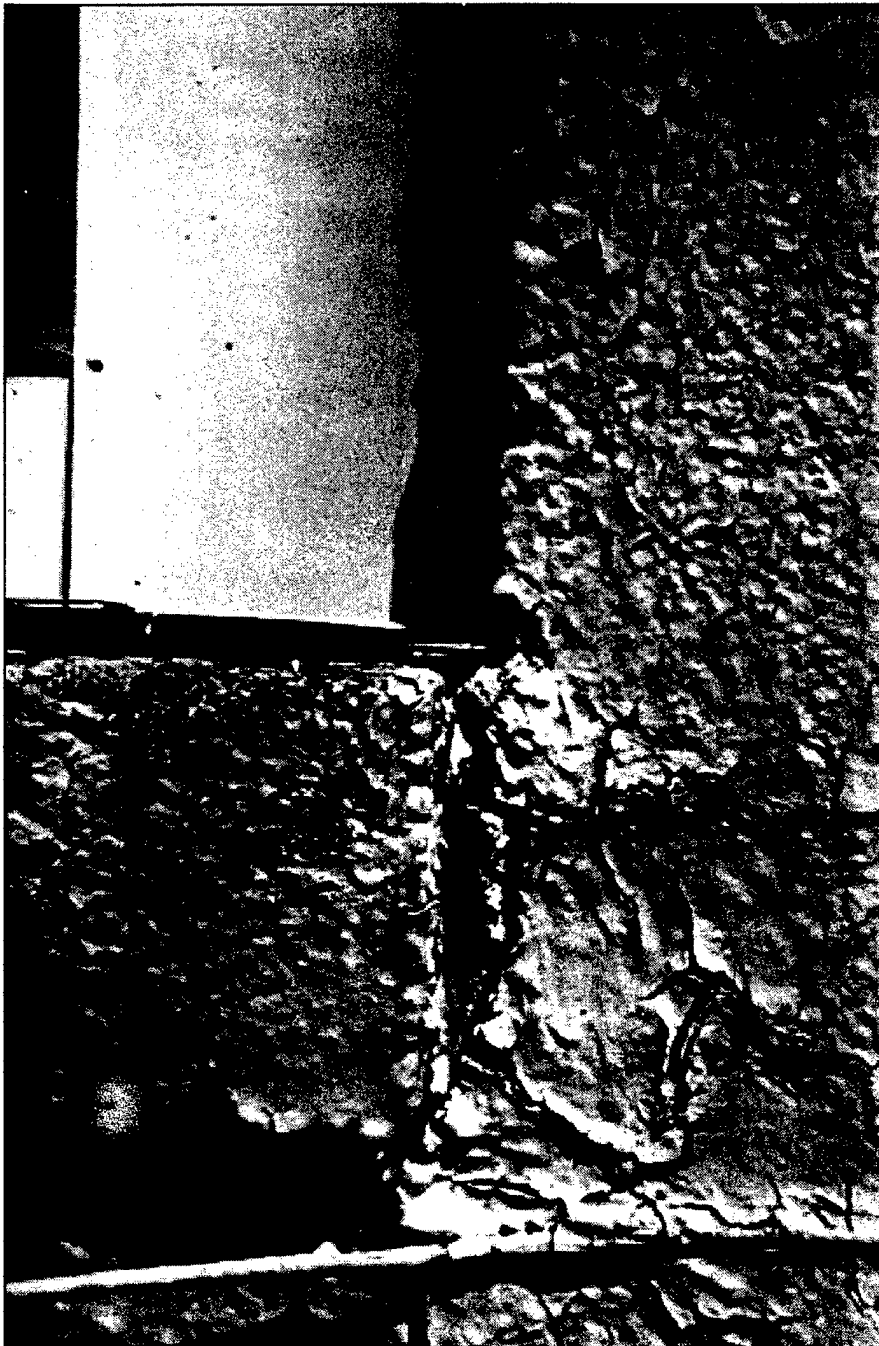
Figure 3-28. Shrunken mortar.

Regardless of the cause, it is evident that extensive repointing and painting is necessary to restore weather resistance integrity. Whether the entire wall surface must be repointed, or whether there may be areas where mortar is intact can be evaluated when the old paint is removed. There is approximately 18,000 SF of exterior masonry surface. If the structure is stable, recurrence of cracking is not imminent. Consideration must be given to mortar, sealant, and paint materials and their compatibility with the type of block used for these buildings. Consideration must also be given to providing some measure of stress relief in the exterior walls to accommodate thermal movement and minor structural movements.

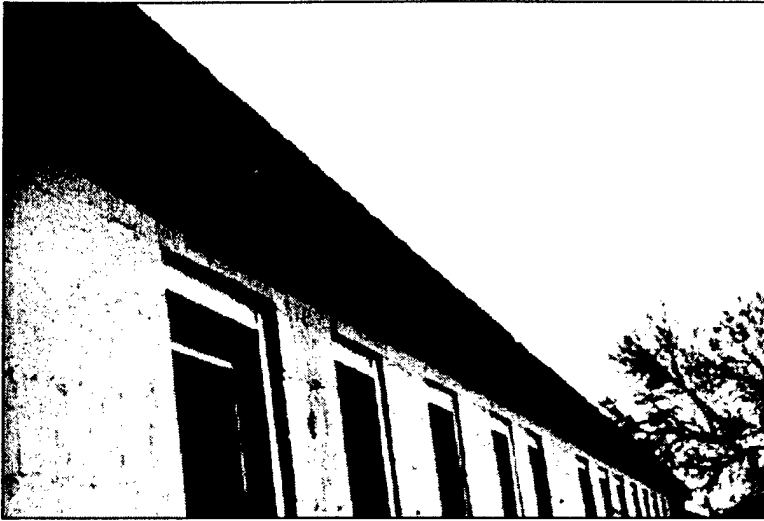
The eave trim appears to be generally intact throughout the main portion of the building. The paint is generally intact. Warping and shrinkage are evident. Warping generally has only opened up gaps in the eave trim (evidenced by daylight visible from the attic spaces), although one fascia board on the west side is severely warped (Point T and Figure 3-30). It is apparent this is caused by the lumber drying out, as opposed to structural movement.

Figure 3-30. Warped fascia board.

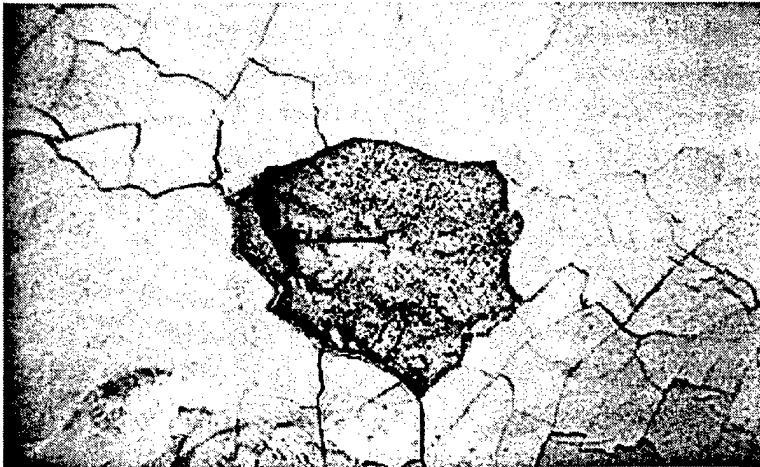
The plaster wall finish in the core areas, both within the rooms and in the hallways, appears to be in overall sound condition. However, there are numerous cracks and defects, most of which appear to be cosmetic. Damage from attached items and penetrations has also occurred throughout these areas. Damage appears behind radiators, where constant heating has spalled the finish coat away from the sheet lath (Figure 3-32). This damage occurs at almost every radiator, and there is at least one radiator in each room. In some places, plywood or Masonite boards have been nailed to the wall behind the radiator.

Figure 3-32. Spalled plaster behind radiators.
