Periodic Inspection Report No. 4
West River
Townshend, Vermont

Townshend Lake

October 1996

US Army Corps
of Engineers

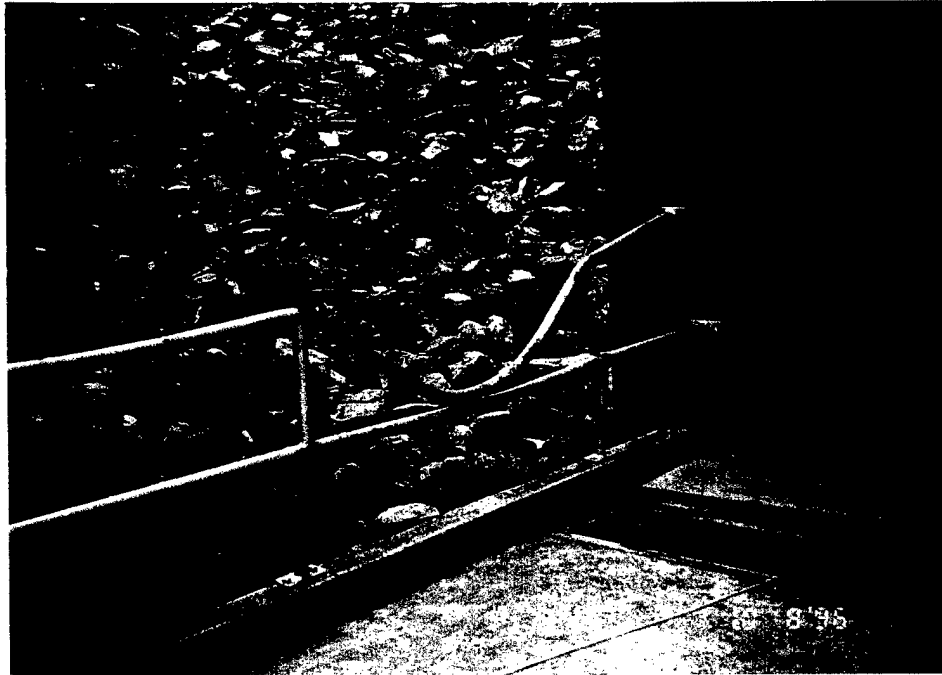
PHOTO A-9. Damaged railing section at the south east corner of the upstream control platform.

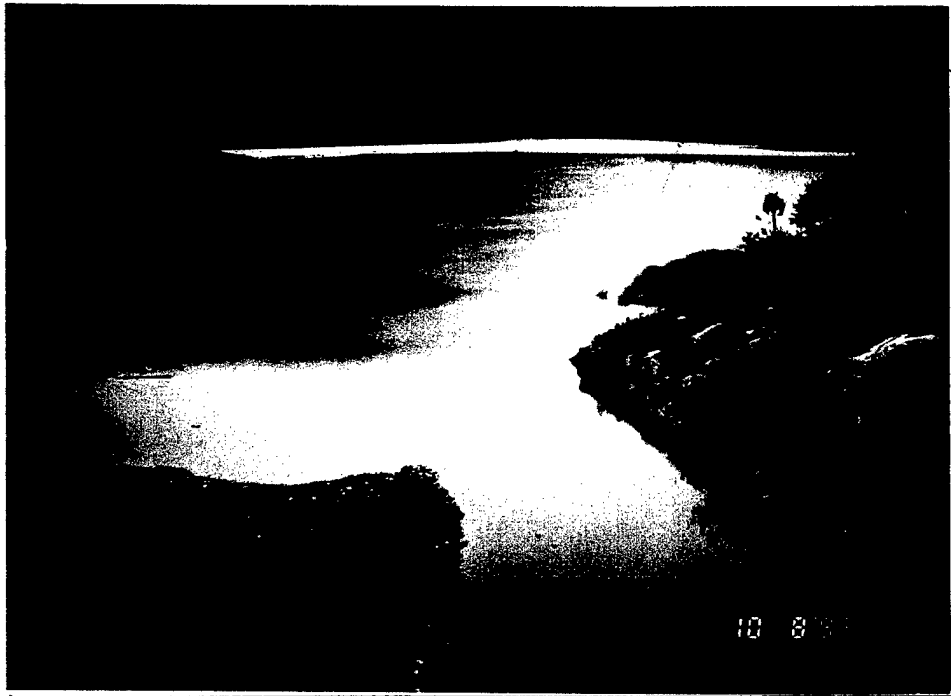
(a) Inlet Channel. The inlet channel is in good condition with no major obstructions. See photo D-3, Appendix II.

Photo D-3 Upstream view of inlet channel

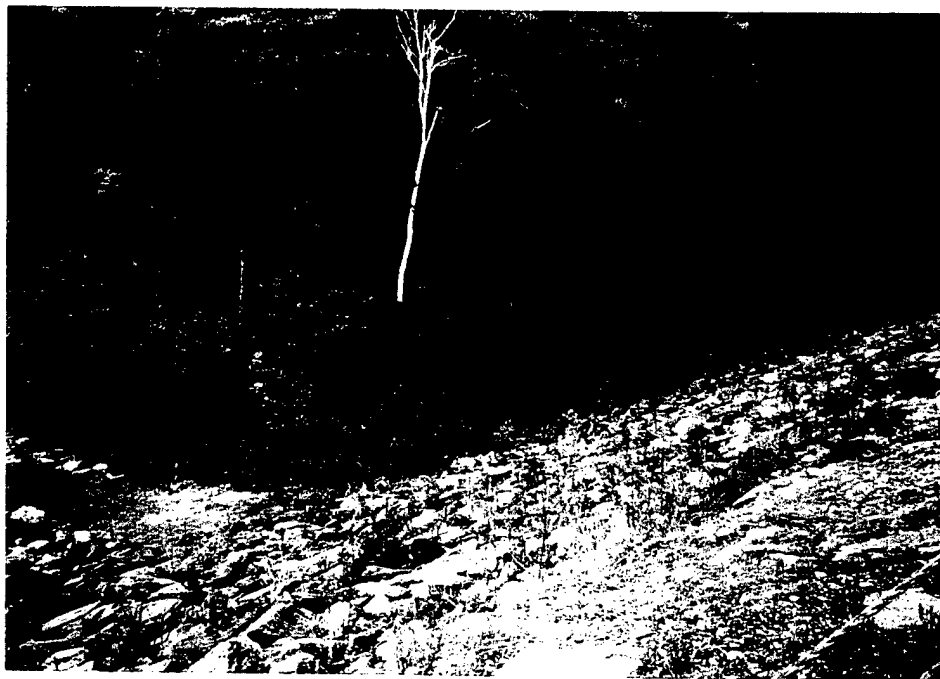
(3) Downstream Slope. The rock fill slope is in good condition and appears stable with no indication of movement or sloughing. Sparse brush growth was observed on the slope. See Photo E-8, Appendix II.

PHOTO E-8: Closeup view of downstream toe above rock fill blanket (area noted by arrow in Photo E-7). Note large trees and brush growth.

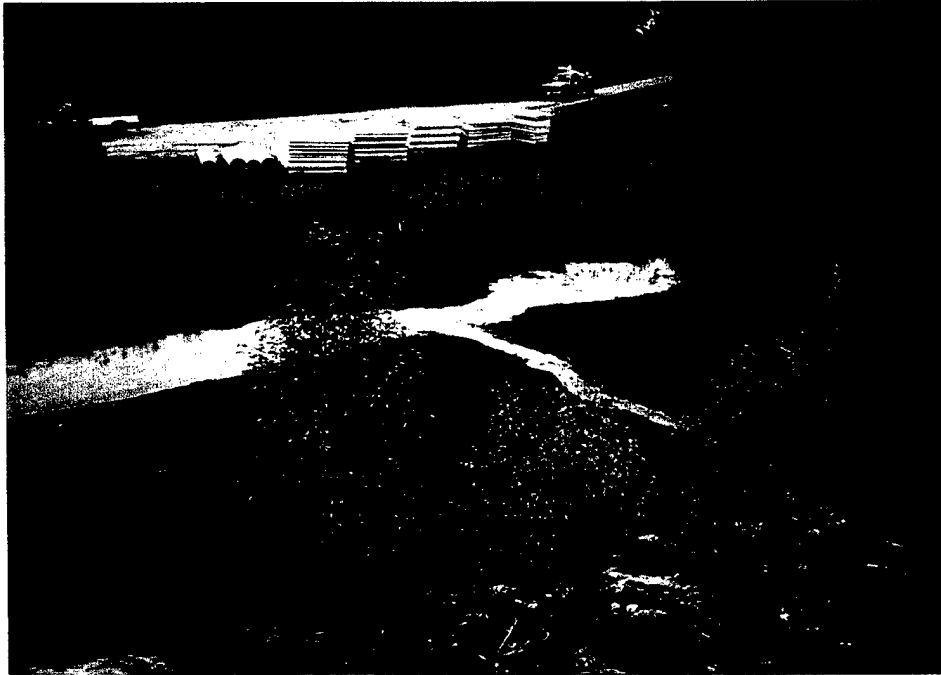
(4) Seepage. Townshend Dam has a history of seepage problems including piping and boils along the downstream toe. On the day of the inspection, flow of about 5 to 10 gpm was observed at a point along the toe of the downstream slope, within the measuring pool. See Photos E-9

and E-10, Appendix II. No subsidence or movement of the rock fill slope immediately above the seepage area was observed.

PHOTO E-9: Seepage emerging from downstream toe within the seepage pool. Flow was estimated at 10 gpm.

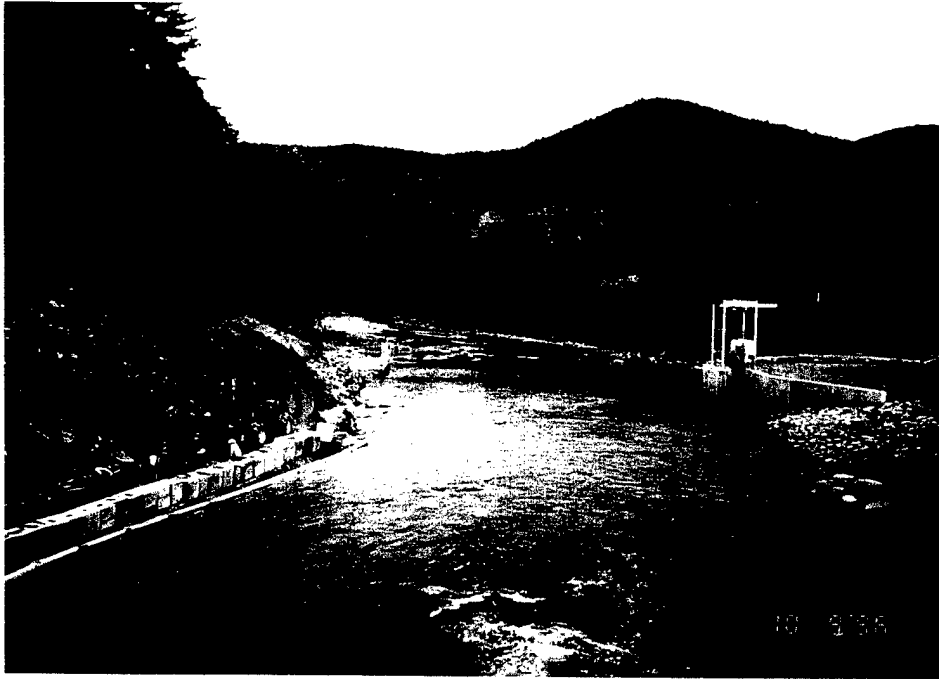
PHOTO E-13: Construction underway to repair banks of outlet channel.

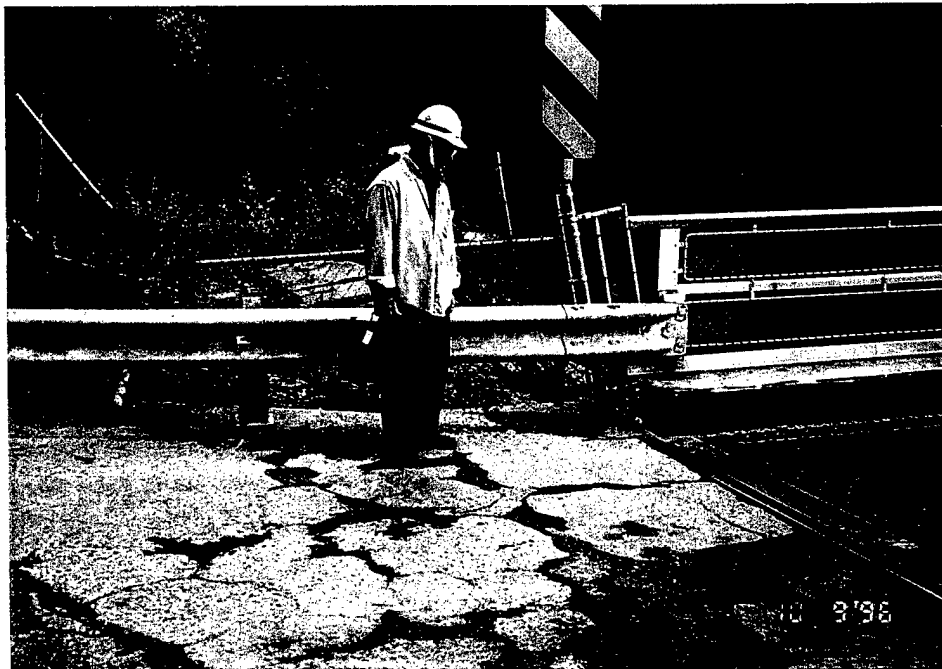
(4) Access Bridge Over Spillway. There is no indication of movement of the concrete abutments. Alligator cracking in the concrete surface in the roadway approach lip is caused by deterioration of the concrete rather than by movement of the abutment. See Photo E-16, Appendix II. Overall condition of exposed rock is good. The structural condition of the bridges at this project are evaluated in the Bridge Inspection Program. The last inspection of the spillway bridge was performed in 1996, and is in good condition. The service bridge is scheduled to undergo an Inventory Inspection in FY97.

PHOTO E-16: Left side of spillway bridge. Note alligator cracking on asphalt and damaged safety fence.

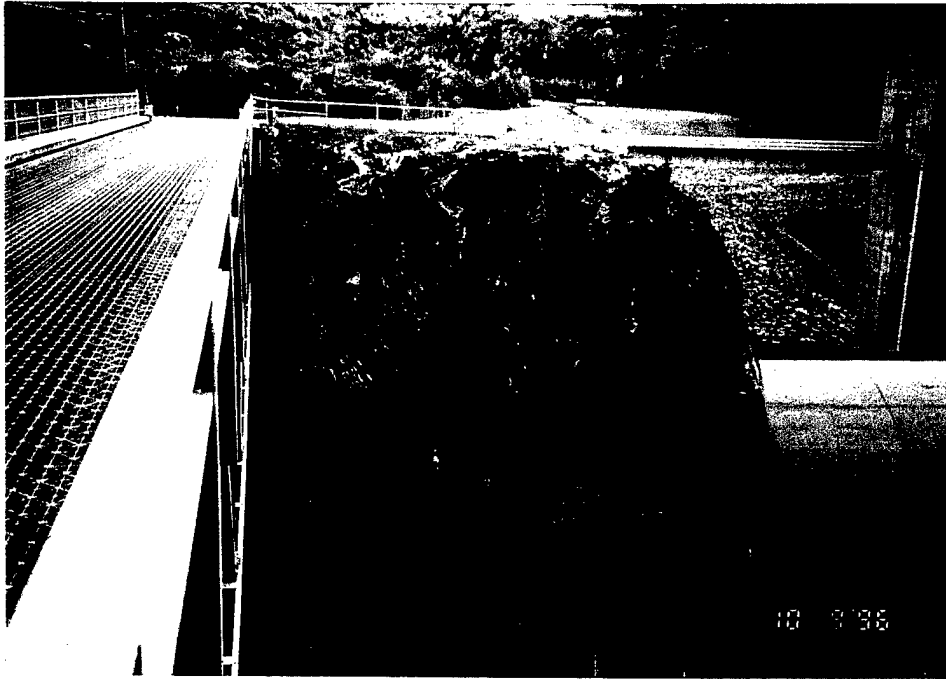
PHOTO E-17: Exposed rock face at spillway bridge
right abutment.
