CORROSION EXPERIENCE WITH TYPE 316 STAINLESS STEEL  
IN SODIUM-POTASSIUM EUTECTIC ALLOY AT 1400°F

**IDAHO NUCLEAR CORPORATION**  
NATIONAL REACTOR TESTING STATION  
IDAHO FALLS, IDAHO

IN-1185  
Issued: October 1968  
Metals, Ceramics and Materials  
TID-4500

T. L. Hoffman

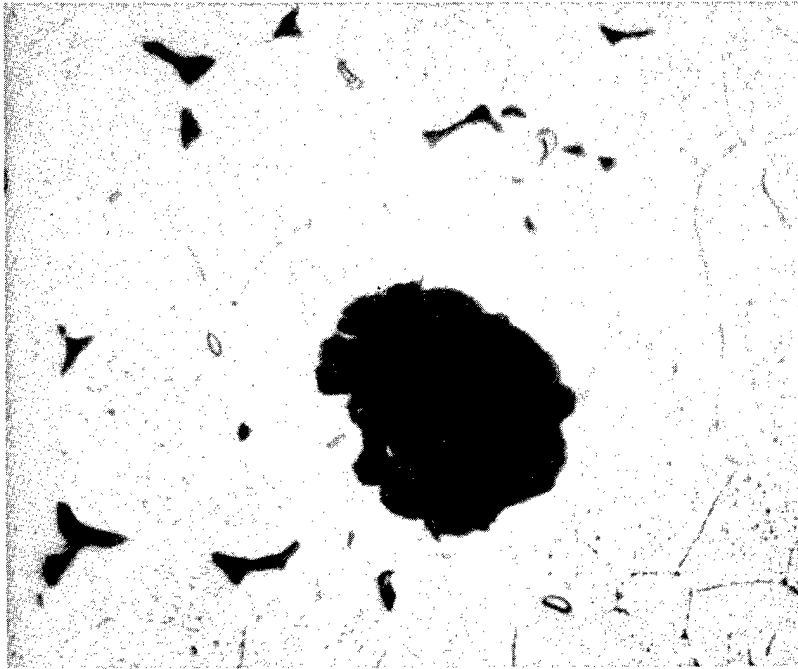
A metallographic examination of the piping indicated carbide precipitation at the grain boundaries and concentrations of up to 11 percent sigma phase as shown in Figures 6 and 7. A band of decarburized material 1 to 2 mils thick, was found on the NaK-side of the pipe wall, as illustrated in Figure 8. A 0.2- to 0.3-mil thick porous oxidation film was observed on the outer surface of the pipe wall, as illustrated in Figure 9. This film was only partially soluble in boiling nitric acid and was magnetic.

Figure 6 Sigma particle in cross-section of Type 316 ss pipe after 15,000 hours service at about 1400°F. Total Sigma is about 11%.

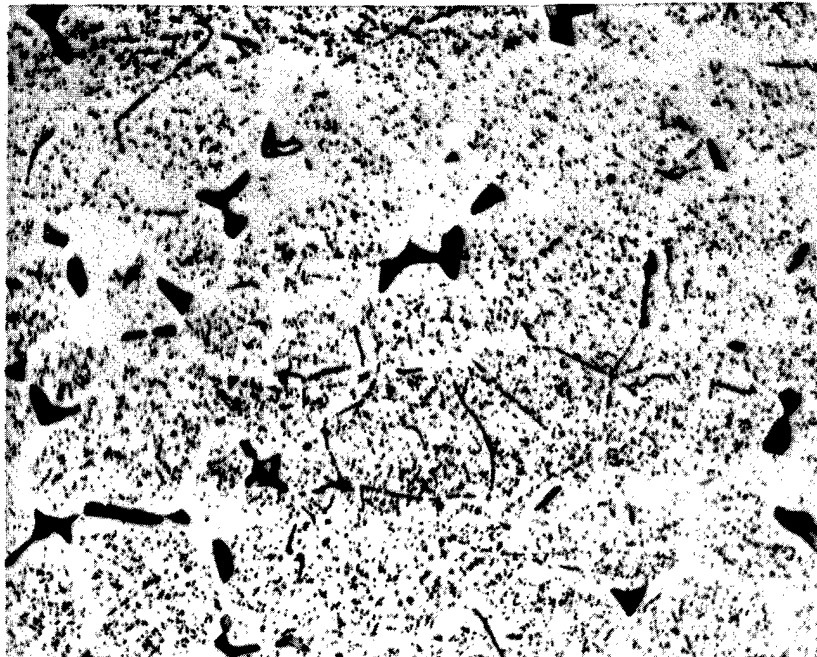
Figure 7 Cross-section of Type 316 ss pipe after 15,000 hours service at about 1400°F. Total Sigma is about 4%.

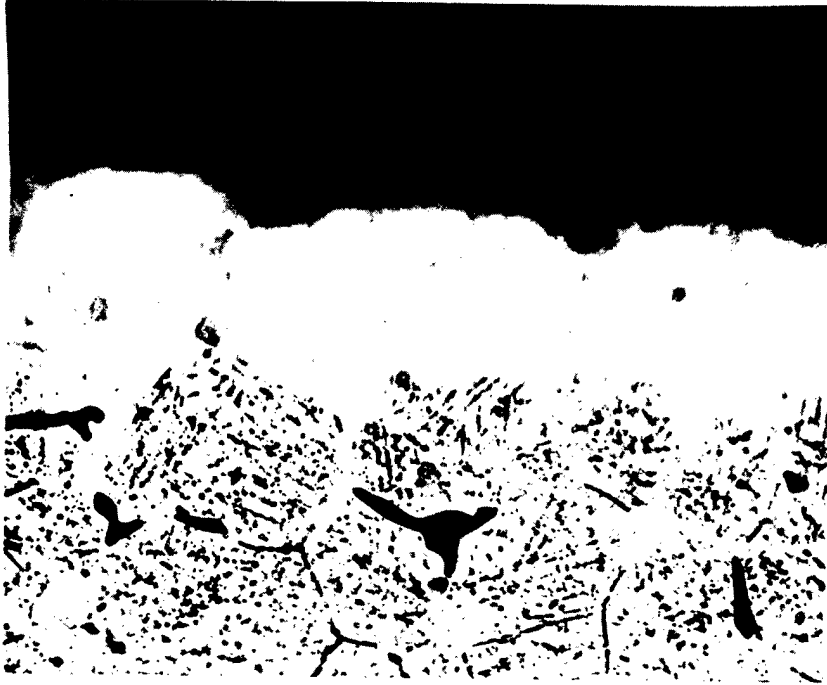
Figure 8 Decarburized zone of inside edge of 3-inch Sch. 40 Type 316 ss pipe after 15,000 hours service at about 1400°F.

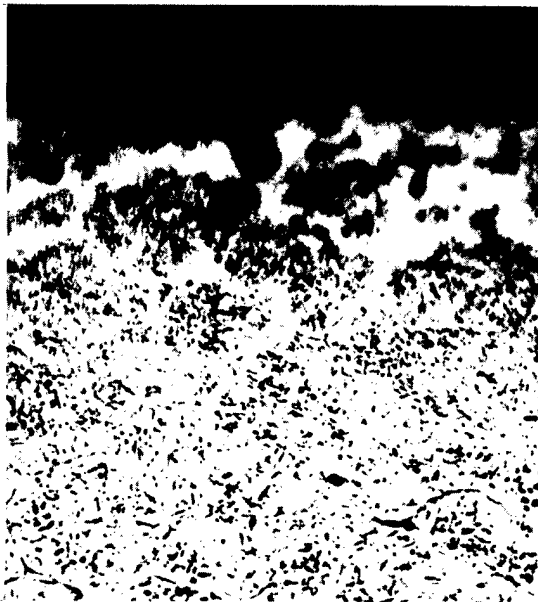
Figure 9 Air-side of Type 316 ss pipe after 15,000 hours service at about 1400°F.

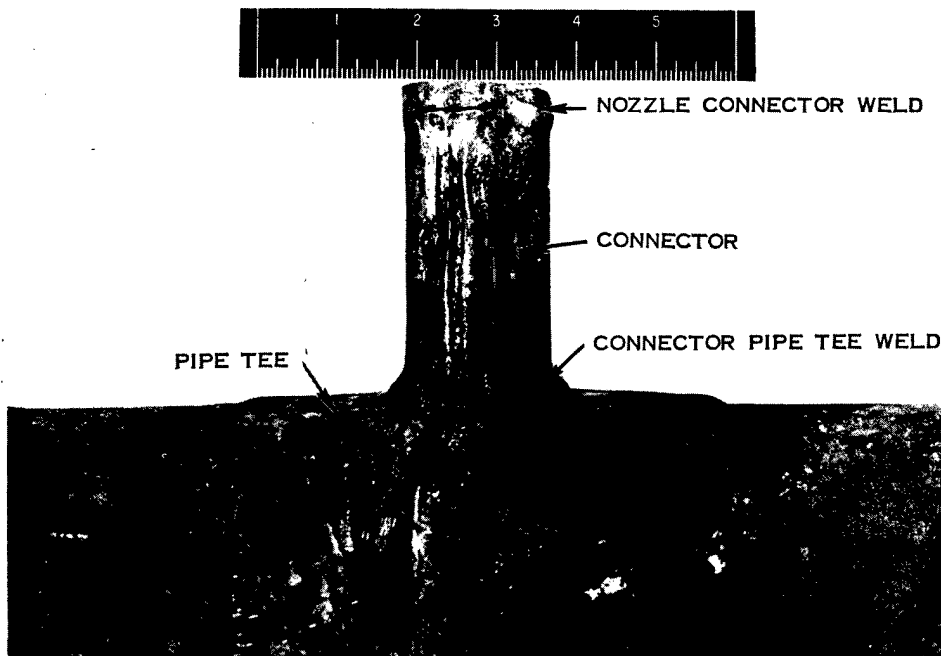
A service failure occurred at the weld joining a 1½-inch Schedule 40 pipe tee connector and the nozzle of a NaK expansion tank (Figure 11) after 3,240 hours service at 1100-1400°F and 360 hours service below

Radiographs showed that along the circumference of the root of the weld there was inadequate weld deposit penetration, and incomplete fusion. In addition, mis-alignment and poor beveling of the pipes were observed. A post-failure examination showed hundreds of 10-mil deep marks on the surfaces of the inside pipe shoulders. These marks presumably are tool impressions from a fluted burring reamer that may have been used for removing burrs caused by cutting the piping. In addition, the machining marks on the faces of the two pipes were still evident. An almost continuous combination of both double and triple notches also existed at the pipe-weld-pipe joint.

A microscopic examination of cross sections of the pipe-weld-pipe joint revealed only one crack in the weld and none in the piping. The crack was propagated both through the grains as a transgranular fracture and between the grains as an intergranular fracture, as shown in Figure 10. No plastic deformation of the grains of the weld occurred. No sigma phase or carbide precipitation at the grain boundaries of either the wrought piping or the case weld deposit was found. Electron microscope fractographs of this weld are typified by classic striations or crack arrest lines shown in Figure 12. By comparing this fractograph against published<sup>(15)</sup> standards, the fatigue failure appeared to be caused by multi-cycle, low stress forces. Evidence of "dimples", typical of ductile fractures, were absent.

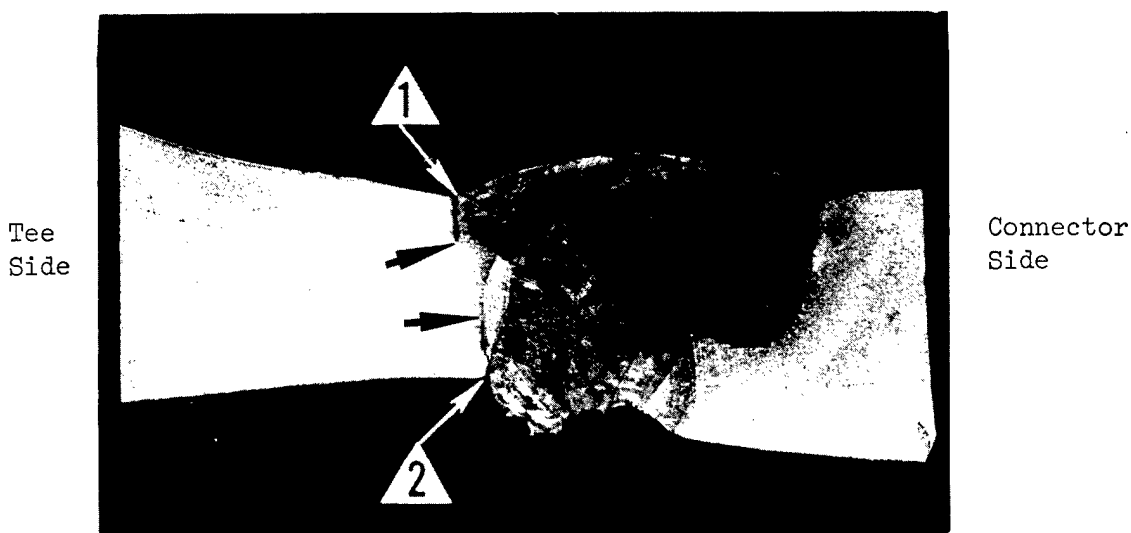
The crack on the outside of the tee-to-connector weld (tee side) was approximately 0.8-inch long. The crack on the inside of the same weld (also on the tee side) followed the edge of the weld around approximately 75 percent of the circumference. A photograph of these cracks is shown in Figure 13. In this figure, the crack on the outside penetrated 0.053 inches, the inside crack 0.047 inches, with 0.080 inches of sound metal between the crack terminations. The crack on the outside originated at the base of the weld bead at a sharp re-entrant angle. A further inspection showed the presence of a crack on the inner wall of the connector, Figure 14. The crack originating on the outside was lined with an oxide deposit while the inside crack was free of oxide. The three cracks were transgranular, as can be seen in Figures 15 and 16. A second transgranular internal (NaK side) crack, shown also in Figure 14, was found in the wrought pipe that was about ½-inch from the tee-to-connector weld.

Figure 13 Cross-section through tee connector weld. White arrow 1 shows outside crack. White arrow 2 shows inside crack. Black arrows indicate crack terminations.

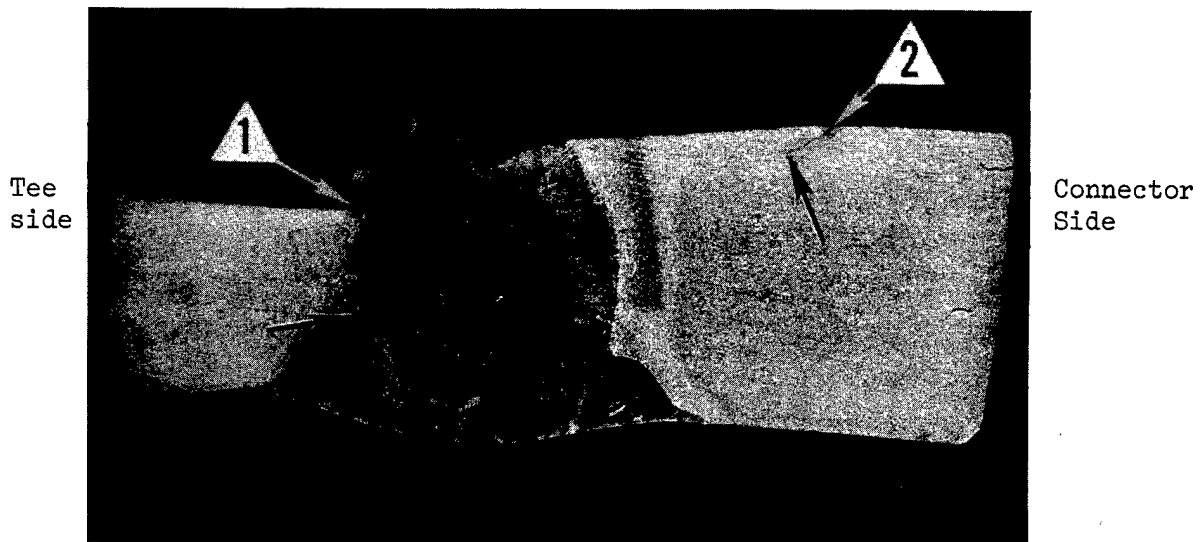
Figure 14 Cross-section through wrought connector. White arrow 1 shows crack on the inside at the base of the weld bead. White arrow 2 shows additional crack found on the inside of the connector. Black arrows indicate crack terminations.

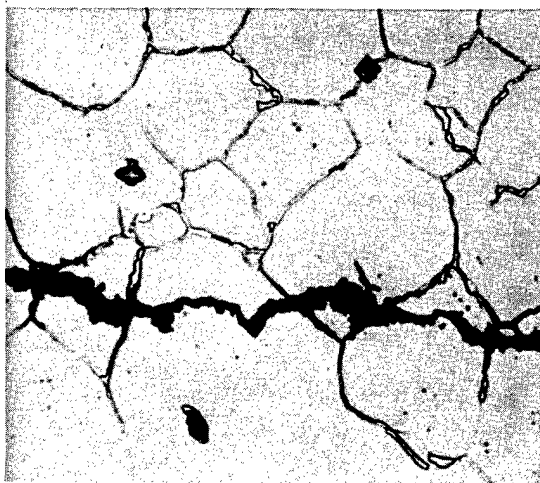
Figure 15 Internal crack in wall of pipe tee connector showing transgranular propagation after 15,800 hours service at about 1100-1400°F.

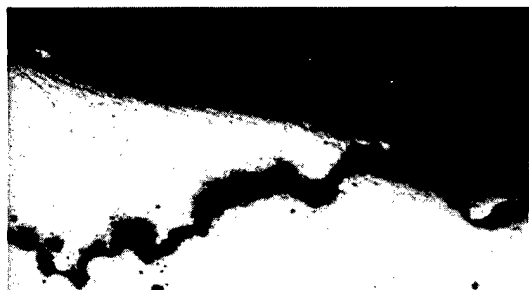
Figure 17 Internal crack in wall of connector. (Same area shown in Figure 16.)

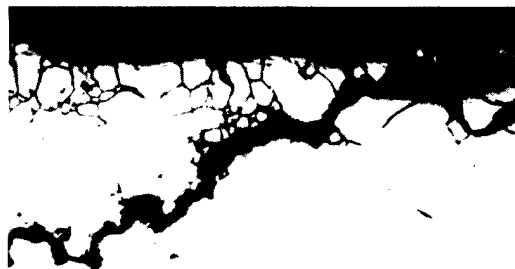
Figure 18 Internal crack in wall of connector. (Same area shown in Figure 16.)

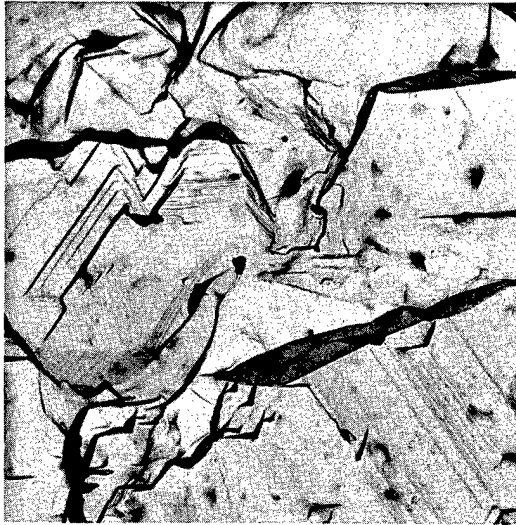
A section of the weld that joined the pipe tee to the connector, containing a representative portion of the inside and outside crack, was opened up by first cutting part way through the weld from the outside. The fracture surface of the inside crack was slightly tarnished and appeared to have been produced much later than the outside crack.

Figure 21 Surface topography of outside crack at the pipe tee connector weld.

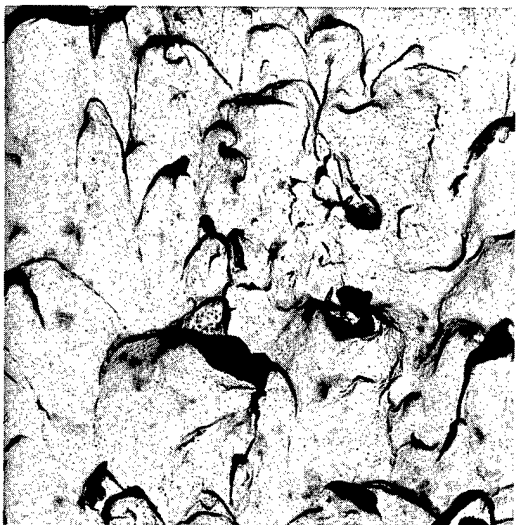
Figure 22 Surface topography produced by tearing material beyond the crack.

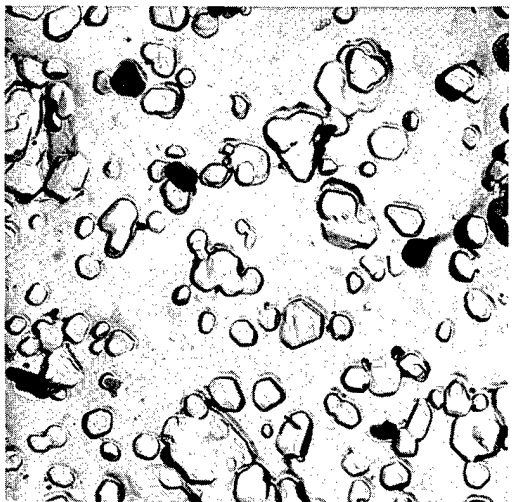
Figure 23 Surface topography of inside crack at the pipe tee connector weld.

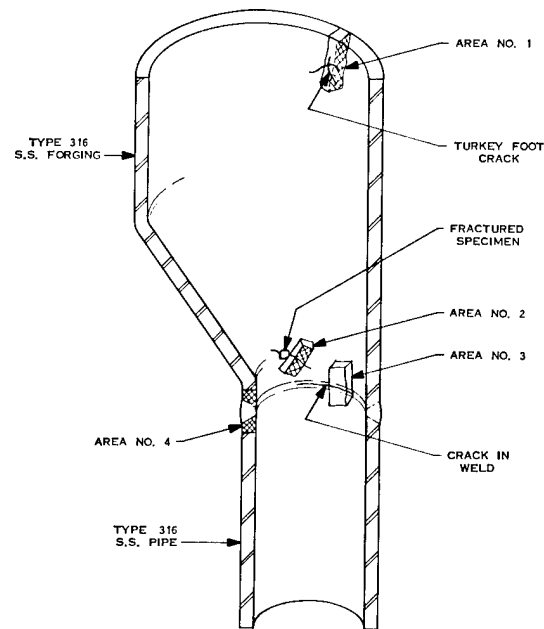
An investigation of the failure that occurred in the NaK drain line of the WCF indicated that residual and/or applied stresses cracked an eccentric reducer (Figure 24) in a manner characteristic of a brittle fracture. The weld joining this forged reducer to the 1 1/2-inch pipe suffered a ductile thermal fatigue fracture. Service time on this fitting was 19,080 hours at 1100-1400°F and 1,300 hours below 1100°F. There were 43 starts from room temperature.

Post-failure examination revealed two cracks in the reducer, and another crack in the weld that joined the reducer to the 1½-inch pipe. Both reducer and pipe were Type 316 stainless steel. Figure 24 shows the location of the three cracks. The cracks located at areas 2 and 3 in Figure 24 completely penetrated the forged reducer and weld, respectively, while the turkey-foot crack in area 1 was about 77 mils deep. Both cracks in the reducer were next to welds.

Figure 24 Diagram of 3-inch x 1½-inch eccentric reducer.

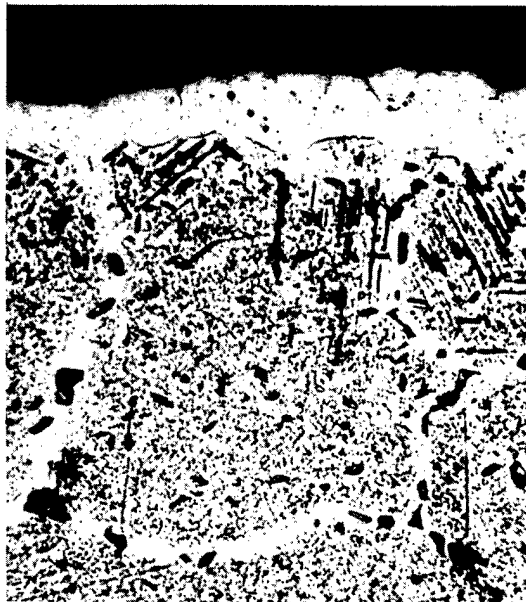
A metallurgical study of the reducer and weld at the cracks indicated that a decarburized zone occurred at the NaK stainless steel interface, Figure 25. Some grain droppings were observed in the decarburized zone, Figure 26. Sigma phase was observed at the root of the turkey foot crack, Figure 27, and in a cross-section of the weld in area 4, Figure 28. The massive disintegration of the forging at area 2, together with intergranular fracturing, is shown in Figure 29. A careful inspection of Figures 25 and 27 shows that carbides were precipitated at the grain boundaries of the forged reducer.

Figure 25 Decarburized zone of the inside surface of the reducer at Area #1 in Figure 24 after 19,100 hours at about 1100-1400°F.

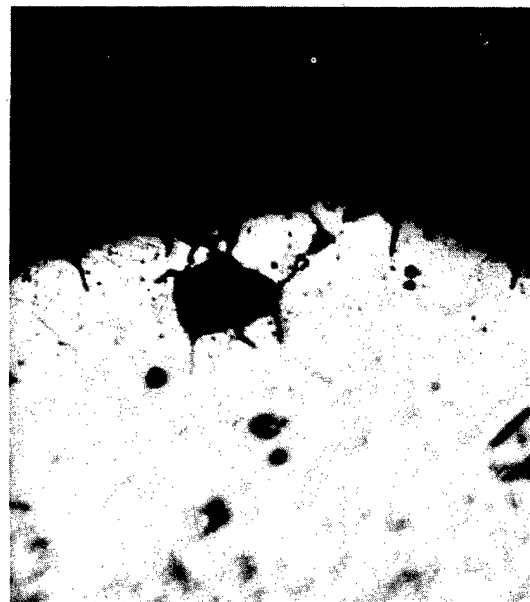
Figure 26 Grain droppings in the decarburized zone of the reducer at Area #1 in Figure 24 after 19,100 hours at about 1100-1400°F.

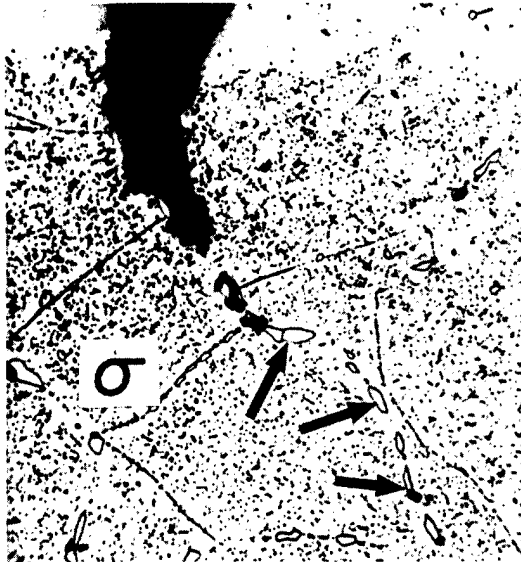
Figure 27 Root of the turkey foot  
crack on the inside surface of the  
reducer at Area #1 in Figure 24  
showing sigma phase formation after  
19,100 hours at about 1100-1400°F.

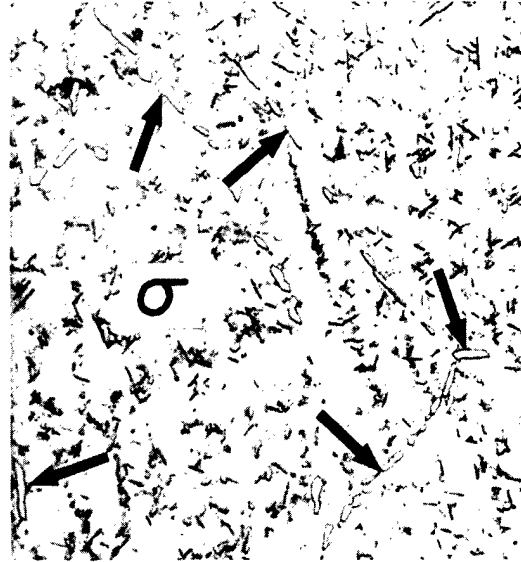
Figure 28 Weld at Area #4 in Figure  
24 showing sigma phase formation  
after 19,100 hours at about 1100-  
1400°F.

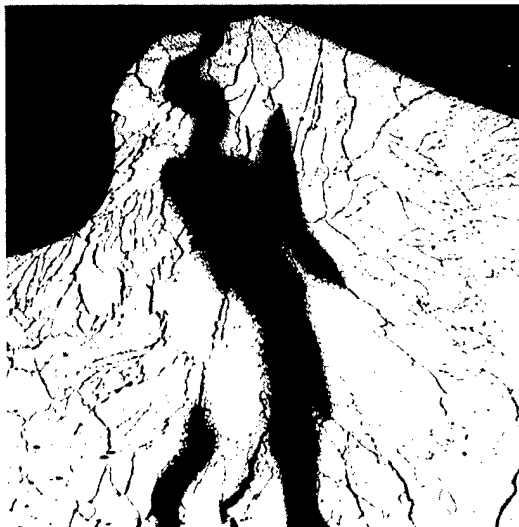
Figure 29 Cross-section of forging  
at Area #2 in Figure 24 showing  
intergranular fracturing after  
19,100 hours at about 1100-1400°F.

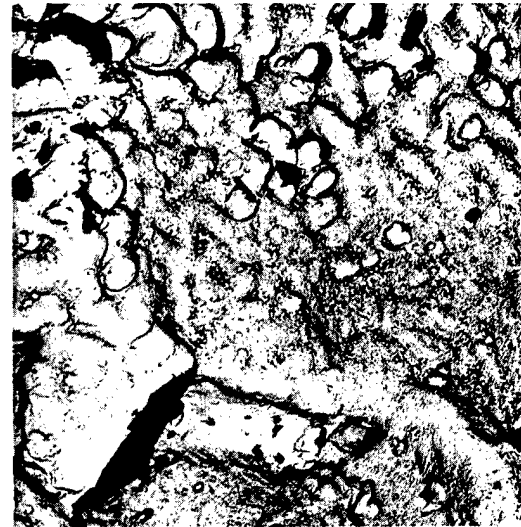
Electron microscopic fractographs of the fracture in the weld are typified by elongated dimples, Figure 30. These data suggest that shearing forces were imposed upon the weld, causing a ductile fracture. The fracture in the eccentric formed reducer has a cleavage type profile, Figure 31. This suggests that a brittle fatigue mechanism fractured the reducer.

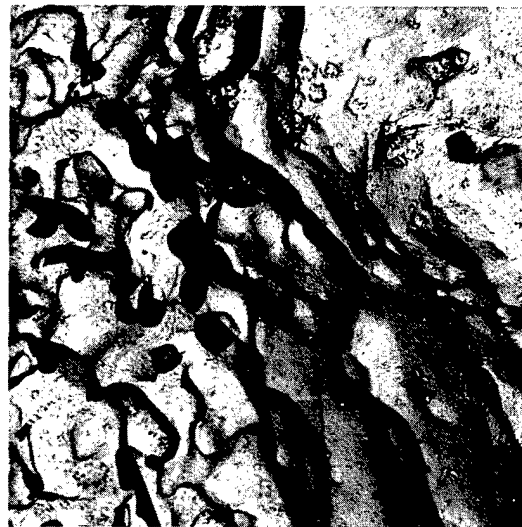
Figure 31 Surface topography of the crack of the forged reducer at Area #2, after 19,100 hours service at about 1100-1400°F showing both elongated or tear dimples of ductile fatigue and intergranular brittle fatigue.

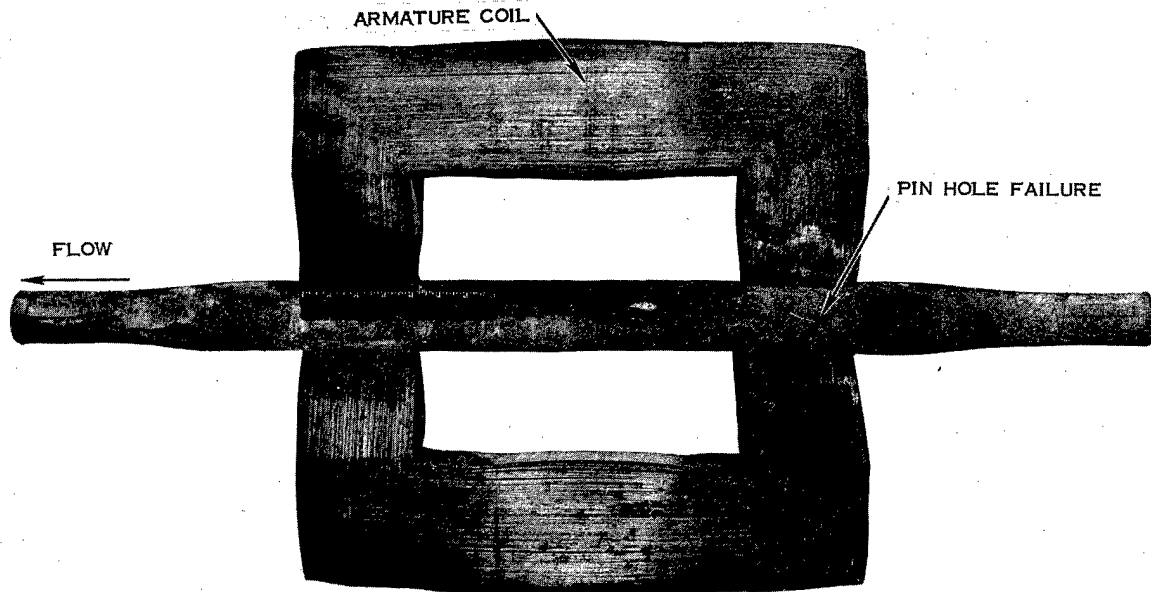
There is no complete explanation for this failure; although, there is considerable evidence of carburization of the pump tube, and this is an area where cavitation could occur.

Figure 33 Dismantled NaK electromagnetic pump tube and armature coil.

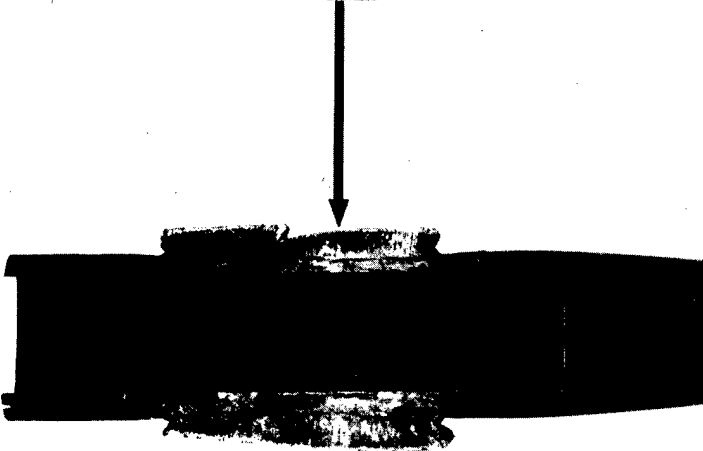
Unetched .25X  
Figure 34A Inside surface  
of NaK EM pump tube after  
20,100 hours at 1022-1400°F.

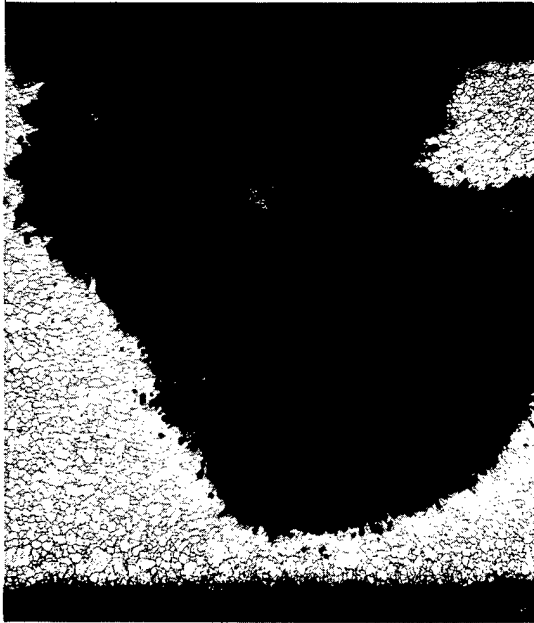
Figure 35 Cross-section of pin-hole in NaK pump tube after 20,100 hours at about 1022-1100°F.

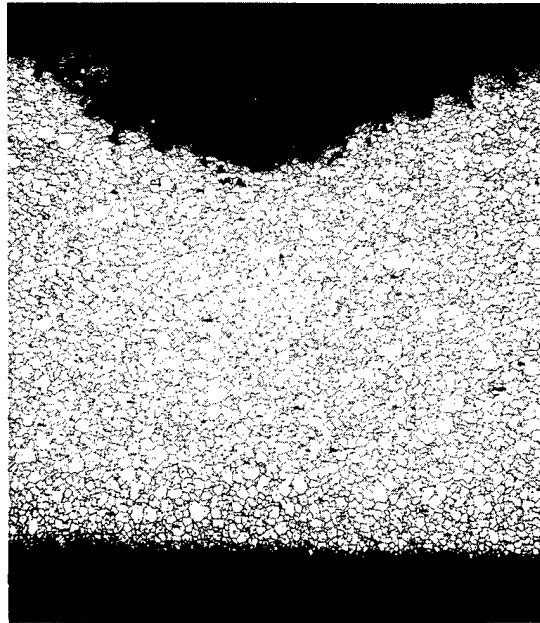
Figure 36 Cross-section of pit in NaK pump tube after 20,100 hours at about 1022-1400°F.

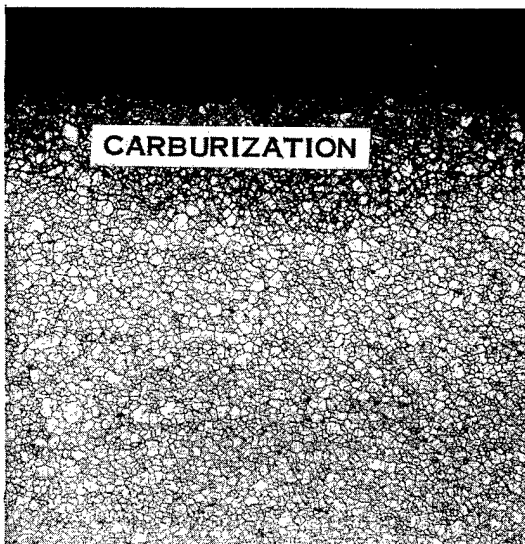
From X-ray diffraction studies, the carburized band was characterized as almost 100 percent alpha iron; silicon carbide was a minor crystalline component of the band. Chemical analysis confirmed that the pump tube material was Type 316 stainless steel.

Figure 37 Cross-section of EM pump tube showing a carburization band on the NaK side of pump tube after 20,100 hours at about 1022-1100°F.
