OH-6A

ACCIDENT SUMMARY

OH-6A ACCIDENT SUMMARY

1 February 1965 through 30 June 1967

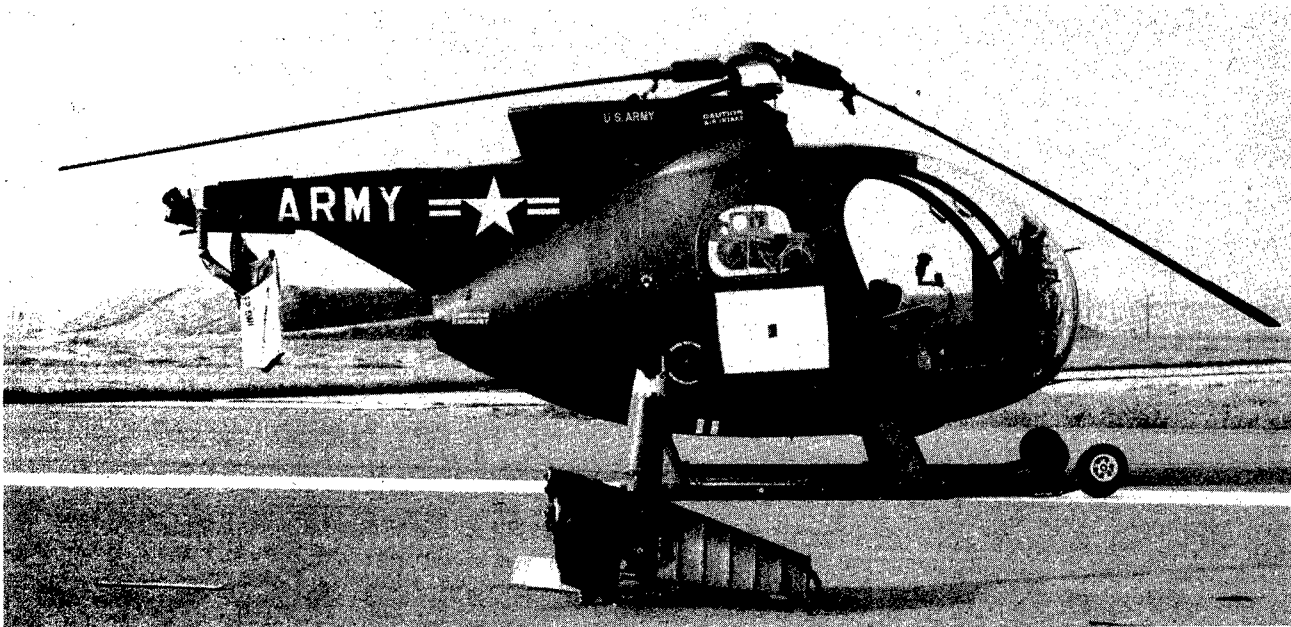
E252

E252—A test pilot, with a flight test engineer aboard, was making a practice autorotation. The maneuver appeared normal to the pilot and qualified ground observers. The helicopter touched down in a near level attitude with minimum forward speed. Immediately after touchdown, a main rotor blade struck the tail boom, severing the tail section and damaging the main rotor. The landing was made on a smooth hard surface runway. The helicopter slid approximately 14 feet from the point of touchdown and turned 20° to the left of the runway heading. The engine was

shut down and the main rotor allowed to stop before the crew got out.

CAUSE—Pilot technique of immediately lowering collective and applying aft cyclic control after touchdown, coupled with the sink rate, slight nose high attitude, and low rotor rpm, resulted in the main rotor striking the tail boom.

RECOMMENDATIONS—The board recommended: 1. A timely analysis of available data be accomplished to identify possible problem areas for future testing. 2. A means of determining clearance between the rotor blades and fuselage be employed when conducting tests of this nature. 3. A more accurate means of providing the pilot with information on absolute altitude and wind be incorporated in future testing involving critical maneuvers. 4. A warning type paragraph be included in the OH-6A Pilot's Handbook concerning the possibility of the main rotor blade striking the tail boom during autorotative maneuvers.

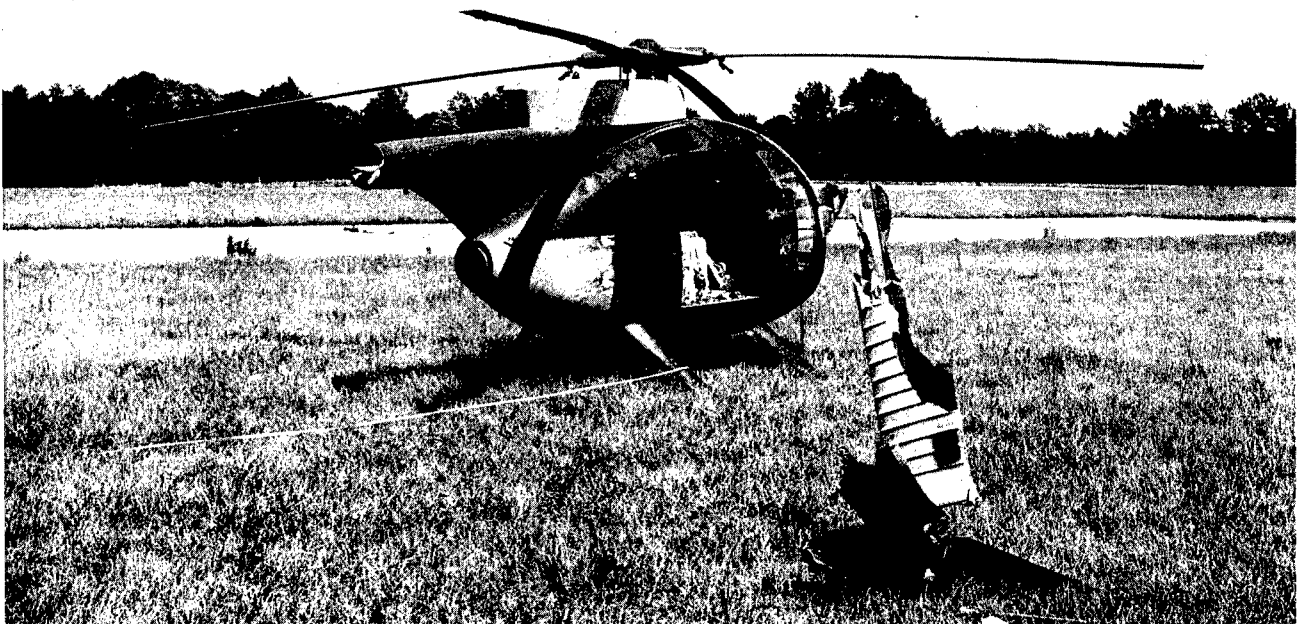
67051220

67051220—The IP and pilot took off with a gross weight of 2,340 pounds, 60 pounds under maximum gross weight. The accident occurred during a practice touchdown autorotation after 30 minutes of flight. The autorotation was made to the sod area between two runways. The aircraft landed in a tail low attitude. When it rocked forward, the main rotor blades

flexed down and severed the tail boom. The empennage arced upwards and forward into the main rotor disc. Skid marks on the ground showed the aircraft slid 55 feet after touchdown. It came to rest in an upright position on a heading of 130°, 10° left of the runway heading.

CAUSES—Instructor pilot allowed aircraft to land tail low. He did not demonstrate procedure for autorotations with loads before allowing pilot to practice autorotation with load. Probable factors were: Skid shoes used on the OH-6A create excessive drag on sod touchdowns. Main rotor blade clearance over the tail boom is less than desired.

A nonrelated factor was found in the engine access door latch. It was found that it can open because it does not have a positive safety latch.

RECOMMENDATIONS—The board recommended:
1. All instructor pilots be directed to comply with the printed syllabus of instruction. 2. The OH-6A Standardization Guide, paragraph 2, lines 3-34, and TM 55-1520-214-10, be reviewed to determine whether the operating techniques now used are satisfactory for the aircraft. 3. An improved skid shoe be designed for the OH-6A. 4. A positive safety latch be developed and installed on OH-6 engine access doors. 5. An engineering study be conducted by higher headquarters to establish a minimum safe blade clearance over the tail boom that can be measured by ground crewmen on a periodic basis.

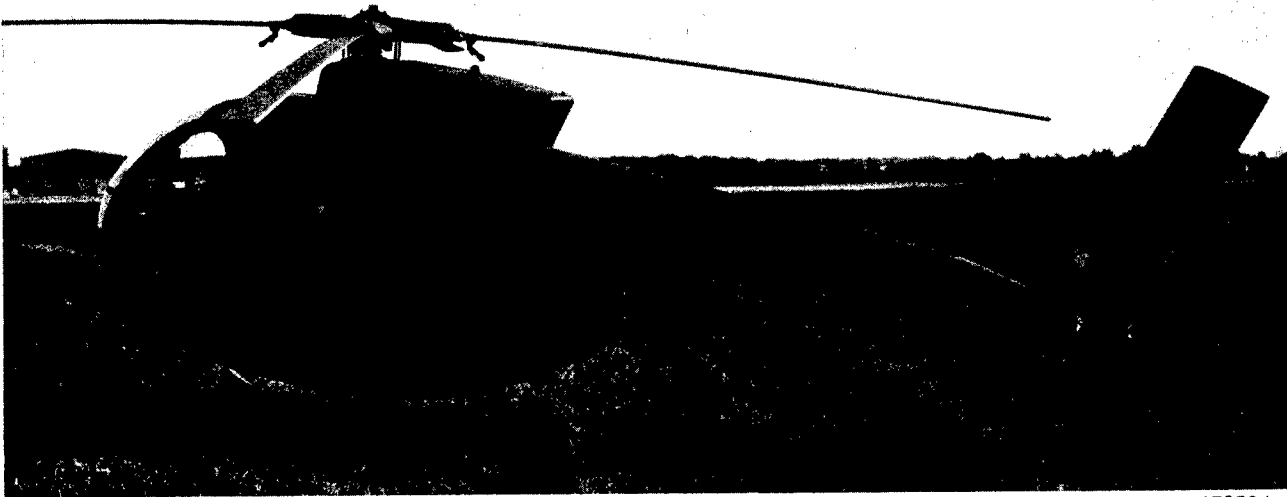
67052402

67052402—Engine instruments indicated normal on

CAUSE—The most probable cause of this accident was the instructor pilot or pilot inadvertently applying power during the completion of the autorotation, causing the aircraft to become airborne and uncontrolled.

RECOMMENDATIONS—The board recommended: All pilots be cautioned that it is imperative for the throttle twist grip to be held against the idle stops during pitch application for termination of autorotations and that the collective pitch must be full down prior to adding power during all ground roll operations.

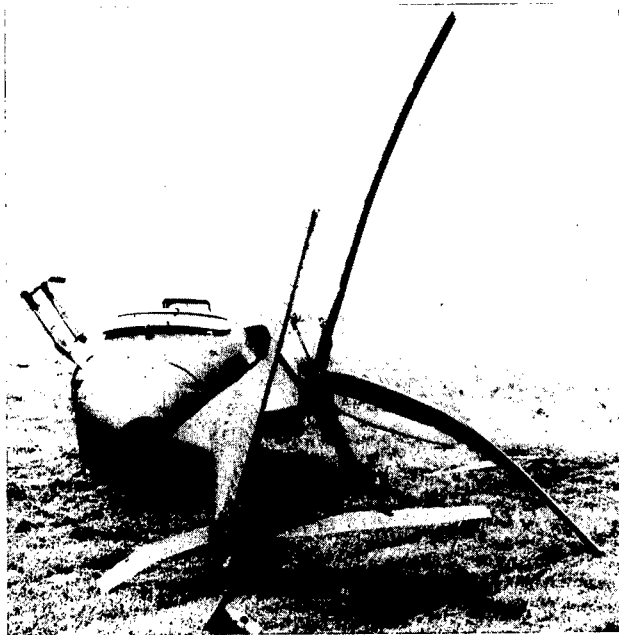
67052503

67052503—The test pilot had been flying for 3 hours, compiling data to verify the height-velocity curve at gross weights of 2,200 and 2,400 pounds. The next phase of testing was started with a change of autorotation entry, airspeed, and time delay. These changes were 30 knots airspeed with a 1-second time delay. Two autorotations, using the above criteria, were made by the copilot. He was not satisfied with the results because he felt they were marginal. The pilot did not consider the copilot's method of acceleration to the desired 50 knot flare speed as the best procedure because he felt the approach angle attitude was too steep. The pilot then entered autorotation at 200 feet agl, indicated airspeed of 30 knots, and a 1-second time delay prior to flight control

movement after chopping the throttle. A lesser dive angle was used to accelerate to the required 50-knot flare speed. This airspeed was never attained. An attempt to flare at an indicated airspeed of 47 knots was discontinued at near level attitude when it was noted that the usual buildup which accompanies the flare was not apparent. The sink rate was high and not abating, so the pilot immediately leveled the helicopter and applied partial collective pitch and full throttle. These actions slowed rate of descent slightly. The aircraft struck the ground in a level attitude with an approximate forward airspeed of 40 knots, fracturing all four landing gear struts. The left skid completely separated, causing the aircraft to pivot to the left more than 360°. It came to rest on its left side.

CAUSE—The cause was determined to be pilot

technique, while operating in the extremely hazardous area of the height-velocity curve. This technique resulted in an extremely high sink rate. The pilot then attempted an abort. However, recovery was started too late to prevent ground contact.

RECOMMENDATIONS—The board recommended: When test pilots are to determine a helicopter's height-velocity curve, extreme care should be exercised when approaching this critical curve area. Operation in the critical area of the curve should

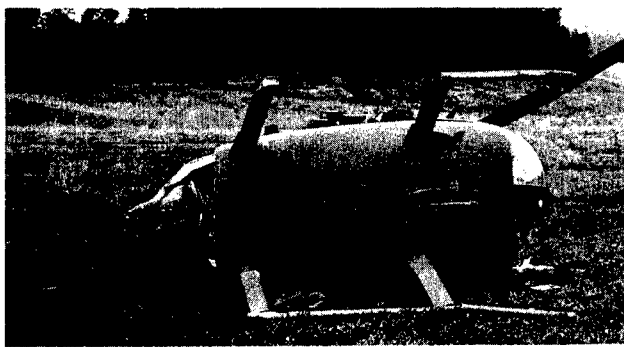
67061507

67061507—The aircraft was returning from a training flight for refueling. Nearing the airfield, the pilot started a descent. As he did, the rotor and engine rpm increased toward the red lines. The pilot increased collective, called his wingman, and informed him of the difficulty. As he lowered collective to start the approach, the engine and rotor rpm began to increase again. The pilot continued to lower collective to approximately 23 pounds of torque. The aircraft leveled off at 20-30 feet and would not descend. A go-around was made. On the second ap-

proach, the pilot used the governor control beep switch and beeped the engine to low range for 10 seconds. He then began the approach by lowering collective. The engine and rotor again went to 110% and 514 rpm and the aircraft would not descend. On the third approach, the pilot used the same technique of keeping the engine down to low range and also closed the throttle to the ground idle position. Again, the aircraft would not descend. On the fourth approach, the pilot attempted to get as low as possible before reaching the field. As he started the approach with the engine beep at low range and throttle closed to ground idle position, the engine and rotor rpm started increasing and the aircraft began a slow climb. The pilot lined the aircraft up with the runway, completely closed the throttle, and entered autorotation. Rotor rpm on entry was 520, altitude was 20-30 feet, and airspeed approximately 40 knots. The pilot began a slight flare at approximately 12 feet and pulled pitch at approximately 6 feet. The aircraft touched down heels low and slid 32 feet before becoming airborne again. During the ground slide, the yellow main rotor blade struck the top of the tail boom, causing it to snap violently. This snap caused the coupling between the tail rotor drive shaft and tail rotor gearbox to separate, resulting in loss of antitorque control. At this point, the aircraft became airborne, possibly from application of aft cyclic. It yawed to the right with the heel of the right skid striking the ground. The red and black blades struck the tail boom and ground, causing the aircraft to spin to the left. It came to rest on its left side.

CAUSES—Engine and rotor overspeed due to failure of the fuel control governor. This failure was caused by a small piece of nylon (used as a thread locking device) lodged in the Py bleed orifice. The pilot used poor judgment and technique in starting an autorotation at low altitude and airspeed in the caution area illustrated by the Flight Envelope Curve Chart in TM 55-1520-214-10. Supervisory error was evident on the part of the IP at ground control for advising the low shallow approach.

RECOMMENDATIONS—The board recommended:
1. This accident be brought to the attention of all OH-6 aviators.
2. Positive quality control be established in manufacturing the fuel control unit.

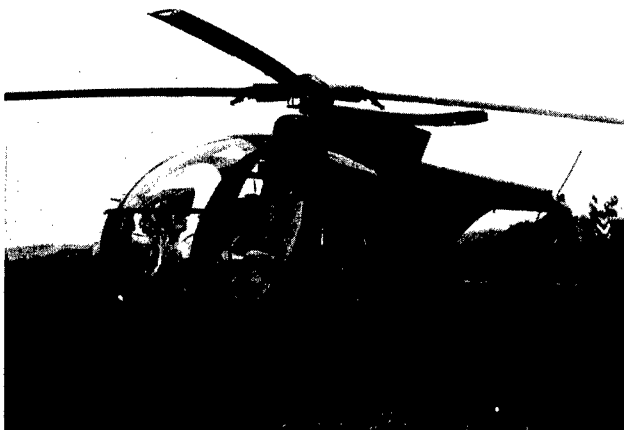
67062708

struck the tail rotor drive shaft and severed the tail boom.

CAUSES—IP allowed the pilot to hold centered or slightly aft cyclic during initial touchdown, with possible further aft cyclic movement after touchdown. This, combined with full collective travel prior to touchdown, caused a harder than normal touchdown. Low rotor rpm resulted in the main rotor striking the doghouse and tail boom.

RECOMMENDATIONS—The board recommended:
1. An investigation to determine the feasibility of lowering the doghouse and/or adding a droop in the tail boom similar to the UH-19D. 2. Stricter control over the OH-6A IP techniques and procedures for standardization. 3. All aviators be informed of the proper cyclic control movement for terminating autorotations (forward movement of the cyclic on touchdown). 4. All aviators be made aware of the correct

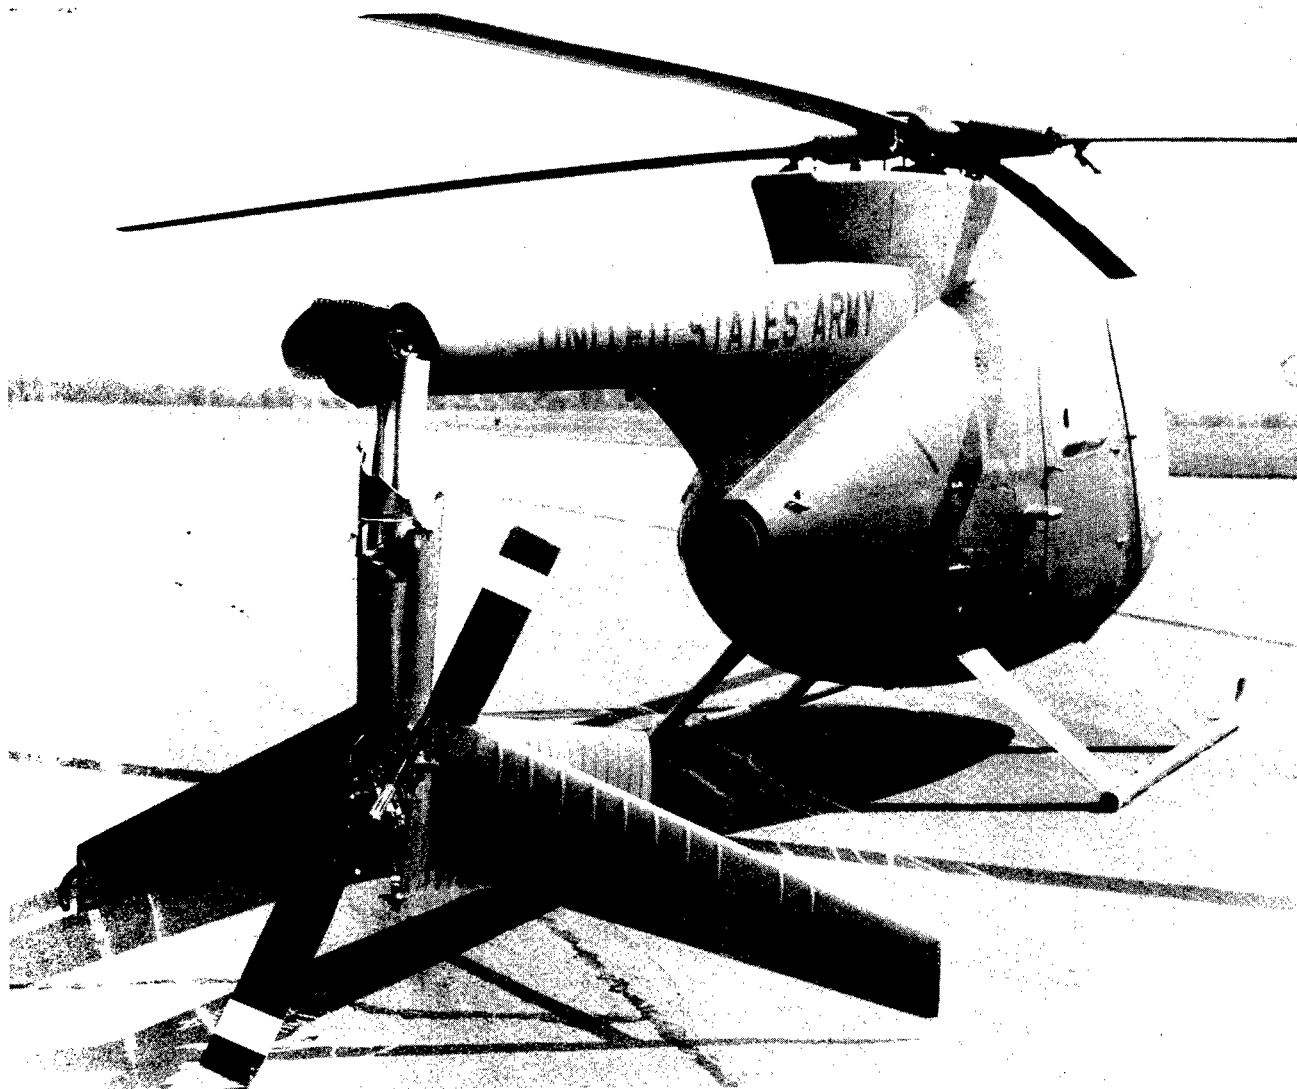
67063003

67063003—After flying 1 hour with one pilot, the IP landed and picked up another pilot without shutting down the helicopter. Six hovering autorotations were made. IP requested and received permission to use the active runway for autorotations because the sod area was too wet. He then let the pilot attempt a straight-in autorotation, entering at 500 feet. Normal deceleration was made to approximately 60 knots, rotor rpm was stabilized in the green, and a decel-

erative flare was started at 50-75 feet. Initial pitch was applied at approximately 10 feet. The right skid struck the ground at approximately 5 knots forward speed. The helicopter skipped off the ground and left cyclic was applied. Shortly after initial ground contact, the red main rotor blade struck the tail boom, partially severing it. Directional control was lost and the helicopter slid 27 feet from point of initial contact, turning approximately 43° to the right. The engine continued to run and was shut down by the crew.

CAUSES—The static main rotor blade droop angle was 1° out of tolerance due to inadequate inspection. It was suspected that the pilot landed slightly tail low with low rotor rpm, allowing the main rotor blade to flex down and strike the tail boom.

RECOMMENDATIONS—The board recommended: 1. Rigid inspection requirements of the OH-6A static droop angle to prevent recurrence. 2. Acceptance facilities establish procedures to insure the static droop angle is correct before aircraft are accepted and assigned to units. 3. Paragraph 3-34, TM 55-1520-214-10, be changed to include a warning about
