OV-1

# ACCIDENT SUMMARY

MAJORS • MINORS • INCIDENTS • FORCED LANDINGS

NOVEMBER 1, 1961 TO OCTOBER 31, 1963

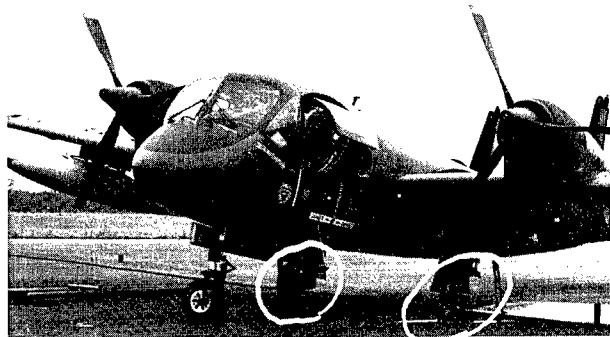
02791

THE ACCIDENT: Aircraft landed with high sink rate in nose-high attitude.

THE CAUSE: Student pilot performed power-off approach with low airspeed. IP failed to take corrective action in time.

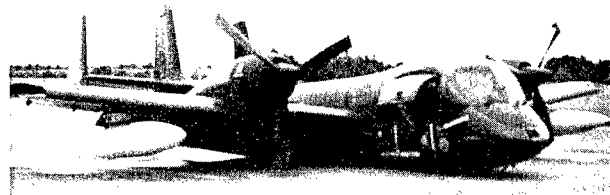
03844

THE CAUSE: IP accidentally moved gear handle instead of flaps lever during roll of touch and go landing.

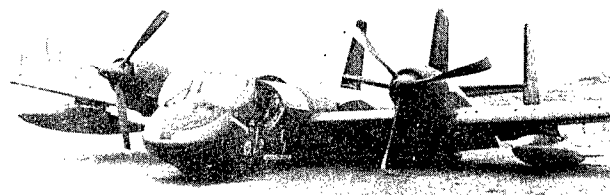
04106

THE CAUSE: High, fast downwind approach and use of reverse thrust before touchdown.

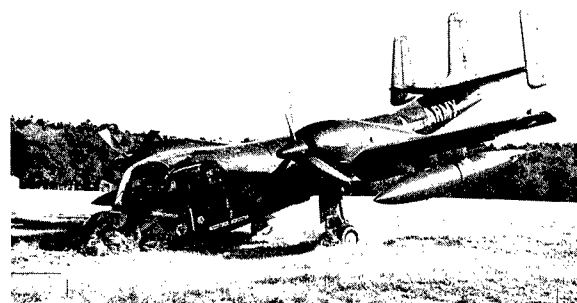
04200

THE ACCIDENT: Nose gear collapsed during landing roll on sod strip. Pilot applied full reverse thrust at touchdown and nose gear drag brace failed, allowing wheel to retract.

THE CAUSE: Materiel failure.

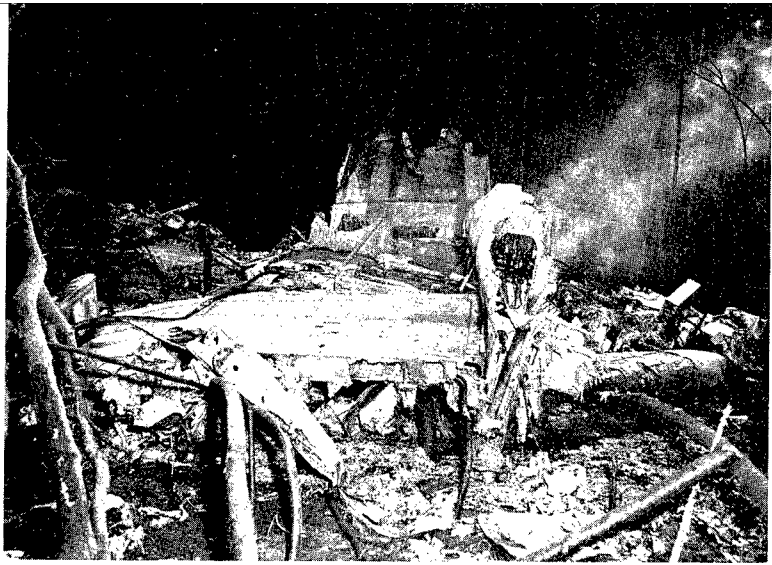
06847

**THE ACCIDENT:** Nr. 2 engine failed in flight. Propeller was feathered. Pilot was unable to jettison auxiliary fuel tanks electrically and elected not to attempt manual jettison. Aircraft lost altitude and

airspeed en route to airfield. Pilot and passenger ejected at approximately 150 feet. Aircraft crashed and burned. Pilot sustained compression fractures of vertebrae and abrasions. Passenger sustained compression fractures of vertebrae, second degree burns on hand, minimal burns of face, and abrasions. Burns caused by descent through flames of burning aircraft.

THE CAUSE: Engine failed (cause undetermined); auxiliary fuel tanks failed to jettison by electrical means (cause undetermined); and pilot failed to manually jettison auxiliary fuel tanks (emergency procedure outlined in -10).

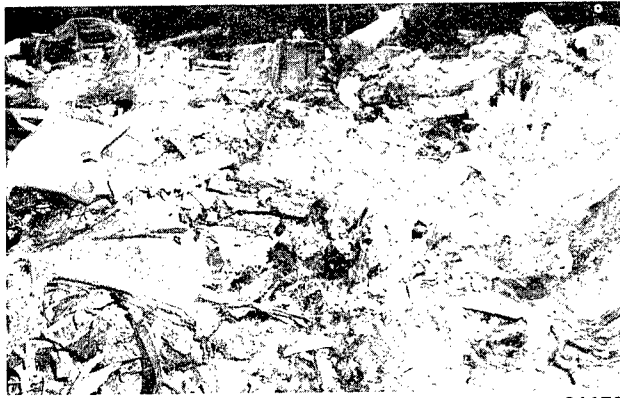
06672

fuselage in vicinity of flare pod when remaining flares were salvoed in completion of night photo mission. Fuselage broke in two and aircraft crashed. Pilot ejected and sustained minor injuries. Copilot failed to eject and sustained fatal injuries.

**THE CAUSE:** The most probable cause of this accident was premature firing of one or more flares which caused an explosion in the flare pod.

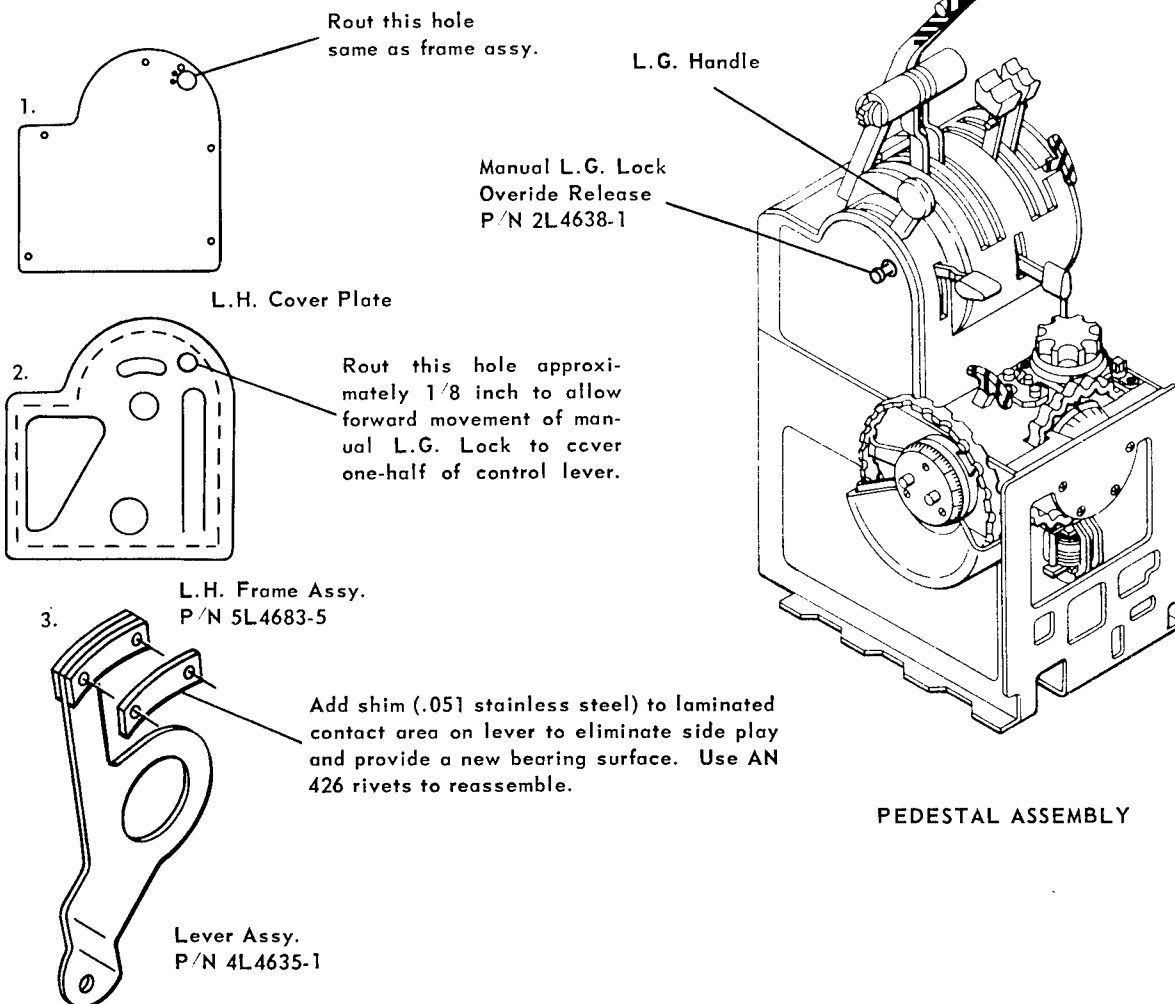
Due to several inadvertent landing gear retractions, MWO 55-1510-204-34 1, 21 Nov 1961, was issued covering inspection of the landing gear lever. Inadvertent retractions can be caused by wear in various parts of the pedestal assembly. Repair as shown should be incorporated during the next scheduled periodic inspection.

### TO PREVENT INADVERTENT RETRACTION OF LANDING GEAR DUE TO WEAR AND TOLERANCE BUILD UP OF POSITION LOCK, REWORK THE THREE PARTS SHOWN BELOW.
