# CH-37

## ACCIDENT SUMMARY

**CH-37 ACCIDENT SUMMARY**

1 July 1957 through 30 November 1966

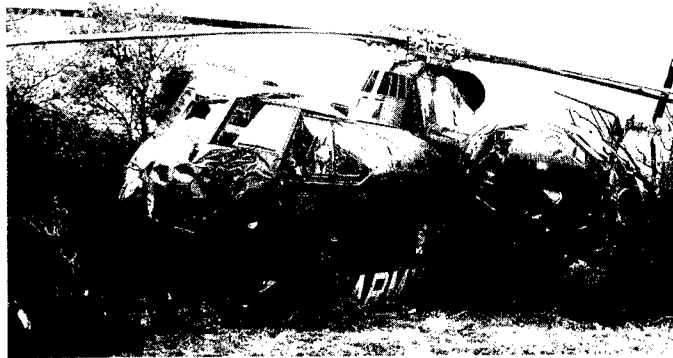
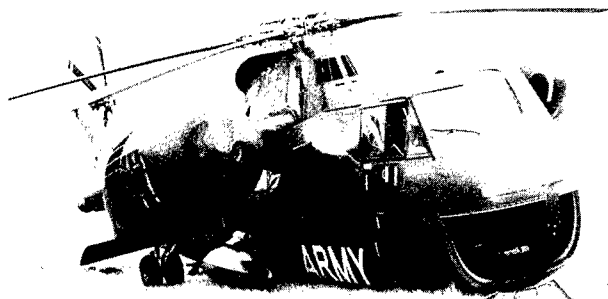
04603

**04603**—Helicopter lost altitude abruptly, following maximum performance takeoff, and settled into trees. Major damage to main rotor blades, tail rotor blades, landing gear, clamshell doors, engine and nacelles and fuselage. CAUSE: Shifting, gusty wind and downdraft, which the pilot did not anticipate prior to takeoff.

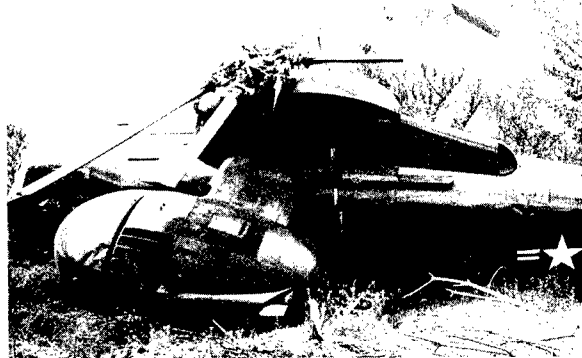
04318

**04318**—Right main gear hit soft spot in sod, digging in approximately one foot. Aircraft moved forward and came to rest on right auxiliary tank and right bottom side of fuselage. CAUSE: Landing gear down lock pin sheared during running landing due to soft spot.

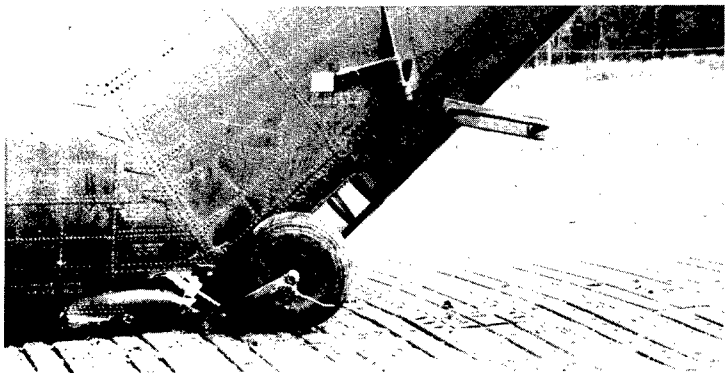
00578

**00578**—During a practice demonstration, the helicopter landed and the pilot was instructed to take off again. At approximately 50 feet, the helicopter began to lose altitude. The main rotor blades struck a tree 240 feet from the point of takeoff. One fatality and two injuries resulted. CAUSES: (1) Pilot was

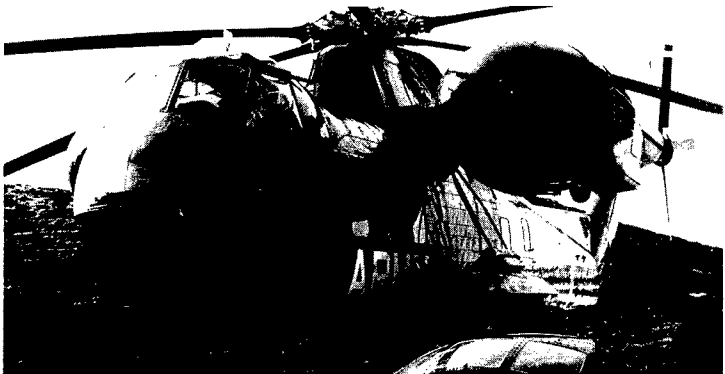
04608

**04608**—Noise was heard as helicopter landed. Investigation revealed tail wheel assembly had collapsed. CAUSE: Low tail wheel strut condition, combined with the wave action of touching down on

PSP, caused tail wheel yoke to hit ground. It was determined that the liquid spring failed due to the loss of hydraulic fluid from the strut which occurred during one of four previous landings.

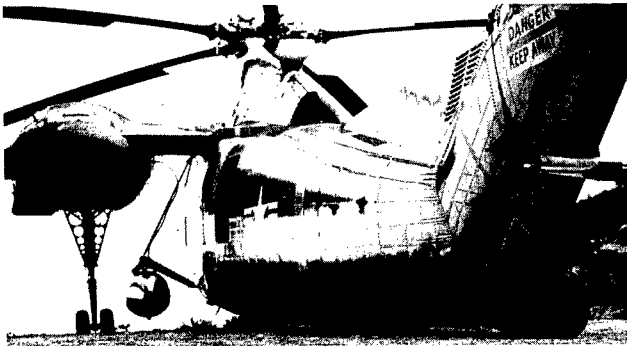
A117

**A117**—After takeoff, the No. 1 engine began to lose power. The helicopter failed to develop sufficient airspeed and altitude to clear wires across the flight path. Pilot attempted to abort takeoff and land. Helicopter settled through the wires and struck a curb, causing major damage to the tail wheel and pylon section. CAUSES: Engines failed to develop sufficient power for takeoff due to prolonged operation at ground idle which resulted in fouled plugs. Pilot selected takeoff flight path obstructed by wires and parked automobiles.

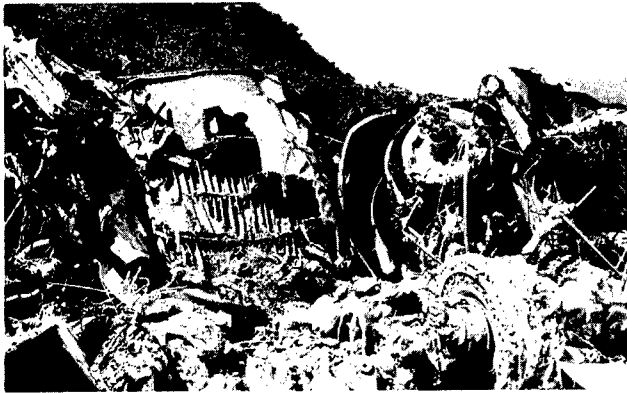
06742

**06742**—Helicopter flew into downdraft 15 feet above and 25 feet short of the desired touchdown spot during approach to mountain helipad. The pilot applied power and stopped the sink rate, but the tail wheel strut hit the edge of the concrete helipad. The helicopter continued forward and the tail wheel strut assembly was pulled loose from its attaching point. CAUSE: Failure to evaluate wind in the vicinity of the helipad.

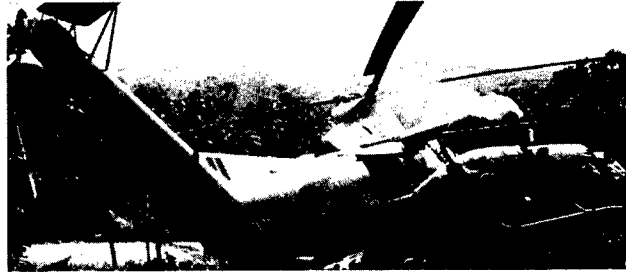
A284

**A284**—Helicopter approached a mountain helipad (altitude 3,800 feet) with a sling load of three telephone poles. Approximately 60 feet short of the helipad, a loss of lift occurred and the sling load was dropped. The pilot attempted to fly over the crest of the mountain and the helicopter struck a rocky ledge on the tail pylon, at a point approximately four feet forward of the tail wheel. As the

helicopter continued down the north slope of the mountain, the tail pylon separated from the fuselage and control was lost. The helicopter crashed and the auxiliary fuel tanks ruptured. The aircraft burned and five occupants were killed. CAUSE: Loss of lift during final stages of the approach, coupled with high density altitude and near maximum gross weight condition.
