# UH-1 ACCIDENT SUMMARY

THE U.S. ARMY BOARD FOR AVIATION ACCIDENT RESEARCH - FORT RUCKER, ALABAMA

1 July 1966 through 30 June 1967

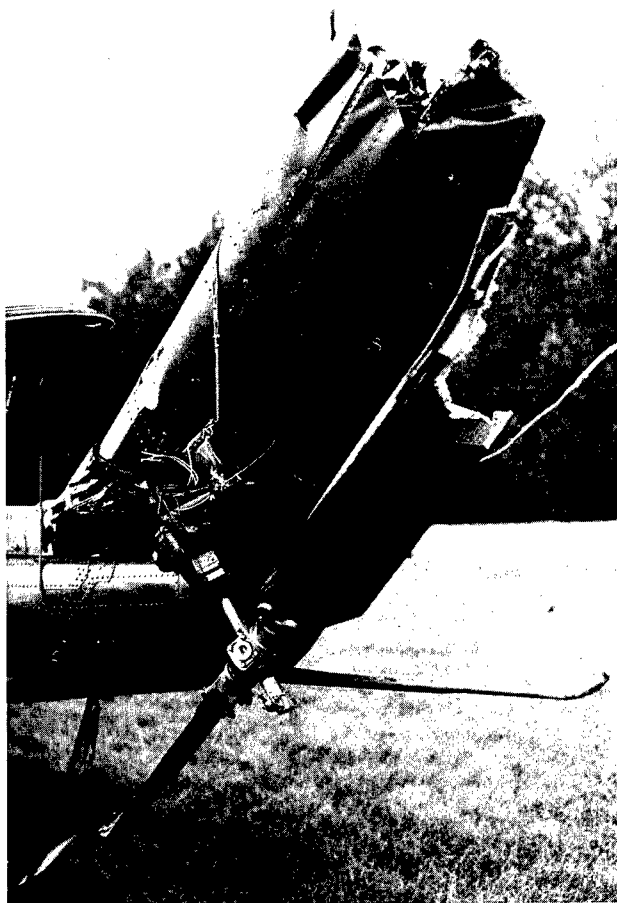
**G481**—While hovering from parking zone at night, aircraft drifted right and tail rotor blades hit main rotor blades of parked aircraft. Caused by loss of orientation and by preoccupation of copilot due to tuning radios and by attempting to correct an inoperative instrument light.

G481 - Copilot was preoccupied and tail rotor blade struck parked aircraft.

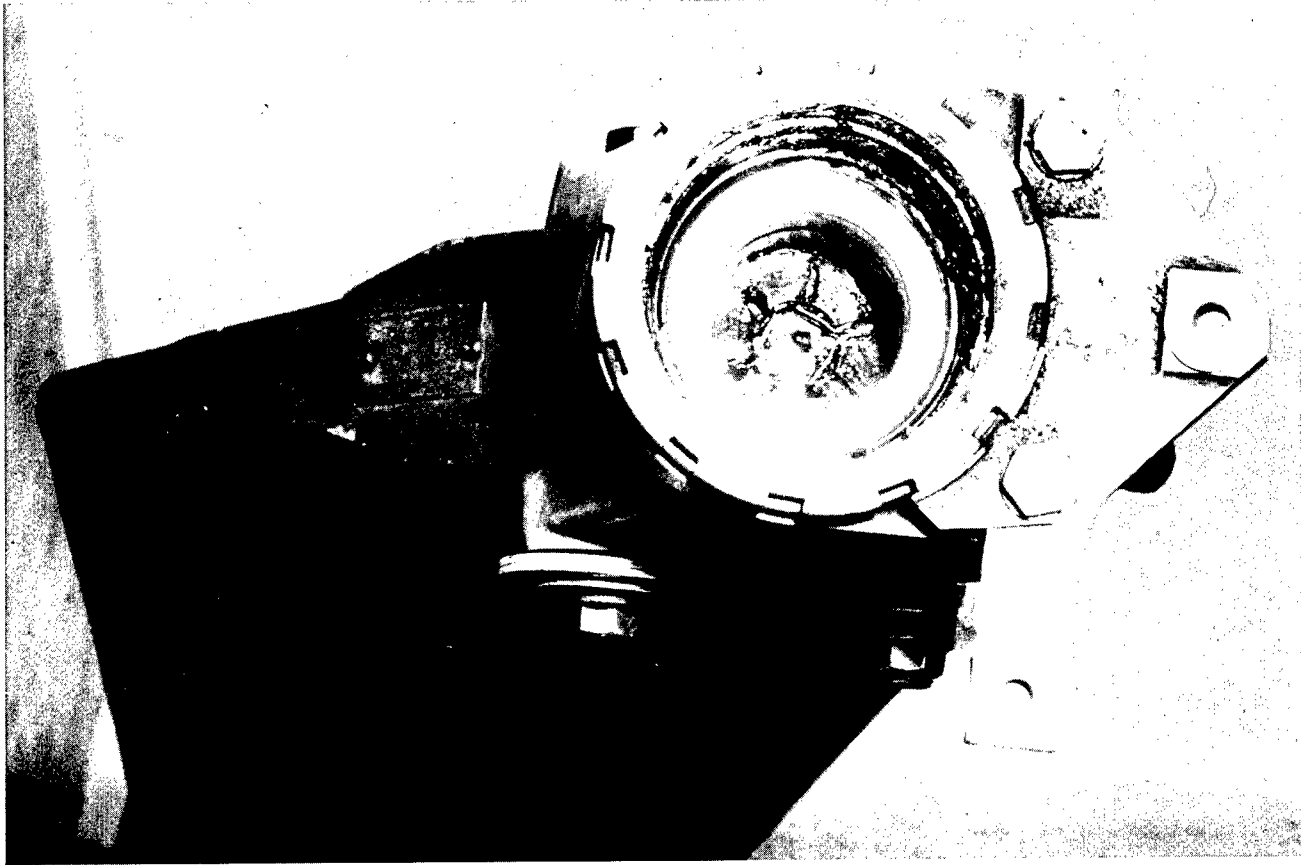
H813 - Tail rotor yoke failed because retaining nut was improperly torqued.

**H813**—Pilot heard loud explosive noise during hover to takeoff pad for maintenance test flight. Aircraft vibrated and turned to the right. Power was reduced and aircraft landed hard on left skid. Tail rotor and gearbox separated from pylon, and tail boom was severed by main rotor blade. Caused by failure of tail rotor yoke due to loss of retaining nut torque.

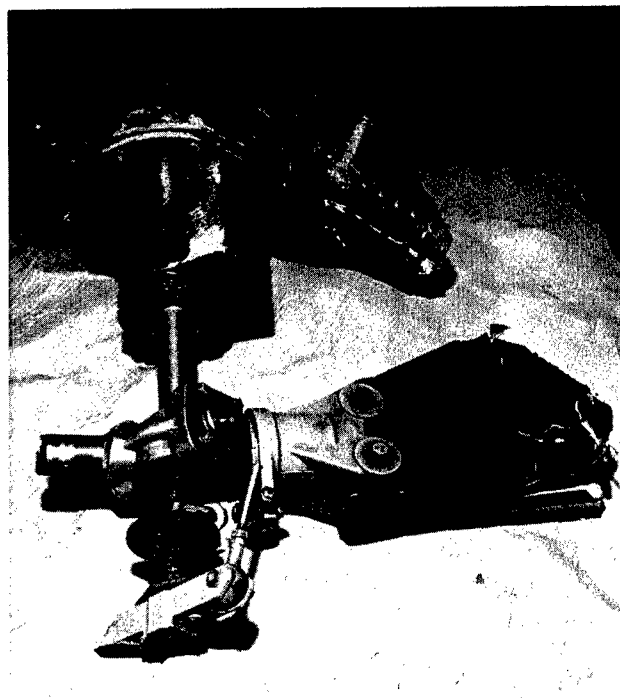
050512 - Severed threaded area of yoke arm caused by failure of tail rotor hub assembly.
