# **OH-58 ACCIDENT SUMMARY**

May 1969 through February 1971

Aircraft Accident Analysis and Investigation Department

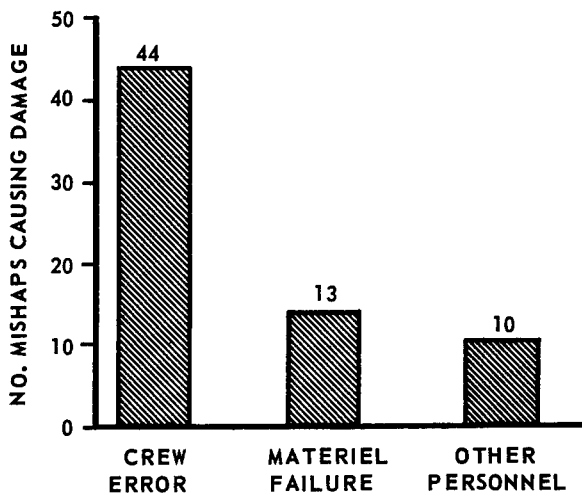
FIGURE 1  
OH-58A Mishaps Resulting In  
Damage Shown By Cause Factors

**DISCUSSION.** Figure 1 depicts graphically, by cause, 67 of the 202 OH-58A mishaps in which damage was incurred. As can be readily seen, crew error caused the preponderance of these 67 mishaps in which 17 fatalities and 15 injuries occurred. Crew error was listed as the cause factor in all of the fatal accidents and in 22 of the 37 incidents. Except for one injury, all injuries and fatalities occurred in the major accidents.

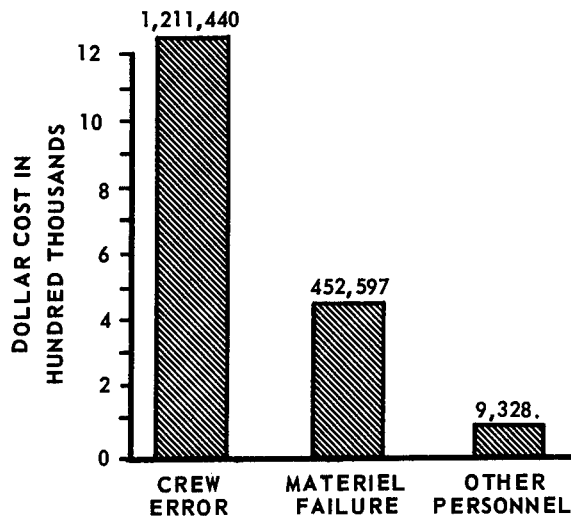
FIGURE 2  
Mishap Costs

Figure 2 depicts the cost breakdown of the 67 mishaps by cause factors. Although secondary in significance by far to the loss of life, the loss in dollars sustained in both the fatal and

nonfatal mishaps is staggering. The OH-58A mishaps reported during this period cost the taxpayer approximately \$1,674,000. About 72 percent of this cost, or about \$1,212,000, was incurred in crew-error caused mishaps.

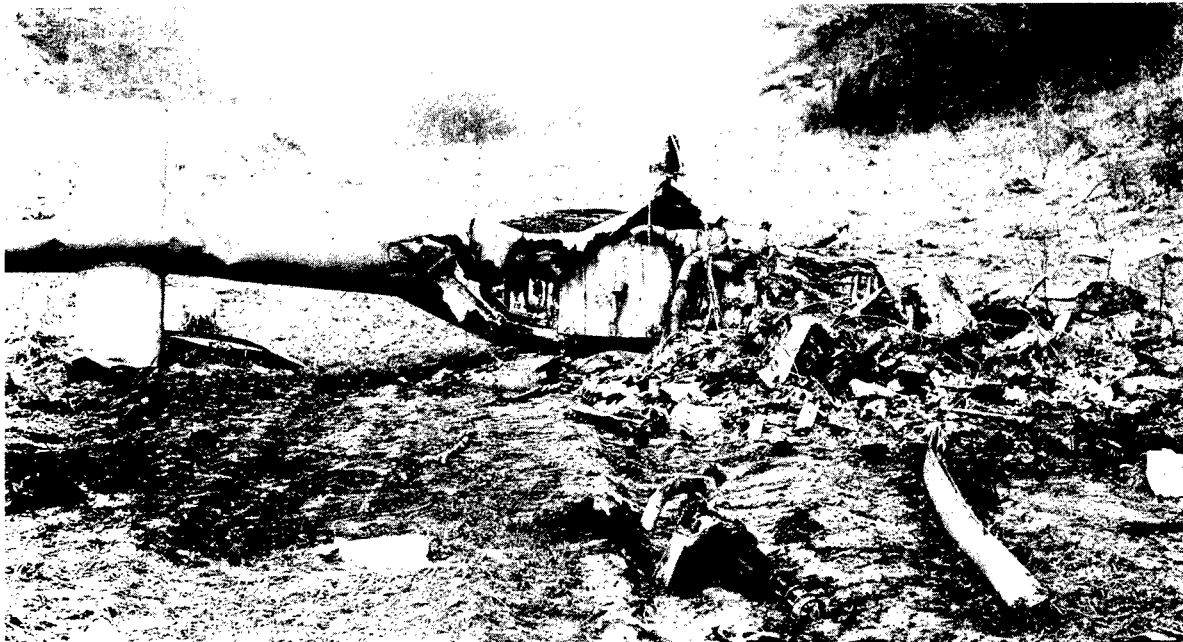
70040902--During low-level flight in a valley under conditions of rain, snow, and fog, aircraft struck powerlines and crashed. The pilot and observer were fatally injured and the aircraft was destroyed by postcrash fire. Caused by flying at unnecessarily low altitude and high airspeed for mission accomplishment, and failing to respond to warning of imminent wire dangers. Probable or suspected cause factors were (1) improper supervision within the unit of flight planning procedures and disregard of basic safety regulations, and (2) false impression on the part of the pilot that the powerlines ran parallel to the intended route of flight.

70040902 - Pilot failed to respond to warning of imminent wire dangers.

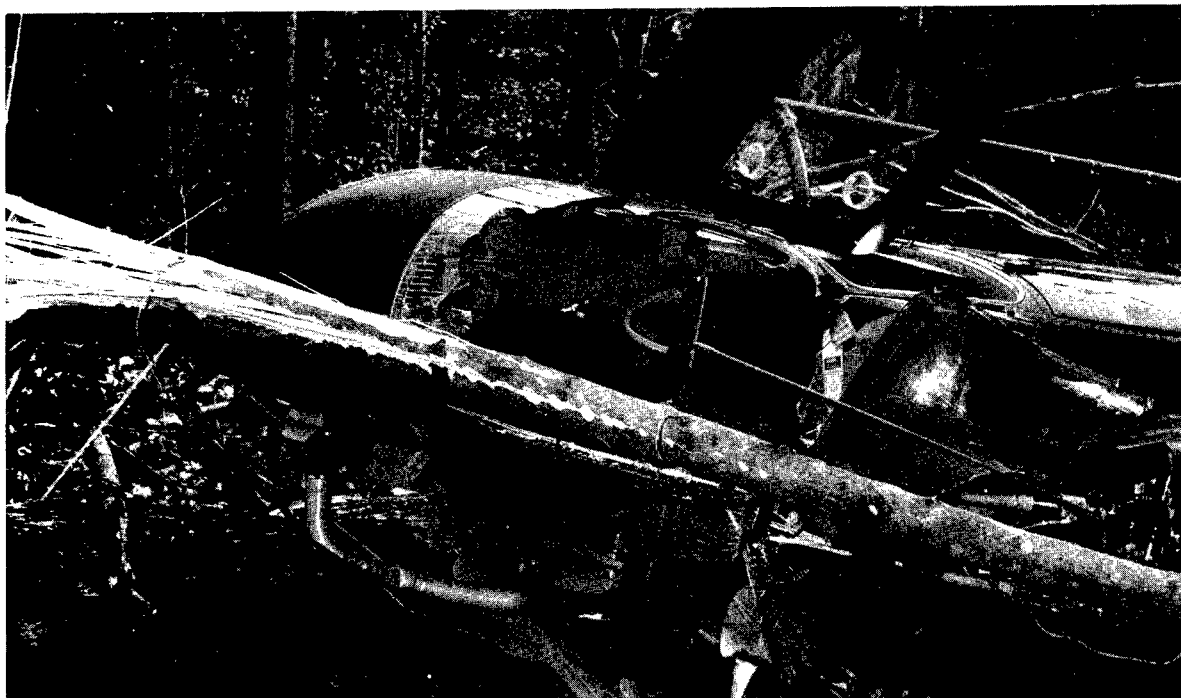
71012813--Pilot was on a low-level training mission. After 15 to 20 minutes of flight, he made a climbing turn coming from behind a ridge-line and the aircraft struck high tension wires, causing loss of antitorque control. He autorot-

71012813 - Pilot became disoriented and struck the trees.

tated from low altitude prior to entering trees. The aircraft descended through the trees and crashed on rocks in a streambed in a ravine, damaging the main rotor blades, right skid, vertical stabilizer, tail rotor gearbox, airframe, and skin. The pilot and two passengers suffered minor injuries. Caused by pilot disorientation. Contributing factors were (1) unapproved area for contour flying and (2) possible complacency.
