THE UNITED STATES ARMY BOARD FOR AVIATION ACCIDENT RESEARCH • FORT RUCKER, ALABAMA

CH-34 AND CH-37 ACCIDENT SUMMARY

1 July 1966 through 30 June 1967

by
P. R. Thompson

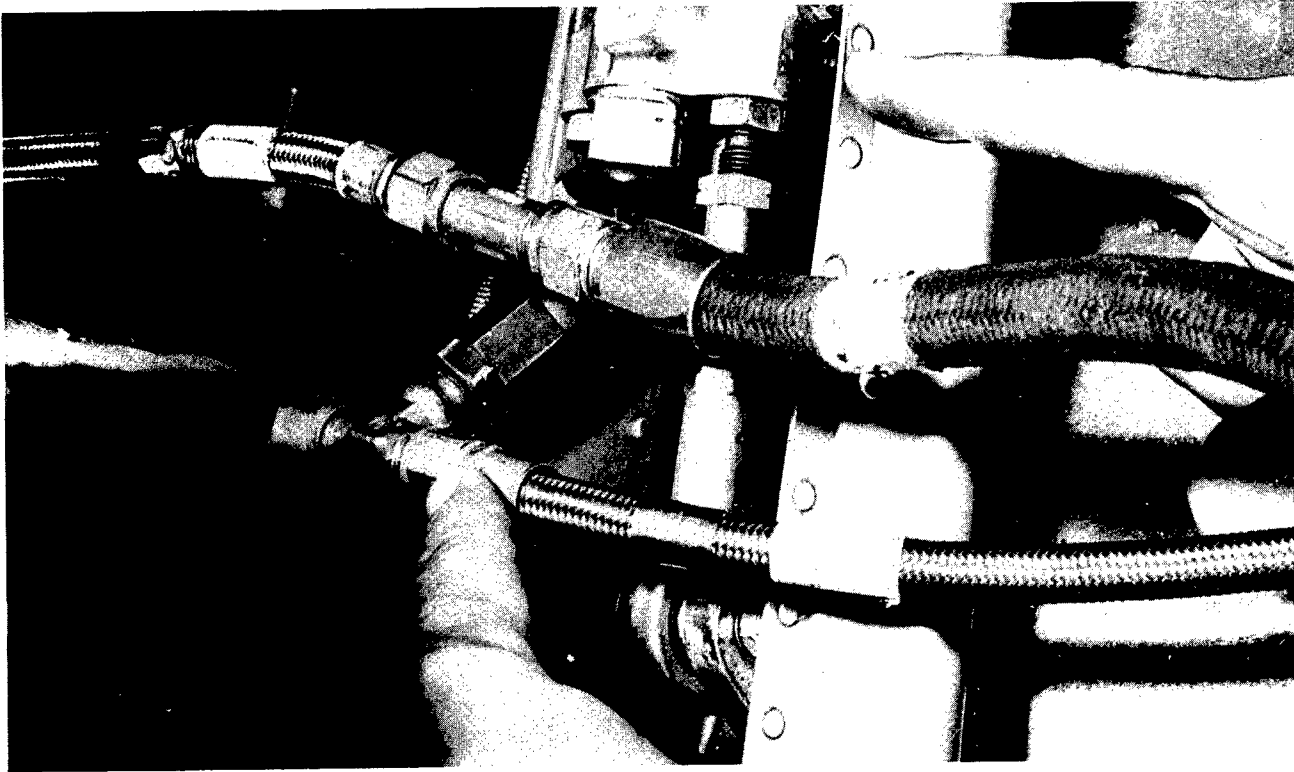
F542—Accident occurred during ground runup phase of a maintenance test flight to check out replacement of a left lateral primary servo. Preflight was accomplished with no discrepancies noted. Engine was started and warmup was normal. Rotor was engaged, but two attempts were required to complete engagement. RPM was established at 1700-1800 and maintained to allow clutch to drain, then a flight control check was made. The cyclic was moved fore and aft and during forward movement, the collective pitch moved upward about 3 inches. Primary servo was turned off and cyclic was moved about again, but no difficulty was encountered. Servo selector switch was moved from "primary off" to "both" to "auxiliary servo off." When the auxiliary servo was switched "off," the collective pitch began to rise. Pilot was unable to push the collective down, and attempted to close throttle to reduce rpm while applying down pressure on the collective. Aircraft became light on its main

landing gear, moved slightly rearward and left, and rolled over on left side, damaging tail rotor, tail pylon, main rotor blades and head, and three bell-crank assemblies. Pilot had minor injuries. Caused by improper installation of primary servo system pressure and return hydraulic lines. The low pressure hydraulic return line from the hydraulic reservoir was attached to the high pressure port of the left lateral servo, while the high pressure line was attached to the low pressure port of the left lateral servo. Other causes were (1) local maintenance supervisor did not adequately supervise or properly check completed installation of the left lateral primary servo, including pressure and return lines, (2) technical inspector failed to detect the incorrect installation and accepted installation, (3) neither the crewchief nor the maintenance test pilot detected the incorrect installation during preflight, and (4) use of improper technique in overcoming malfunction.

F542 Collective could not be lowered due to improperly installed primary servo system pressure and return hydraulic lines.

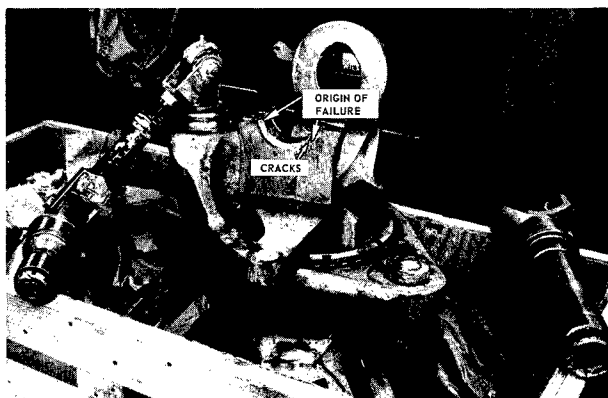
H798—Two CH-37Bs were flying at about 600 feet en route to destination. After 2½ hours, the lead aircraft began descending and turning left from 210° to 150° at a rate consistent with a normal landing approach. Rate of descent increased greatly at about 100 feet, and rotor assembly and transmission seemed to separate from aircraft about 15 feet above the ground. Aircraft, which was in a nose low attitude, was consumed in a ball of fire on or just prior to impact and was destroyed. Pilot, copilot, and crewchief killed. Caused by (1) fatigue failure of rotor head spindle through the aft pin hole, occurring from low overstress fatigue mechanism induced by high residual tensile stresses around outside hole periphery, and (2) lack of quality control.

H798 Rotor assembly and transmission separated from CH-37B due to fatigue failure of rotor head spindle and lack of quality control.

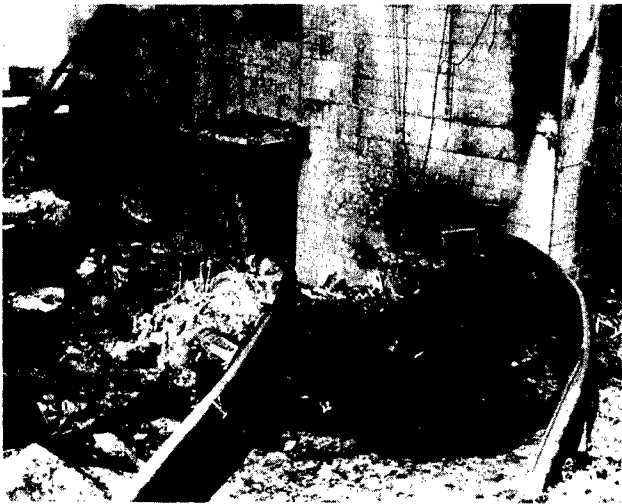
020903—A high reconnaissance was made of landing site, and a turn to final approach was made to a heading of 240°. On short final, aircraft descended below the desired approach angle, and the twist grip

020903 Improper pilot technique in applying power.

throttle was applied. Descent continued to increase and rpm was lost. Full overhead throttles were applied, but with little effect. A right turn was made for a go-around to gain airspeed and rpm. As aircraft passed over helipad, tail rotor blades struck right corner of pad. Aircraft passed through security fence, coming to rest about 150 feet down a steep slope between two buildings and burned. One occupant had major injuries and two had minor injuries. Caused by improper technique in power application.
