THE UNITED STATES ARMY BOARD FOR AVIATION ACCIDENT RESEARCH • FORT RUCKER, ALABAMA

# OH-13 and OH-23

**OH-13 AND OH-23 ACCIDENT SUMMARY**

1 July 1966 through 30 June 1967

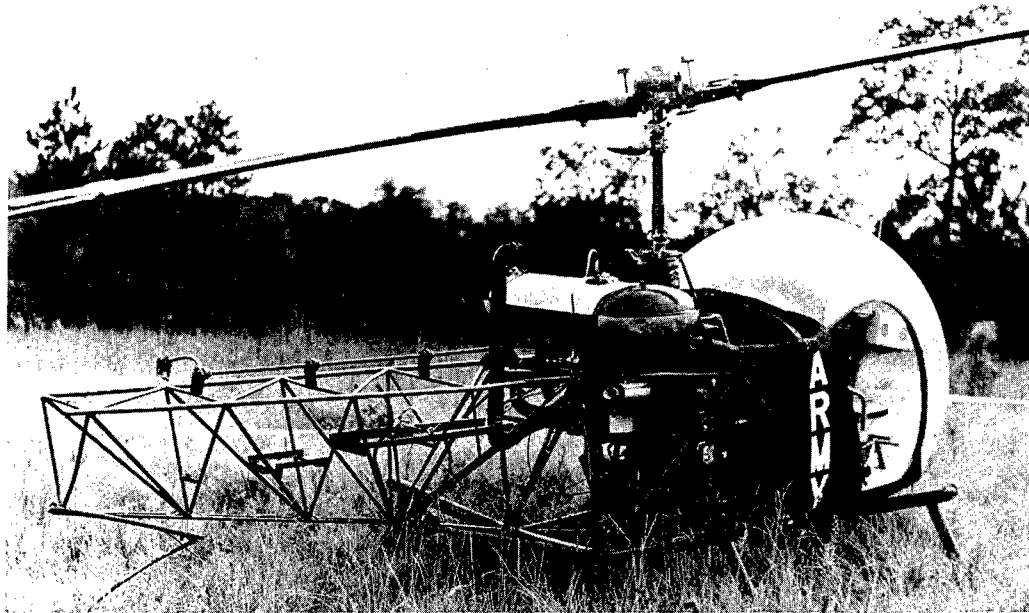
**F567-RPM** was lost during landing approach. Full throttle was added, collective pitch pulled, and aircraft flared, but rpm could not be regained. Aircraft entered high sink rate and full collective pitch was pulled at 10 feet to cushion landing. Aircraft hit on heels of skids, tail guard, and ventral fin, and bounced forward, with a main rotor blade flexing and severing tail boom. It then skidded left and settled to ground, damaging cross tubes, skid tubes, center frame, cabin, and tail rotor. Caused by allowing rpm to dissipate because of slow cross check, using improper technique for correcting low rotor rpm, and placing aircraft in high sink rate by flaring without completely lowering collective pitch.

**F567**  
RPM was lost and aircraft entered high sink rate. Improper technique was used for correcting low rotor rpm.

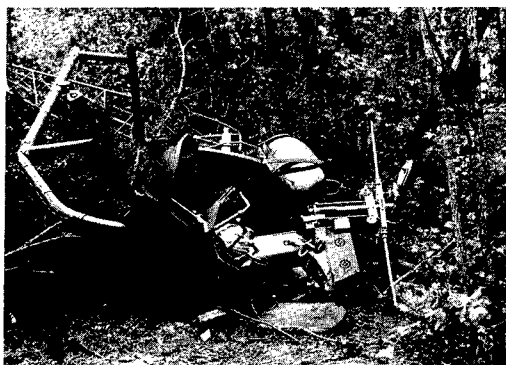
**G791**  
Aircraft settled and struck trees due to loss of translational lift. Poor quality control and inadequate maintenance supervision were factors.

**G791**—Downwind takeoff was made from confined area. Aircraft settled after clearing trees, struck trees, and crashed. Pilot was killed and aircraft destroyed. Caused by (1) loss of translational lift, (2) lack of quality control, and (3) inadequate maintenance supervision. Maintenance records for the 6-month period preceding the accident revealed that numerous partial and ineffective corrective maintenance actions had been taken without apparently correcting (1) continual magneto troubles due to improper timing, which caused a rough running engine, possible preignition and/or detonation; excessive cylinder head and oil temperatures; and lack of power; (2) continual trouble with No. 2 cylinder, ranging from bent push rods to “O” compression; (3) excessive oil consumption (No. 4 piston was changed because of engine throwing oil); (4) excessive smoke from right exhaust after starting; (5) fluctuating oil pressure; and (6) high cylinder head and oil temperatures. Engine teardown analysis revealed that engine was incapable of producing maximum power for high performance takeoff. Analysis also revealed loss of compression in three cylinders, magnetos out of time, loose spark plugs, and burnt piston rings. Iron content in engine oil had risen from 23 to 75 parts per million during 12-hour period before accident.

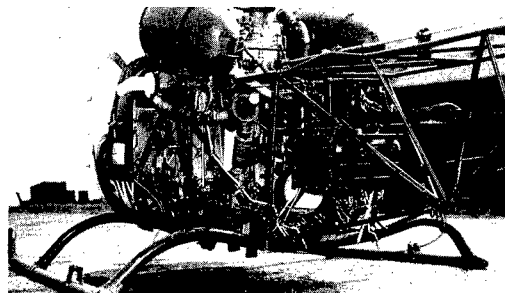
**G266** Improper removal and installation of tail rotor gearboxes due to poor supervision.

**G266**—Loud pop was heard during hover, left pedal hit stops, and aircraft turned right. Pitch was reduced to full “down” position and aircraft struck ground, damaging cross tubes. A whip action of the tail boom caused tail boom assembly to bend at upper left attaching point. Caused by improper removal and installation of tail rotor gearboxes.

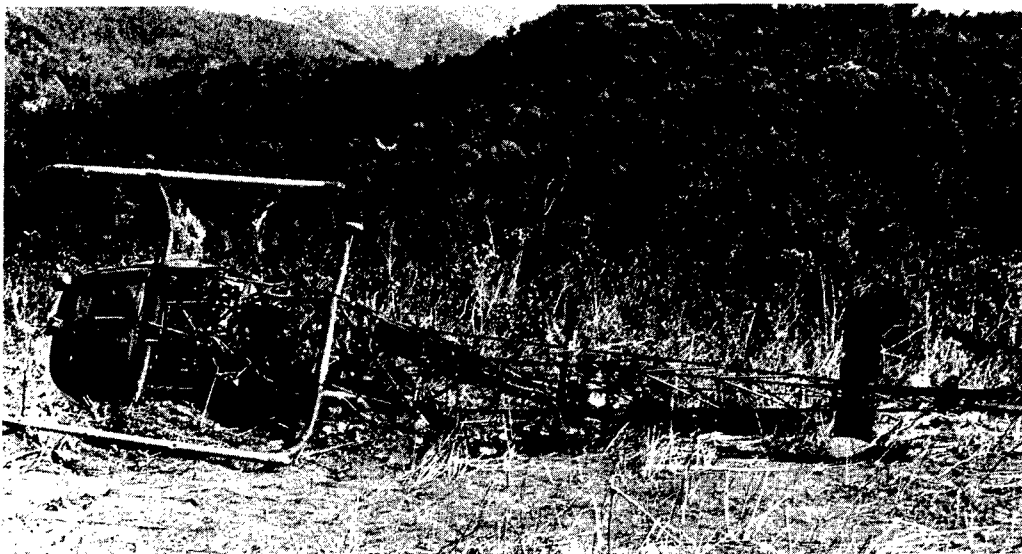
**020501**—Approach was made to hover and observer cleared tail rotor. Left skid was placed on ground and, as right skid was lowered, aircraft tipped right. Full left cyclic was applied, but aircraft continued to tip until main rotor struck ground. Pilot and observer escaped through broken bubble. Aircraft caught fire and burned. Caused by (1) allowing aircraft to tip too far for recovery, (2) landing on rough slope, (3) unimproved LZ, and (4) lack of provisions for ground guides.

**020501**  
Attitude got beyond recovery and aircraft was landed on rough slope. Pilot was relatively inexperienced and there was no improved LZ's or provisions for ground guides.

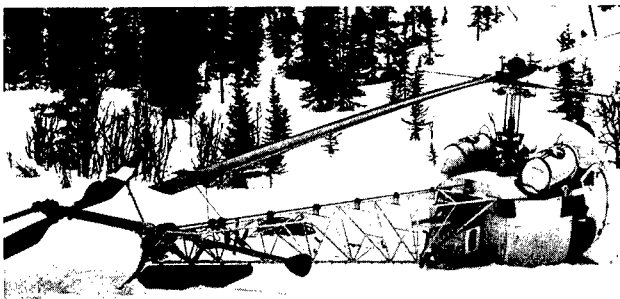
031709 Tail rotor struck tree. Suspect blowing snow prevented accurate judgment of hover height and hovering turn allowed tail rotor to swing upslope.

deep snow while passenger got out to remove flag-pole. Takeoff was made and area orbited until flag-pole was removed. Aircraft was then landed to pick up passenger. As aircraft was brought to hover during takeoff, left turn was made and tail swung into upslope, striking tree, damaging tail rotor blade, and severing tail rotor drive shaft. Aircraft began uncontrollable right turn, throttle was closed, and hovering autorotation was made. Caused by allowing tail rotor to strike tree. Suspect blowing snow prevented accurate judgment of hover height and turn allowed tail rotor to swing upslope.

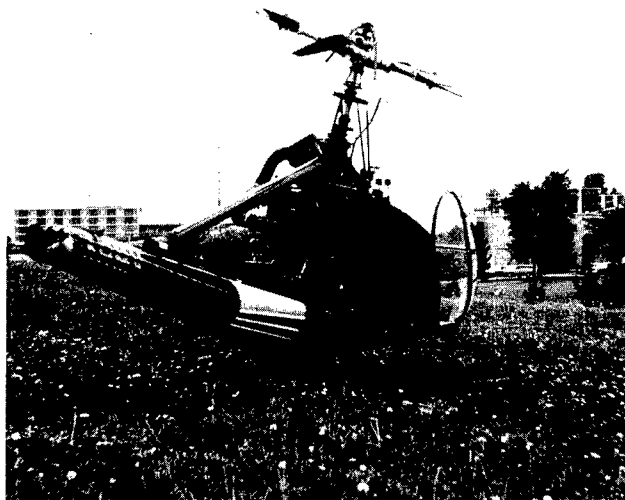
**F480** Application of excessive pitch during takeoff over low wires.

**F480**—RPM dropped rapidly during takeoff and aircraft settled, struck sloping area on right skid, and tilted left. Skids folded under and main rotor blade warped downward, cutting away 4 feet of tail boom. Pilot sustained minor injuries. Caused by application of excessive pitch.

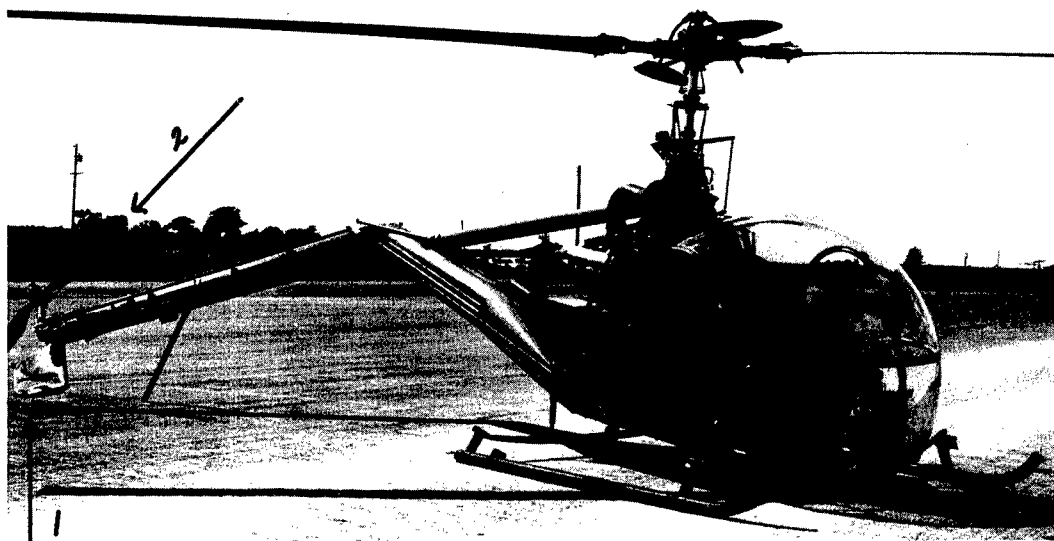
**G290**  
 SP bottomed collective and IP failed to recover. IP was relatively inexperienced and violated training directive.

**G290**—SP was hovering through parking area to takeoff panel. IP cut throttle for simulated forced landing and SP bottomed collective. IP was unable to recover and aircraft landed hard, damaging tail boom, cross tubes, airframe, lower beacon, stabilizer, 1-inch drive shaft, and hanger bearing. Caused by (1) bottoming collective, (2) inability of IP to recover, and (3) violation of training directive.

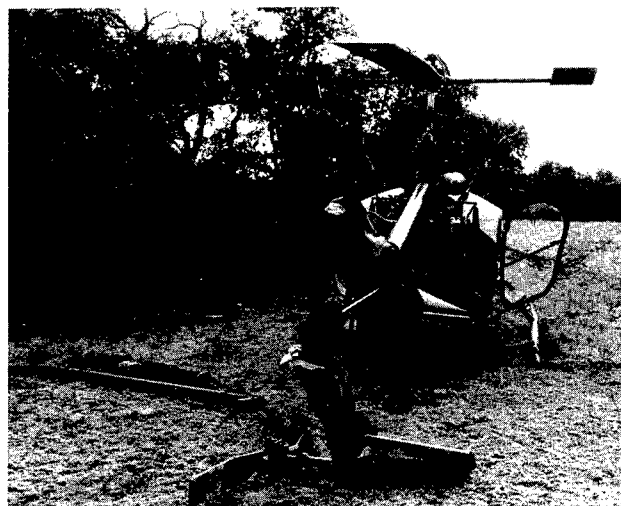
**H396**—Pilot heard thumping noise from engine and felt vibration in controls. Power approach was made and vibration continued. Engine ran rough and failed at 30-40 feet. Aircraft hit hard, damaging

**H396** Engine failed due to broken piston rings and damaged piston and a downwind landing was unsuccessful.

main rotor blades, 1-inch drive shaft, tail rotor blades, cross tubes, and tail boom. It came to rest upright. Engine failure caused by broken piston rings and damaged piston. Aircraft damage caused by downwind approach.

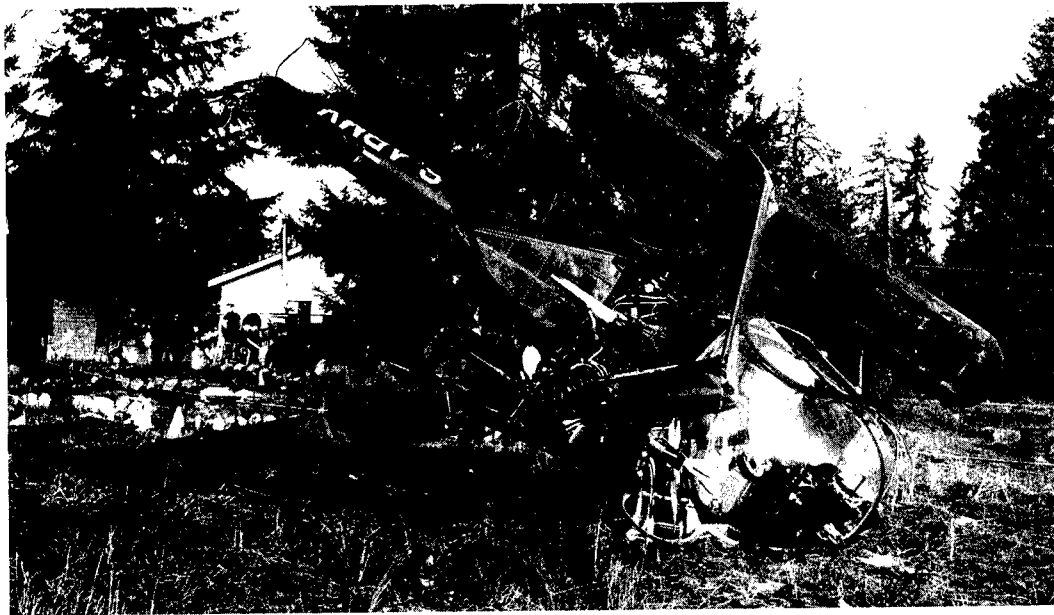
**013001**  
 Engine failed due to failure of No. 6 connecting rod assembly. An extensive maneuver was performed during approach due to powerlines and touchdown groundspeed was excessive.
