OV-1 ACCIDENT SUMMARY

1 July 1963 through 30 June 1966

Investigation and Engineering Division
Engineering Branch

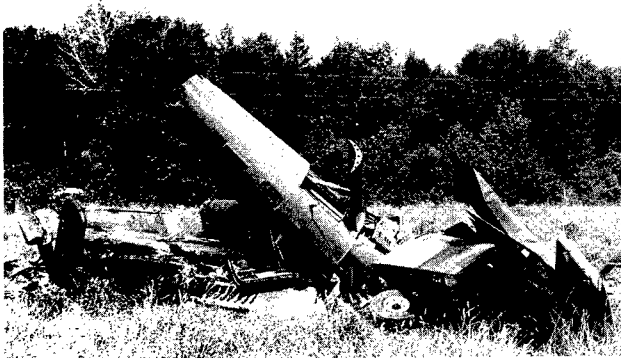
08113

08113—Aircraft struck two 3/8" ground cables located above high tension electrical power lines. The wires broke and aircraft hit a 40-foot pine tree, coming to rest in the center of a pond, and scattering debris throughout the pond and 55 yards up the side of a hill. Caused by: 1. Aircraft flying into 3/8" steel ground cables. 2. Difficulty in detecting wires from low altitude. 3. Failure to indicate location of a known flight hazard on maps used during low level flight. 4. Lack of positive instructions on gunnery procedures to be used during combined arms training exercises. 5. Conducting instruction in low level gunnery techniques to a non-gunnery qualified pilot during a combined arms training exercise.

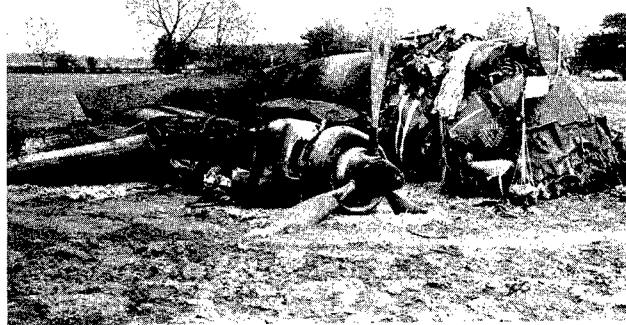
C664

C664—Aircraft departed airfield and was climbing through 4,200 feet when the No. 1 engine caught fire. Fire could not be extinguished with internal fire bottles. Both the instructor pilot and pilot made a safe ejection at 1,600 feet and received only minor injuries. The primary cause of this accident was a fire in the area of the No. 1 engine caused by misalignment of the dowel pin located in the No. 4 bearing pump housing and retainer ring, causing pressurization of the No. 3 and 4 bearing package. Pressurization resulted from inability of the front pump located forward of No. 3 bearing to evacuate the additional oil. The oil was then forced between the carbon seal and the power turbine stub shaft seal journal. This resulted in the erosion of the carbon seal, loss of lubrication, and subsequent failure of the No. 3 and 4 bearings.

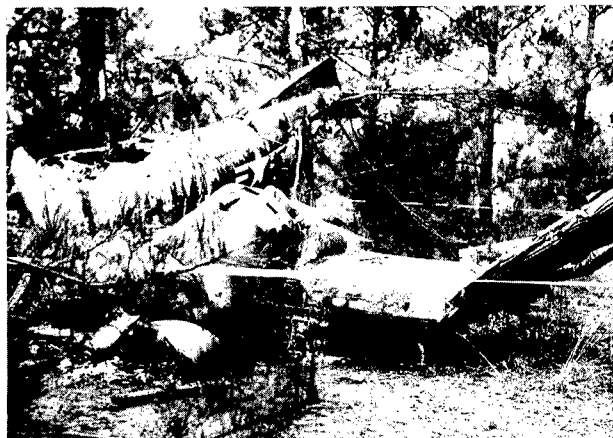
C122

C122—Aircraft was landed gear-up. Caused by failure to lower landing gear. Pilot did not use pre-landing checklist.
