PREPARED BY THE U. S. ARMY BOARD FOR AVIATION ACCIDENT RESEARCH, FORT RUCKER, ALABAMA

**OV-1 ACCIDENT SUMMARY**

1 July 1966 through 30 June 1967

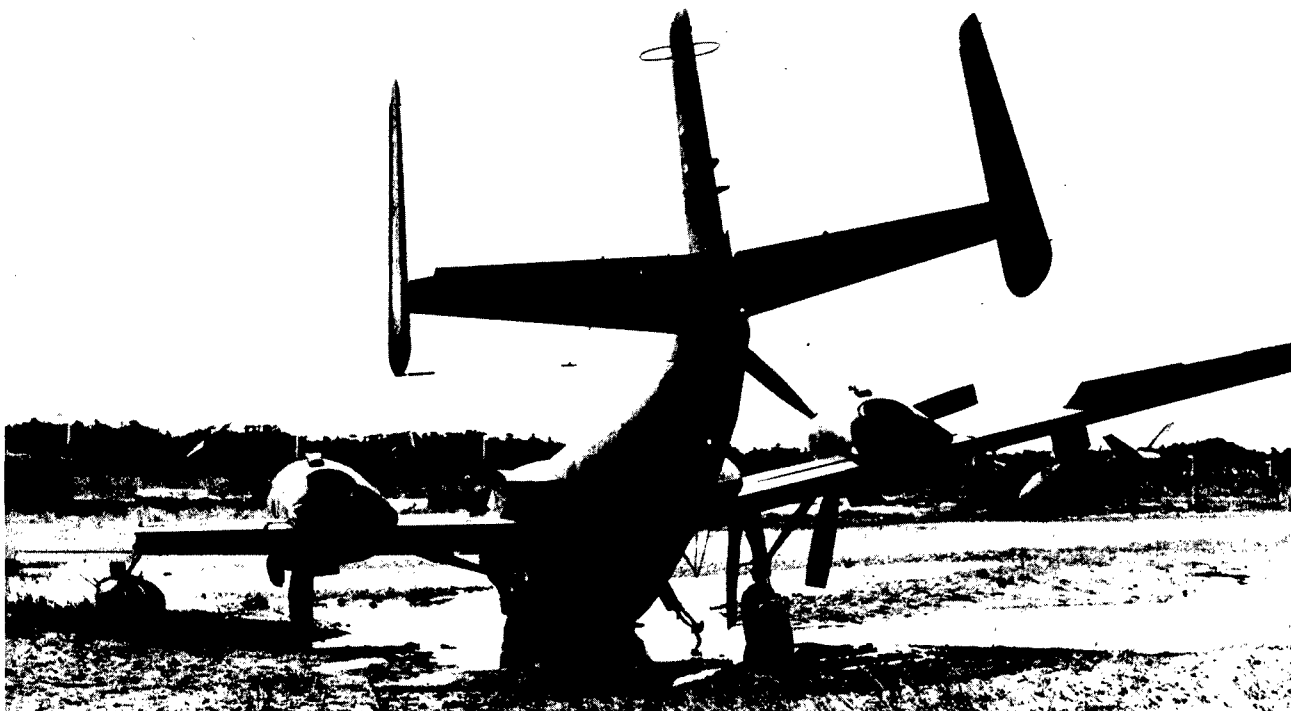
F495

**F495**—Odor was detected in cockpit and hydraulic pressure on both gauges dropped to zero. Flight was continued to burn off fuel in drop tanks, and approach was made, using emergency blowdown bottle to lower gear. Nose gear and right main gear locked, but left main gear failed. Right rudder was applied, and aircraft was yawed until left gear locked into place. A GCA, due to heavy rain and visibility, was made to a PSP, and two go-arounds were made before aircraft was aligned with PSP. Due to loss of hydraulic pressure, pilot had no power steering, power brakes, flaps, or windshield wipers. Landing light was turned off because of glare, and aircraft touched down about 1,000 feet down runway at 110 knots. Props were reversed and aircraft swerved left. Reverse power was reduced on No. 1 engine to idle reverse, and reverse power was pulled into No. 2 engine. Full right rudder, right aileron, and right brake were applied, but aircraft ran off runway, hitting rocks and sand. Nosewheel collapsed and aircraft slid on SLAR antenna. Full aft elevator was pulled and left main gear dropped into a concrete-lined hole, breaking gear, shoving it through wing and severing SLAR

antenna. Left prop struck ground and aircraft came to rest on left tip tank, nose, and right main gear. Both engines were shut down and attempts to feather were ineffective, because No. 1 propeller was striking the ground and No. 2 could not be pulled all the way in, due to lever catching on emergency gear blowdown handle. Caused by turning off battery switch before propeller could complete its travel while attempting to feather from reverse position, and failing to pull handle far enough or hold it long enough to completely lock the blowdown valve open and allow full available pressure. The bottle still contained 1,500 pounds of pressure and blowdown valve was in closed position. The hydraulic filters were dirty and the fluid was contaminated with debris and water. Two filters were not safetied and fluid starvation caused a vacuum in the pump. Small leaks were found throughout the system.

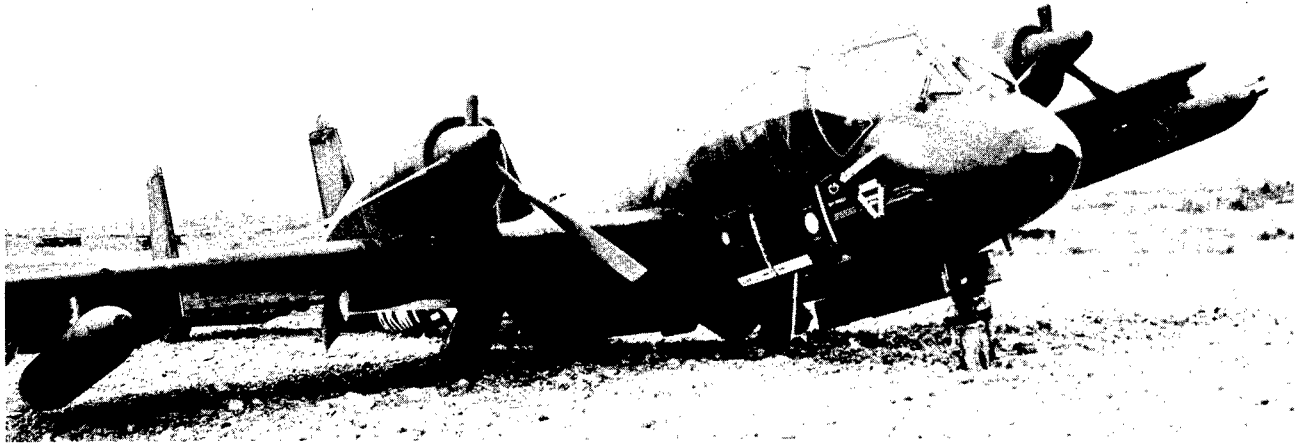
G922

**G922**—A VFR landing was attempted in poor visibility and heavy rain. GCA equipment was inoperative. Pilot made 360° turn 3 miles out on right base to let helicopter land. Forward visibility was zero and pilot lost sight of runway. Looking outside and using familiar ground references, pilot turned final. When runway was sighted, aircraft was off center and high. He made 180° turn and entered on left downwind for runway. Pilot told tower he was turning final with gear and pressure, and attempted to line up with runway by looking out the side. Tower would not clear aircraft for landing because of poor visibility. Pilot, thinking he had only 20 minutes of fuel left and that weather would get worse, continued on final. He sighted runway and thought he was at approach end, but he was actually about 1,800 feet out. Aircraft touched down with full flaps and swerved left, then skidded right before control was regained. Runway was 6,000 feet of PSP. Only 3,000 feet were available due to resurfacing. There was not enough room to go around. One piece of PSP was not interlocked with the adjoining piece, and protruded, causing all three gears to hang as aircraft crossed with brakes locked. Aircraft hit construction area and gear collapsed. Damage was so extensive that only the engines could be salvaged. Caused by attempting to remain VFR in IFR conditions. Other factors were weather, improperly installed PSP, and lack of overrun.
