**Loading, Degradation and Repair of  
F-111 Bonded Honeycomb Sandwich  
Panels - Preliminary Study**

DSTO-TR-1041

## ABSTRACT

Many of the fixed and removable panels on the RAAF F-111 aircraft are made up of bonded honeycomb sandwich panels. Experience with the RAAF fleet has shown that a serious problem exists with degradation and damage of these panels. A review of the literature was undertaken to gain an understanding of the extent of this problem. It was found that panels were subject to large areas of adhesive bond separation and corrosion damage. This damage was believed to be caused by the ingress of water in the panel through poor sealing at the edges or after repair of the panels. Moisture in the panel is also believed to cause adhesive degradation that may reduce the strength of the bonds in such panels. At the same time the literature was surveyed to determine the design load cases for such panels. This information was used to develop a simple finite element model of a bonded honeycomb sandwich panel. This model was in turn used to generate data on the loading and failure of such panels. In addition, an understanding of current repair techniques was gained by review o

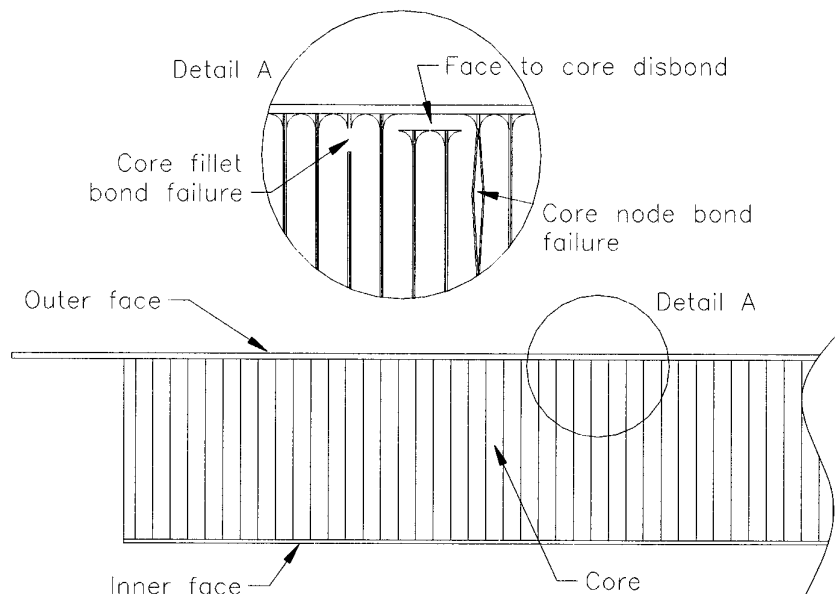
Adhesive bond failure is generally exhibited in three types of failure; face to core disbond, core fillet bond failure and core node bond failure. These are described in Figure 2 (adapted from Reference 9). Degradation of the bond strength through exposure to moisture and free water will decrease the strength of these bonds. Sandwich panels are generally designed so that the core fails in shear before the face-to-core bond or fillet bond fails. Reduction in bond strength may change the failure mode and cause premature failure of the panel.

Figure 2: Failure of adhesive bonds in sandwich panels after degradation.

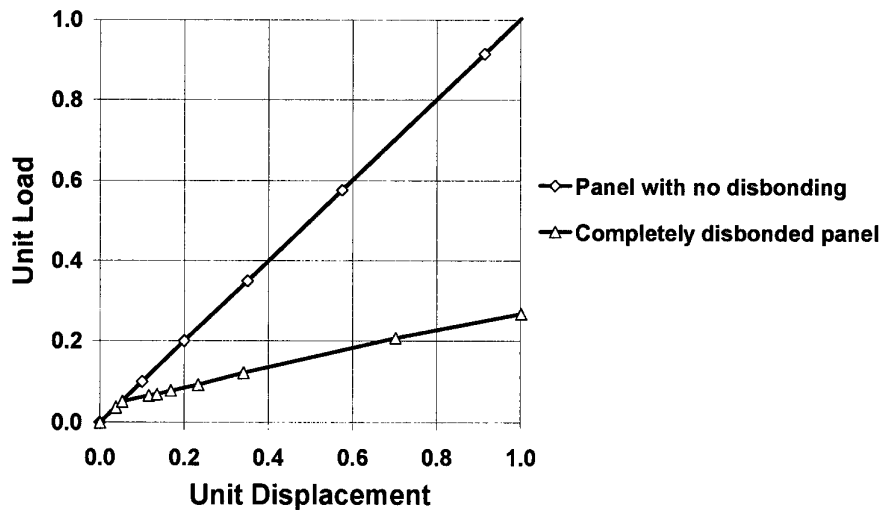
The load-displacement response is shown in Figure 14 and this shows that the onset of general buckling instability begins at about 5% of ultimate load. Further, more realistic, work is planned which will consider the effect of smaller disbonded regions.

Figure 14: Load-displacement response of an intact panel and a completely disbonded panel.

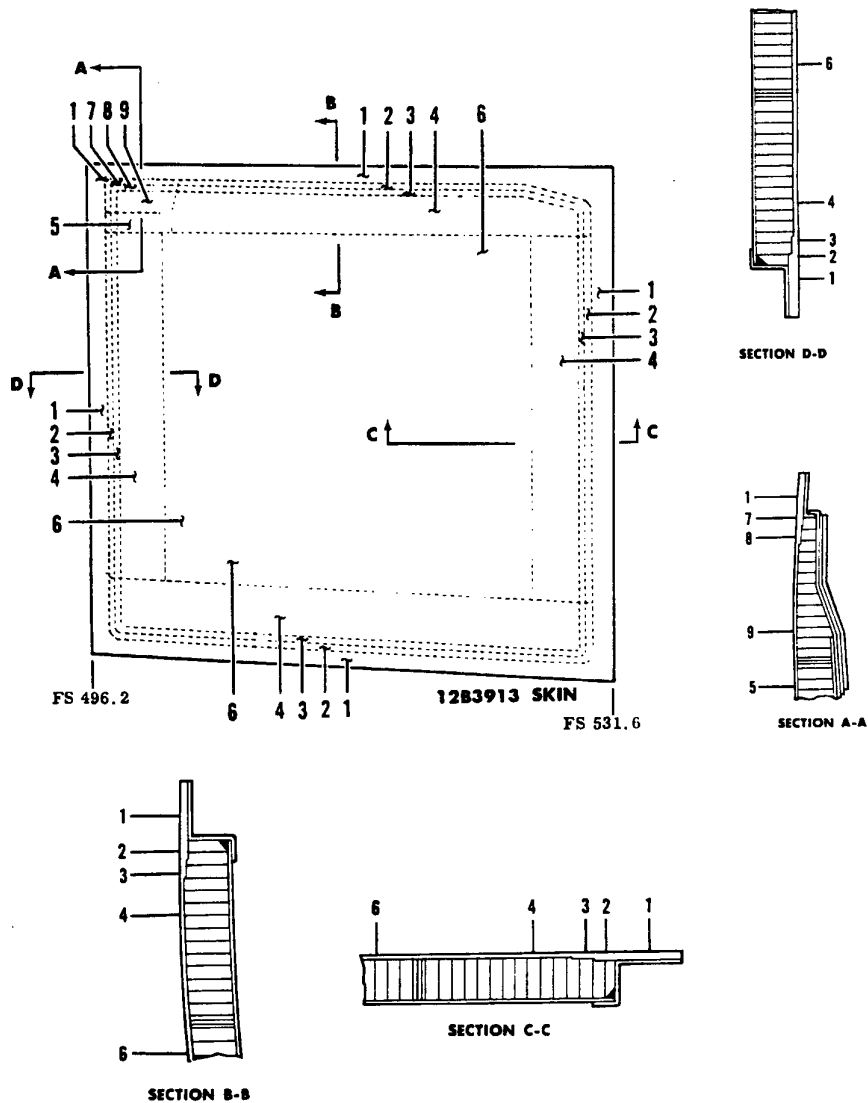
Table 2 is a description of the defects that have occurred in panel 3208 along with pictorial representations of the defects. (Note that these diagrams are not intended to be an exact replication of the defect, rather an approximate representation of their size and shape.)

Figure 16: Structural detail of panel 3208. [2]

Table 2: Relevant defect information for panel 3208. (Cross reference with Appendix B.)  
The grey shaded areas show the defective area; the striped areas signify existing repairs.

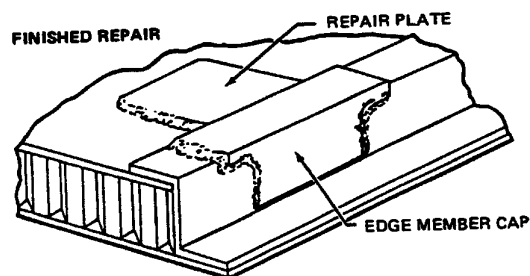
Figure 20. Finished repair for a hole or void in the face adjacent to an edge member.

This repair is for damage in the face or core adjacent to an edge member. The panel is cleaned and a moisture removal procedure carried out to dry the honeycomb core. The damaged area and edge member flange are routed to remove the damage. A core plug is manufactured and both the core plug and routed hole are prepared for bonding by performing a standard surface preparation for adhesive bonding. The plug and repair plate is then bonded to the damaged panel. An edge member angle cap is installed to cover the repair plate and edge member and finally, a honeycomb leak test carried out. A diagram of a finished repair is shown in Figure 20.

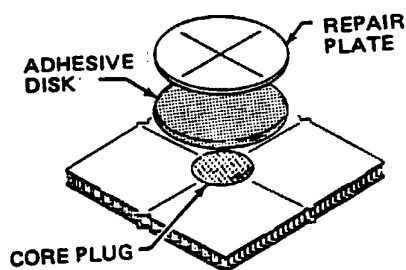
Figure 21. Hole repair using an overlap patch.

This repair is similar to D12 but without the complication of being adjacent to an edge member. The panel is cleaned, the damage removed and the panel is dried. The repair plates and core plug are then fabricated to suit. The surfaces to be bonded are prepared and the core plug installed, followed by the installation of the repair plate (note that the repair plate is non-flush) by bonding. Finally, the repair is surface finished and a honeycomb leak test performed.
