# **FOREIGN OBJECT DAMAGE: CAUSES AND PREVENTION**

1 January 1970 through 31 December 1976

by  
MSG Jerry E. Mills

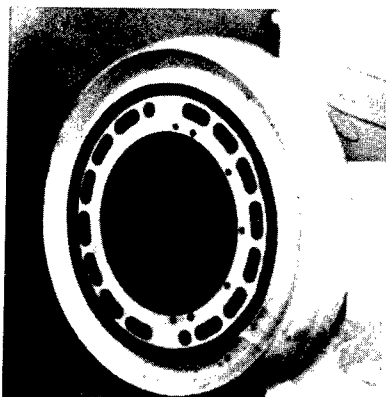
- AH-1G, OH-6A major accidents, \$210,552 damage - During flight unsecured items blew out of ammo bay and passenger areas, hitting tail and causing tail rotor failure. (figures 9a, 9b, and 9c)

FIGURE 9a  
Deflector assembly . . .

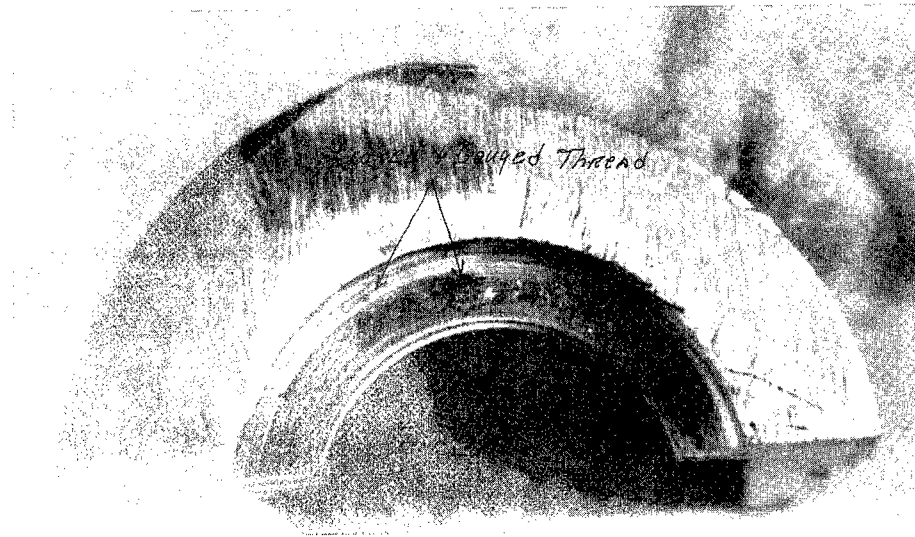
Particles of sand and other foreign matter can cause extra work due to inspections and time required for retaking oil samples. Figure 26 shows an enlarged internal thread area of a UH-1 tail rotor control quill. The threads were scored and gouged from the sand and other foreign particles during movement of the control quill. Particles of the soiled film lubricant and the base metal can work into the tail rotor gearbox. These minute particles, together with excess grease from the crosshead assembly, can damage the 90-degree gearbox.

FIGURE 26.—Scored threads of UH-1 tail rotor control quill. Damage caused by sand and other foreign particles.
