ENGINEERING-SCIENCE, INC.

May 18, 1993

Subject: F33615 - 90 - D - 4014, Order 04,
O&M Effort for the Bioventing System at the 7th Street BX Service Station
(May 1992 through 1st Week in May 1993), Eglin, AFB

**O&M EFFORT FOR THE BIOVENTING SYSTEM AT THE 7TH STREET BX
SERVICE STATION (MAY 1992 THROUGH 1ST WEEK IN MAY 1993),
EGLIN, AFB**

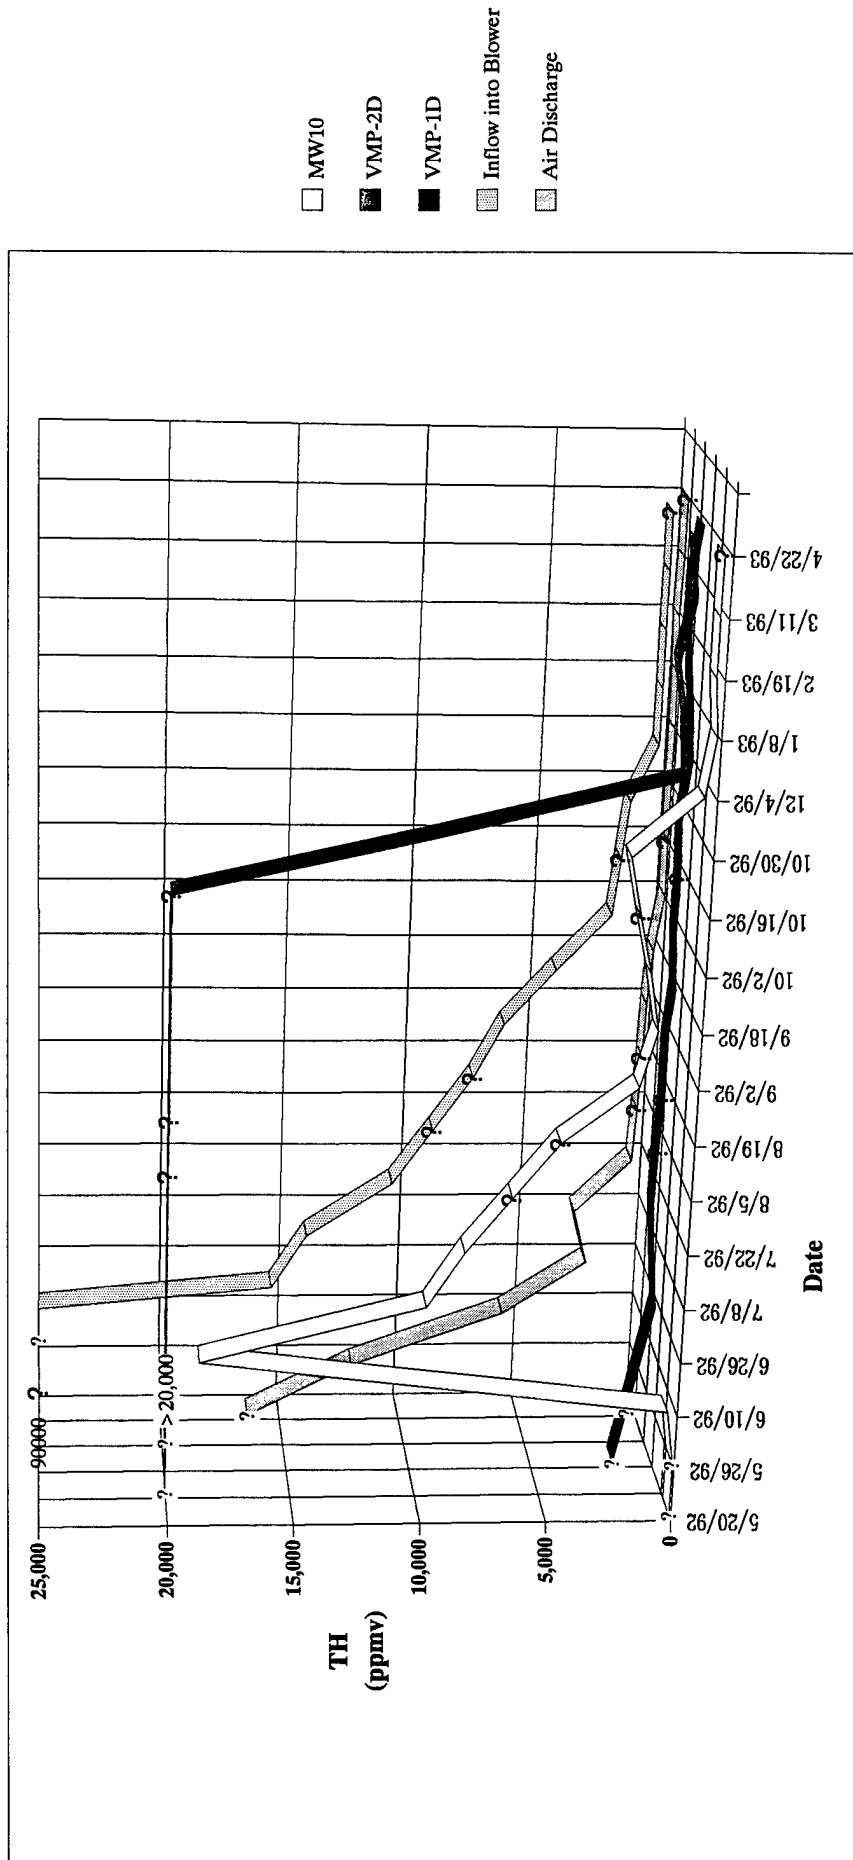
Figure 1

Results of biweekly/monthly concentrations of oxygen, carbon dioxide and Total Hydrocarbons throughout the bioventing system are presented in Table 2 and depicted in the attached charts (Figures 1 through 3). These results continued to indicate increased biological activity in the subsurface and suggest potential increase in aerobic bacterial population. Results indicate oxygen supply to the subsurface has been adequately sustained except for a recent measurement that showed a pronounced decrease in oxygen concentration and slight increase in Carbon dioxide concentration at monitoring location VMP-1D. This monitoring point will be observed closely to determine if increase in bio-uptake of oxygen is the reason for the decline in oxygen level. Available data indicate a rapid decline in total hydrocarbon concentration over the past five months (December through April). Volatilization and to a greater extent biodegradation are believed to be responsible for the total hydrocarbons removed. The system will be watched closely to observe changes that would likely occur as a result of increasing warm weather conditions.

**TOTAL HYDROCARBON LEVELS DURING BIOVENTING
AT 7TH STREET BX SERVICE STATION (5/20/92 - 4/22/93)**

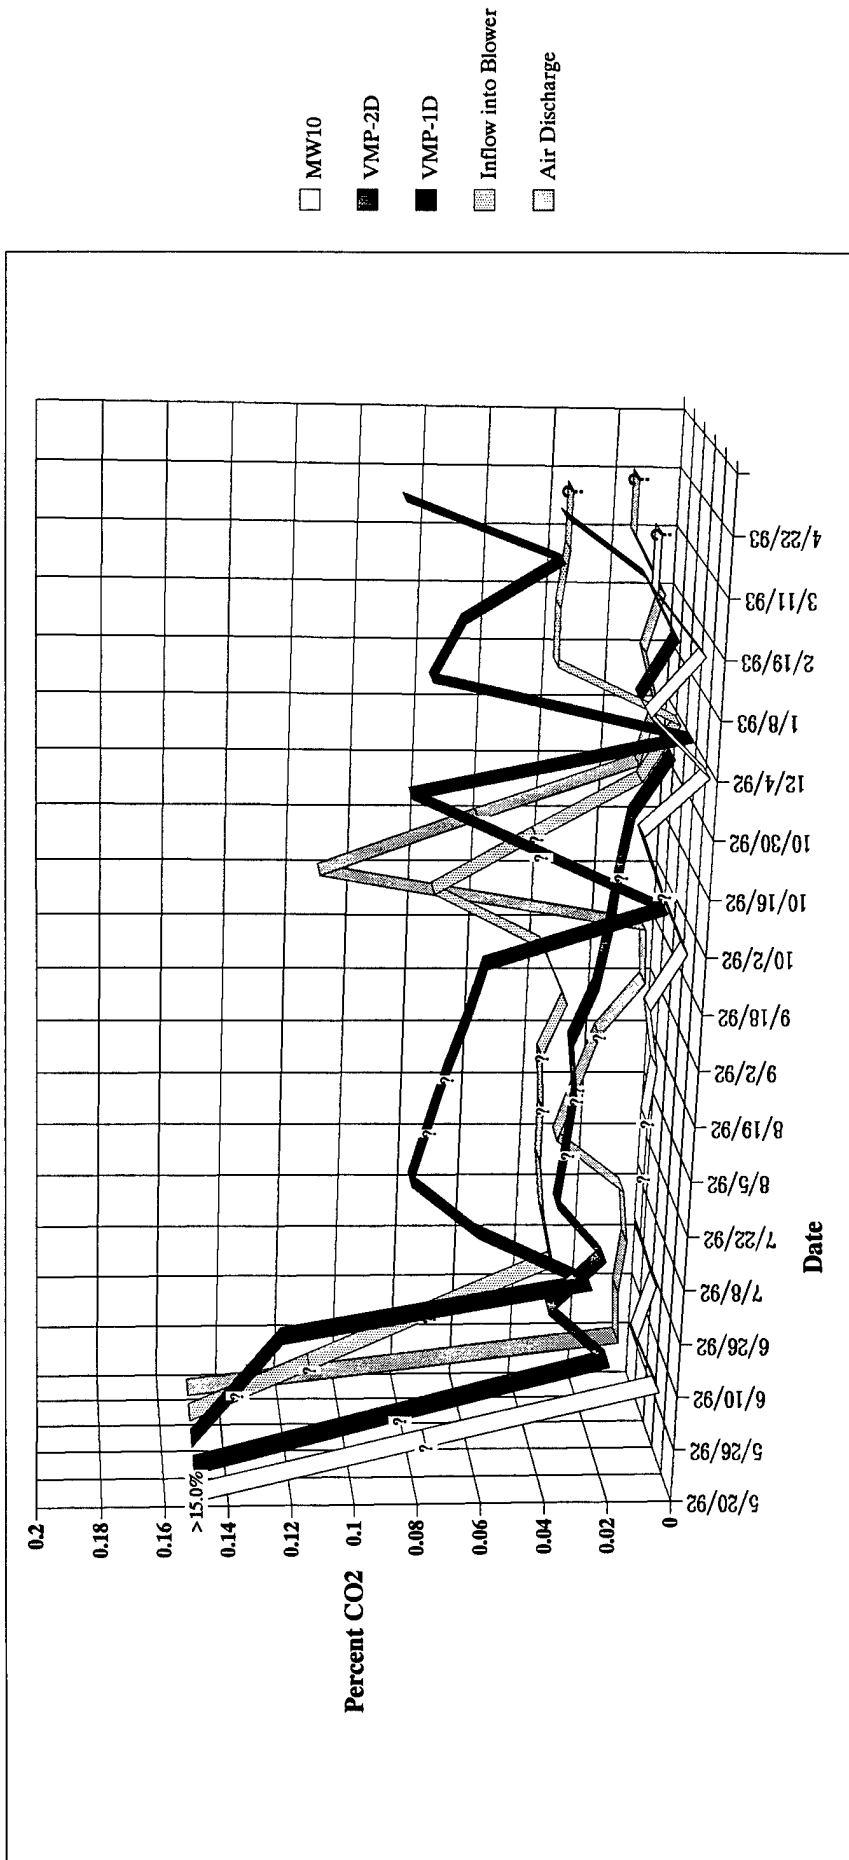
**CARBON DIOXIDE LEVELS DURING BIOVENTING
AT 7TH STREET BX SERVICE STATION (5/20/92 - 4/22/93)
EGLIN AFB**
