August 25, 1992

Subject: F33615-90-4014, Order 04,
O&M Effort for the Bioventing System at the 7th Street BX Service Station
(May through August 1992), Eglin, AFB

O&M EFFORT FOR THE BIOVENTING SYSTEM AT THE 7TH STREET BX SERVICE STATION (MAY THROUGH AUGUST 1992), EGLIN, AFB

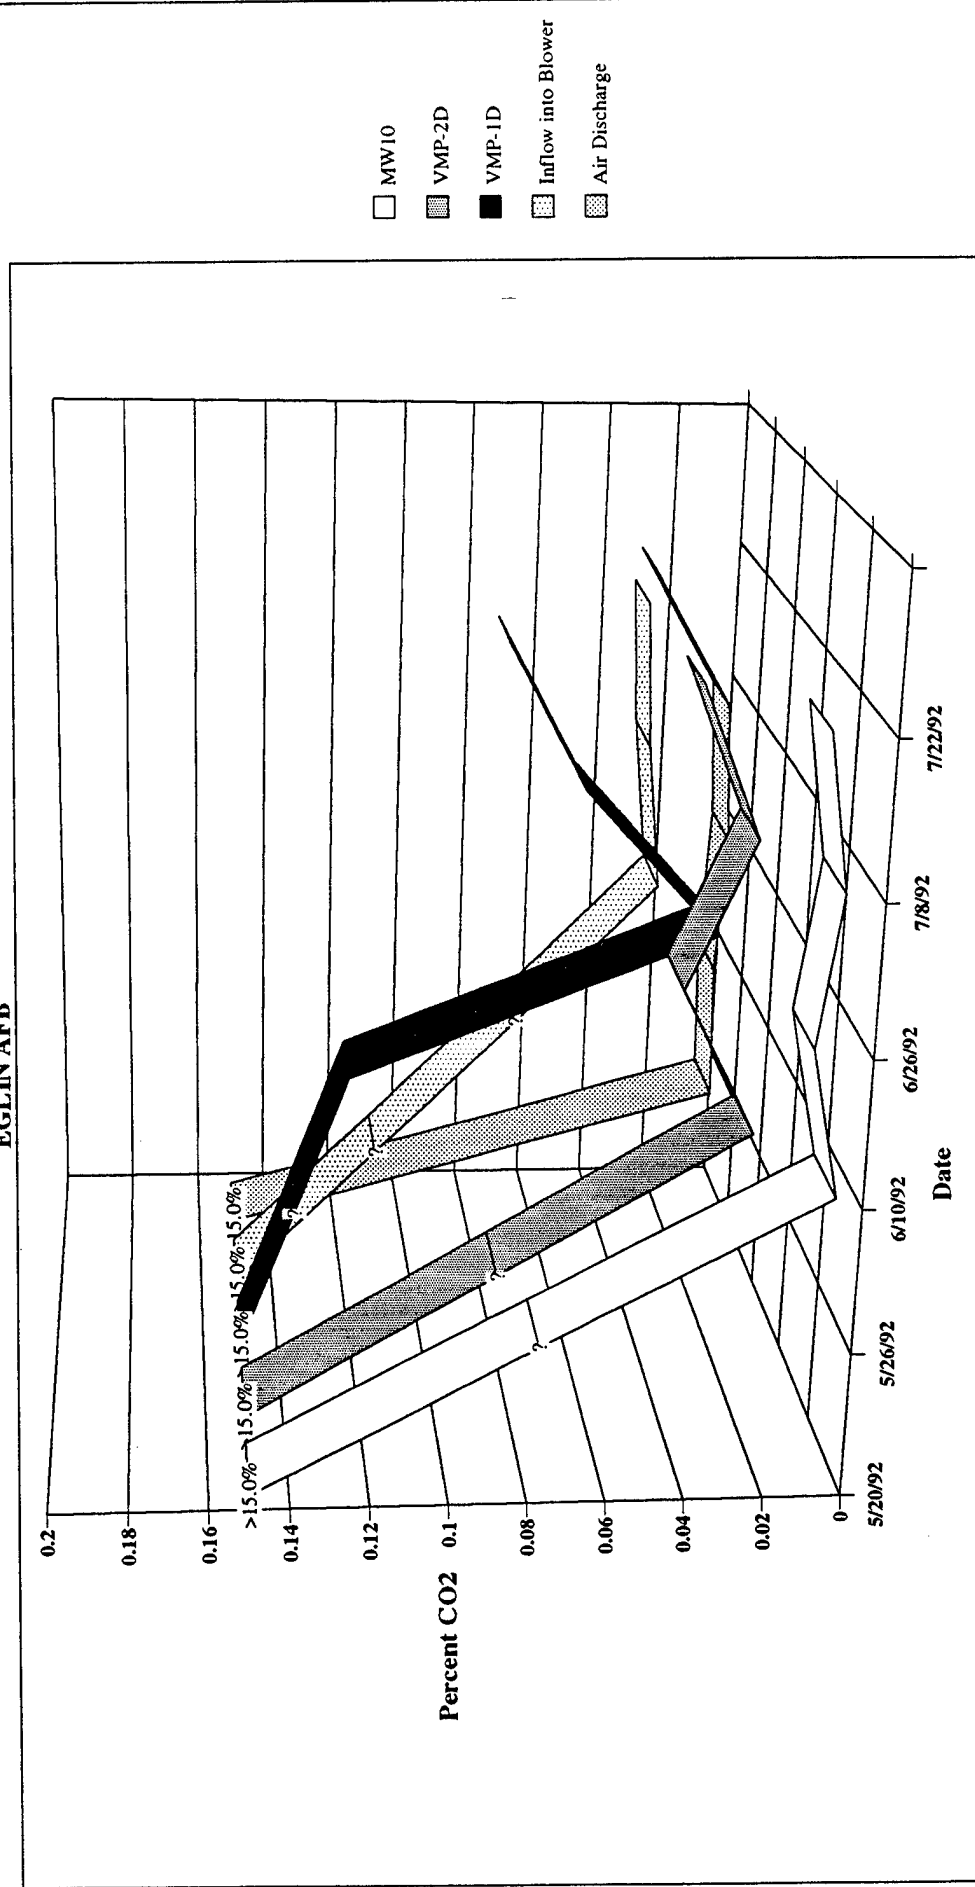
Results of biweekly/monthly check of oxygen, carbon dioxide and Total Hydrocarbons in the off gas from the bioventing system are presented in Table 1. These results continued to indicate increased biological activity in the subsurface and suggest potential increase in aerobic bacterial population. Specifically oxygen supply to the subsurface has been adequately sustained. Notably, pre-venting condition indicated soil oxygen concentration of zero at VMP-1 and VMP-2. By July 22, oxygen concentrations at all monitoring locations have increased to values ranging from 9.8 to 20.0 percent. In contrast, carbon dioxide which was in excess of 15 percent prior to startup has declined to values ranging from 1.4 to 8.1 percent at all monitoring points.

**CARBON DIOXIDE LEVELS DURING BIOVENTING
AT 7TH STREET BX SERVICE STATION (5/20/92 - 7/8/92)
EGLIN AFB**

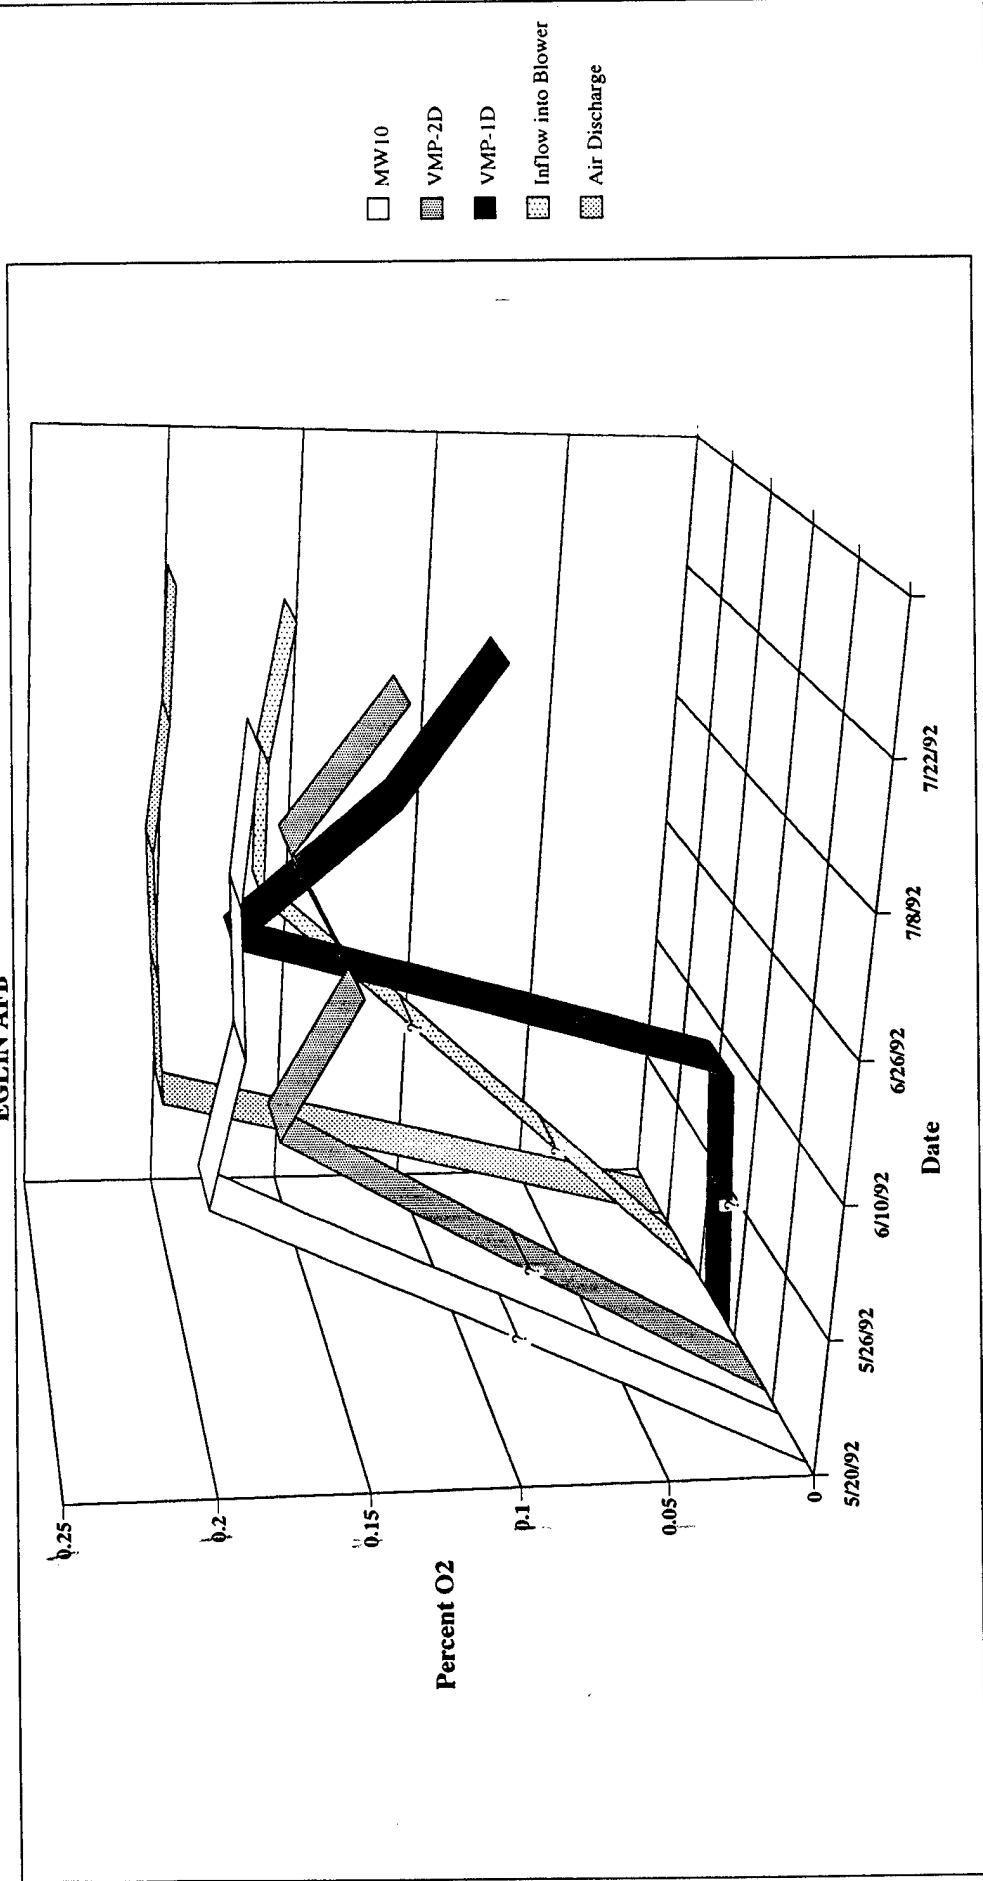
Figure 2

**OXYGEN LEVELS DURING BIOVENTING
AT 7TH STREET BX SERVICE STATION (5/20/92 - 7/8/92)
EGLIN AFB**

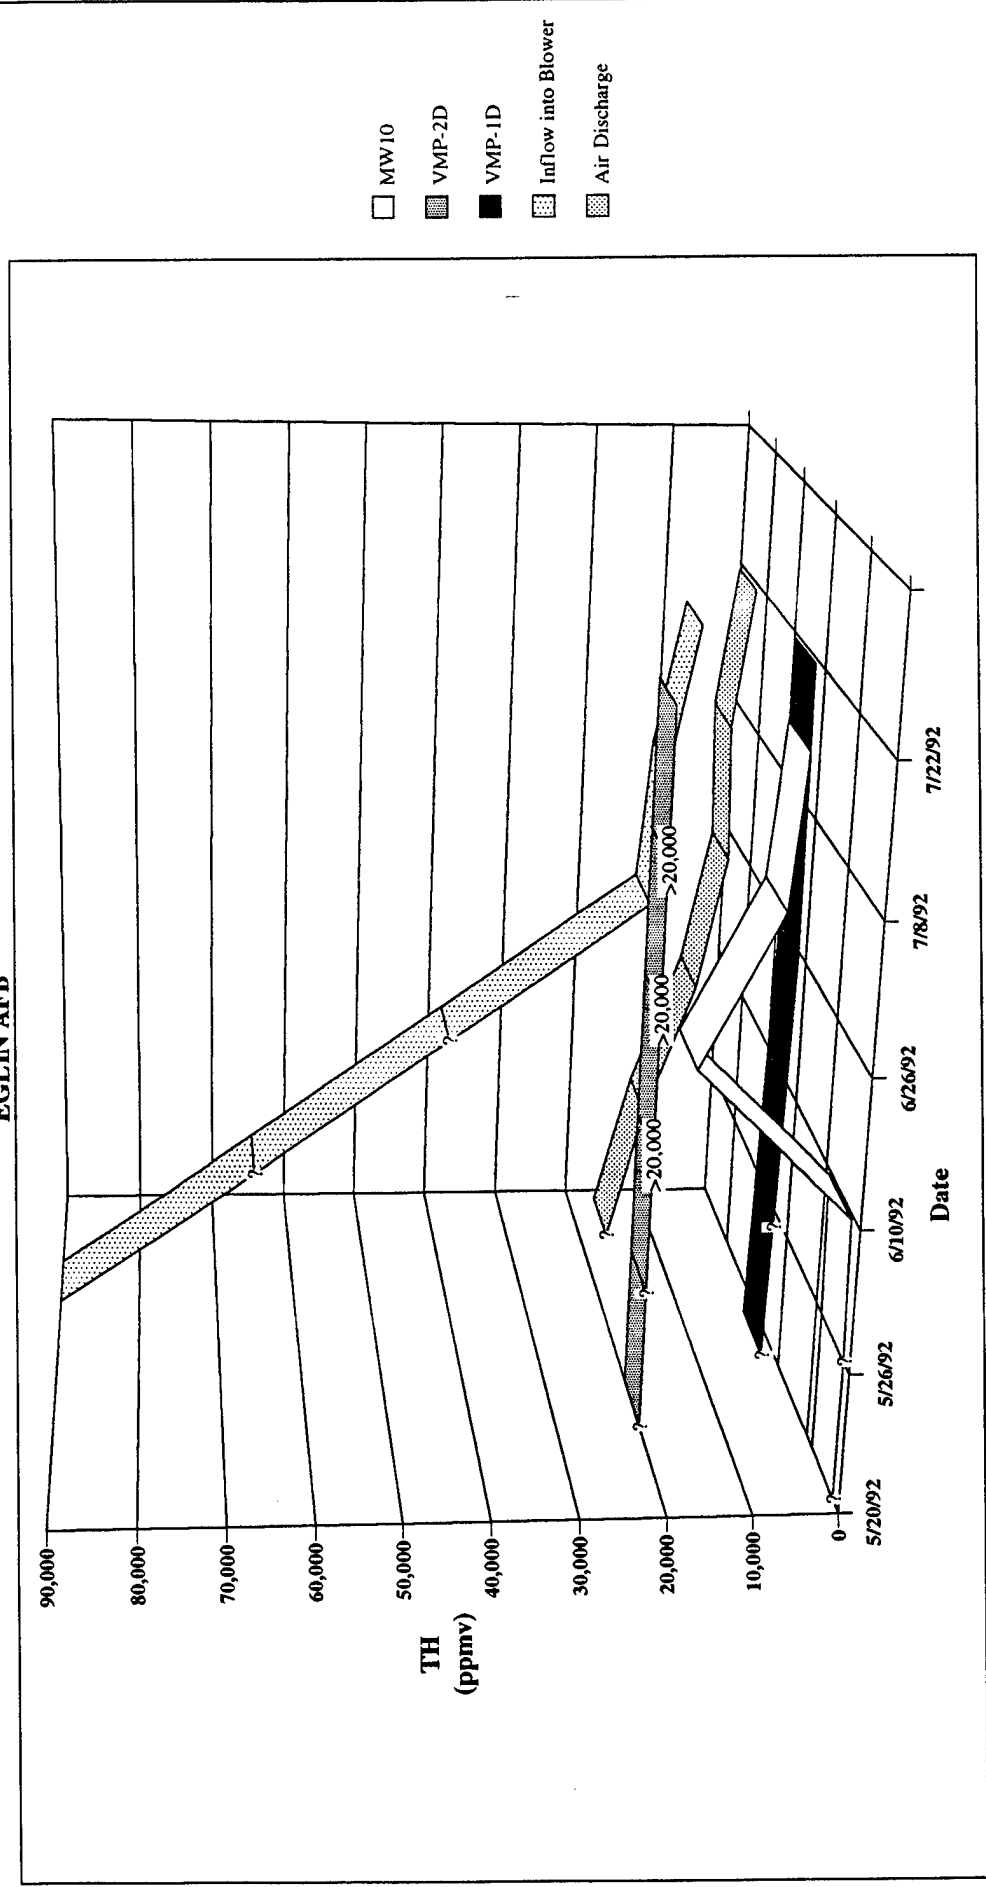
**TOTAL HYDROCARBON LEVELS DURING BIOVENTING
AT 7TH STREET BX SERVICE STATION (5/20/92 - 7/8/92)
EGLIN AFB**
