**A Laboratory Study on the Failure of
a Petroleum, Oil and Lubricant (POL)
Fuel Tank**

DSTO-TN-0300

**Combatant Protection and Nutrition Branch
Aeronautical and Maritime Research Laboratory**

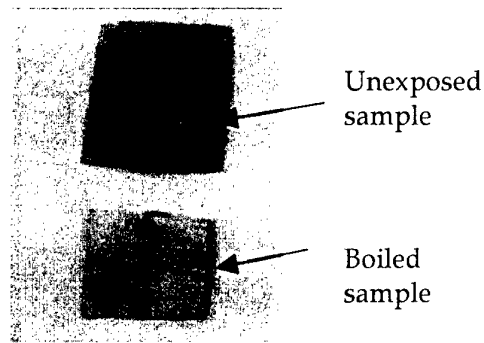
Boiling samples of the coated fabric in a sodium hydroxide solution did not degrade the coating to the same degree as observed in-service. It did have a significant impact on the colour of the coating, which changed from a light brown to grey (Figure 3). It was observed that the change of colour only occurred on the surface and did not penetrate the coating matrix.

Figure 3. Change of colour after 5 hrs boiling in a 4% aqueous sodium hydroxide solution

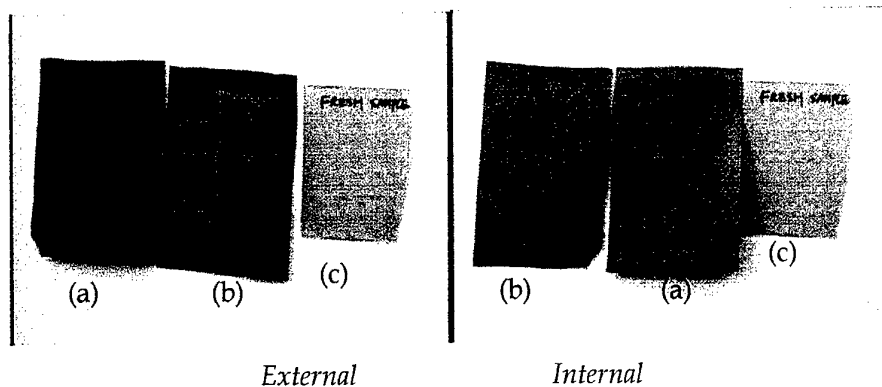
Undamaged samples and samples from undamaged areas of the POL tanks were exposed in the Xenon arc weatherometer for periods ranging from 9 weeks for the undamaged sample and 5 weeks for samples from the POL tanks. Although the samples were exposed to both Xenon light and high humidity (water spray), apart from a change in colour, they showed no evidence of degradation. As shown in Table 2, IR analysis did not indicate any significant loss of ester moiety from the coating material. Figure 5 shows the rear and front faces of the internal and external surfaces of the tank after exposure to Xenon weathering. A sample of unexposed fabric is included for comparison.

Figure 5. POL tank samples after 5 weeks Xenon light and water exposure (a) rear surface, (b) exposed surface and (c) unexposed sample

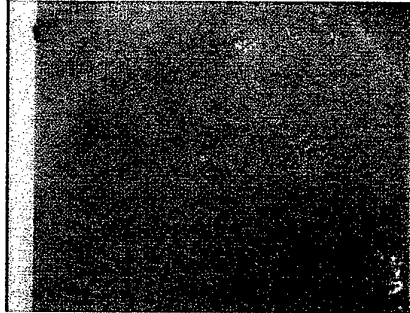
Figures 7, 8 and 9 show the samples following exposure of 4, 6 and 12 weeks respectively in the hot and humid environment within the desiccator. Figure 7 displays visual evidence of water damage and Figure 8 shows the failure of the coated samples after 6 weeks exposure. Figure 9 shows that the sample was completely degraded after 12 weeks with cracks and delamination similar to the damaged areas observed in the in-service POL tanks. This suggests that a combination of a high temperature and high humidity over a period of time is necessary to completely hydrolyse the coating. This is reinforced when the visual appearances between a fresh sample and a sample exposed for 12 weeks in the dry environment within the

Figure 7. Sample after 4 weeks hydrolysis at 80°C and 100%RH

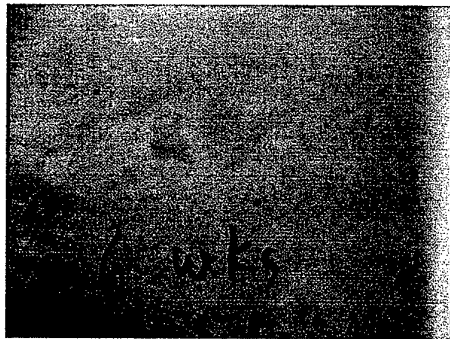
Figure 8. Sample after 6 weeks hydrolysis at 80°C and 100%RH

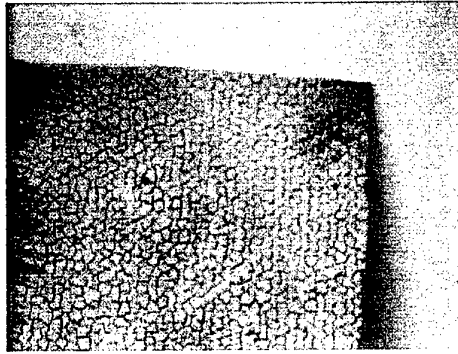
Figure 9. Sample after 12 weeks hydrolysis at 80°C and 100%RH

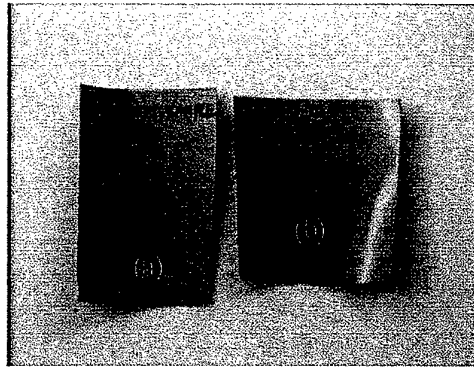
After immersion in diesel fuel for 3 weeks the samples showed a slight visible colour change (Figure 11). No cracks or delamination could be detected.

Figure 11. Unexposed coated fabric and coated fabric sample after 3 weeks immersion in diesel fuel (a) unexposed, (b) after immersion in diesel fuel
