**A Compendium of Bonded Repairs
Applied to the PC9/A Full Scale
Fatigue Test Article During Testing**

DSTO-TN-0324

**Airframes and Engines Division
Aeronautical and Maritime Research Laboratory**

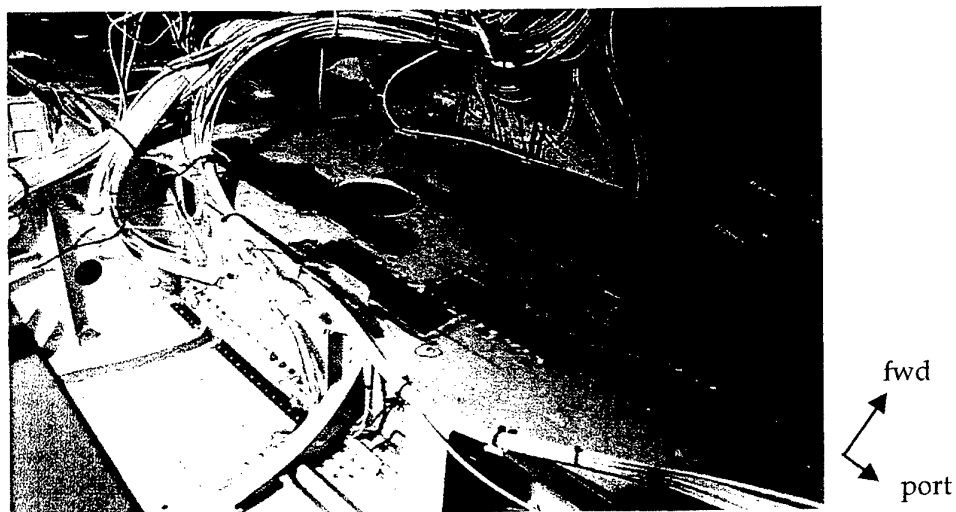
Cracking during testing occurred in the wing centre-section on the lower wing-skin and in the fuselage skin near the tail fin. Figure 2 shows a photograph of the lower wing-skin with all the repairs applied.

Figure 2. Photograph of the centre section of the lower wing-skin showing repairs.

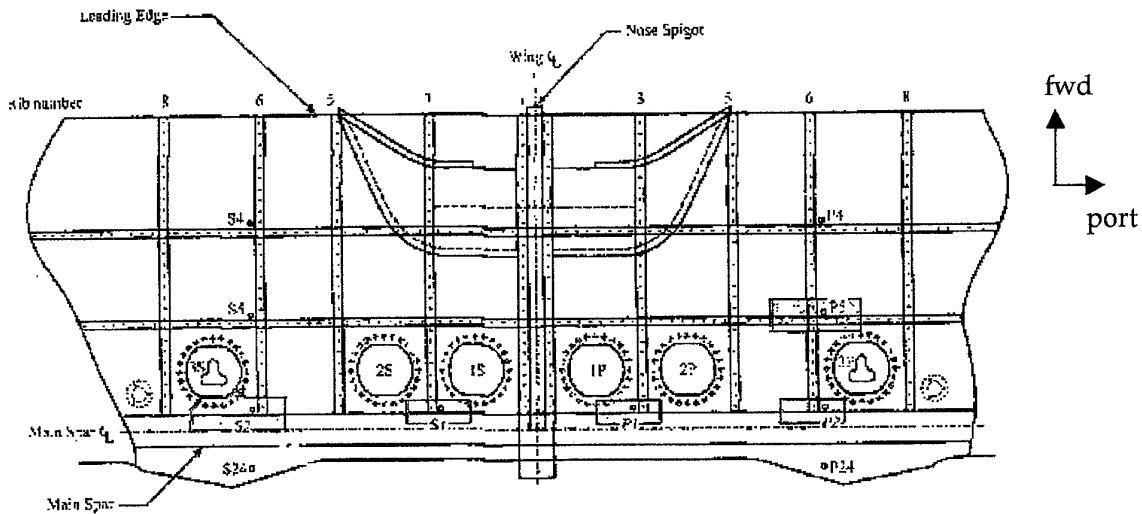
A schematic of the region (from reference 2) is shown in Figure 3. The nomenclature for access holes is 1S, 2S etc for the starboard holes and 1P, 2P etc for the port access holes. For the drain holes, the nomenclature is S1, S2 etc for the starboard side and P1, P2 etc for the port side. The repairs shown over the drain holes were those present at 50,000 SFH.

Figure 3. Schematic of the centre section of the lower wing-skin showing repairs coloured in yellow.

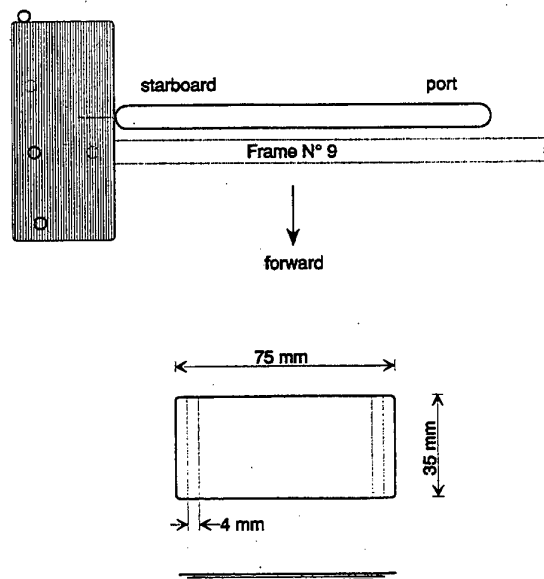
An adhesively bonded boron/epoxy patch was applied to a crack in the top skin emanating from a slotted hole at the forward fin attachment at 6,000 SFH.

Figure 4. Repair to the slotted hole in the top skin at the forward fin attachment

The patch was designed simply on the basis of stiffness matching with the aluminium skin. A three-ply unidirectional boron/epoxy layup was chosen. The thickness of the patch was approximately one third that of the skin as unidirectional boron/epoxy has a modulus approximately three times that of aluminium. The ends of the patches were stepped, at 4 mm per step, to reduce stresses at the patch ends. The patch configuration is shown in Figure 4.

No structural integrity or stress intensity calculations for the repaired crack were done for this repair.

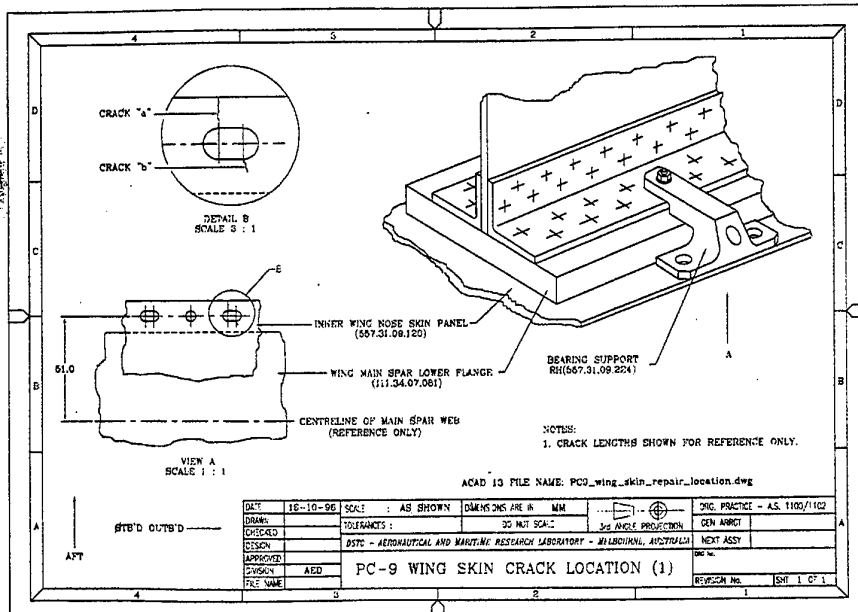
Figure 5 shows the crack location on the starboard wing as at approx. 10,000 SFH.

Figure 5. Starboard Wing Uplock Mechanism- Crack Location.

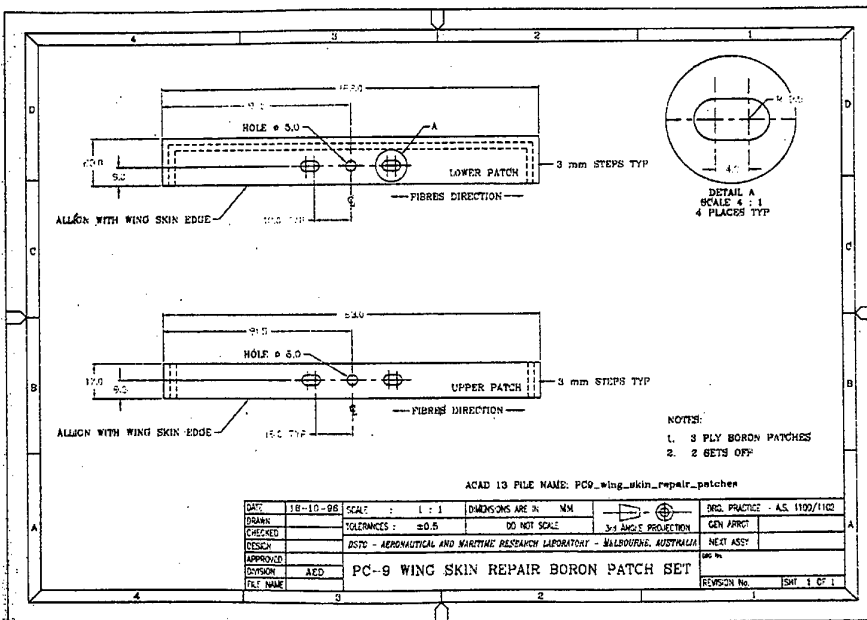
Figure 6. Starboard Wing Uplock Mechanism- Patches.

No crack growth occurred in the starboard lower skin after repair. The patches, which were applied at 10,000 SFH, were removed at 34,000 SFH to allow a re-profiling modification to the region. The port side patches were fitted at about 15,500 SFH. By 17,000 SFH the crack had grown beyond one edge of the external patch. It is thought that the use of the structural acrylic paste resulted in a very thick adhesive bondline which meant that the effectiveness of the patches in reducing crack opening would have been reduced. The patch applied subsequently to the port side used the structural epoxy adhesive FM73. A thicker patch was also employed (a single ten ply patch rather than two three ply patches).

Figure 6 shows a drawing of the patches which were bonded to the aircraft using Click Bond 200.

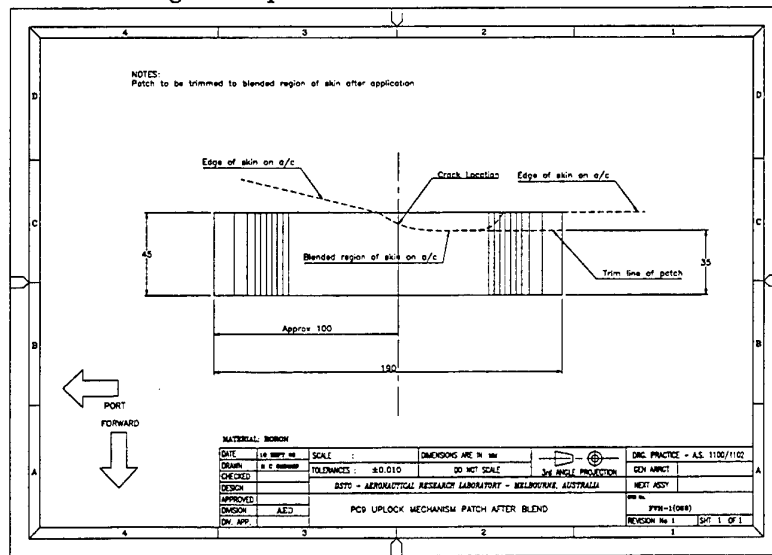
A thicker ten-ply patch was bonded using FM73 to the blended-skin of the port uplock mechanism at 38,000 SFH following re-cracking of this part. At 38,000 SFH the underlying spar had satisfied the requirement of undergoing three lifetimes of loading and so the restriction on patch thickness due to lifing considerations was removed. Eddy-current inspection of the crack showed that this patch stopped crack growth. Figure 7 shows a drawing of the patch.

Figure 7. Drawing of the port uplock mechanism patch applied at 38,000 SFH.

The design and application of these repairs was carried out in accordance with the RAAF Engineering Standard on Composite Materials and Adhesively Bonded Repairs [3]. The design of this patch is as described in Reference 5.

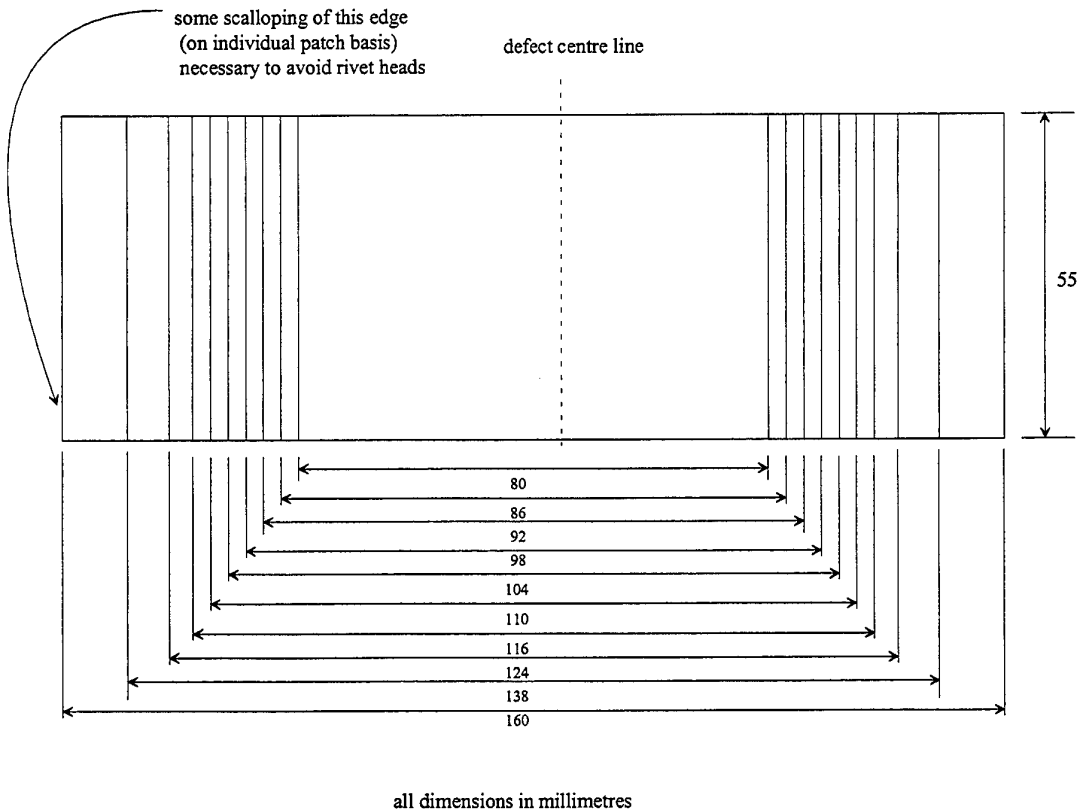
Five cracked lower wing-skin drain holes (P1,P2, S1, P5 and S2) were patched as shown in Figure 3. The drain holes were progressively patched between 23,875 SFH and 44,000 SFH (see Table 1) at scheduled downtimes for the test rig so as to minimise disruptions to the test. The locations of the drain hole patches were shown in Figure 3. The boron/epoxy patches stopped crack growth. A drawing of the generic patch applied to the drain holes is shown in Figure 8.

Figure 8. Drawing of the generic patch applied to the drain holes.

Details on the design and application of the drain hole patches are given in Reference 6.

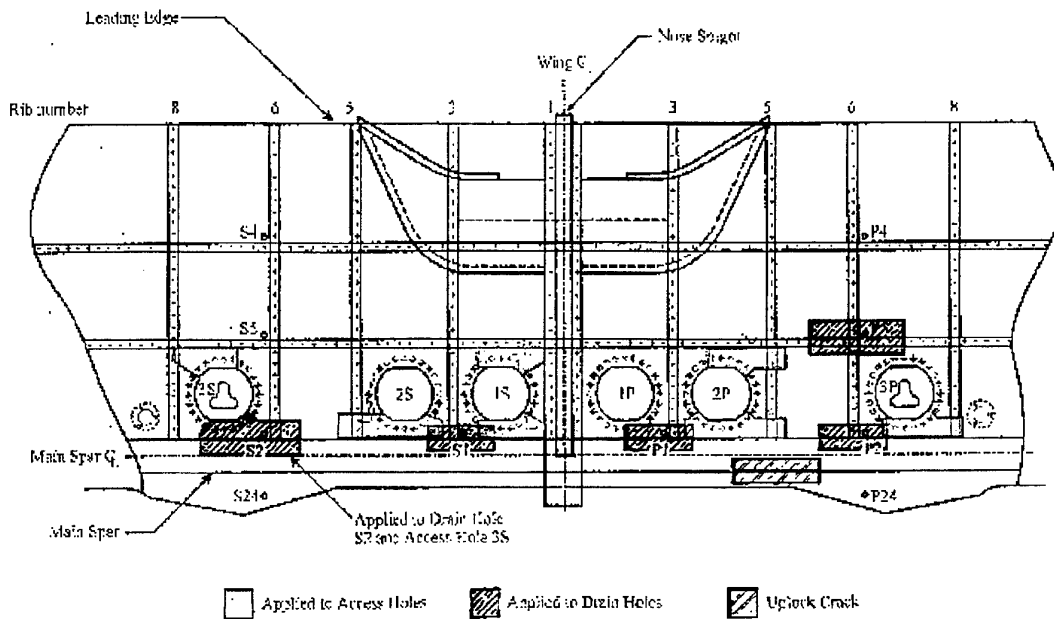
Seven patches to six cracked lower wing-skin access holes were applied progressively from about 37,000 SFH. The locations of the drain hole patches are shown in Figure 9. Inspection by eddy currents showed that the boron/epoxy patches were very successful in stopping crack growth.

Figure 9. Drawing showing the locations and the nomenclature for the access hole repairs [2].

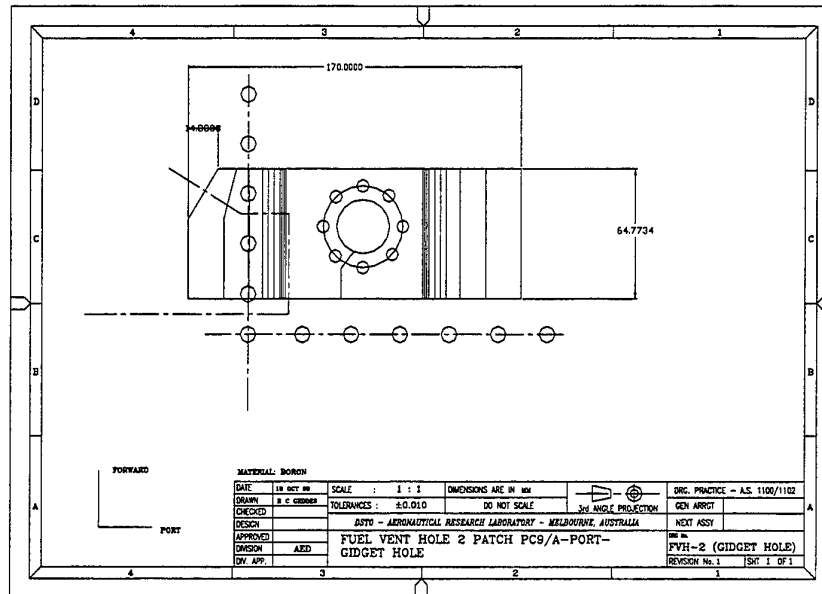
Figure 17. Drawing of patch applied to the port fuel vent hole.

A patch was applied to the port fuel vent hole located just outboard of access hole P3 (see Figure 9) at 52,000 SFH. Figure 17 shows a drawing of the patch. The patch was ten plies thick and design was as for that given in Reference 5.
