## AIRCRAFT ACCIDENT REPORT

CRASH DURING LANDING  
FEDERAL EXPRESS, INC.  
MCDONNELL DOUGLAS MD-11, N611FE  
NEWARK INTERNATIONAL AIRPORT  
NEWARK, NEW JERSEY  
JULY 31, 1997

**NTSB/AAR-00/02**

**DCA97MA055**

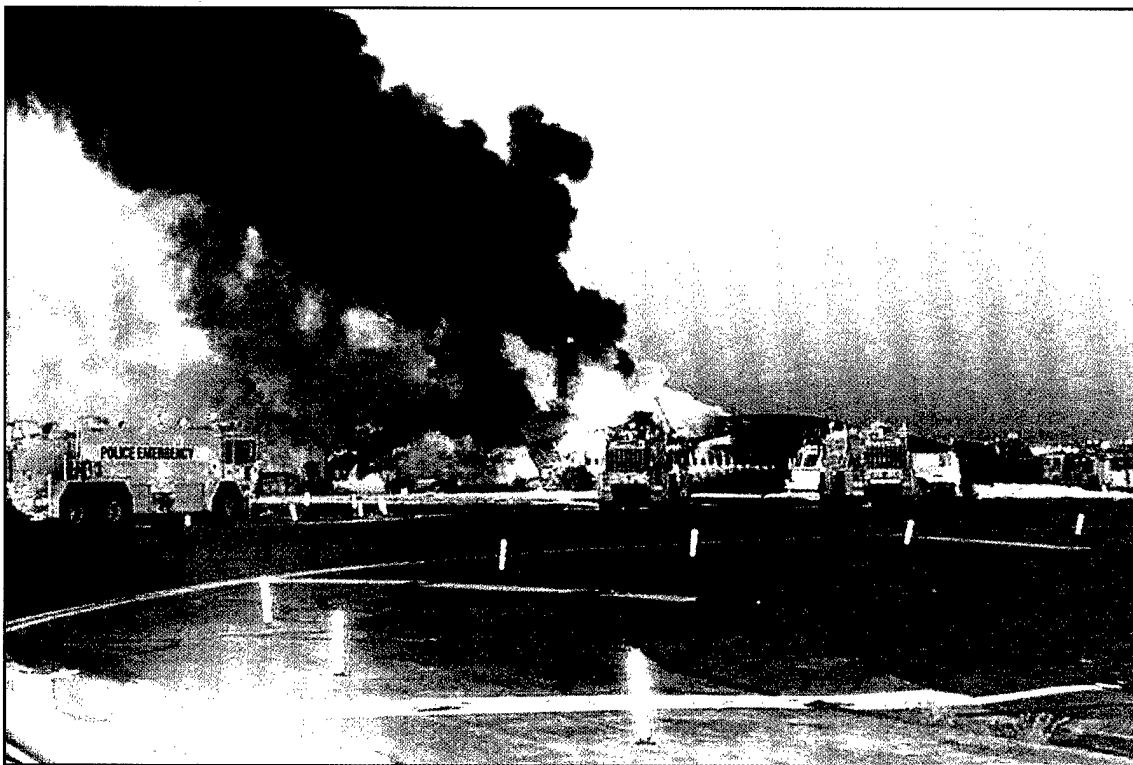
**Figure 2.** N611FE at the height of the firefighting effort.

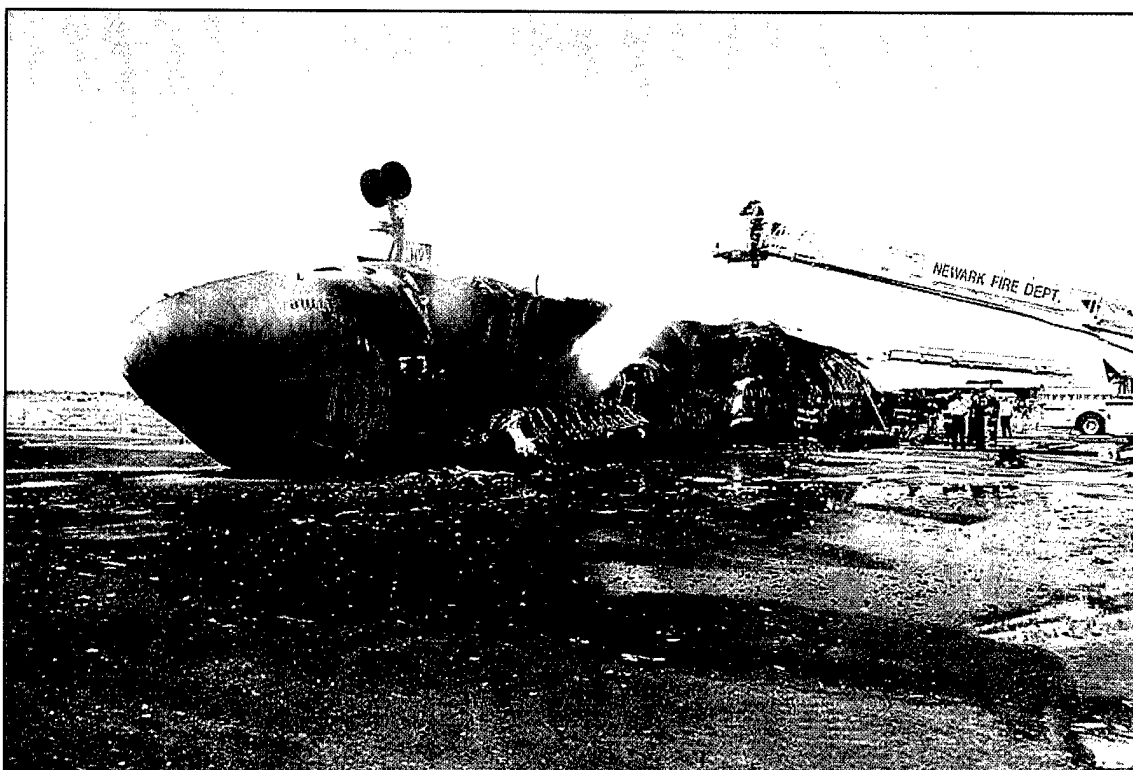
**Figure 3.** N611FE during the final portion of the firefighting effort.

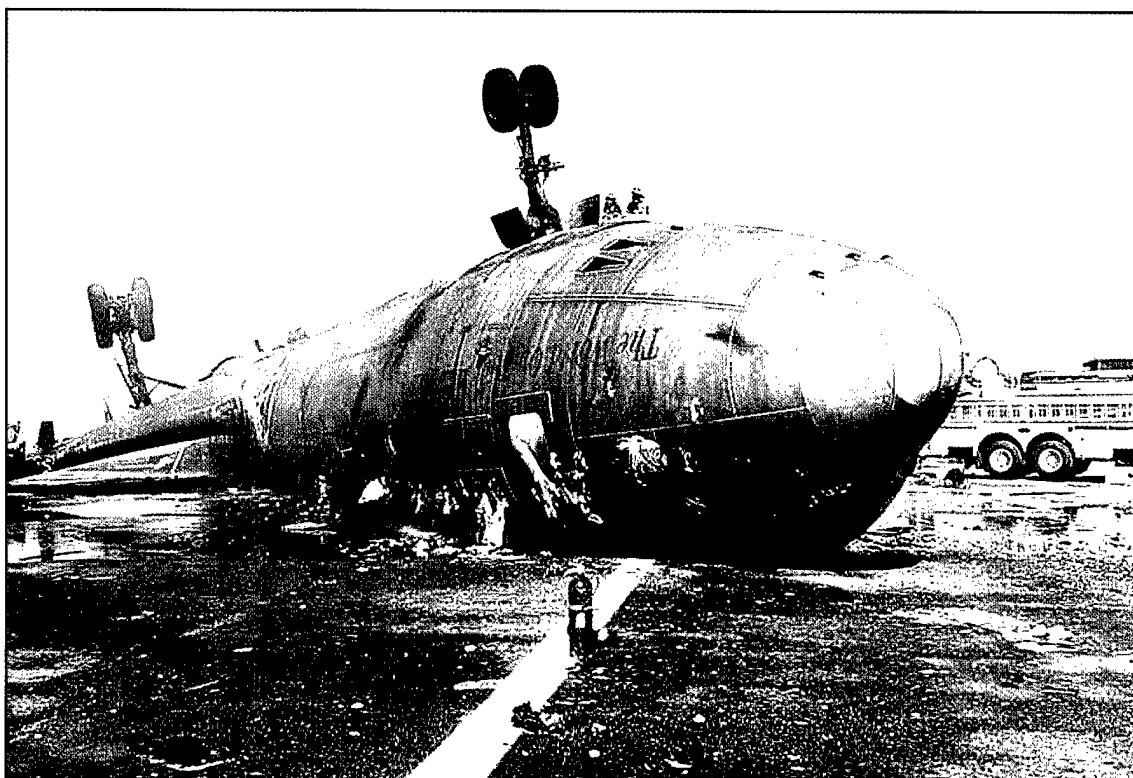
**Figure 4.** N611FE after the fire was extinguished.

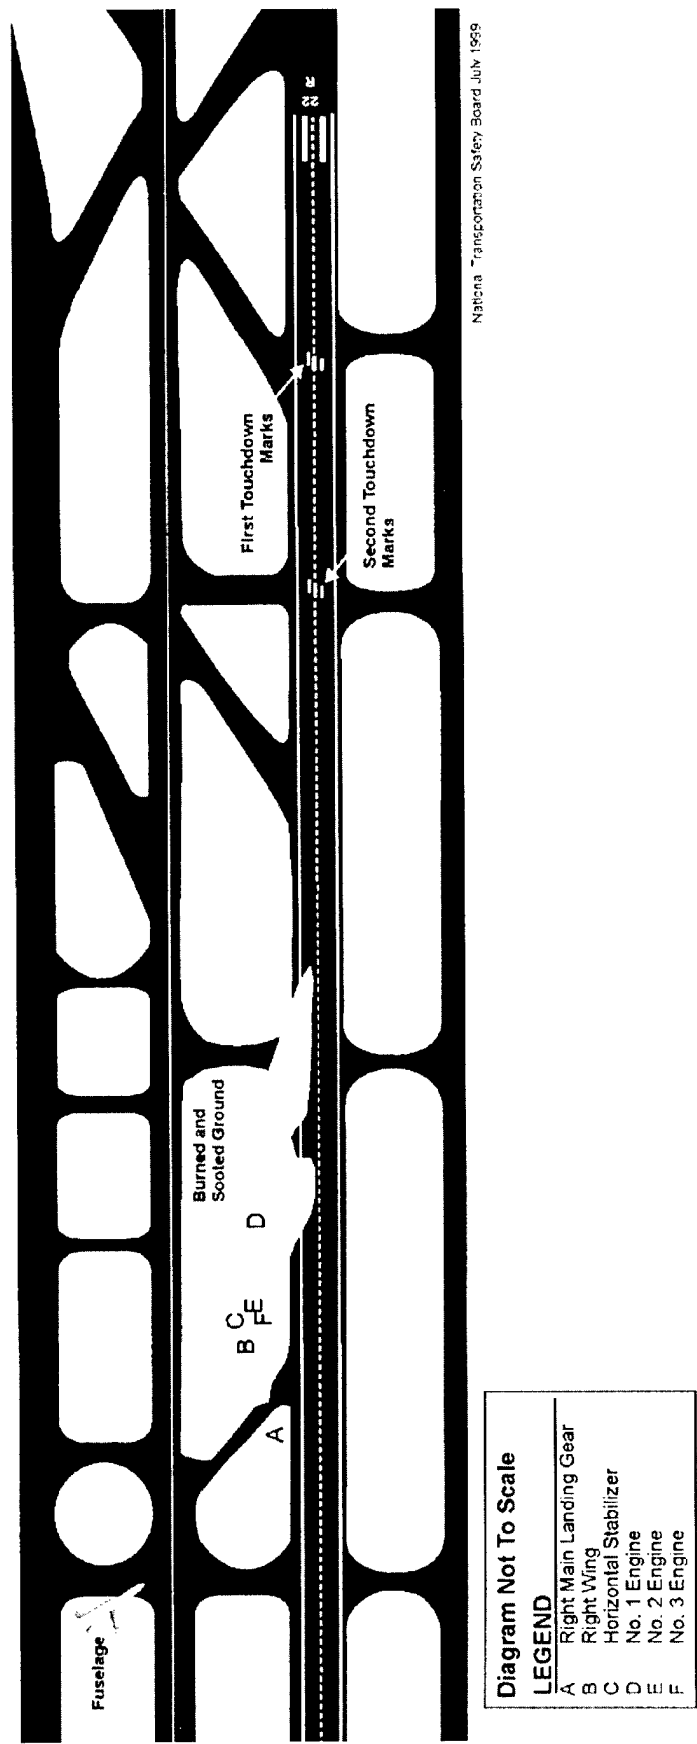
Figure 7. Wreckage distribution diagram.

The airplane's wreckage was distributed along a 2,900-foot-long debris path that gradually arced to the right across runway 22R (see figure 7). Pieces of the right inboard trailing edge flap were found at the beginning of the wreckage path, about 2,226 feet from the runway's displaced threshold. The main wreckage, located about 5,126 feet from the runway threshold and 580 feet to the right of the runway centerline, comprised the fuselage, left wing, nose gear, left MLG, center MLG, and horizontal stabilizer. The fuselage came to rest inverted with the nose on a 95° heading. Other airplane components and structure separated from the airplane during the crash sequence and were located along the debris path.

Rubber marks consistent with the touchdown of the airplane's right MLG tires were found about 1,126 feet from the runway displaced threshold. Rubber marks consistent with the touchdown of the left MLG tires and center MLG tires were found at 1,151 feet and 1,160 feet from the runway displaced threshold, respectively. The location of the tire marks was consistent with a touchdown near the center of the runway. Rubber marks consistent with a second touchdown of the right MLG tires were found about 1,924 feet from the runway displaced threshold (798 feet after the tire marks consistent with the first touchdown). Rubber marks consistent with the center MLG tires were found again about 1,983 feet from the runway displaced threshold. The locations of the second touchdown tire marks were consistent with a touchdown near the center of the runway. The right MLG tire rubber marks veer to the right about 1,995 feet from the runway displaced threshold.

Ground scarring consistent with the No. 3 (right) engine nacelle contacting the runway were found about 2,164 feet from the runway displaced threshold and continued to about 3,476 feet from the runway threshold. Runway scarring consistent with impact of the right inboard trailing edge flap was found about 2,299 feet from the runway threshold, ending about 2,376 feet from the threshold (where the right inboard trailing edge flap was found). Soot marks consistent with burning fuel were found about 2,506 feet from the threshold and continued to the end of the wreckage path. Runway scrape marks and purple paint<sup>42</sup> consistent with the airplane's tail striking the runway were found about 2,644 feet from the runway threshold and ended about 3,060 feet from the threshold. About 2,826 feet from the threshold, runway scrapes, soot marks, and runway surface gouging began turning toward the right of the runway.

The right wing, the vertical stabilizer, and all three engines separated from the airplane and were found in a grassy area to the right of the runway, about 4,577 feet from the runway threshold, and had sustained fire damage consistent with a postaccident fuel fire. The right MLG strut assembly and two MLG wheels and tires were found on the right edge of the runway, about 4,805 feet from the runway threshold. The other two right MLG wheels and tires were found about 235 feet to the right of the runway centerline and about 4,957 feet from the threshold.
