*Monitoring Completed Navigation Projects Program*

## **Periodic Inspection of St. Paul Harbor Breakwater, Alaska**

Robert R. Bottin, Jr., and Alan C. Jeffries

February 2001

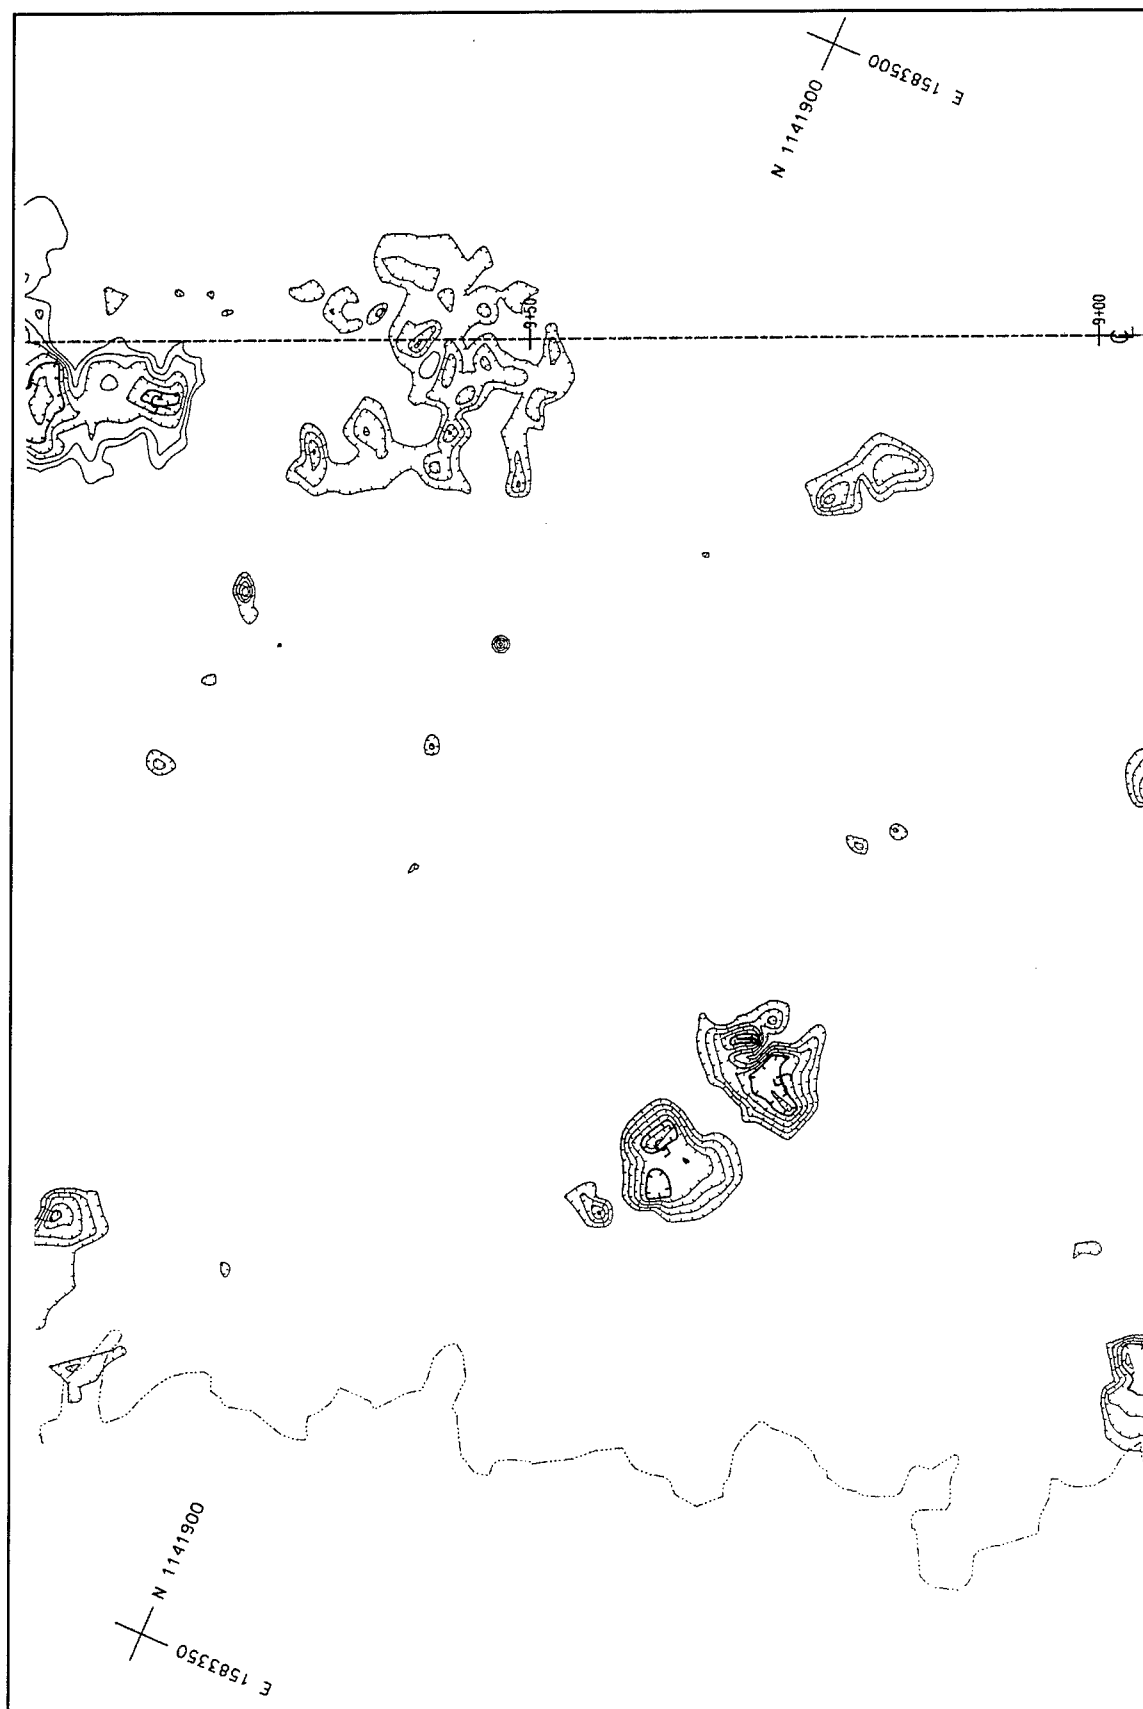
Maps developed depicting changes in contours between 1996 and 2000 revealed several areas in the breakwater where voids or subsidence (on the order of at least 1.5 m (5 ft)) have occurred. On the seaward slope, decreases in breakwater el were noted between sta 7+70 and 8+45 and sta 8+80 and 9+70; and on the shoreward slope between sta 8+80 and 9+30 and sta 13+90 and 14+15. Difference contour maps also revealed voids in several areas along both slopes of the breakwater as well as the crest where single armor units have been displaced.

Figure 11. Example of difference contours for breakwater between 1996 and 2000

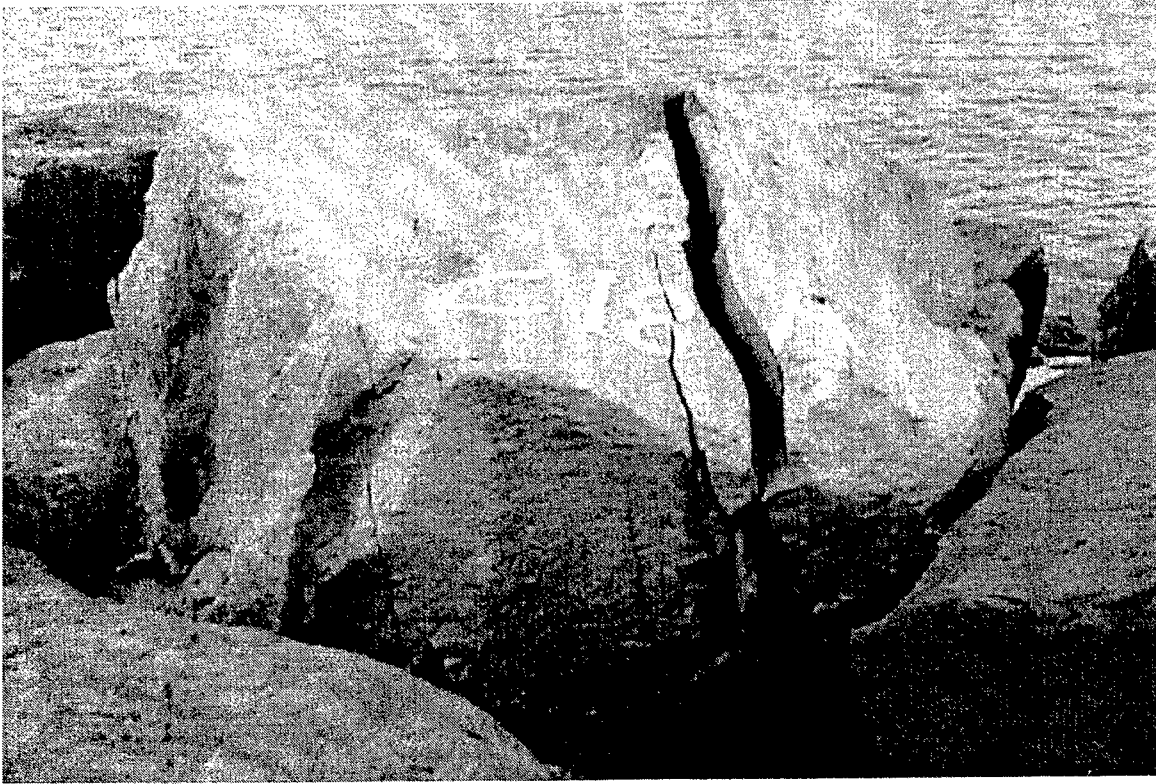
During the broken armor stone survey, 24 new broken stones were noted since the June 1996 inspection. Of the 24 new broken stones, nine were located along the crest, nine on the sea side slope, and five on the harbor side slope. In addition, a total of 33 broken stones, documented during the June 1996 survey, could not be found during the current inspection, indicating they had been moved

Figure 12. View of broken armor stone on St. Paul Harbor breakwater (sta 9+61)

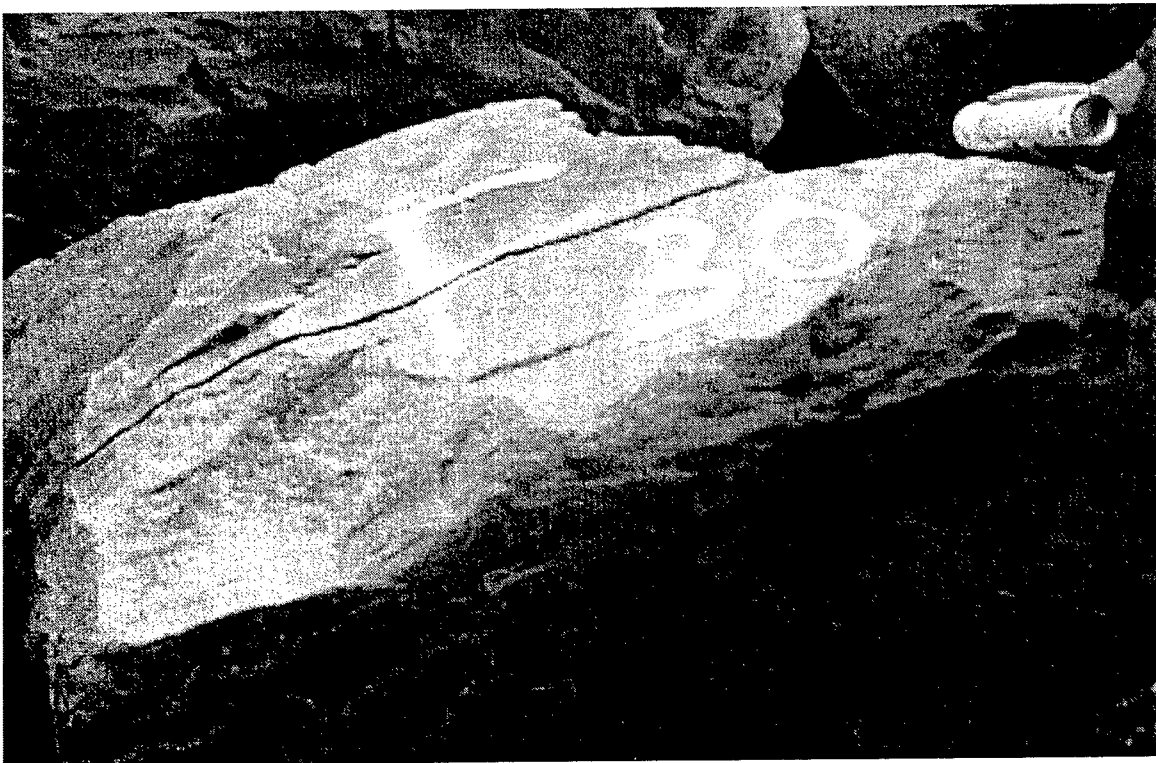
Figure 13. View of broken armor stone on St. Paul Harbor breakwater (sta 11+03)

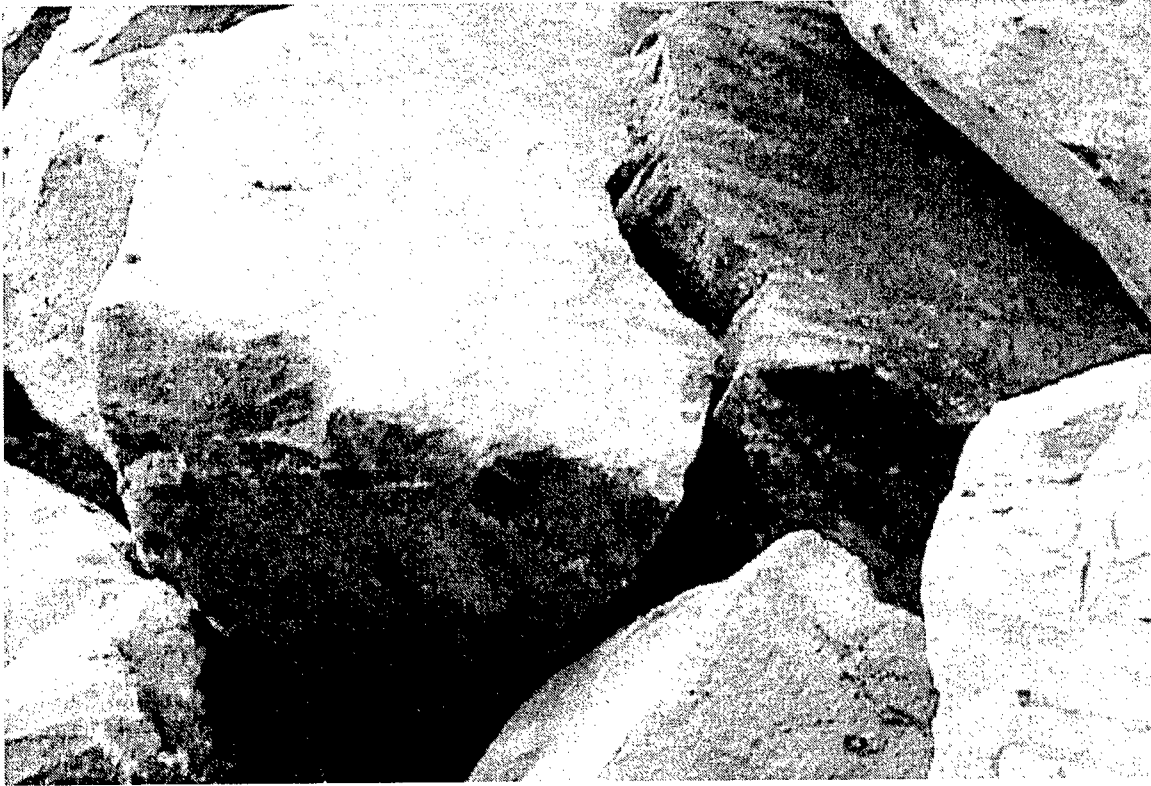
Figure 14. View of broken armor stone on St. Paul Harbor breakwater (sta 16+08)

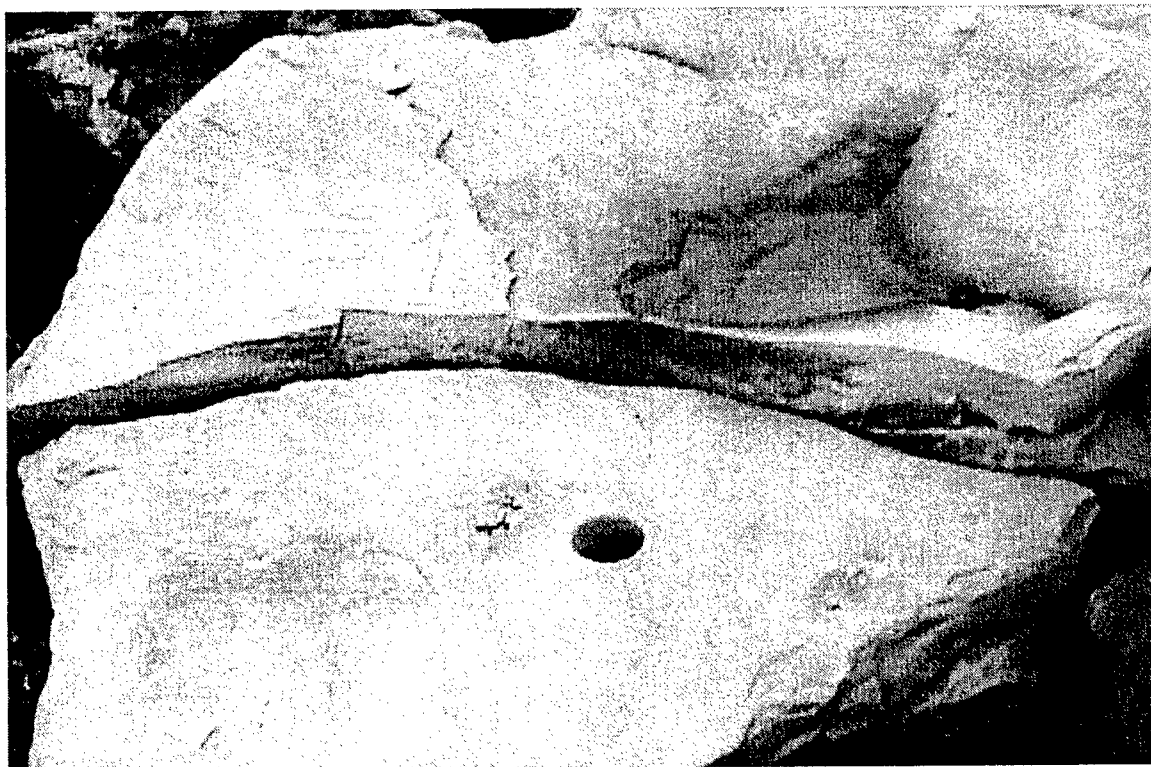
Figure 15. View of broken armor stone on St. Paul Harbor breakwater (sta 17+34)

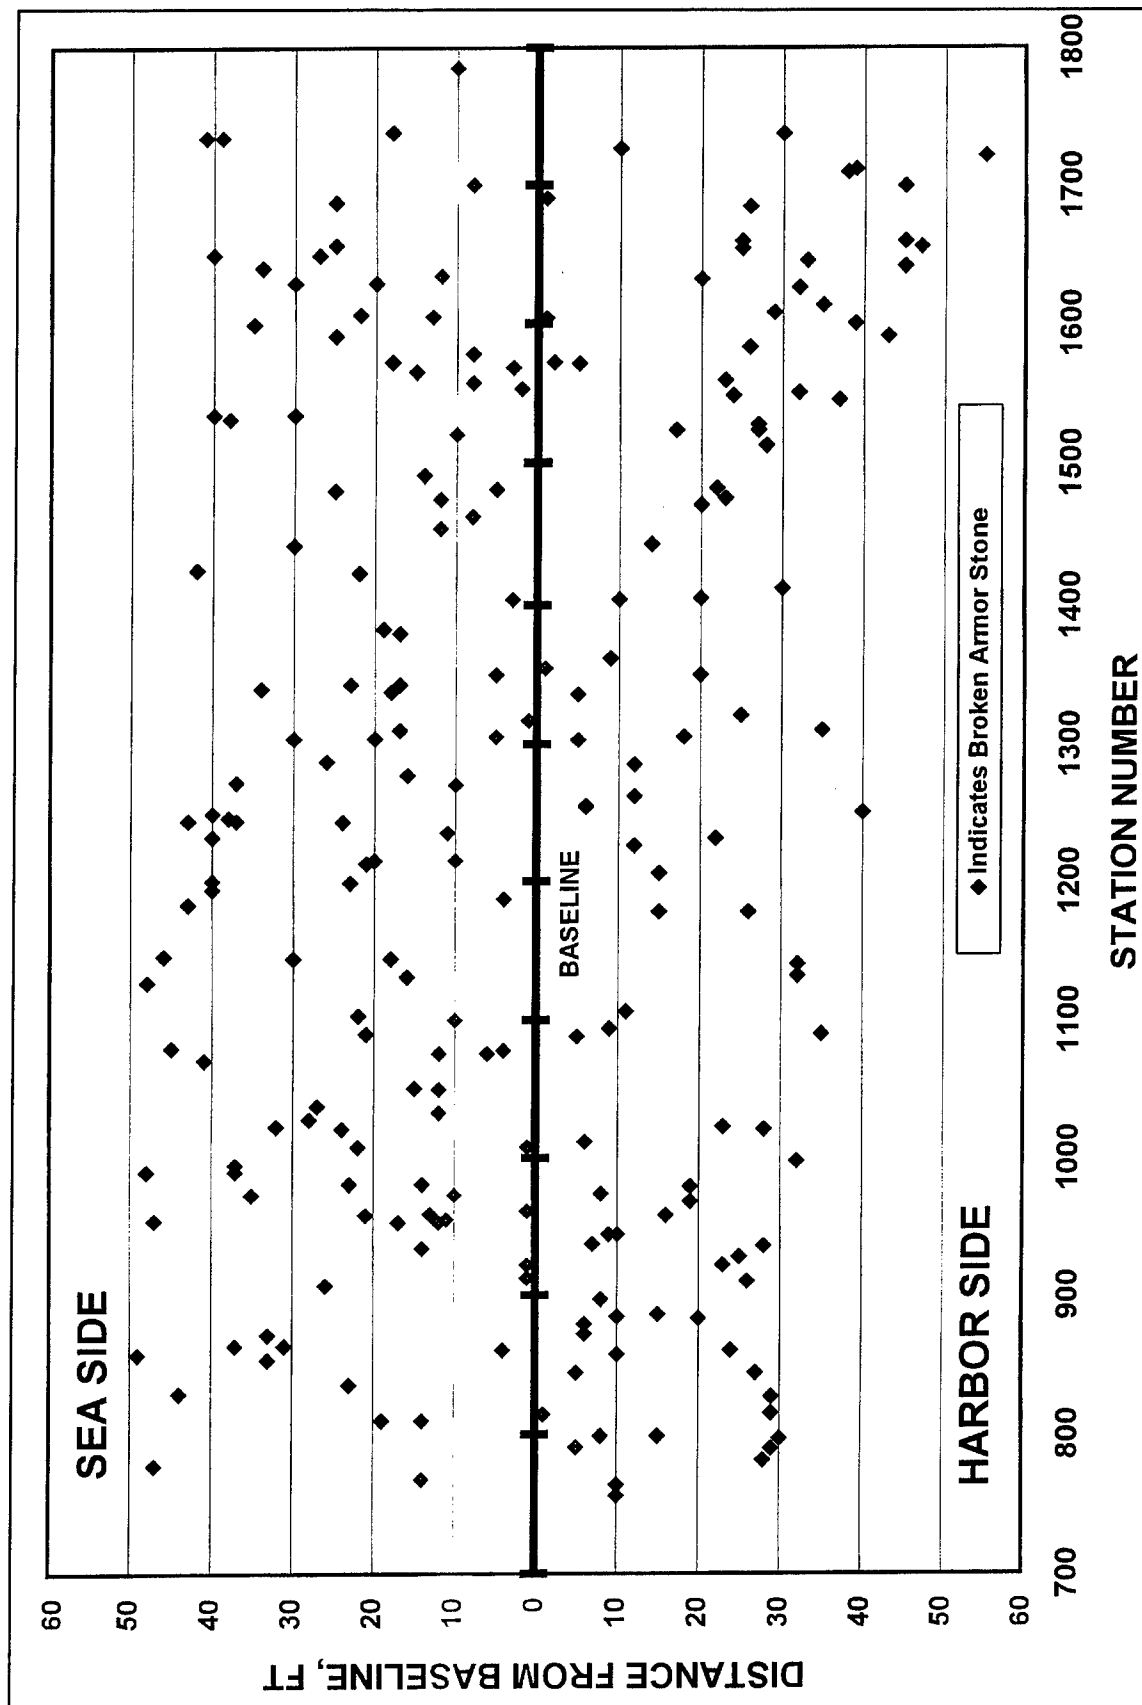
The survey revealed a total of 221 broken or cracked armor stones above the waterline. A total of 219 broken stones was noted on the trunk of the breakwater with only two observed around the head of the structure. Of the 219 stones along the trunk, 55 were located along the breakwater crest, 95 on the sea side slope, and 69 on the harbor side slope. The distribution of broken armor stones along the breakwater trunk as a function of station number and offset from the baseline is shown in Figure 16. Broken stones were, in general, relatively evenly distributed along the length of the structure. The survey indicated that 54 percent of the broken stones were located on the shoreward half of the breakwater extension and 46 percent were on the outer half. About 25 percent of the observed stones were along the crest, 43 percent on the seaward slope, and 32 percent on the harbor side slope. Of the broken stones located on the breakwater slopes, the survey revealed that 44 percent of the broken stones were located on the upper half of the slopes (28 percent on the sea side and 16 percent on the harbor side; and 56 percent were on the lower half of the structure slopes (30 percent on the sea side and 26 percent on the harbor side). The distribution of broken/cracked armor units relative to offset from the baseline is shown in Figure 17.

Figure 16. Distribution of broken armor stones along breakwater trunk relative to station number (To convert feet to meters, multiply by 0.3048)

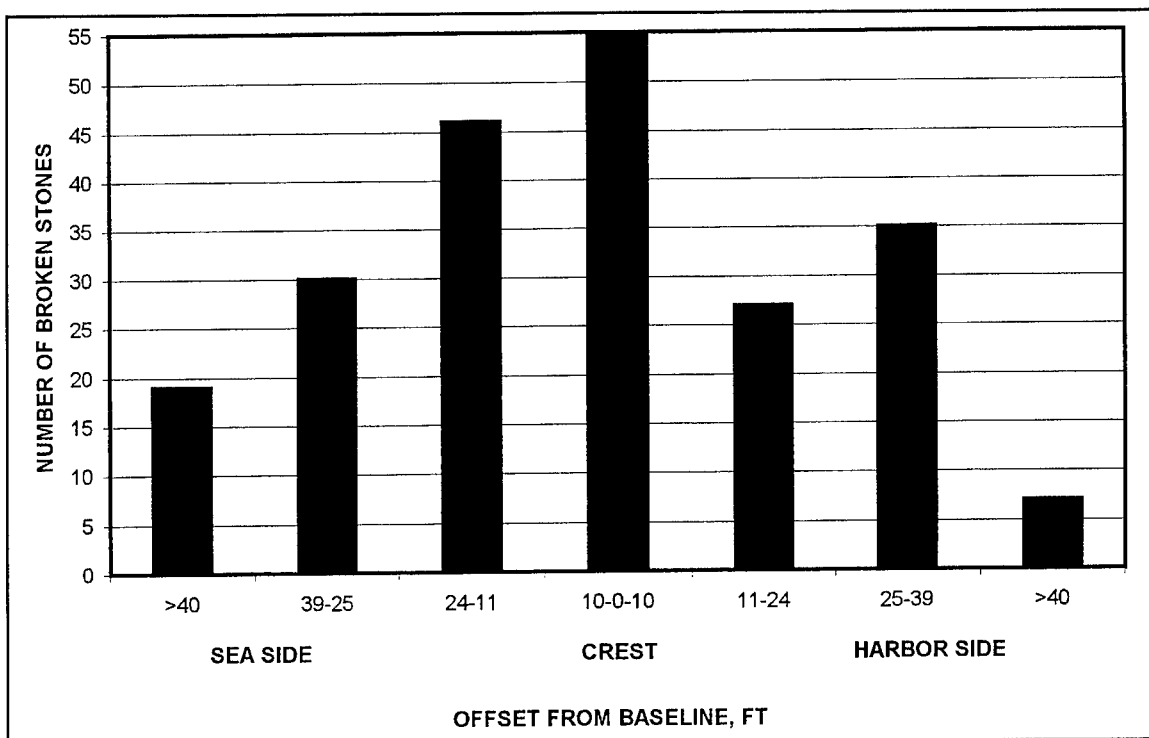
Figure 17. Distribution of broken armor stones relative to distance from baseline (To convert feet to meters, multiply by 0.3048)
