REPORT NO: NAWCADPAX/RTR-2000/97

S-3B SMALL-SCALE APPLIQUÉ COUPON FLIGHT TEST EVALUATION RESULTS

9 January 2001

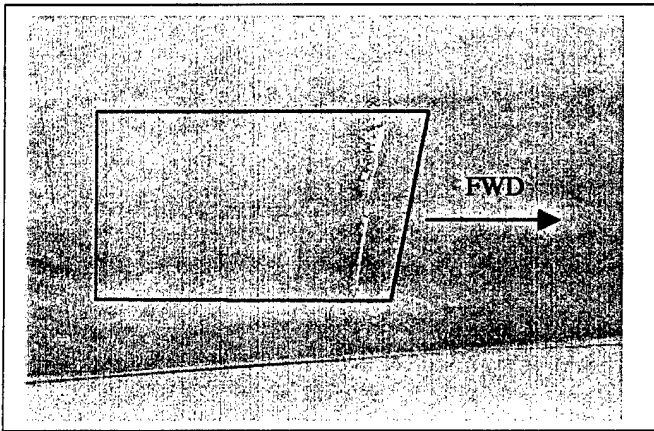
Following the failure mode test flight, the prepeeled coupons at site 1 were inspected. Figure 8 shows the prepeeled coupons at site 1 on the left wing following the flight, and figure 9 shows the prepeeled coupons at site 1 on the right wing following the flight. Neither the FP500 nor FP1500 material experienced any additional peeling, and the film tattered as desired.

Figure 8: Prepeeled coupons at site 1 on left wing following flight. (Test site outlined in black.)

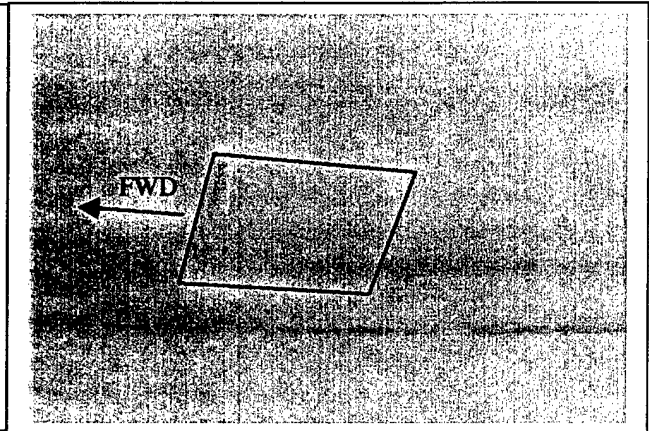
Figure 9: Prepeeled coupons at site 1 on right wing following flight. (Test site outlined in black.)

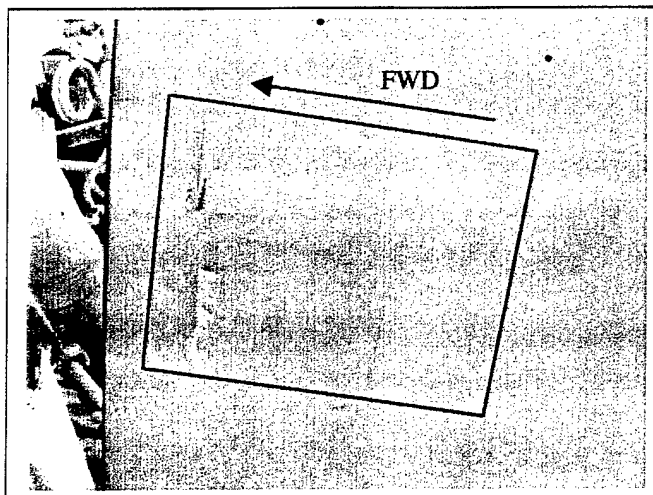
Figure 10: Prepeeled coupons at site 2 on the left lower gear door prior to the flight. (Test site outlined in black)

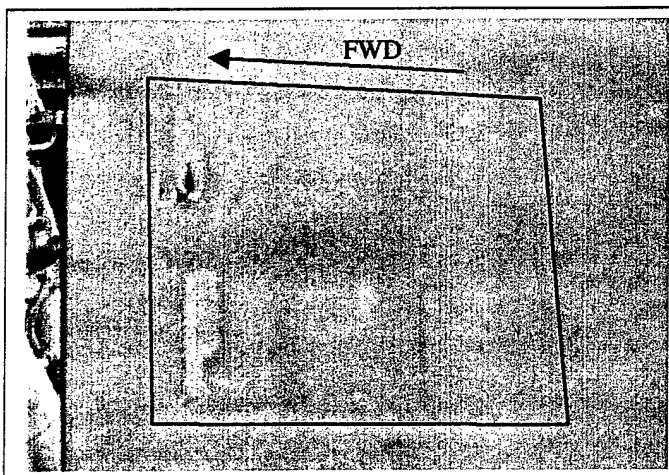
Following the failure mode test flight, the prepeeled coupons at site 2 were inspected. Figure 12 shows the prepeeled coupons at site 2 on the left lower gear door following the flight, and figure 13 shows the prepeeled coupons at site 2 on the right lower gear door following the flight. Neither the FP500 nor FP1500 material experienced any additional peeling, and the film tattered as desired.

Figure 12: Prepeeled coupons at site 2 on the left lower gear door following the flight. (Test site outlined in black.)

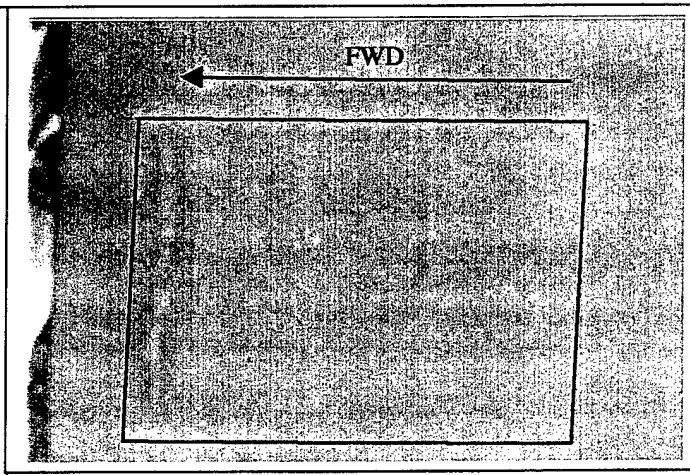
Figure 13: Prepeeled coupons at site 2 on the right lower gear door following the flight. (Test site outlined in black.)

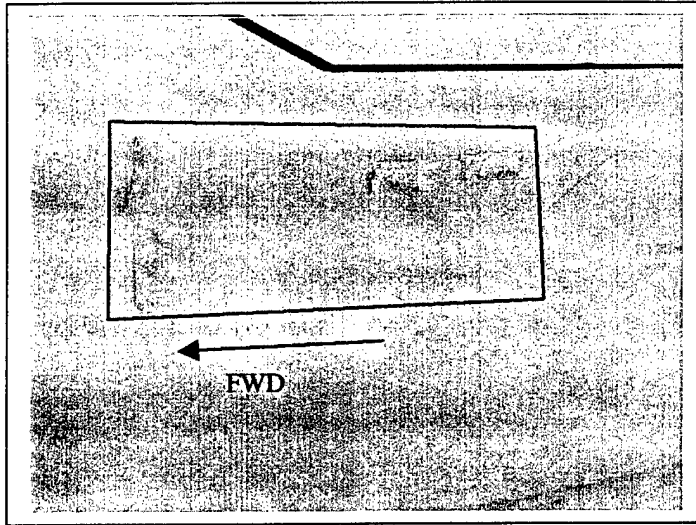
Figure 14: Prepeeled coupons at site 3 on the vertical tail below the rudder prior to flight.
