NRL/MR/6110--01-8561

Report of Green Thread Pipe Installation at Lualualei, HI and Jim Creek, WA VLF Sites: Changes from 1997 to 2001

July 12, 2001

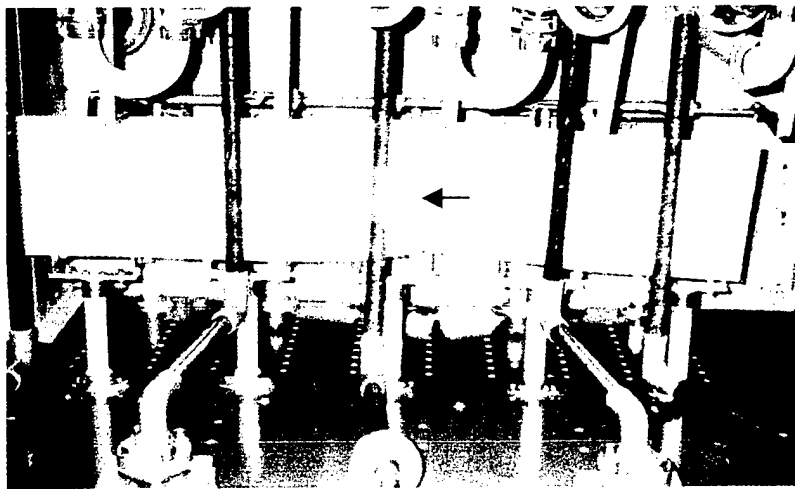
Figure 1. 1998 Photograph of the fiberglass pipe for PA 2 showing the color variations change in 1998 for PA2.

The coloration of the fiberglass pipe was photographed for use in future assessments of the aging process of the fiberglass pipe under VLF operating conditions. The discoloration of the pipe was mapped for all the cabinets. Figure 1 shows the color variations obtained for PA 2 in 1998. In general, the outlet pipes have a darker amber color than the inlet side pipes, but there were significant variations in the color for both inlet and outlet due to the variations in batch production of the pipe. There appeared to be color discontinuities in some of the piping where a splice has been used to join two pieces of pipe (indicated by arrow).

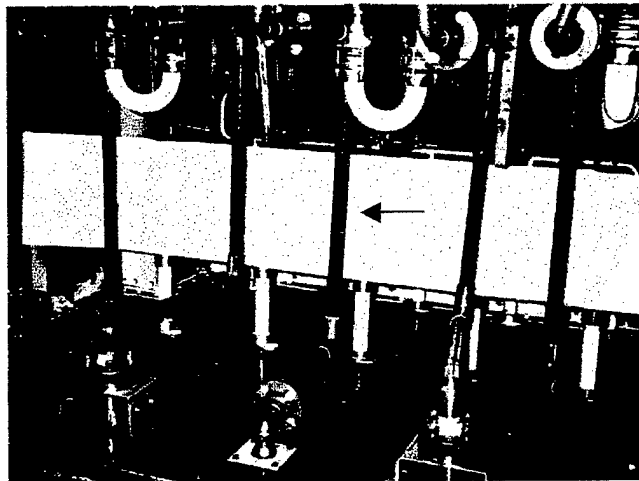
Figure 2 shows the same section of pipe (PA 2 left) photographed in March 2001. It is obvious that the Green Thread pipe has aged to a relatively uniform amber to dark amber color. There is no yellow green pipe coloration in the PA cabinets. Appendix A shows color changes of the Green Thread pipe for several PA cabinets for 1998, 2000, and 2001.

Figure 2. 2001 Photograph of the fiberglass pipe for PA 2 showing the color variations.

The arrow in figure 2 denotes the location of the splice indicated in figure 1. The overall color of the latest photographs are darker than the earlier photographs, yet they portray a relatively true color change for the Green Thread pipe. Appendix A contains photographs showing selected color change from 1998, 2000 and 2001 for Lualualei and Jim Creek.

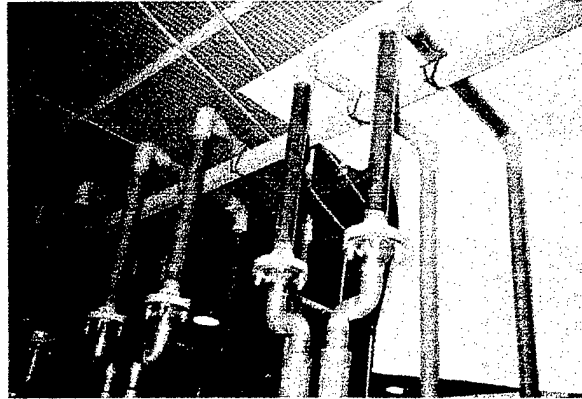
The fiberglass pipe (figure 3) was installed in February 1997 and had been in service for approximately 13 months (May 1998). The upper summer time operating temperature for the cooling water is approximately 110°F. The color variations in the fiberglass pipe at that time were less intense at Jim Creek than those at Lualualei, HI. Once again, the

Figure 3. 1998 photograph of fiberglass pipe discoloration for 13V1001 (starboard side).

variations in color adhere to the rule that the warmer the pipe (i.e., higher temperature of the cooling water) the darker the color. However, similar to the Lualualei site, there are

of pipe immediately attached to the exit flange, the next segment of pipe is dark amber and the remaining segment of pipe is light green/amber. The explanation is probably in the quality control of the fiberglass pipe batches, pipe age and ambient temperature of the situation. As can be seen in figures 3 and 4, the color of the fiberglass pipe has darkened slightly but retained the same color differentials. It may take a very long in service time (many years) before the Jim Creek site fiberglass pipe obtains a relatively even dark color like Lualualei.

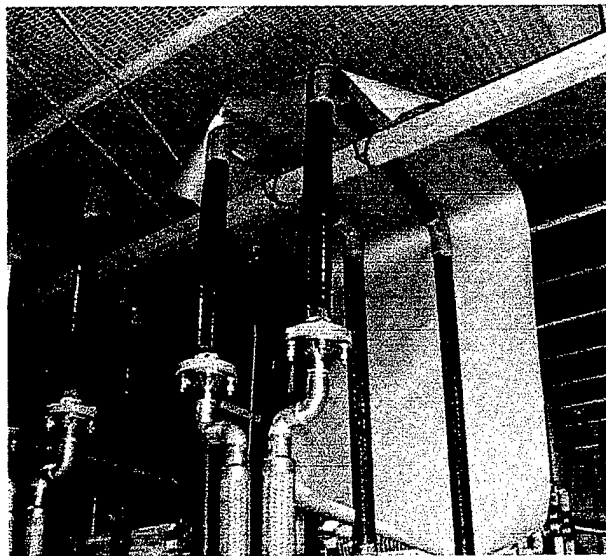
Figure 4. 2001 photograph of the fiberglass pipe discoloration for 13V1000 (starboard side).

light green/amber fiberglass pipe on the hotter exiting water with multiple variations to the general color distribution. There are cases where there is a light green/amber section

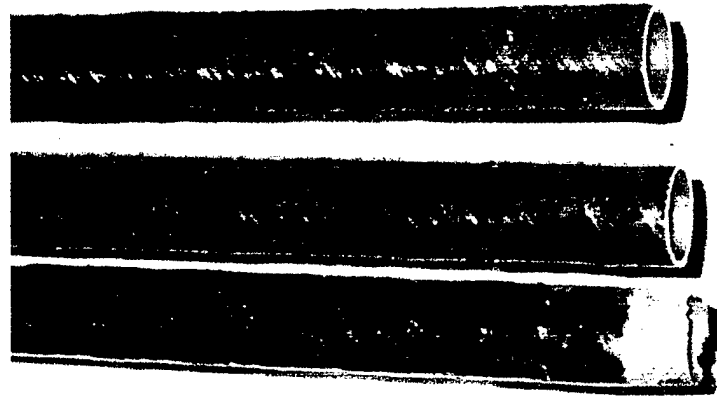
Figure 5 shows how different the color changes can be obtained for the Green Thread pipe over a period of time. Several pieces of Green Thread pipe were stored in

Figure 5. Green Thread pipe stored in warehouse at Lualualei site, March 2001.

the warehouse away from the transmission site at Lualualei. The temperature in the storage building at Lualualei was in the high 90s in March 2001. There apparently

is no air conditioning in that building. We have an example of amber, light amber and close to the original medium yellow-green color. In contrast, several pieces of fiberglass

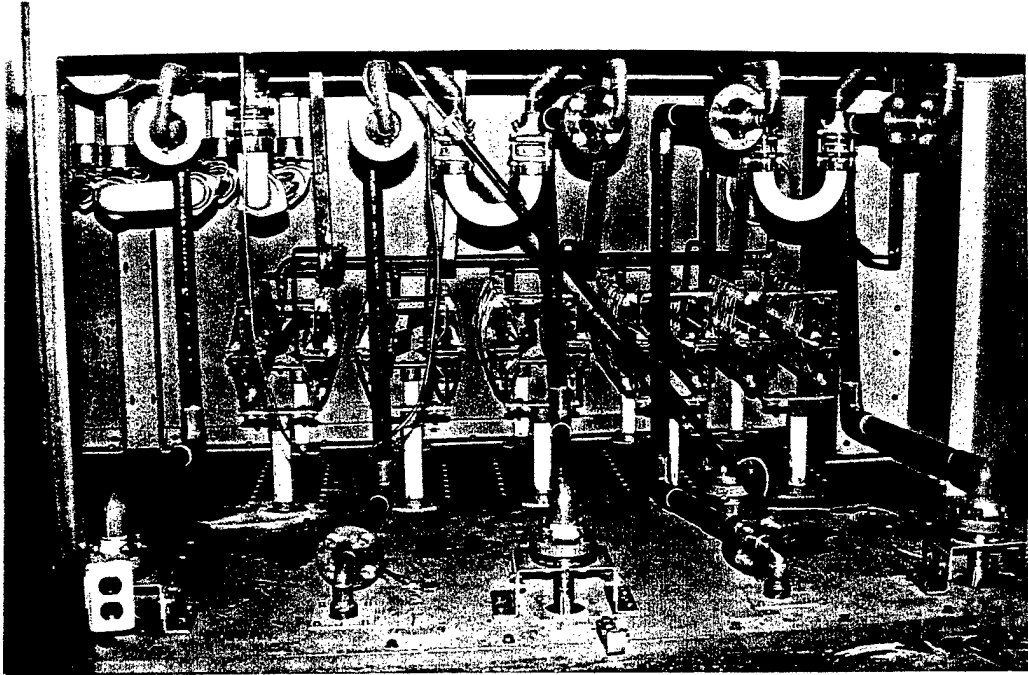
Figure 1. 1998 photograph of PA 1 (right side) fiberglass pipe showing color variations.

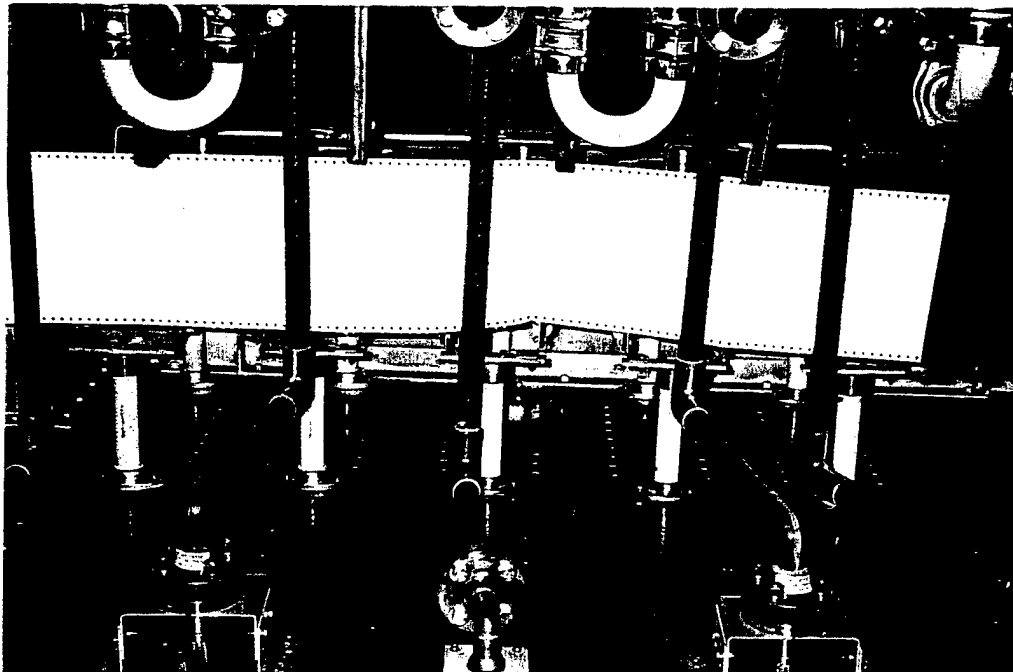
Figure 2. 1998 photograph of PA 2 (left side) fiberglass pipe showing color variations. Discontinuity of color in center pipe probably due to splice.

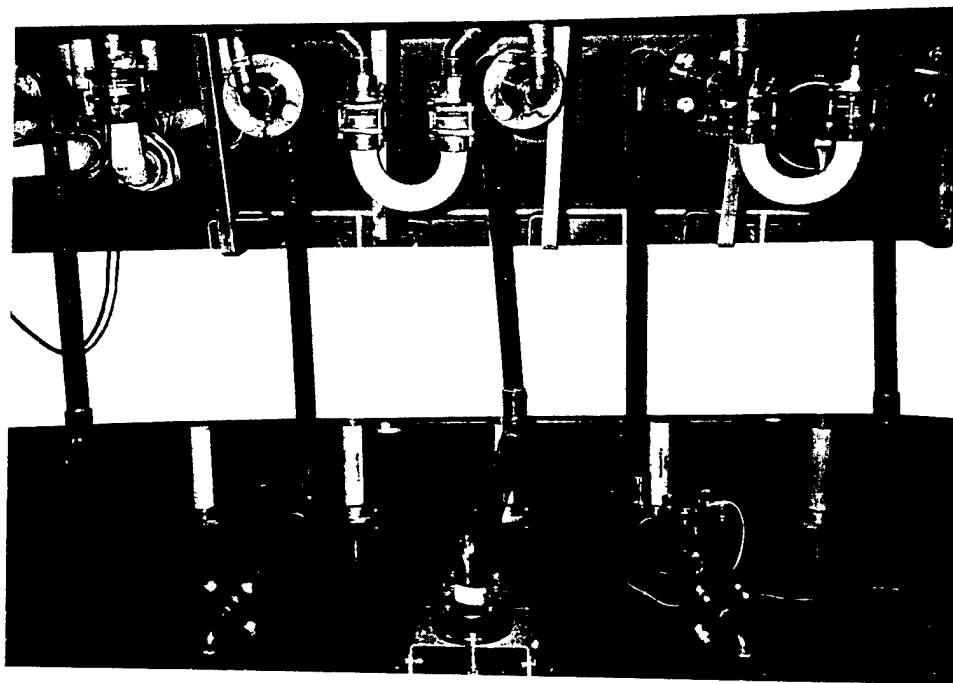
Figure 3. 2000 photograph of PA 1 (right side) fiberglass pipe showing that the color variations are almost nonexistent.

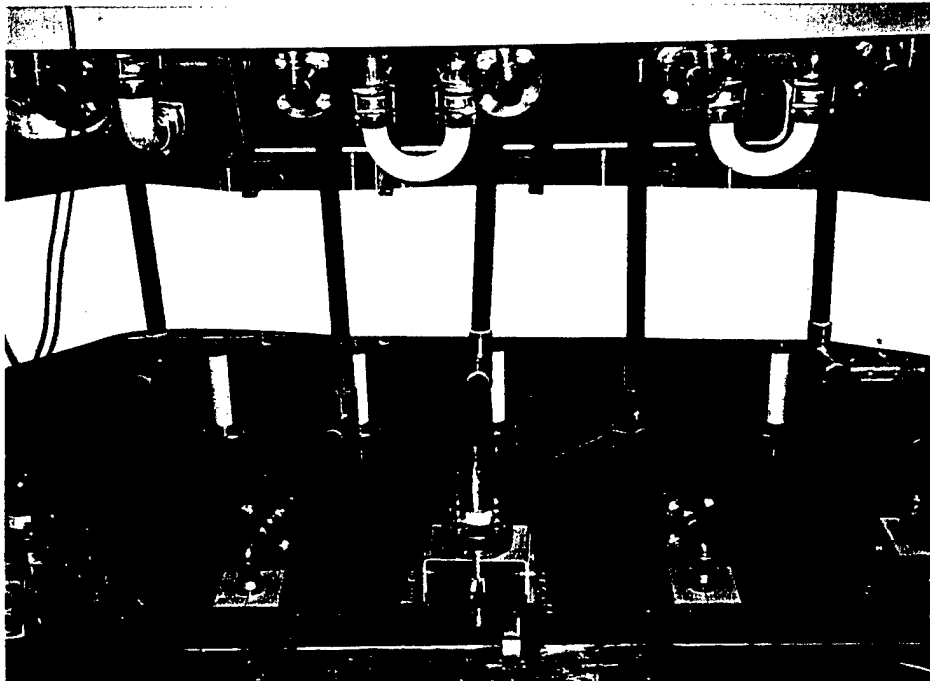
Figure 4. 2000 photograph of PA 2 (left side) fiberglass pipe showing color variations. Discontinuity of color in center pipe shown in figure 2 is not evident now.

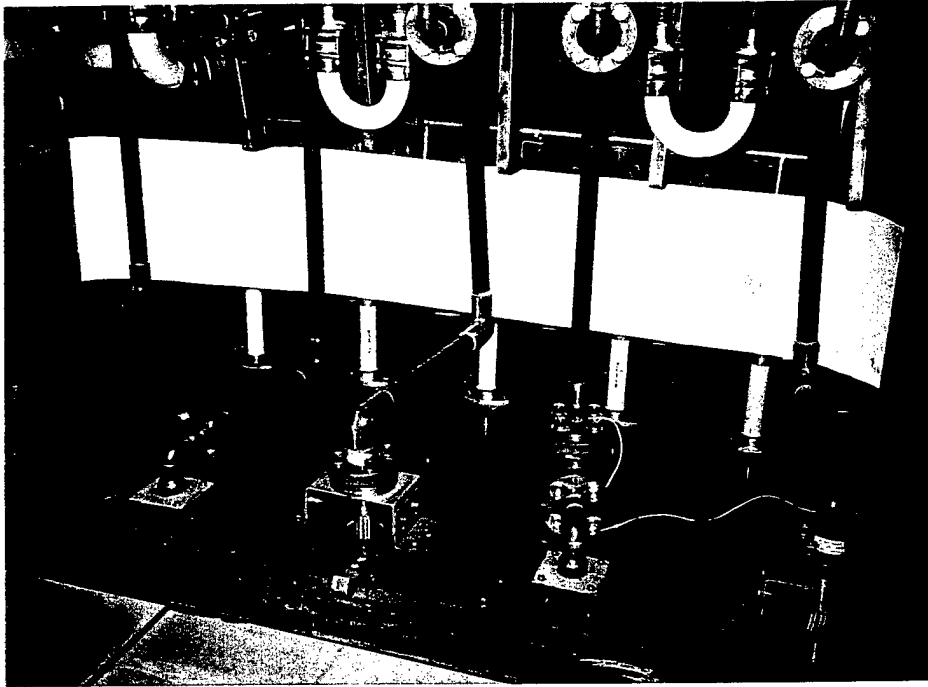
Figure 5. 2001 photograph of PA 1 (right side) fiberglass pipe showing that the color variations are almost nonexistent.

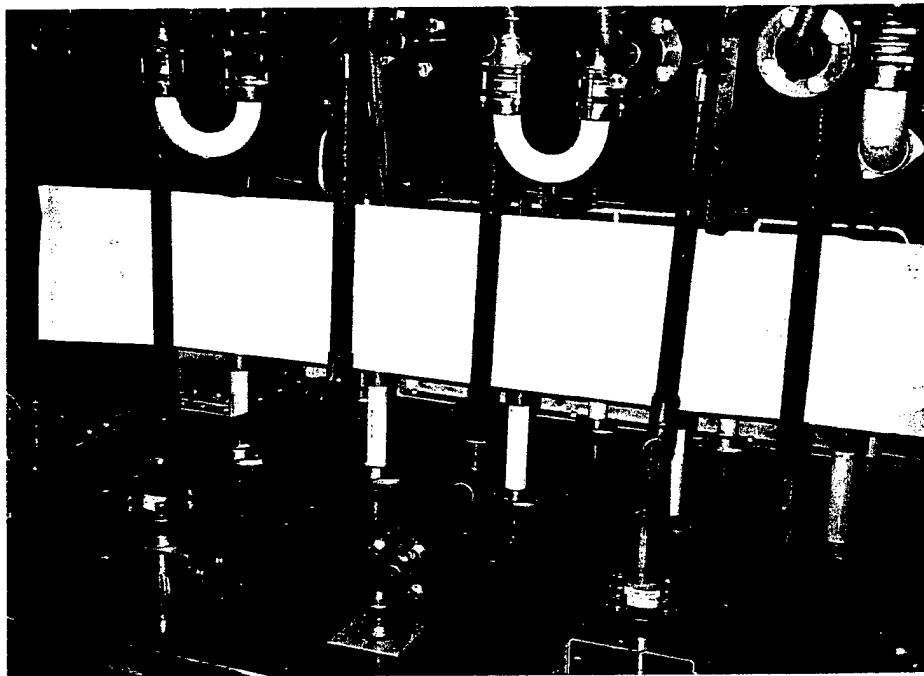
Figure 6. 2001 photograph of PA 2 (left side) fiberglass pipe showing no color variations.

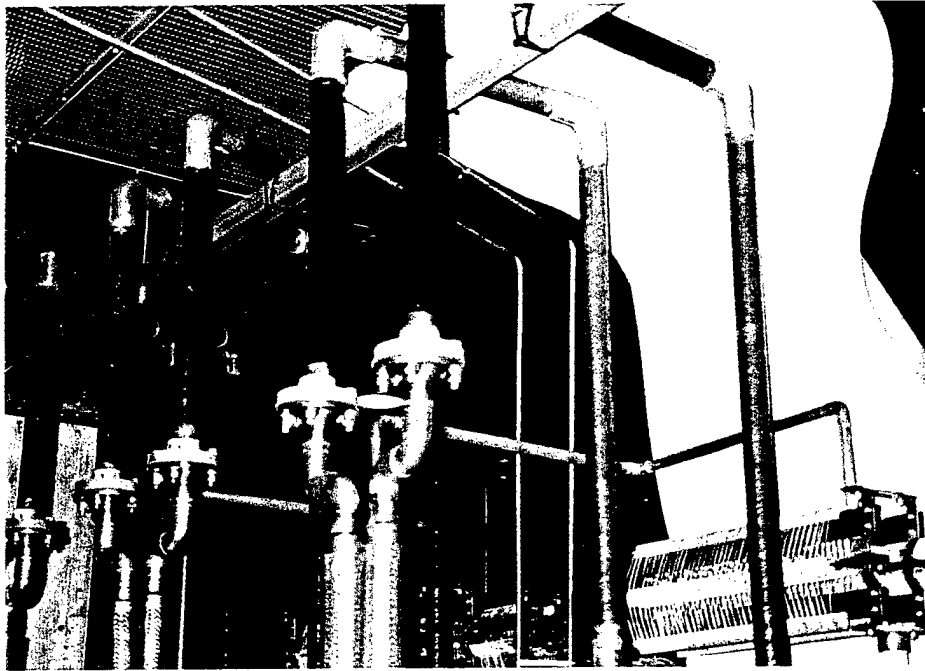
Figure 9. 2000 photograph of fiberglass pipe discoloration for 13V1001 (starboard side)

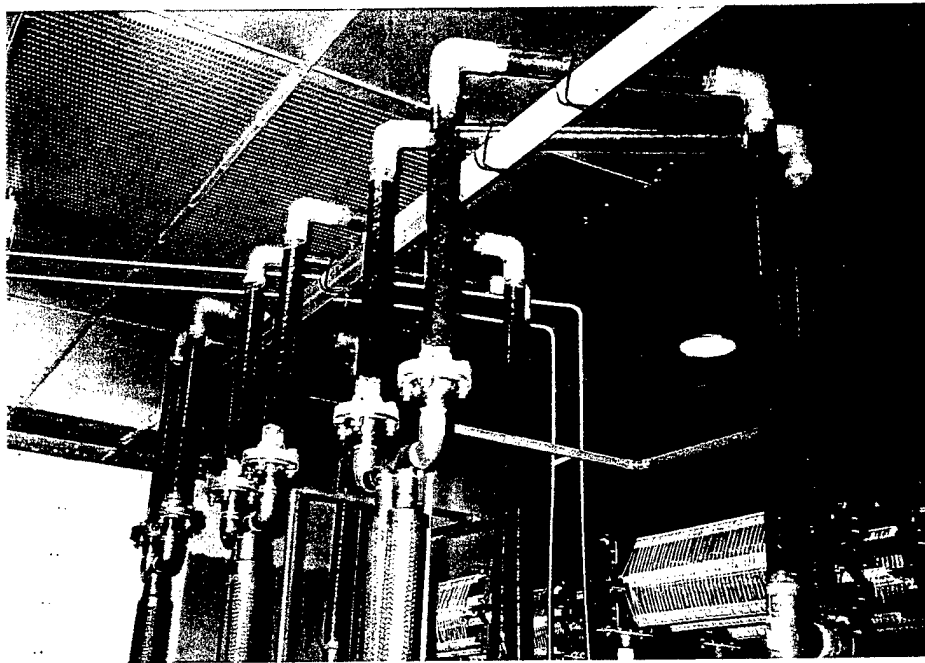
Figure 10. 2000 photograph of fiberglass pipe discoloration for port side PAs.

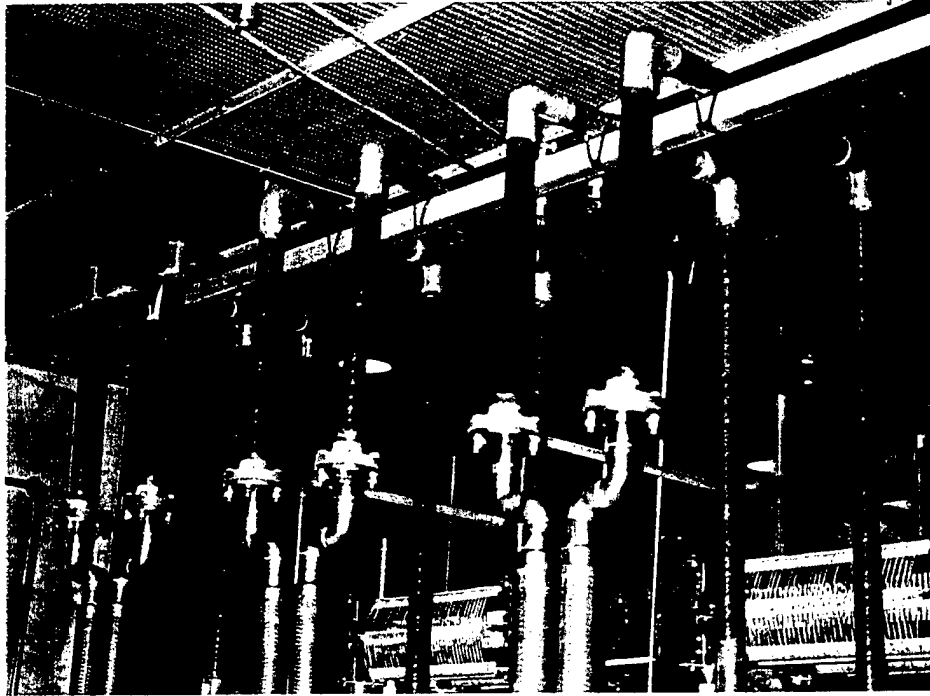
Figure 11. 2001 photograph of fiberglass pipe discoloration for 13V1001 (starboard side).

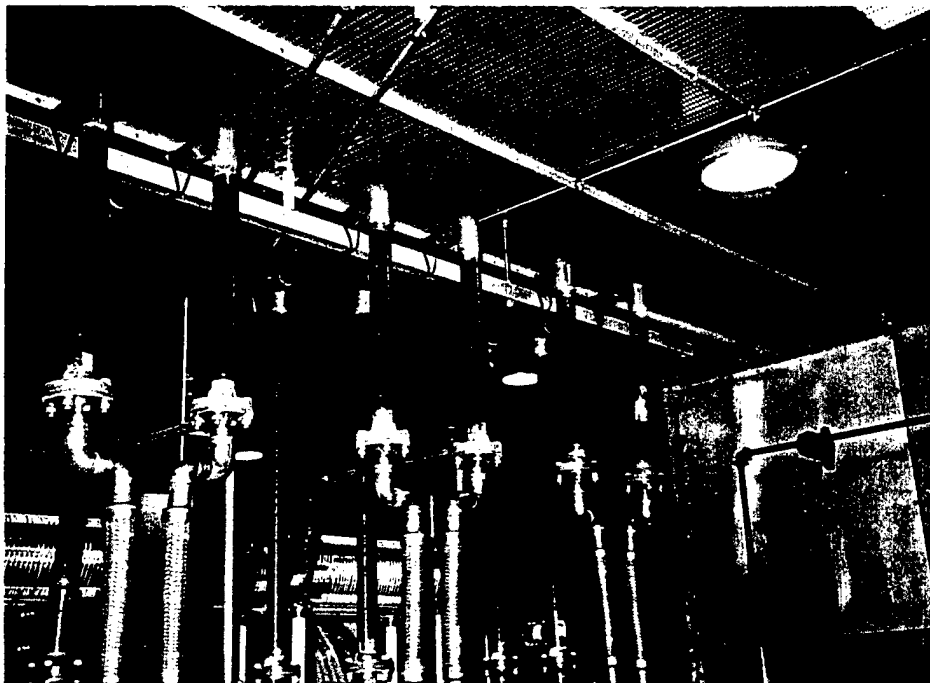
Figure 12. 2001 photograph of fiberglass pipe discoloration for portside PAs.
