# Vehicle Control Unit (VCU) for the HMMWV

<b>Report Date</b> 29May2001	<b>Report Type</b> N/A	<b>Dates Covered (from... to)</b> -
<b>Title and Subtitle</b> Vehicle Control Unit (VCU) for the HMMWV	<b>Contract Number</b>	
	<b>Grant Number</b>	
	<b>Program Element Number</b>	
<b>Author(s)</b>	<b>Project Number</b>	
	<b>Task Number</b>	
	<b>Work Unit Number</b>	
<b>Performing Organization Name(s) and Address(es)</b> TACOM	<b>Performing Organization Report Number</b>	
<b>Sponsoring/Monitoring Agency Name(s) and Address(es)</b> NDIA (National Defense Industrial Association) 211 Wilson Blvd., Ste. 400 Arlington, VA 22201-3061	<b>Sponsor/Monitor's Acronym(s)</b>	
	<b>Sponsor/Monitor's Report Number(s)</b>	
<b>Distribution/Availability Statement</b> Approved for public release, distribution unlimited		
<b>Supplementary Notes</b> Proceedings from 2001 Vehicle Technologies Symposium - Intelligent Systems for the Objective Force 29-31 May 2001 Sponsored by NDIA

# Background of HMMWV Starting Problems

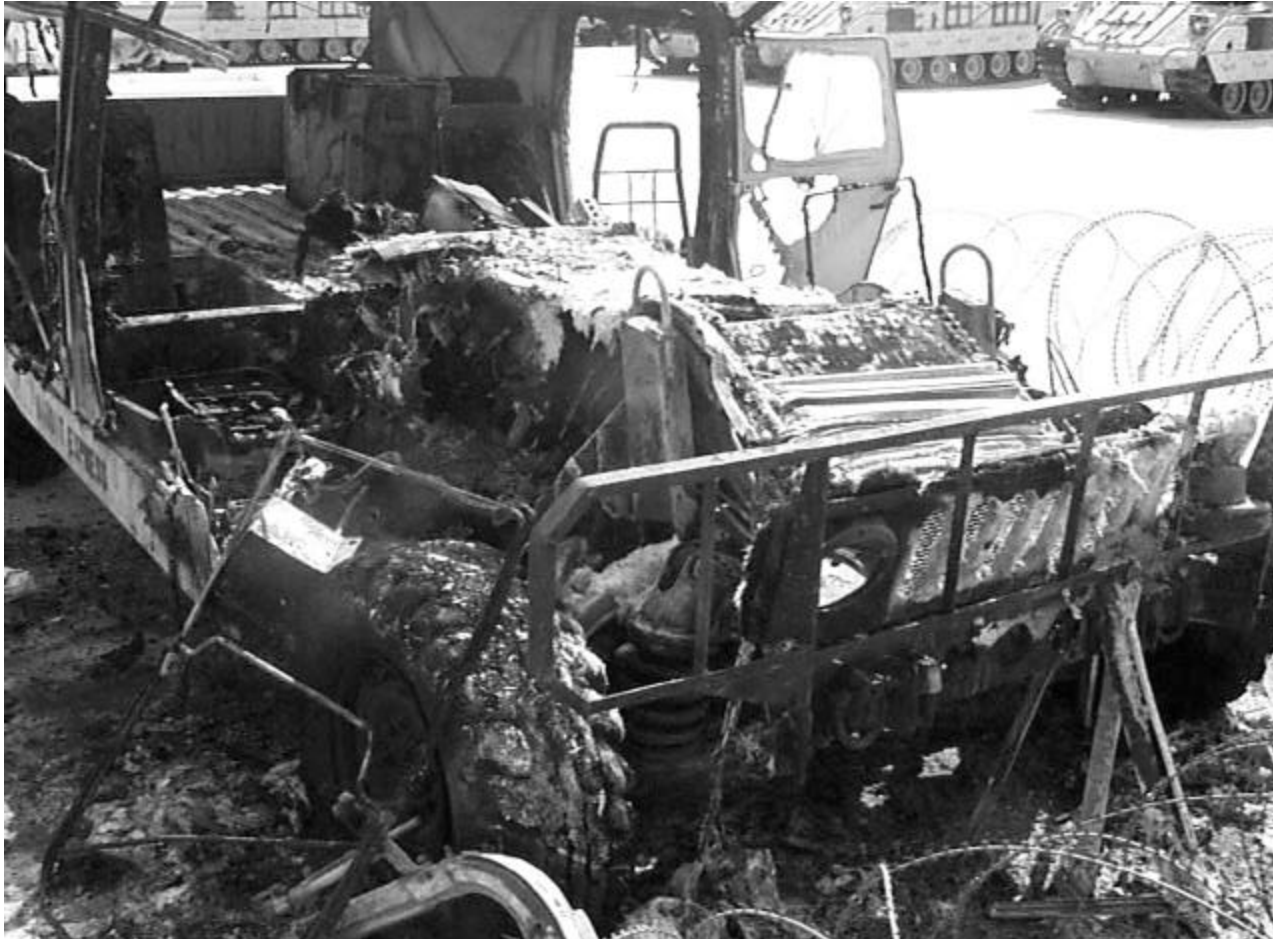
## HMMWV Fire at Ft. Stewart, GA.

- **Some PCB Versions Not Properly Water-Sealed, Nor EMI-RFI Tested**
- **Relays NOT Military Rated – Per Manufacturer**
- **Results:**
  - **Relay Coils Burn out Much too Quickly**
  - **Relay Contacts Weld Shut – Causes Glow Plug Burn-out and Phantom Cranking Leading to Vehicle Fires**
