ERDC/CHL TR-01-12

Beach Erosion and Sediment Processes Study, North East Marina, Erie County, Pennsylvania

Andrew Morang and Jeffrey Melton

June 2001

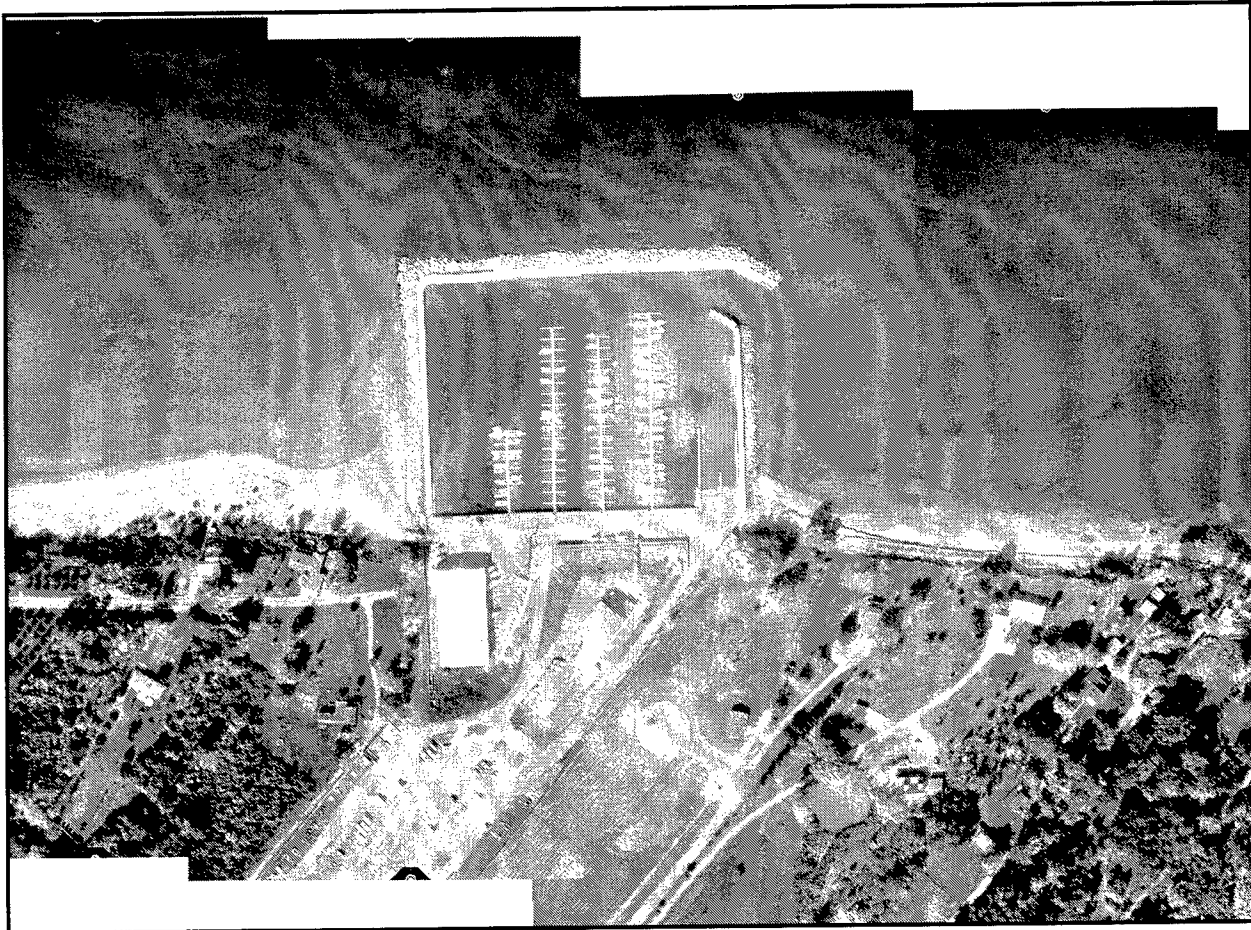
Figure 7. Vertical aerial photograph, October 15, 1999. Shale ledges can be seen through water east (to the right) and lakeward of marina. Bulge in shore west (left) of the marina is accretion on private property that PFBC is unable to mine during biannual bypassing operations

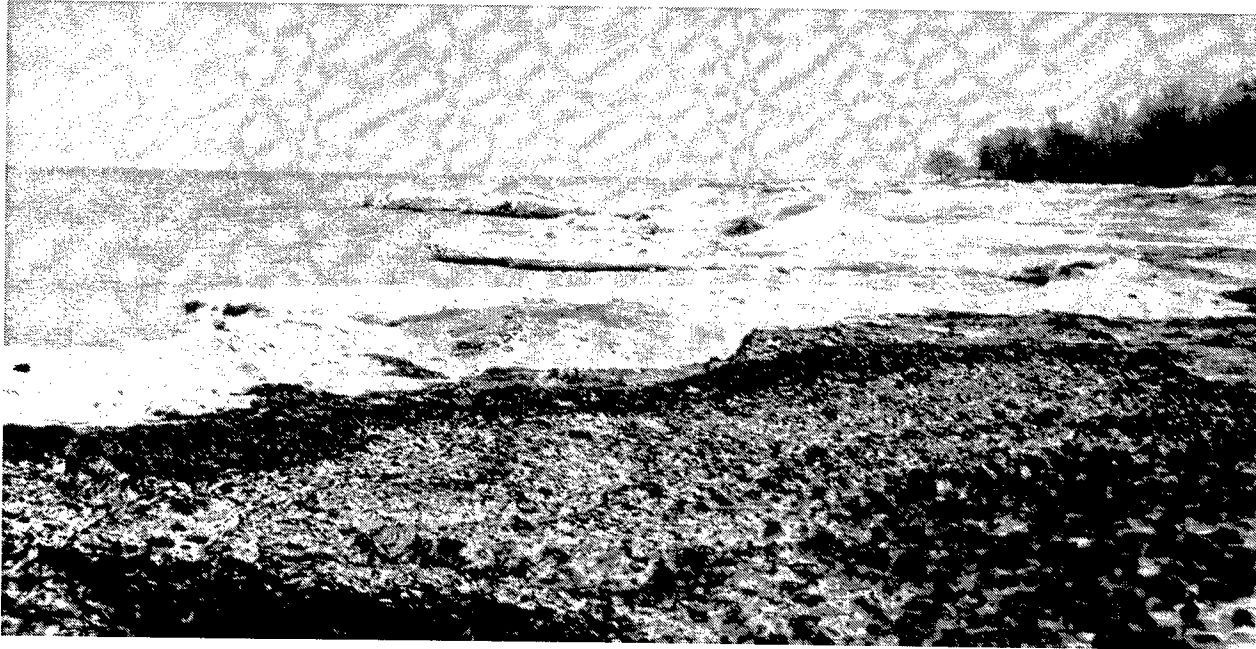
Figure 9. Ice armor along beach, 29 January 1999. During winter, ice protects shore from direct wave attack, but during spring thaw, ice blocks overturn, picking up masses of sand and gravel. View northeast towards Twentymile Creek. Photograph from Buffalo District archives

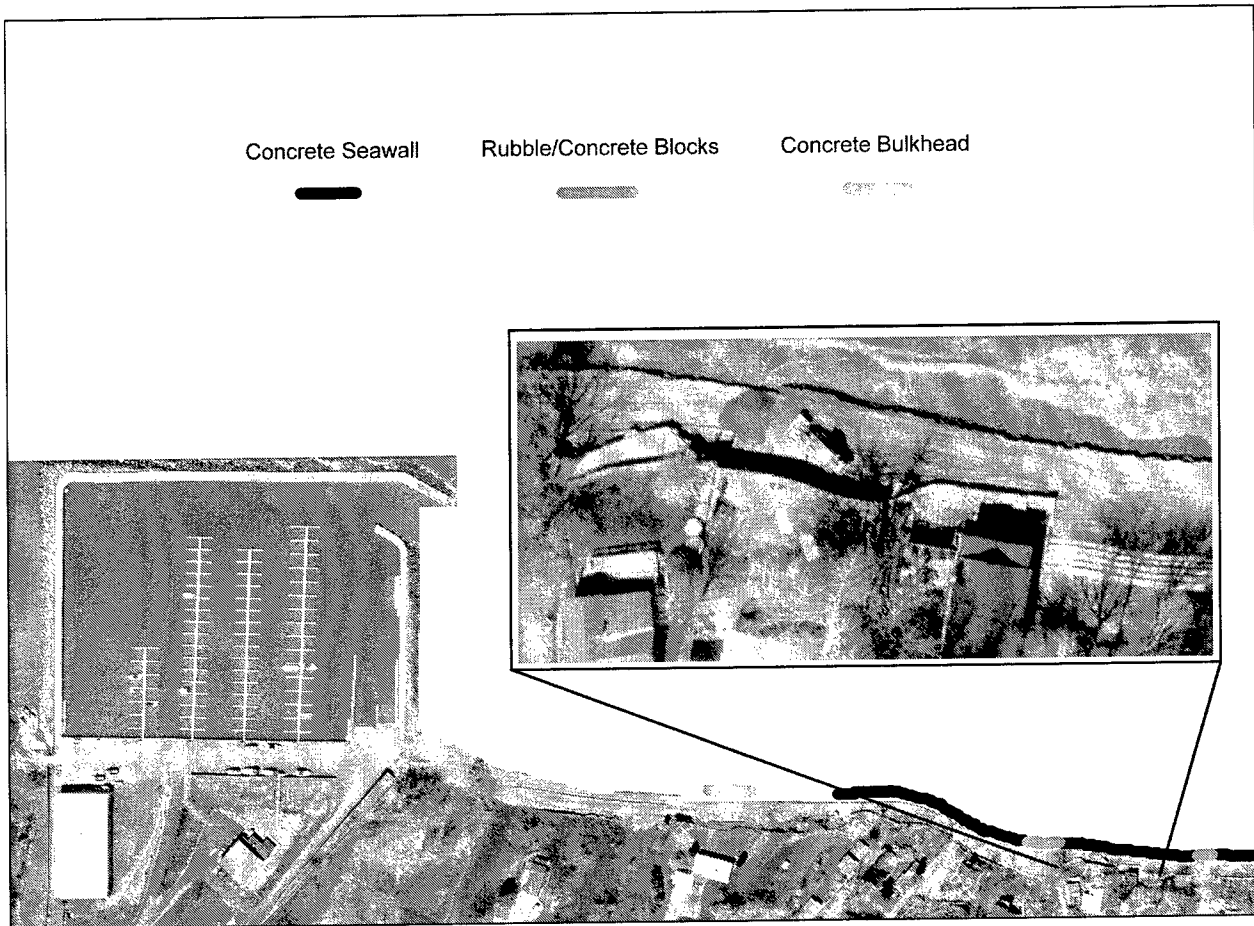
Figure 16. Armoring structures along the shore east of North East Marina (28 April 1999). All of these structures predate the marina. Insert shows a grader moving sand near one of the seawalls that project out from the bluff line

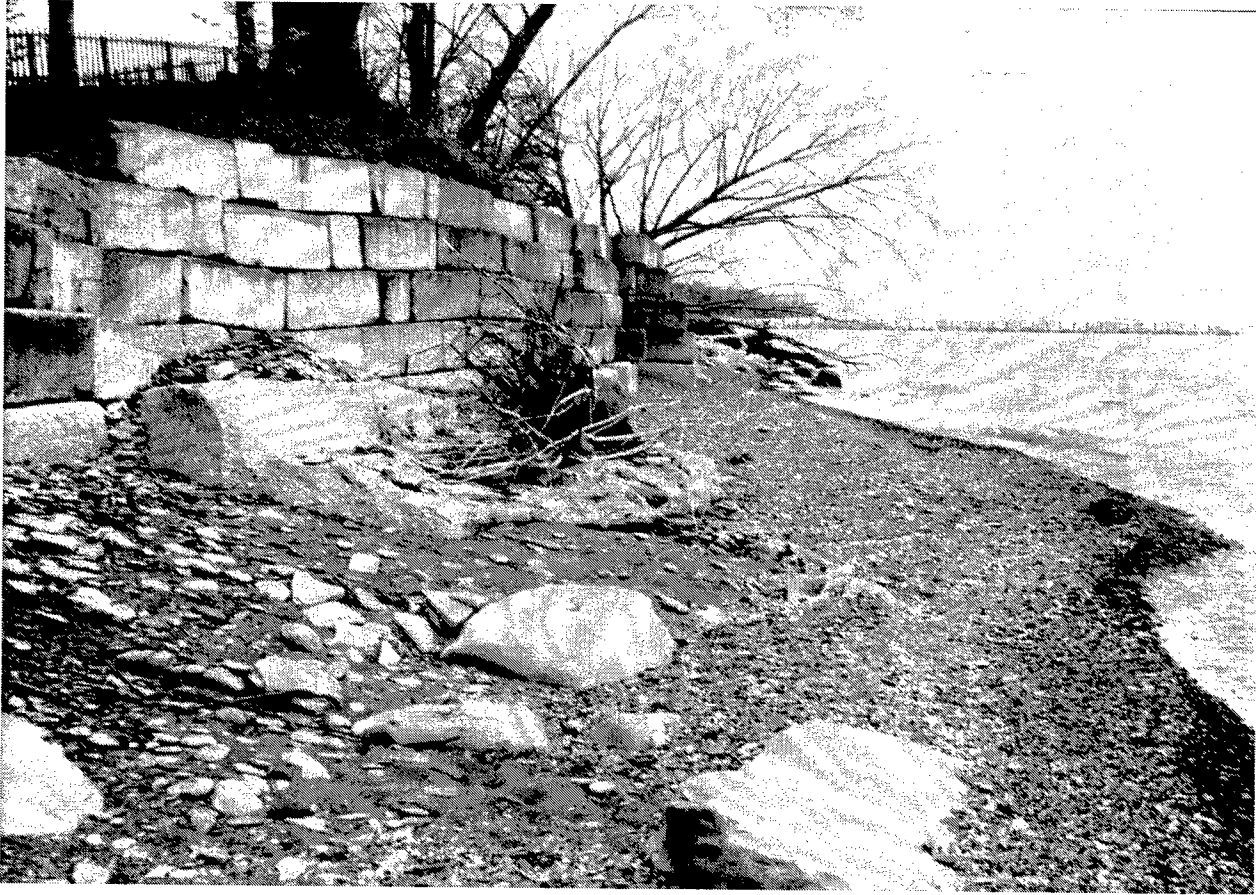
Figure 17. Concrete block wall about 200 m east of marina, 17 May 1991. Leaning tree is seen in subsequent figures

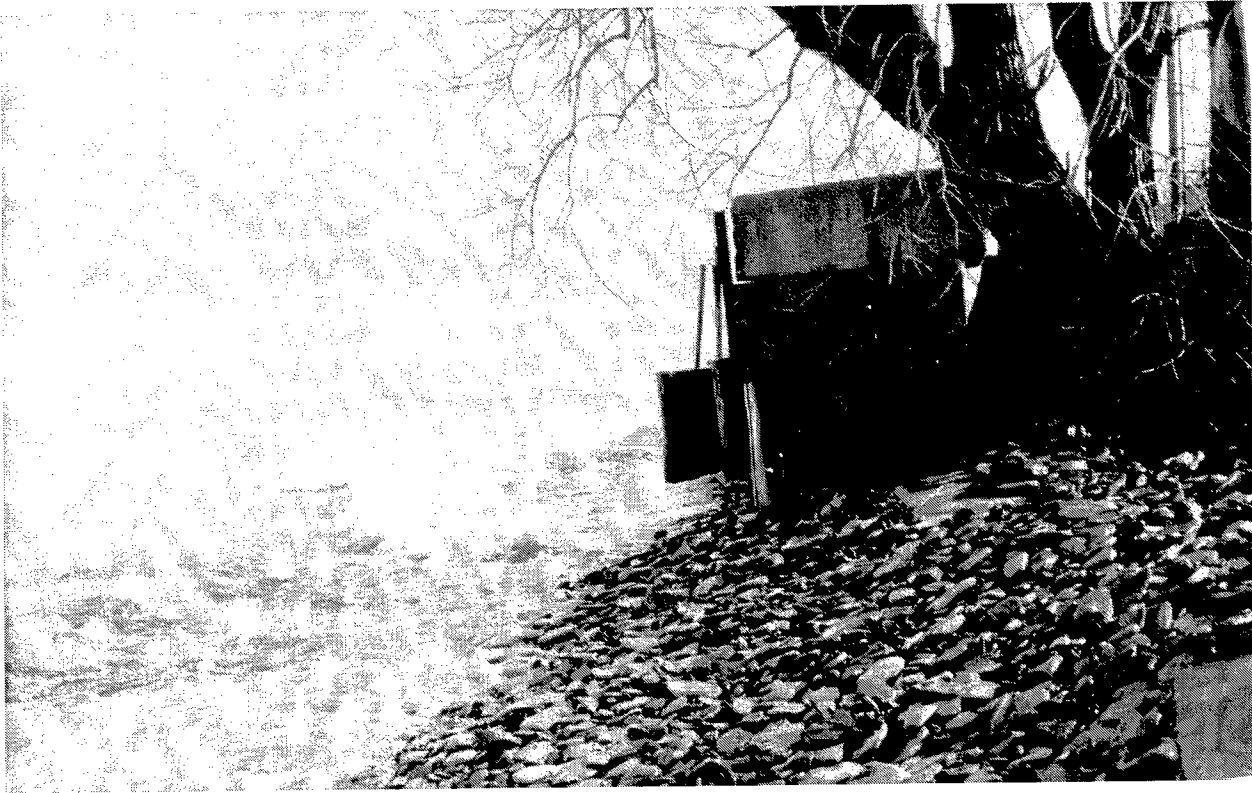
Figure 18. Exposed seawall March 1991, view east. Original photograph label states, "High water from storm just east of Kelley property" (Buffalo District archives)

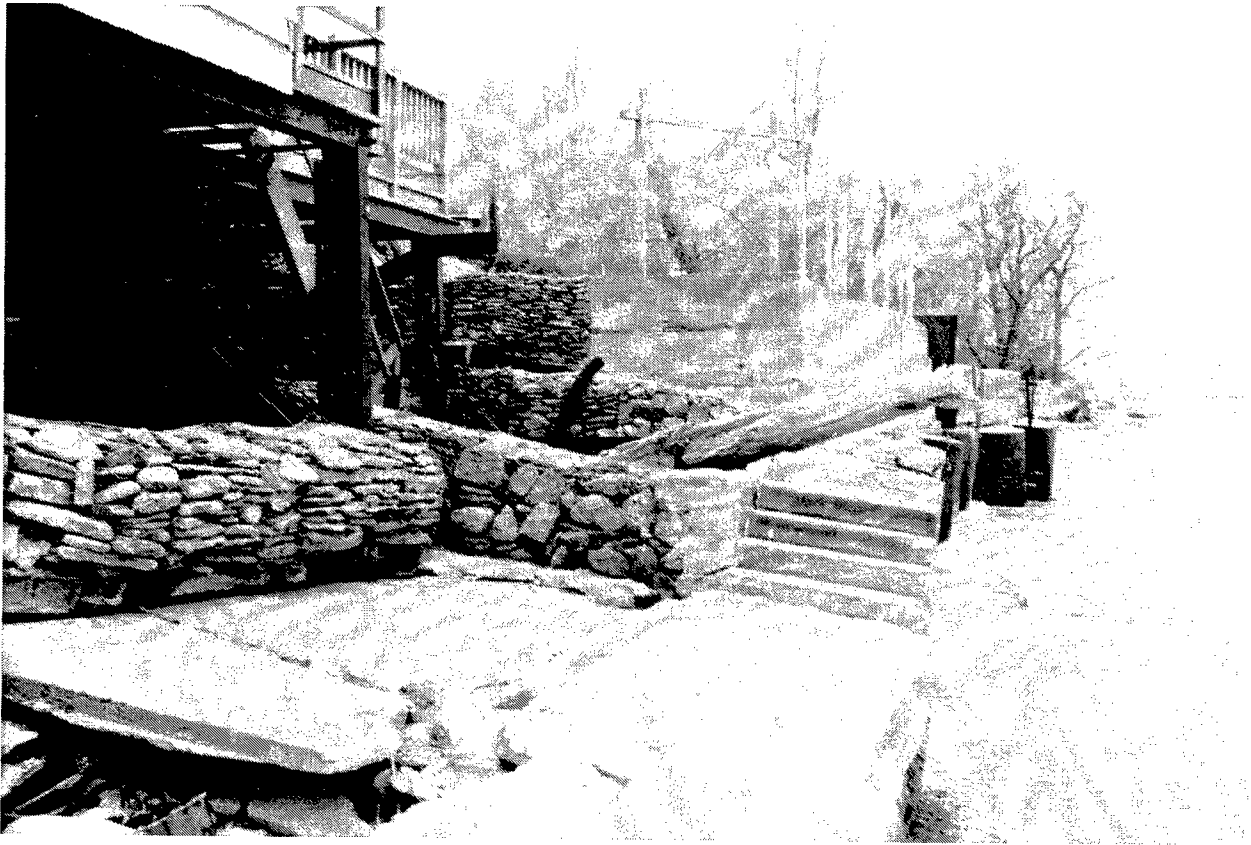
Figure 19. House protected with gabions, concrete, and concrete-filled tanks, May 1991. These structures are about 500 m east of marina's east wall (visible in right side of photograph). Notice tree trunk resting on wall next to steps, evidence of power of storm waves. When this photograph was taken, there was no beach at base of concrete slabs. Photograph from Buffalo District archives

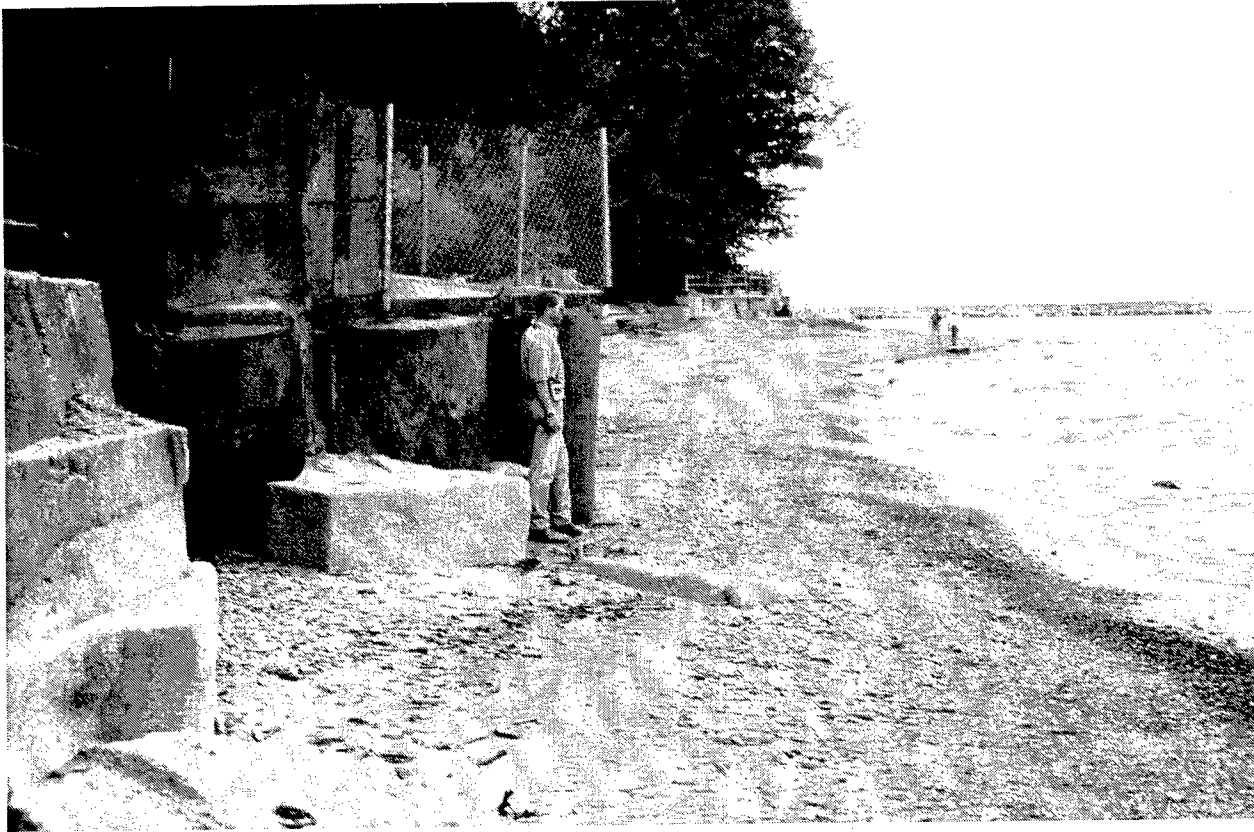
Figure 20. Gravel and sand beach below same structures shown in Figure 19. Beach is about 4 m wide. North East Marina east wall is in distance to right. Photograph taken 11 August 1999, before the autumn bypassing

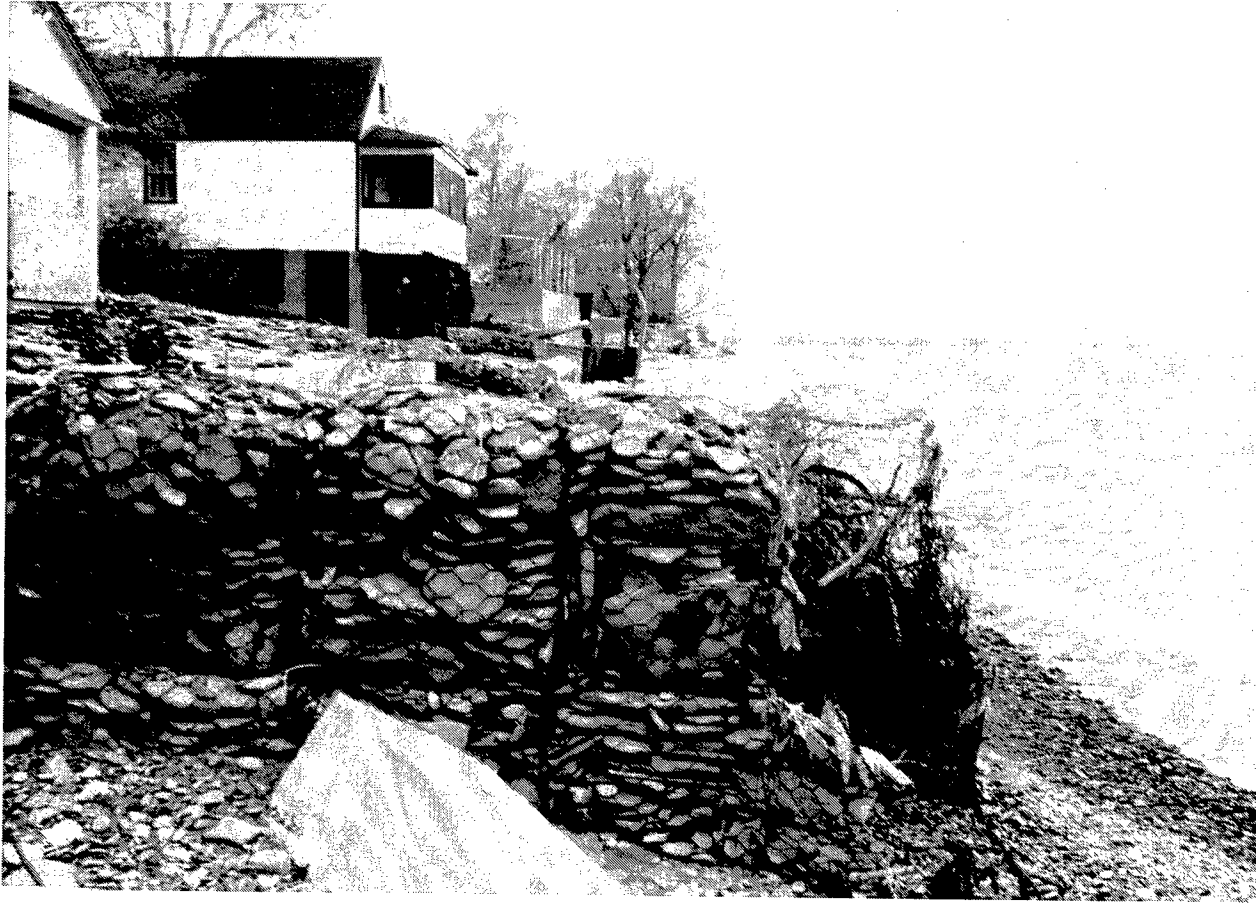
Figure 21. Gabion wall east of property shown in previous photographs, 17 May 1991. Leaning tree where concrete block walls are found is in distance. Photograph from Buffalo District archives

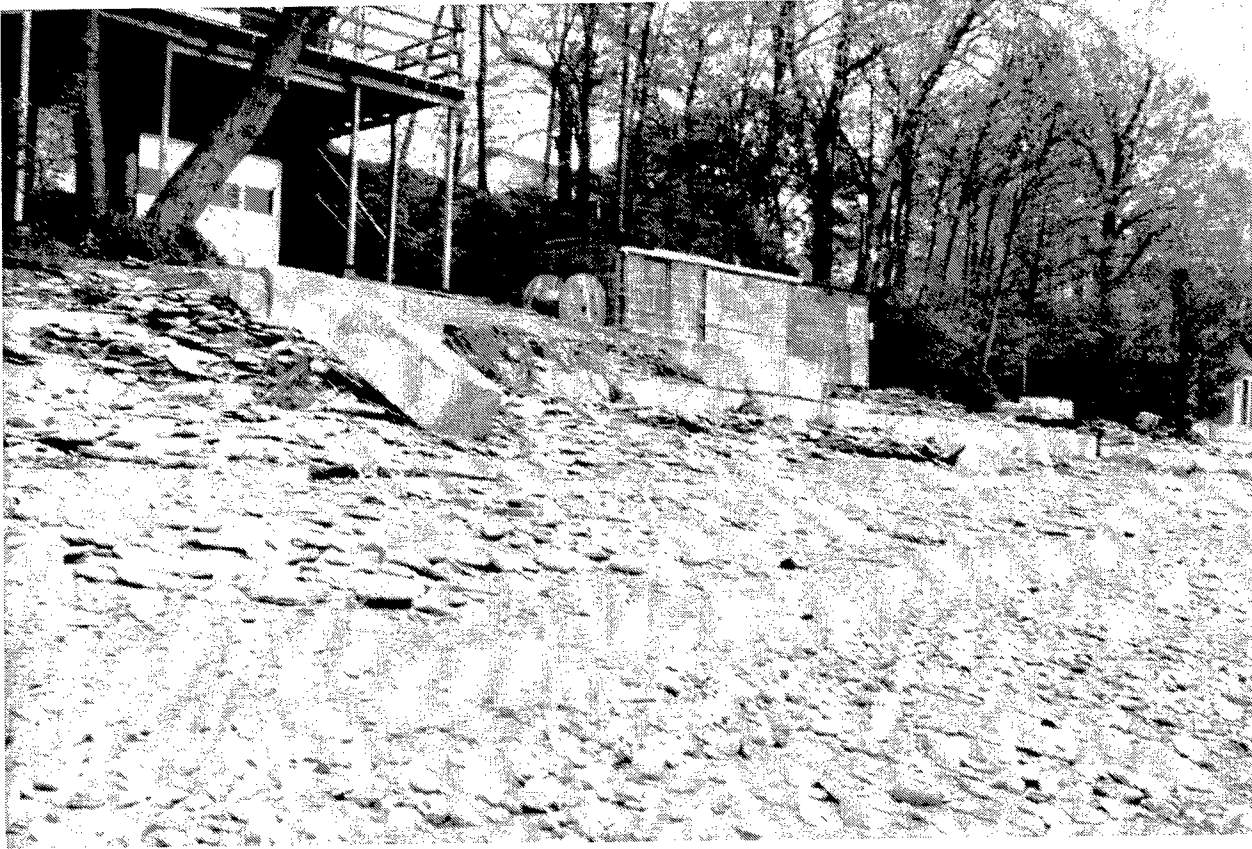
Figure 22. Cottage with protective concrete blocks east of the location shown in previous figures, 17 May 1991. Note the block that has been moved by storm waves. The three properties in the foreground are vulnerable to storm waves because they were built on the beach rather than up on the bluff like the house in the background. Photograph from Buffalo District archives

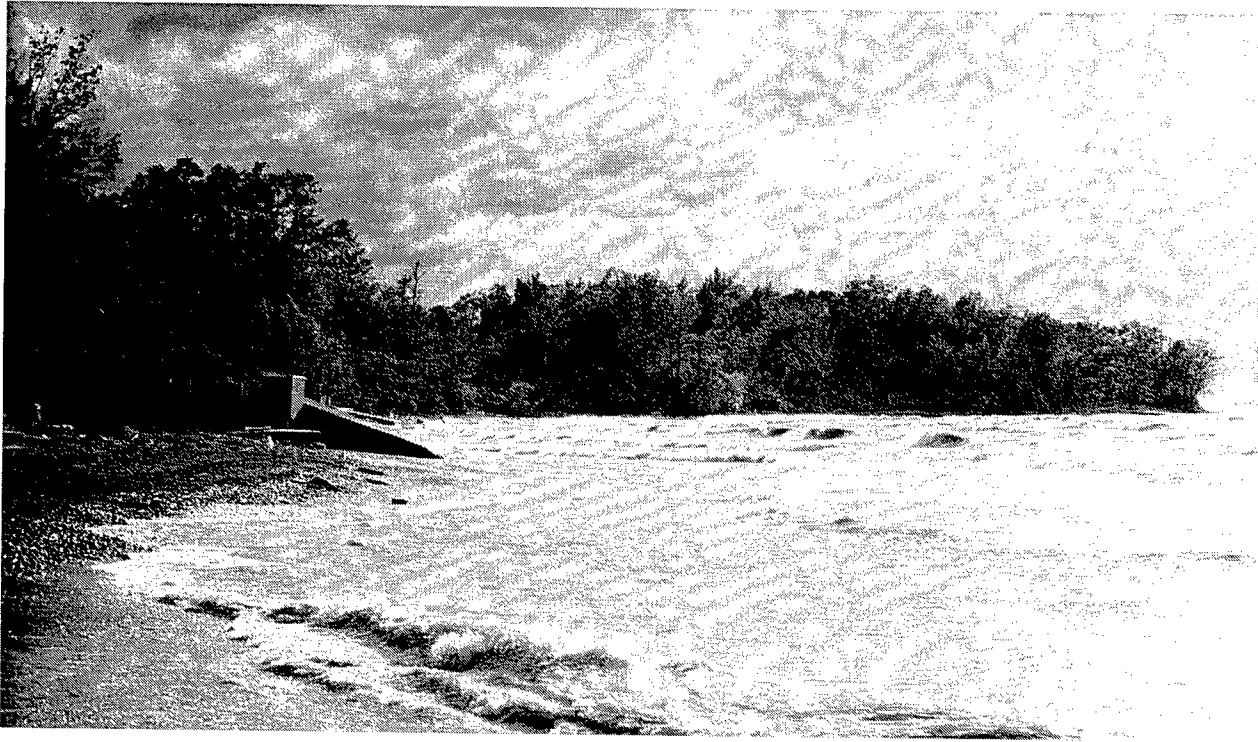
Figure 23. Seawall made of concrete-filled tanks west of North East Marina, November 1991. Most of the ramp and over two thirds of wall are now covered with sand and gravel. In 1991, beyond the walls, there was essentially no beach and waves broke directly at base of bluffs

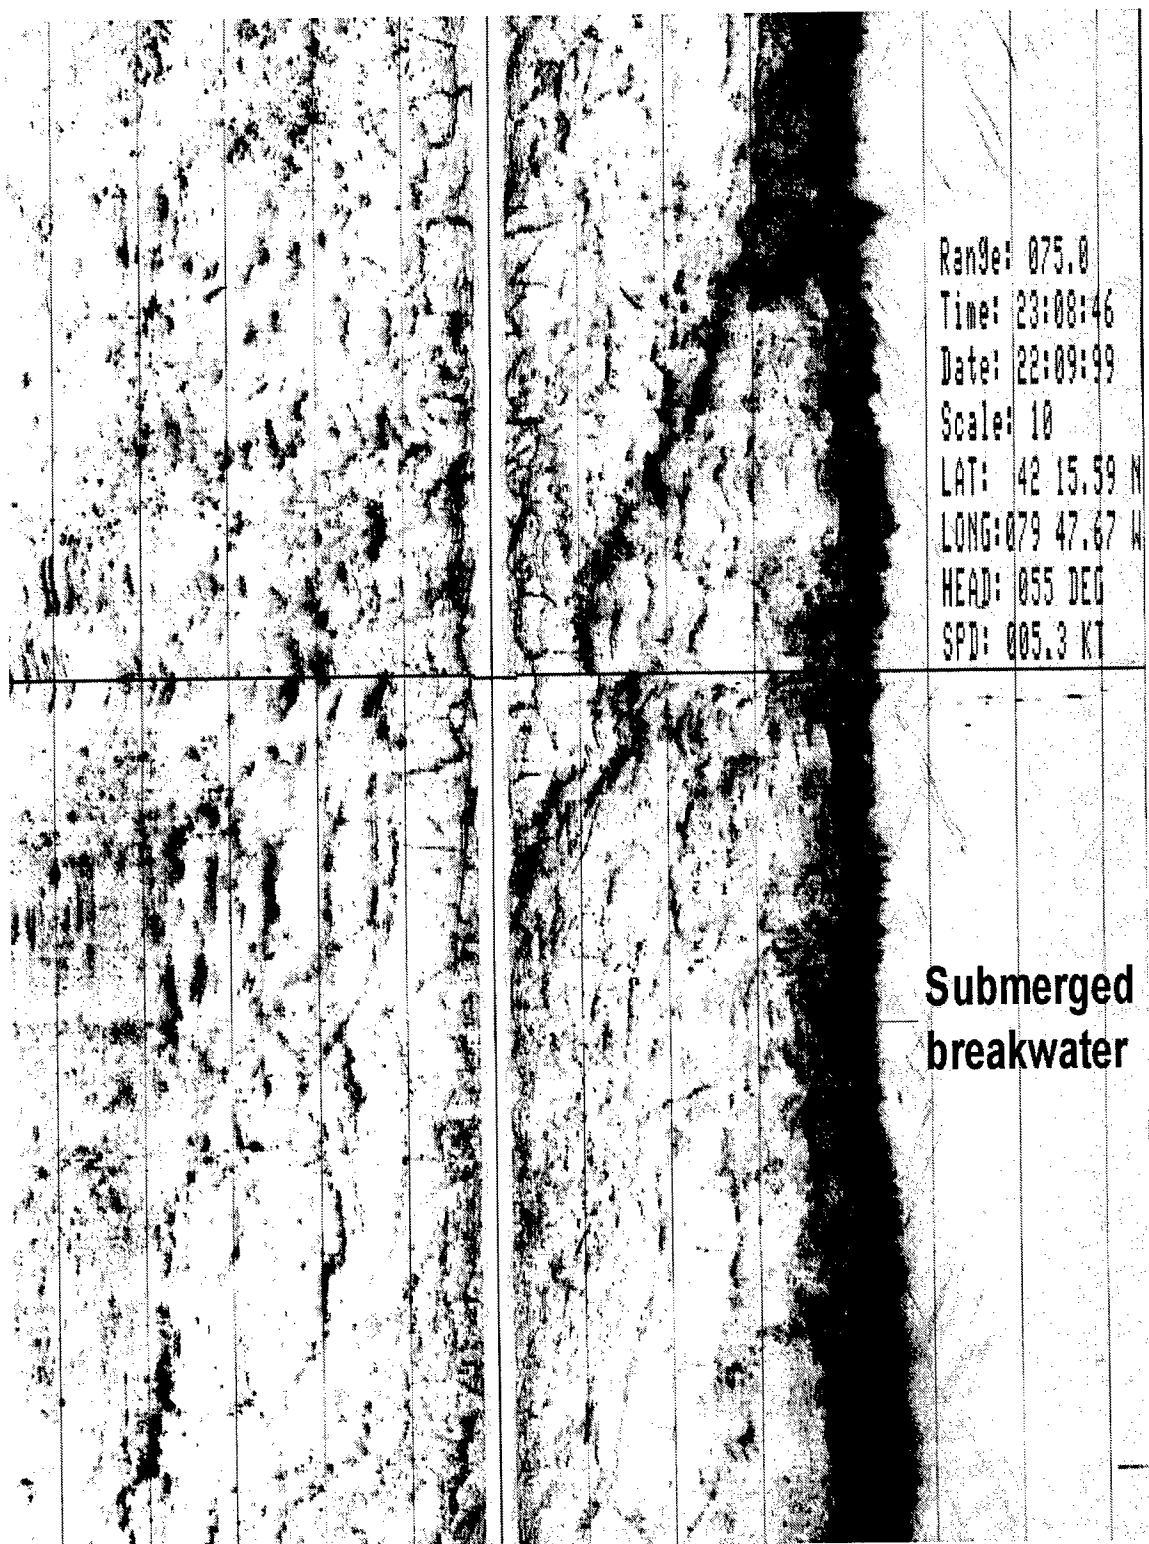
Figure 28. Sonograph immediately off marina wall, approximately halfway between east and west corners. Ship was heading NE paralleling wall. Scale between vertical lines is 10 m, and northeast is to top of page. Dark area to right is highly-reflective submerged portion of breakwater. Bedrock jointing and bedding and lack of sand is clearly shown on record
