## Examination of Suspected Delta II Second-Stage Reentry Debris

15 July 2001

P. M. ADAMS and W. H. KAO  
Space Materials Laboratory  
Laboratory Operations

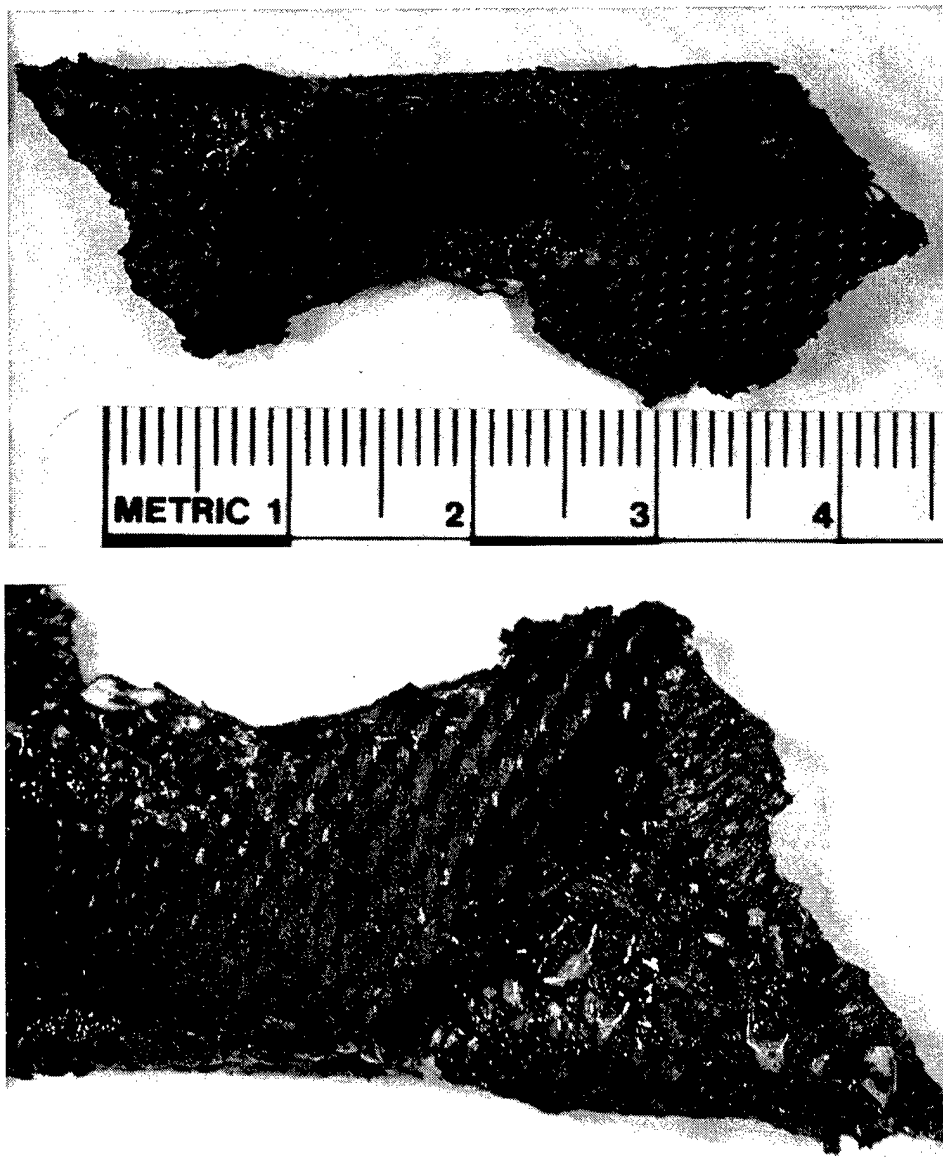
Visually the material appeared to be a piece of black-colored woven fabric that was about 1.5 cm x 0.5 cm x 5.0 cm in size (Figure 4). Initially, before closer inspection and handling, it was thought to be a piece of carbon or graphite fiber cloth because of its color; however, it was very hard and brittle. Upon closer examination, it was found that the fibers were colorless, with a very dark coating, and that there were colorless fused-looking deposits that contained many bubbles (Figure 5). There were also a few small areas (1 mm x 1 mm) that appeared silvery-metallic.

Figure 4. Optical macrophotographs of as-received debris. Upper scale bar is in cm.

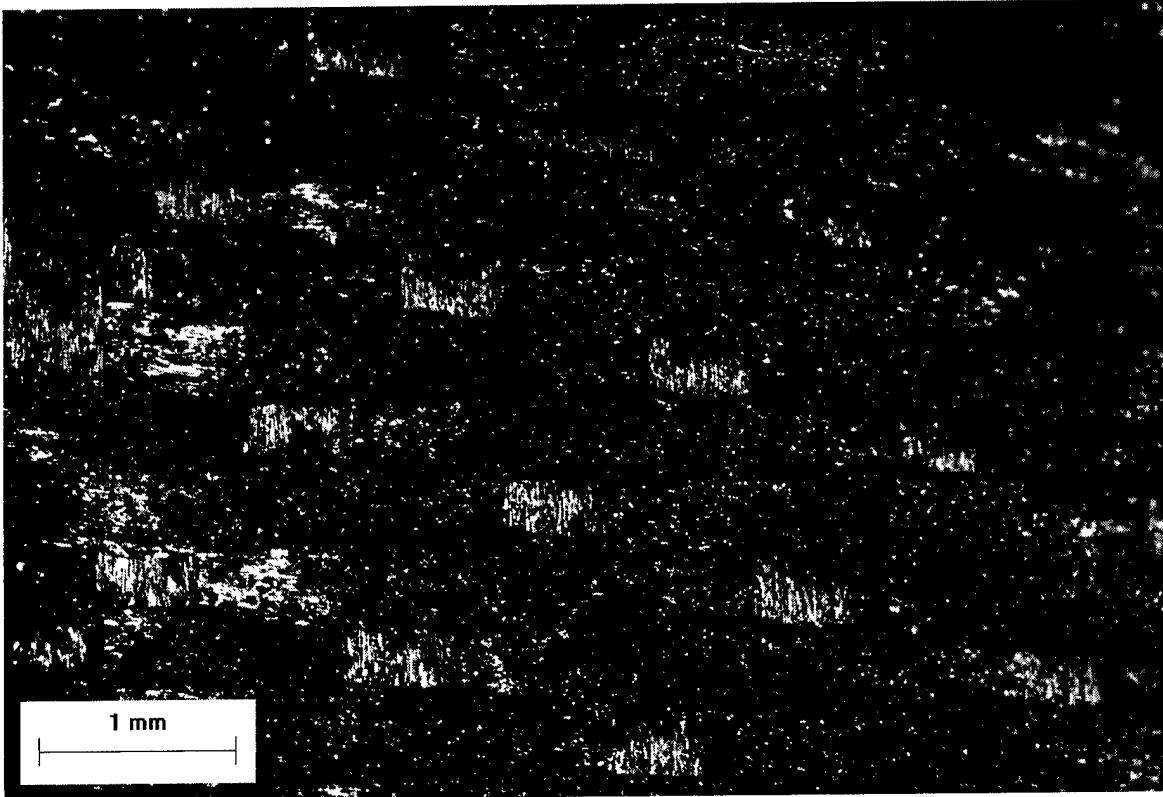
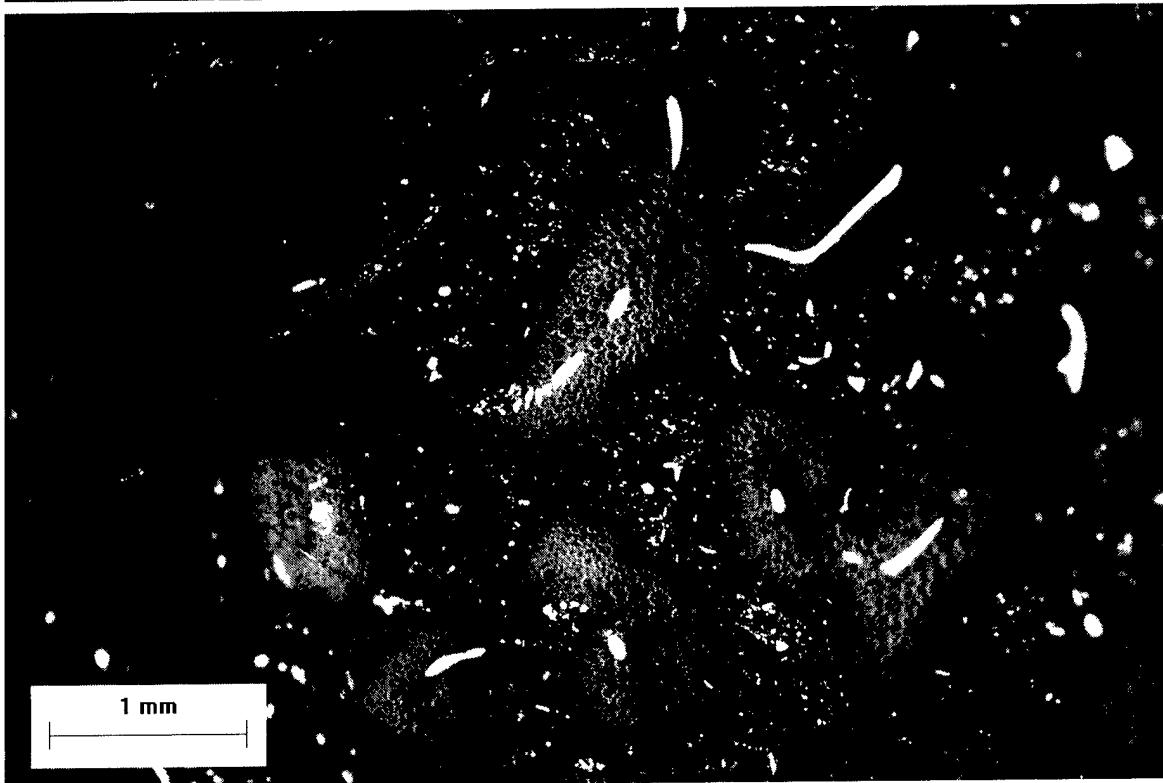
Figure 5. Close-up optical macrophotographs of as-received debris.

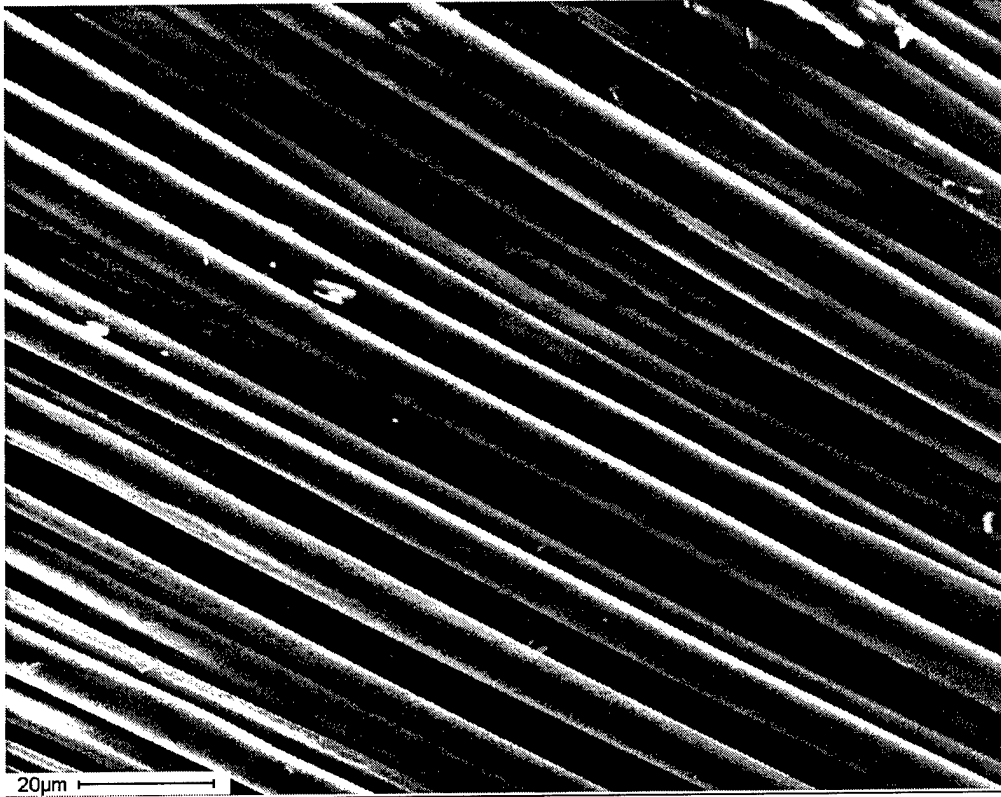
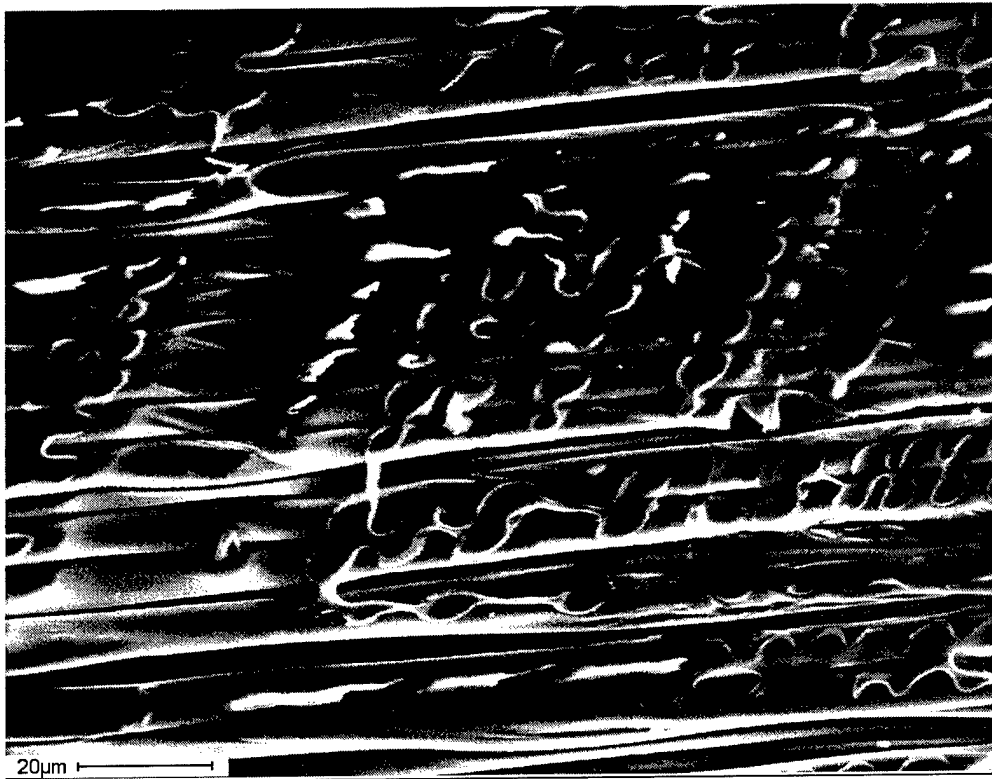
In the SEM, the fibers appeared very smooth, circular in cross section (about 9  $\mu\text{m}$  in diameter), and locally covered with thin deposits (Figure 6). The fused-looking areas had smooth surfaces, and in some areas bubbles were observed on fracture surfaces (Figure 7). The chemical analyses of the fibers and fused deposits indicated that they both contained primarily oxygen (O), silicon (Si), calcium (Ca) and aluminum (Al) (Figure 8), which is consistent with the material being fiberglass. It is noted that the EDXS system can not detect lithium or boron. The residue on the fibers (lower photograph in Figure 6) consisted primarily of carbon (C) (Figure 8). The metallic-looking areas had a number of different textures, which ranged from rounded-melted, to folded, to feathery-dendritic (Figures 9 and 10), which probably resulted from the melting and resolidification of the aluminum. Several of the small silvery-metallic deposits were analyzed by EDXS, and all contained primarily aluminum (Al) and oxygen in varying proportions (Figure 11); however, minor amounts of magnesium were occasionally detected. The lower picture in Figure 10 shows the dross layer, which consists of aluminum oxides and impurities, that forms on the surface of molten aluminum that is in contact with an oxidizing atmosphere for a certain length of time. The EDX spectrum from this area did show more oxygen (bottom of Figure 11) than in other metallic areas. The depth of penetration in the EDX analysis is on the order of 1  $\mu\text{m}$ . An XRD pattern of one metallic particle indicated that the bulk of the material was metallic aluminum; however, some very weak lines attributed to alpha aluminum oxide ( $\alpha\text{-Al}_2\text{O}_3$ ) were also observed. Based on the XRD and EDX analyses, it is assumed that the aluminum oxide is a thin surface layer.

Figure 6. SEM photographs of fibers in the debris.

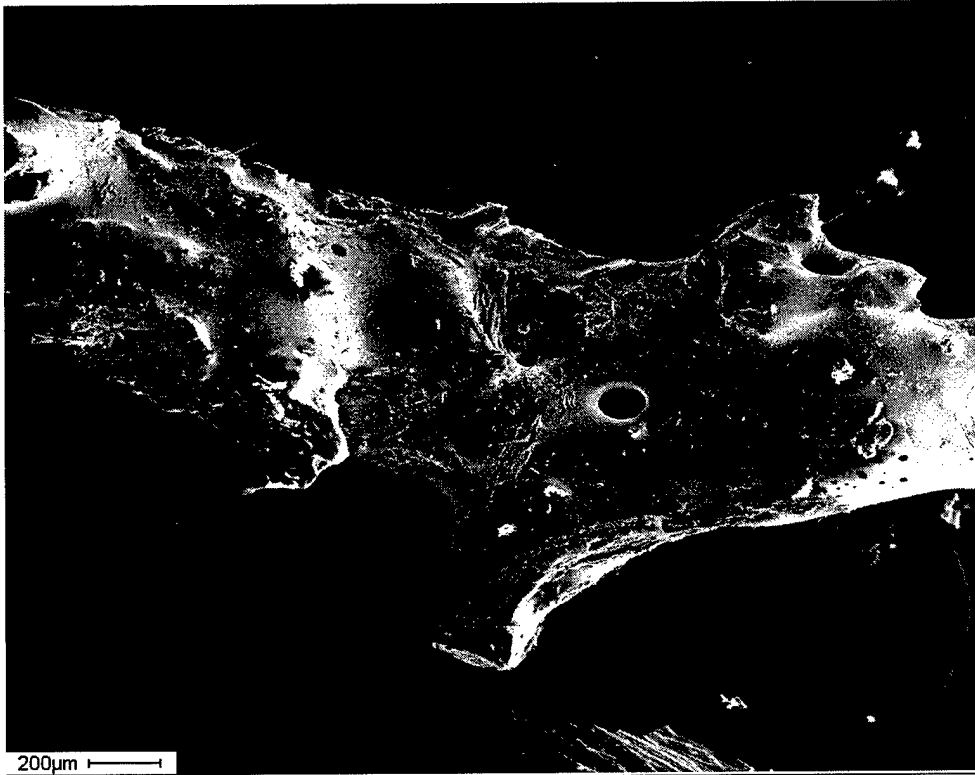
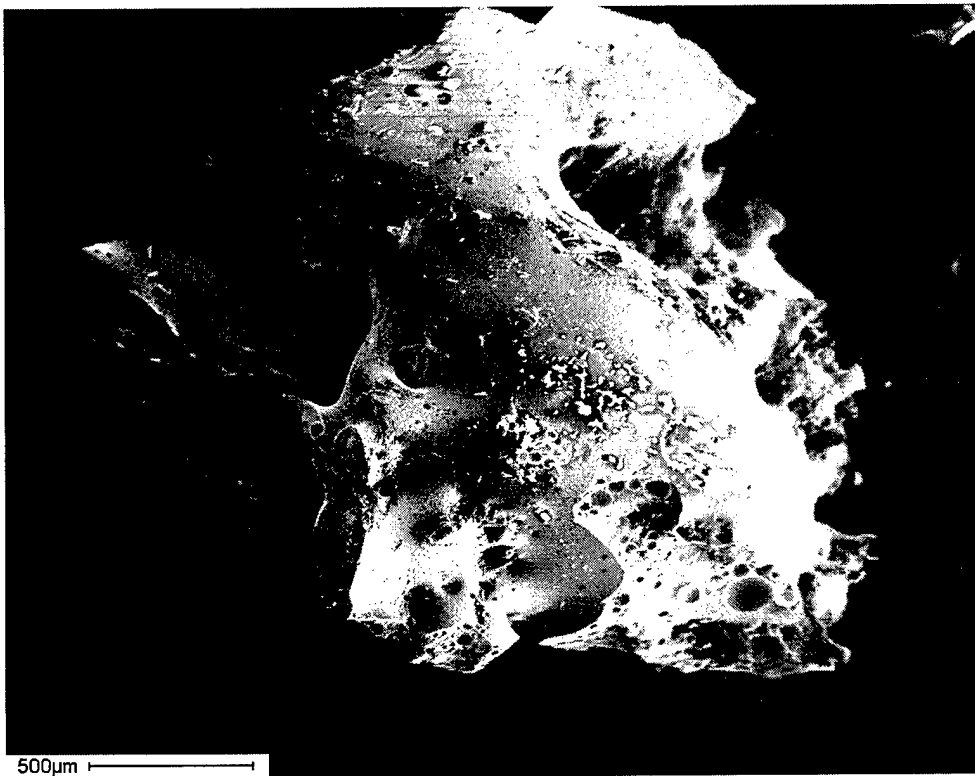
Figure 7. SEM photographs of fused deposits on debris.

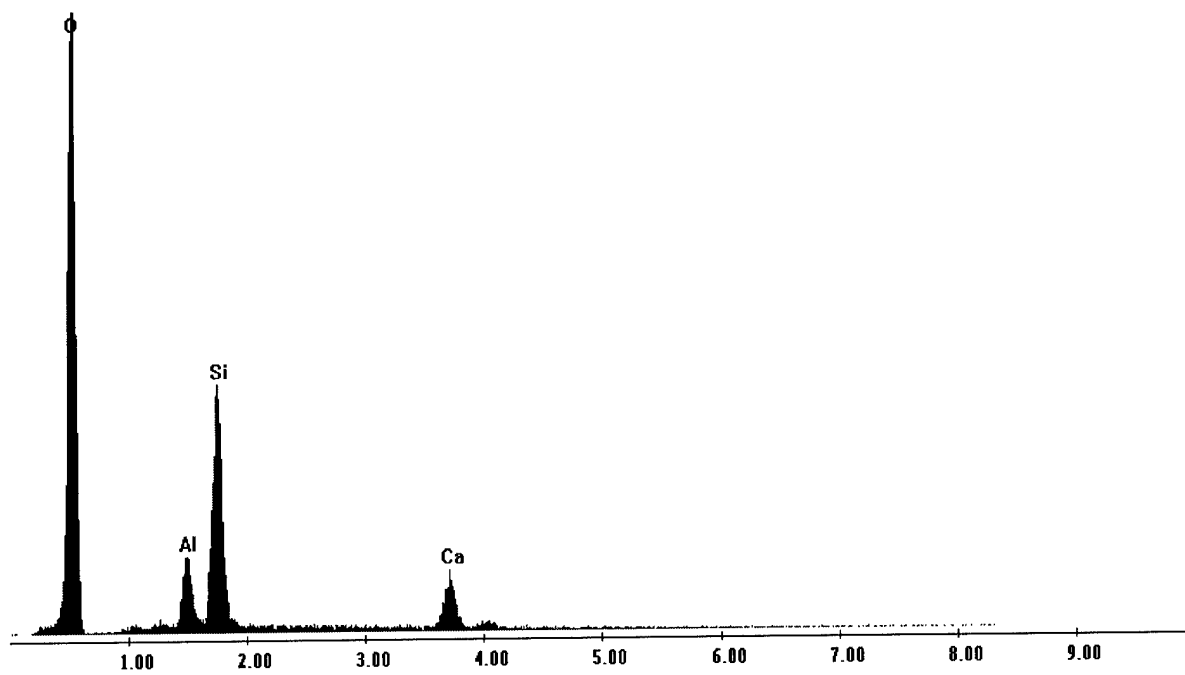
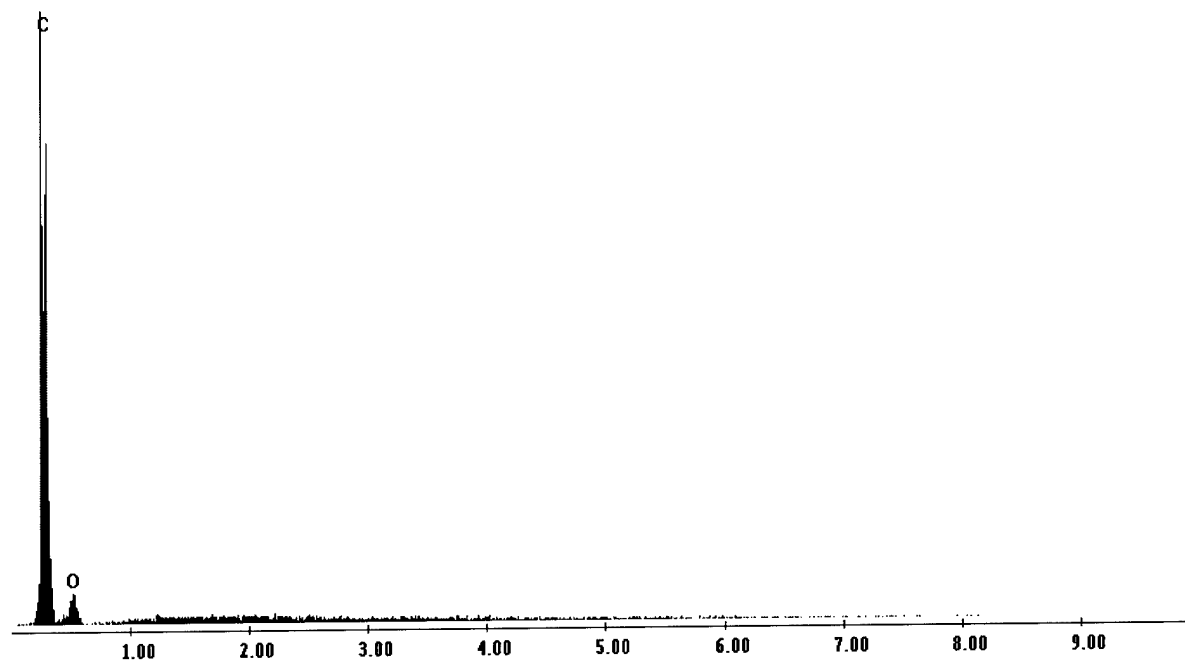
Figure 8. EDX spectra of fibers in debris (top) and deposit on fiber (bottom).

The chemical composition of the fibers is consistent with their being a type of fiberglass. There are several types of glass fibers, at least one of which (E-glass) has a composition (calcium aluminoborosilicate) consistent with the analyses of the debris (boron can not be detected by EDXS). The fact that the compositions of the fibers and fused deposits were nearly identical implies that the fused material was derived from melting of some of the fibers.

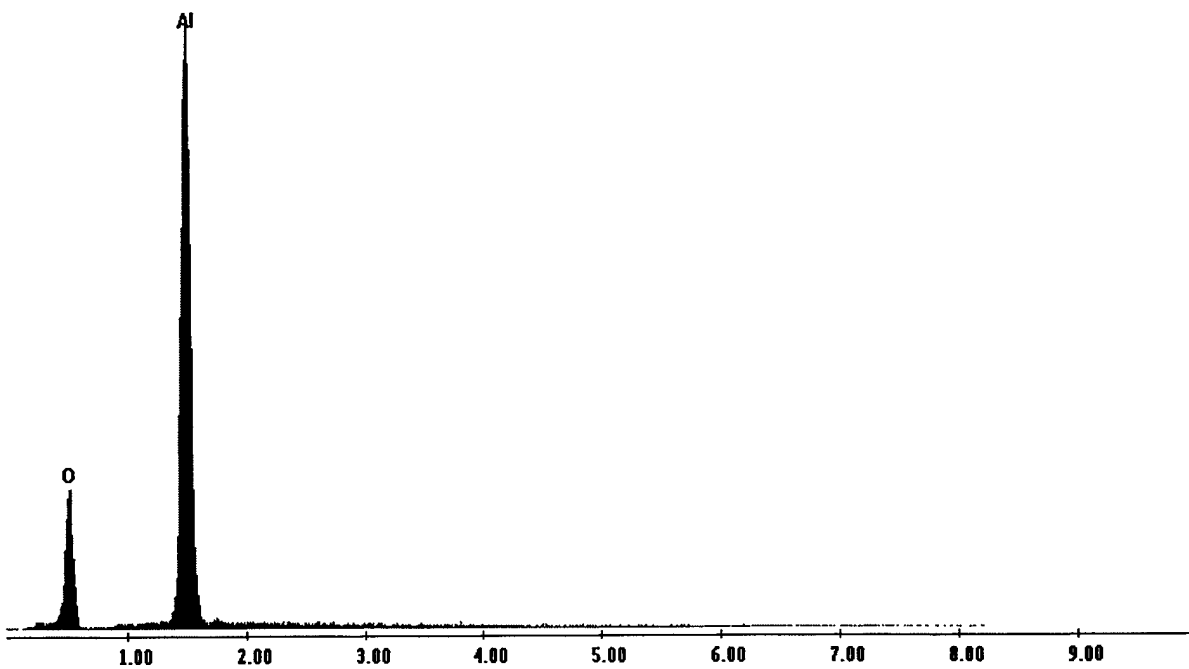
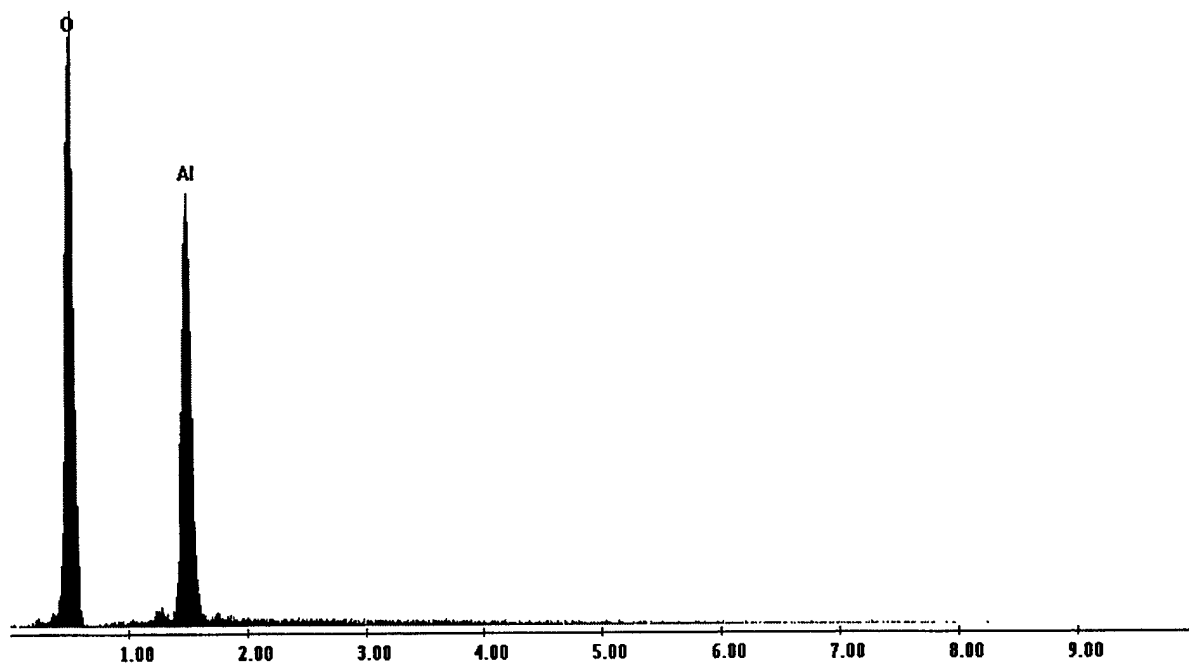
Figure 11. EDX spectra of shiny metallic deposits in debris.

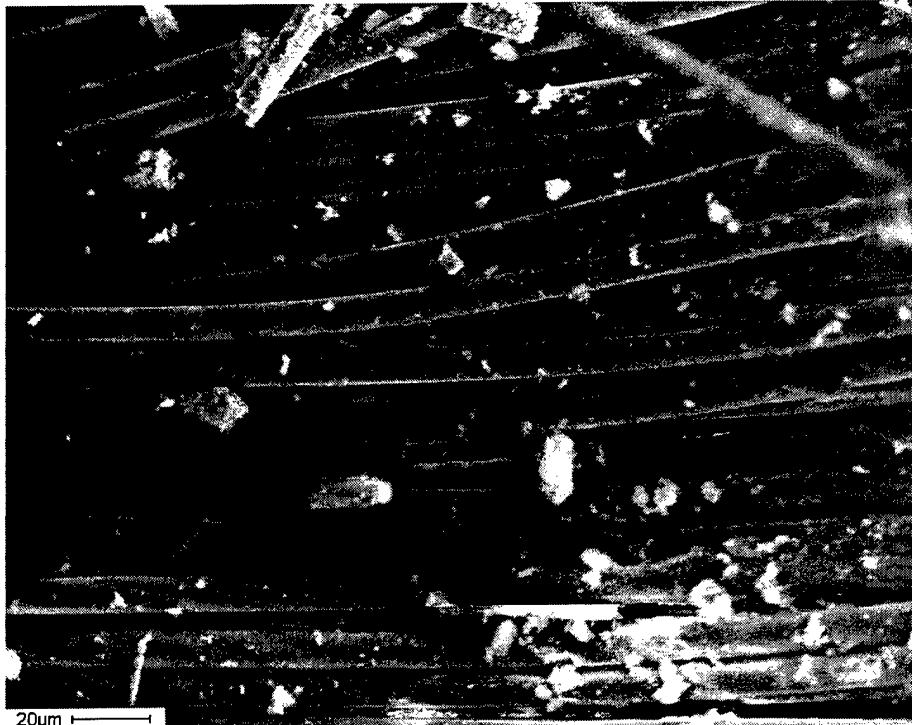
Figures 12 and 13 are SEM photographs of the glass fibers from the silica phenolic and glass fabric overwrap, respectively. The fibers from both materials are similar in size and appearance with the fibers from the debris. Figures 14 and 15 present the EDX spectra of the glass fibers from the silica phenolic and glass fabric overwrap, respectively. It can be seen that the fibers from the silica phenolic contain only silicon and oxygen, indicating that they were not the source of the debris. However, the spectrum of the overwrap fibers contains oxygen, silicon, calcium, and aluminum, and is nearly identical to that of the debris fibers (Figure 8). Figure 16 compares the debris with the fabric from the overwrap. The weave pattern in each is very similar.

Figure 12. SEM photograph of fibers from silica phenolic liner of test fired thrust chamber.

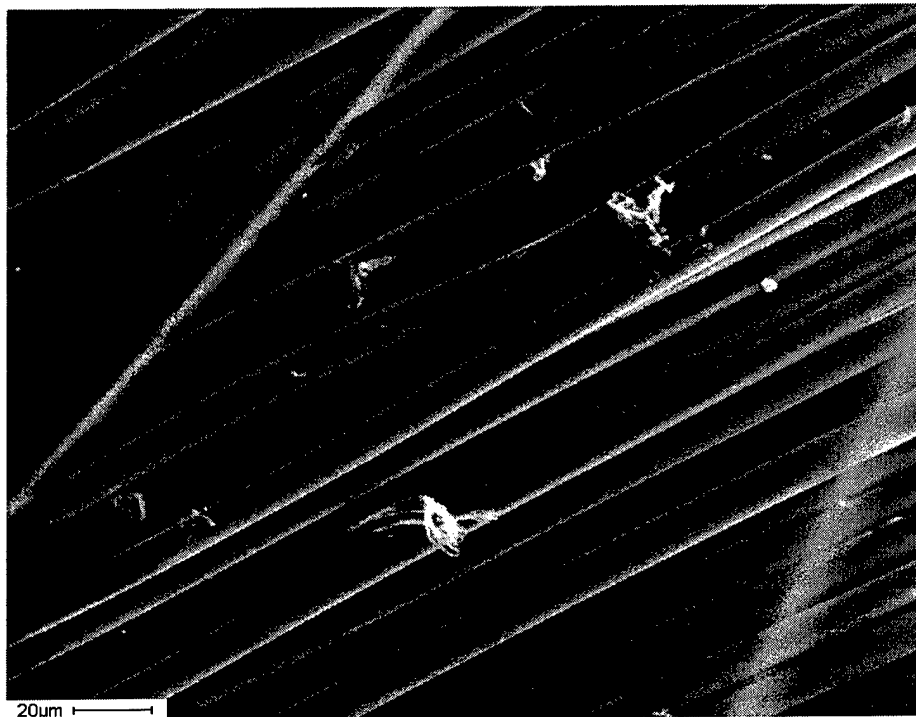
Figure 13. SEM photograph of fibers from glass fabric overwrap used on thrust chamber.

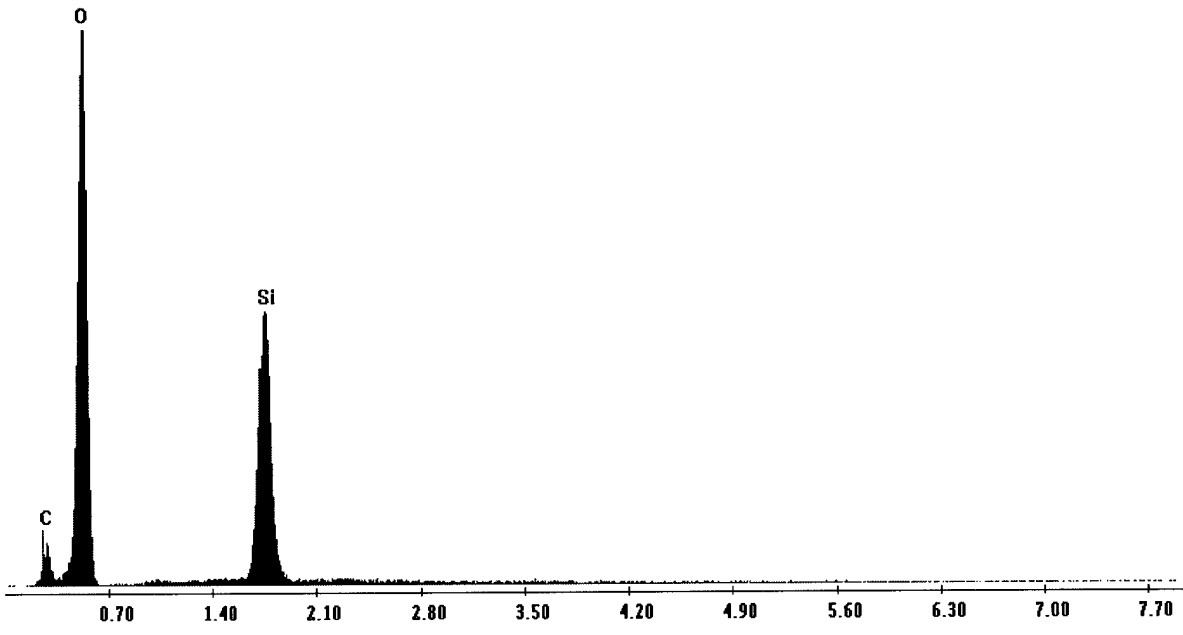
Figure 14. EDX spectrum of fibers from silica phenolic liner.

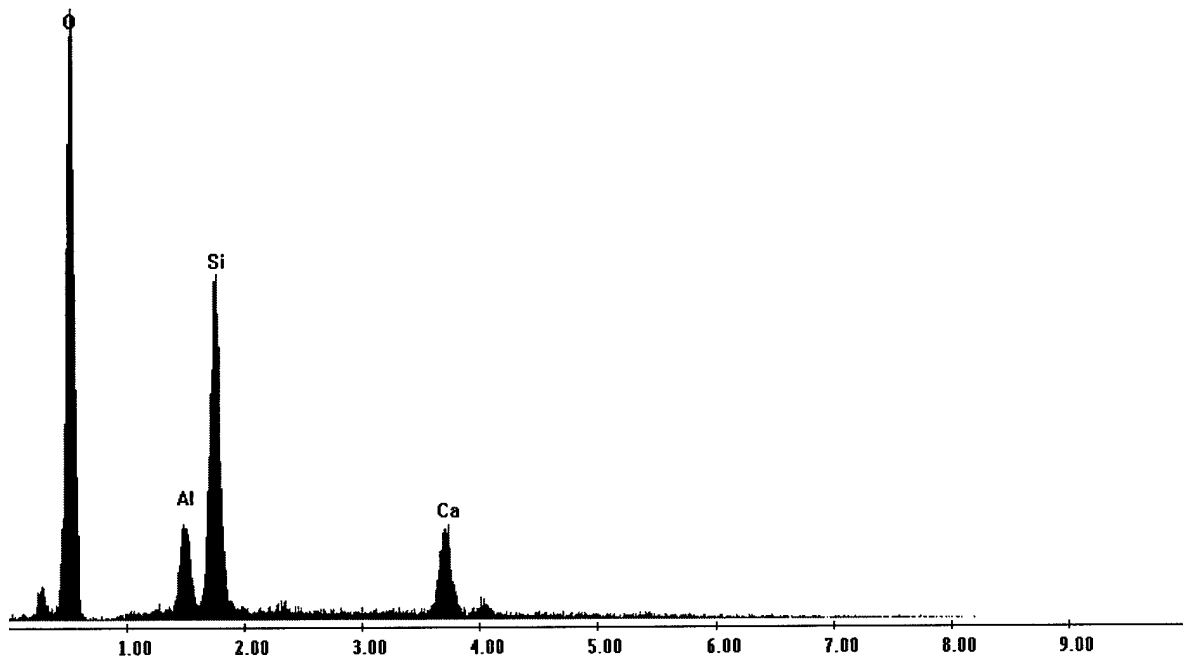
Figure 15. EDX spectrum of fibers from thrust chamber glass fabric overwrap.
