MANPRINT ASSESSMENT OF THE  
HIGH MOBILITY MULTIPURPOSE WHEELED VEHICLE  
HEAVY VARIANT (HMMWV-HV)  
(Contract MDA903-83-C-0033)

Daniel A. Krohn  
Douglas K. Spiegel  
Essex Corporation

March 1988

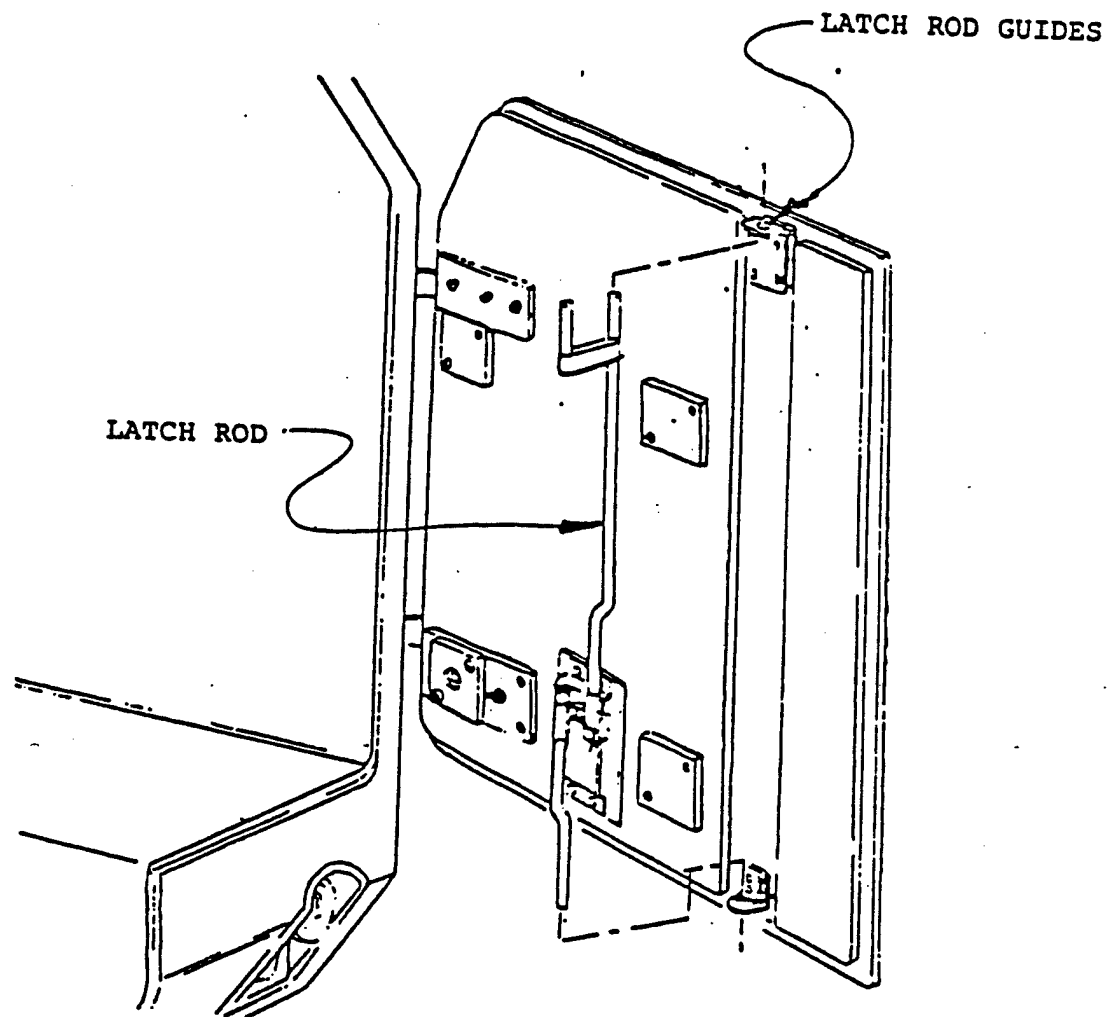
b. During cross-country operations, a rocking motion set up by road conditions results in locked doors shimmying back and forth relative to each other. This swaying works the latch rods until the door handle twists and the door opens.

d. Latch rod seats have sustained a great amount of wear, reducing their ability to properly seat the latch rod.

Unsecured doors pose a safety hazard to personnel inside the enclosure. May require unscheduled stopping for the ambulance.

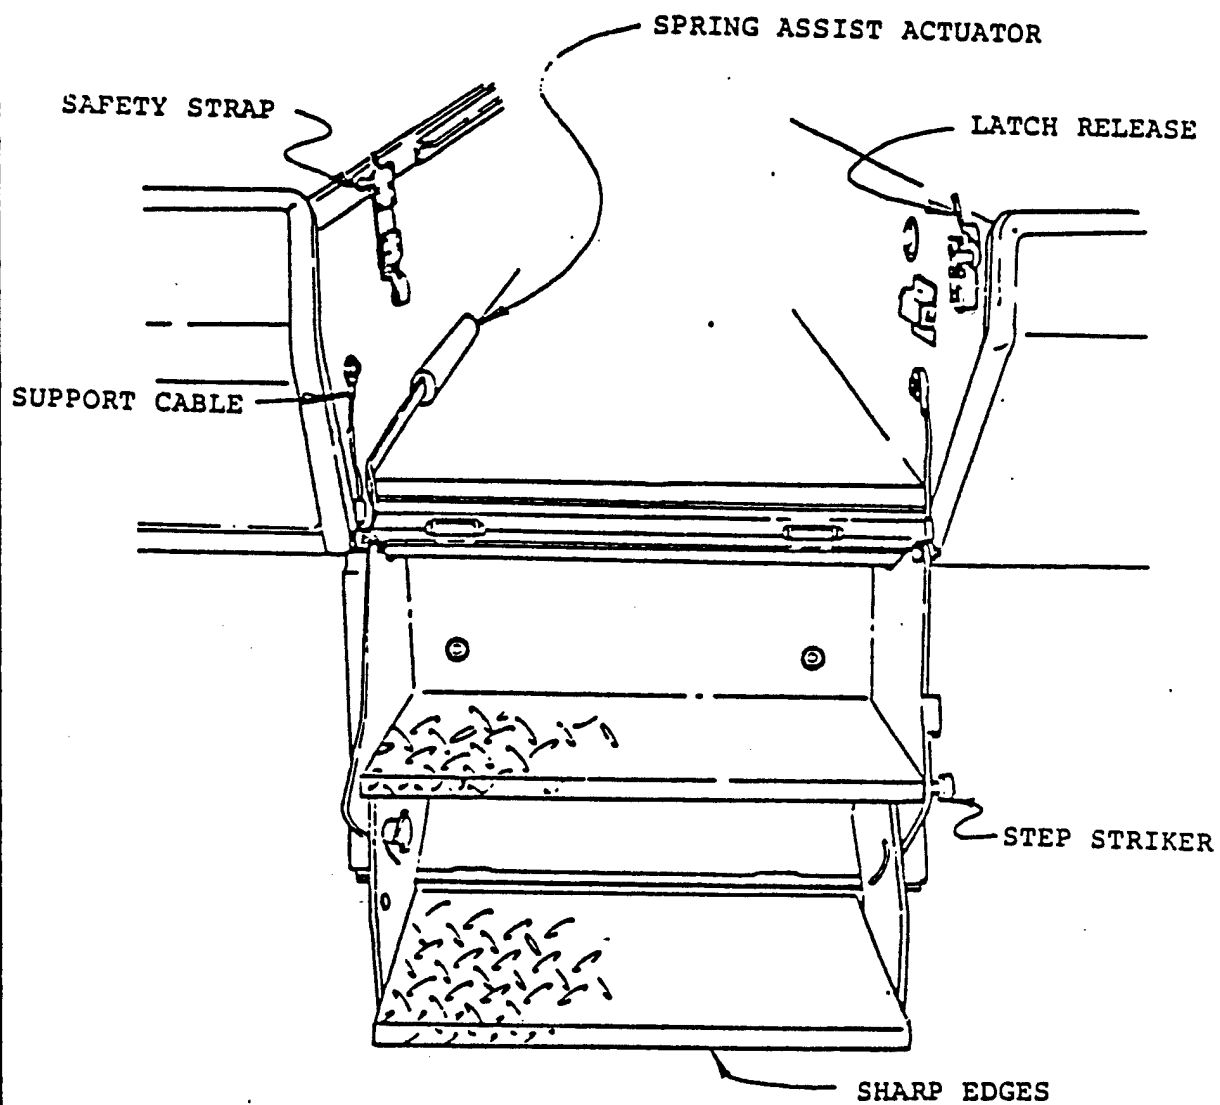
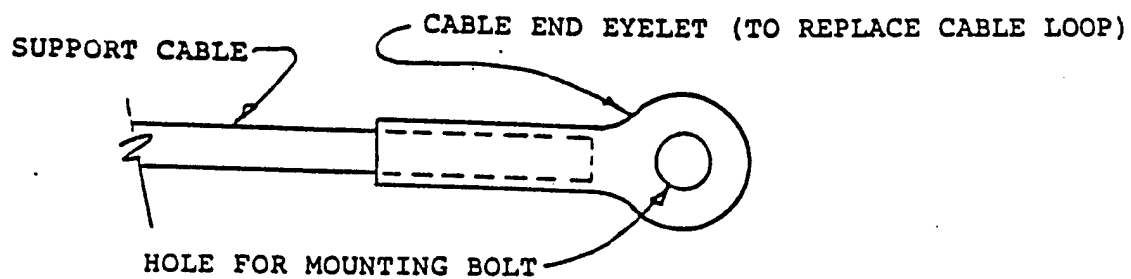
- a. The stair release latch is stiff, prone to sticking, and interferes with the litter support strap in the maxi-ambulance (see Figure 3.2.2.1).
- b. The safety strap for stowed position is hidden from operator's view while the operator is attaching or unattaching the strap hook.
- c. Sharp edges on steps have caused lacerations of the operators' hands.
- d. The stair support cables have come off of their attachment fasteners (see Figure 3.2.2.2).
- e. The mini-ambulance step seat (used while steps are in stowed position inside the van) restricts the headroom of a seated aidman.

The step latch hardware, when fouled with dust, malfunctions. The motion to actuate the release lever is lateral to operator's frontal plane and is difficult to grasp in order to release. The stair support cable loops wear, increasing their diameter and allowing them to come off their mounting fasteners (see Figure 3.2.2.2).

A malfunctioning release latch slows the operator's ingress or egress and has caused finger and knuckle injuries. Attaching and disconnecting the safety strap slows the operator's ingress or egress. The sharp edges also cause numerous hand lacerations. Unattached stair support cables could lead to severe injury. The lack of head room available for stair seat in mini-ambulance could cause severe head or spinal injury. The noisy spring assist may increase the possibility of detection if quiet operation is imperative.

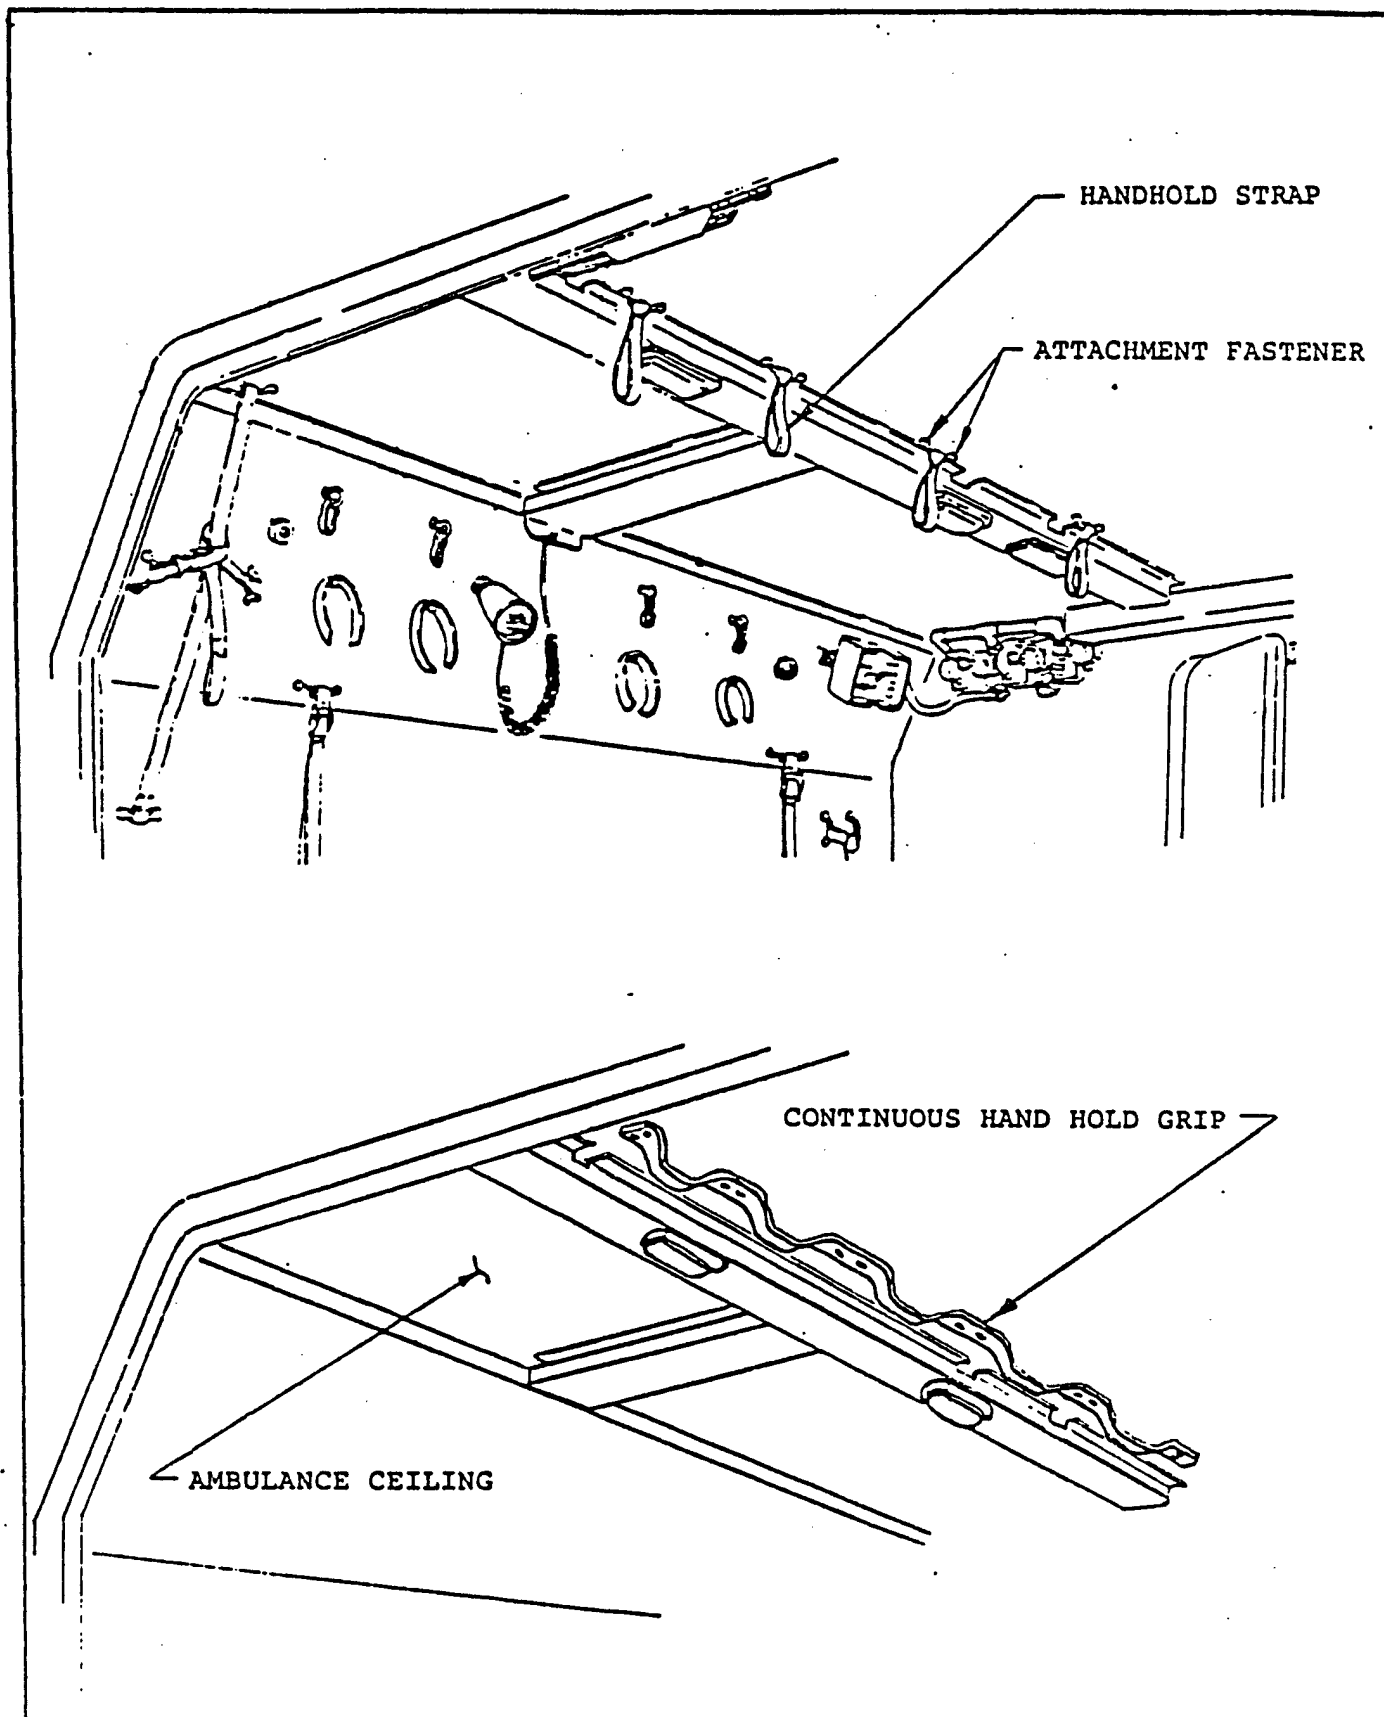
c. The mini-ambulance has handhold straps for use by seated ambulatory patients. The securing fasteners frequently failed, rendering the strap useless. It is also difficult to slide hands in and out of the hand strap loop (see Figure 3.2.3).

c. Failure of hand strap fasteners in the mini-ambulance render the strap useless and require a maintenance action to repair. Strap loops that are difficult to pull hands free from slow egress and could result in injuries if wounded are thrown while hands remain secured in the hand strap.

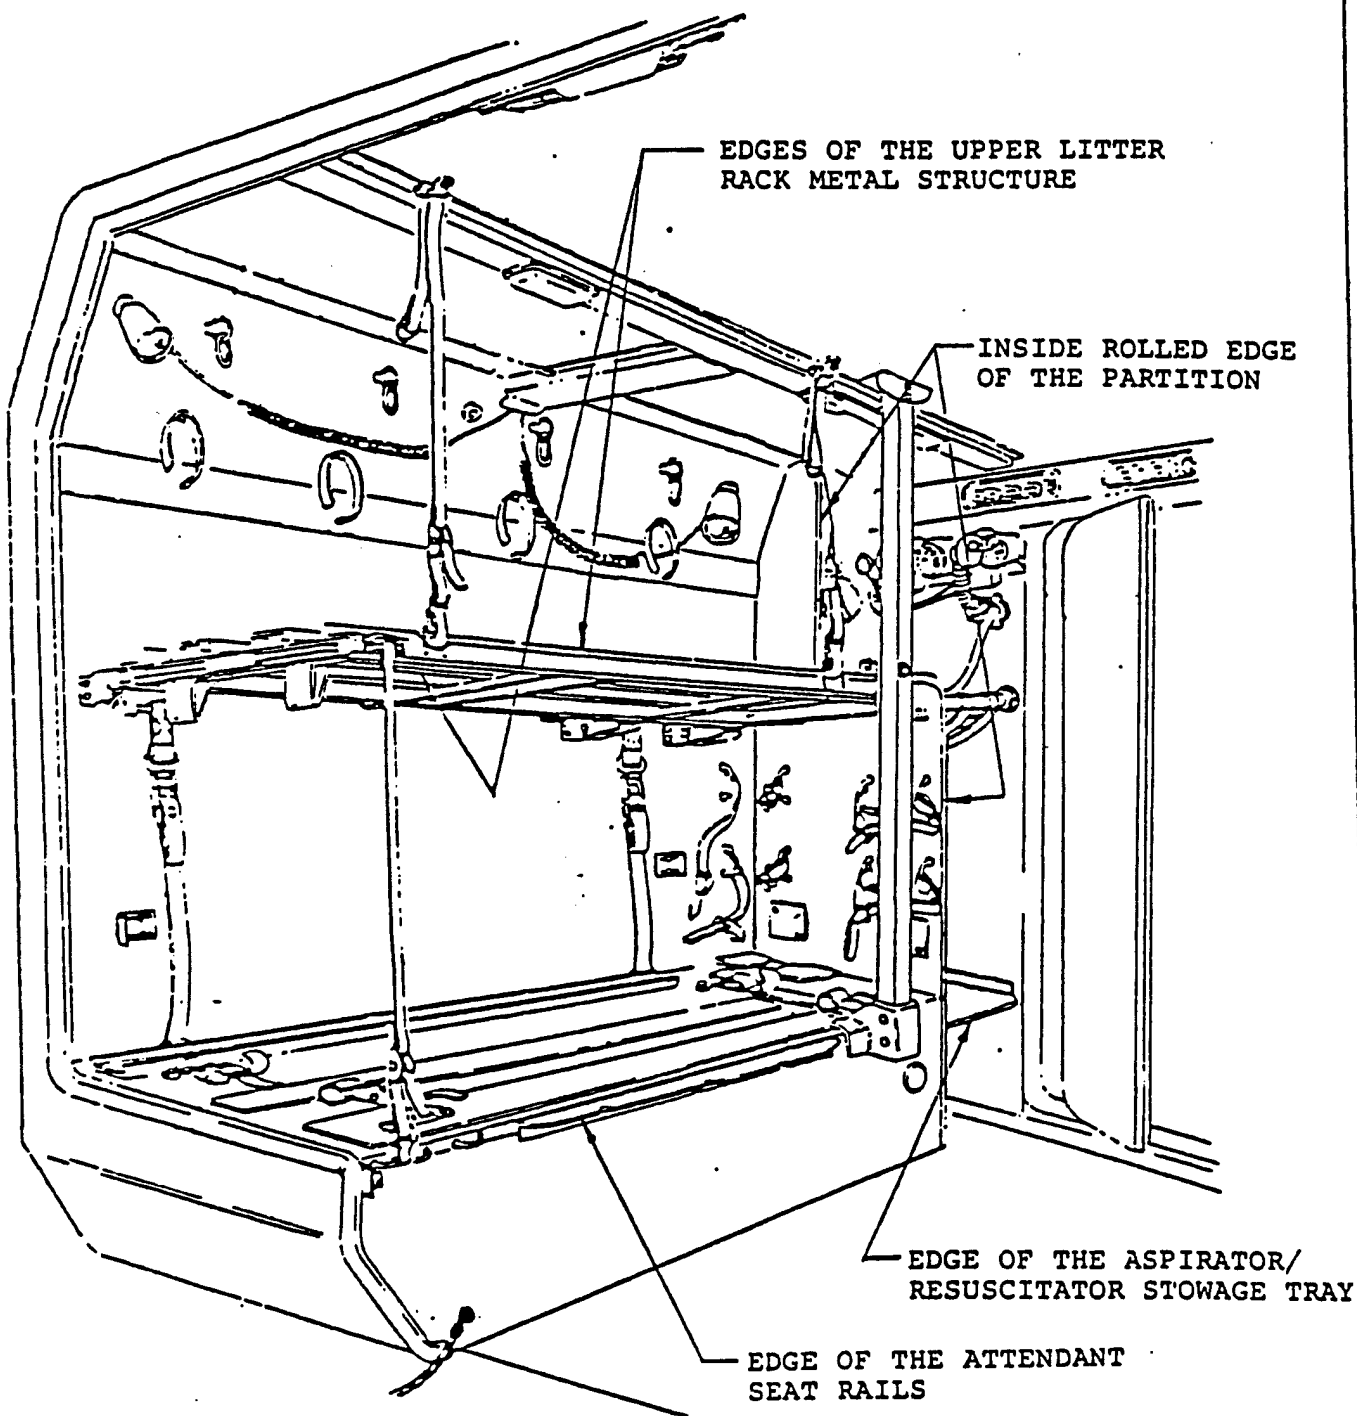
LEFT SIDE OF MAXI-AMBULANCE

- 1) Edges of aspirator/resuscitator stowage tray.
- 2) Edges of upper litter rack metal structure.
- 3) Inside edges of partially rolled edge of stowage area/litter area partition.
- 4) End of light bar structure next to air conditioning outlets.

Manufacturing processes that leave an unfinished edge and corners of equipment where projections are not padded or broken.

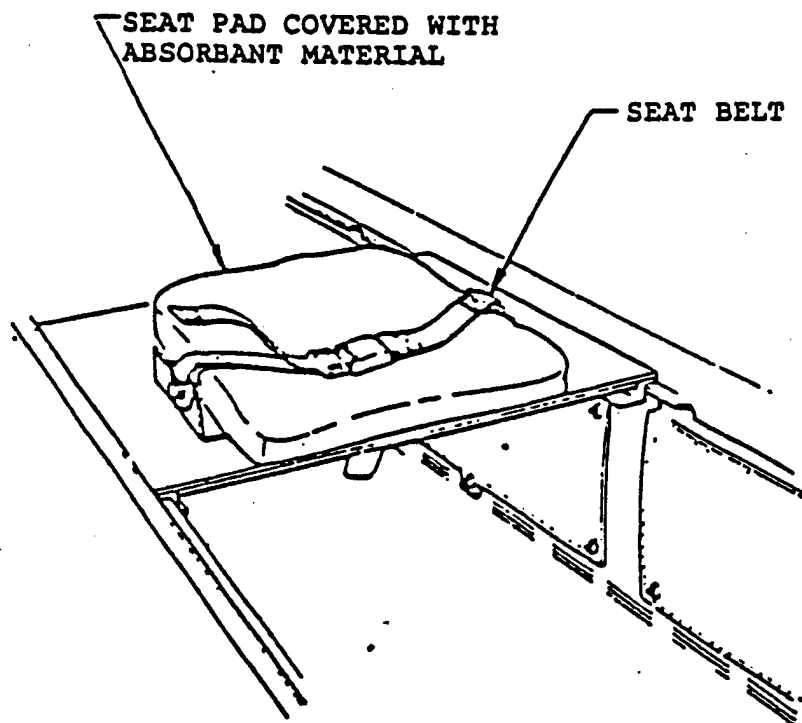
Attendants commonly straddle the attendant's seat but must lean awkwardly to access the patient's head, thus decreasing attendant's effectiveness and comfort. Lack of back support for the attendant's seat allows the attendant, with or without the seat belt, to slide and fall backwards out of the seat when the vehicle travels on rough roads or during hard forward vehicle accelerations. An absorbent seat covering will allow contaminants to penetrate and remain lodged in the seat. This condition will make cleaning of biological materials or other contaminants, without replacing the cushion, extremely difficult. The aidman must leave the attendant seat to access upper litter patients. This can result in injuries to aidmen from being thrown about the ambulance compartment.

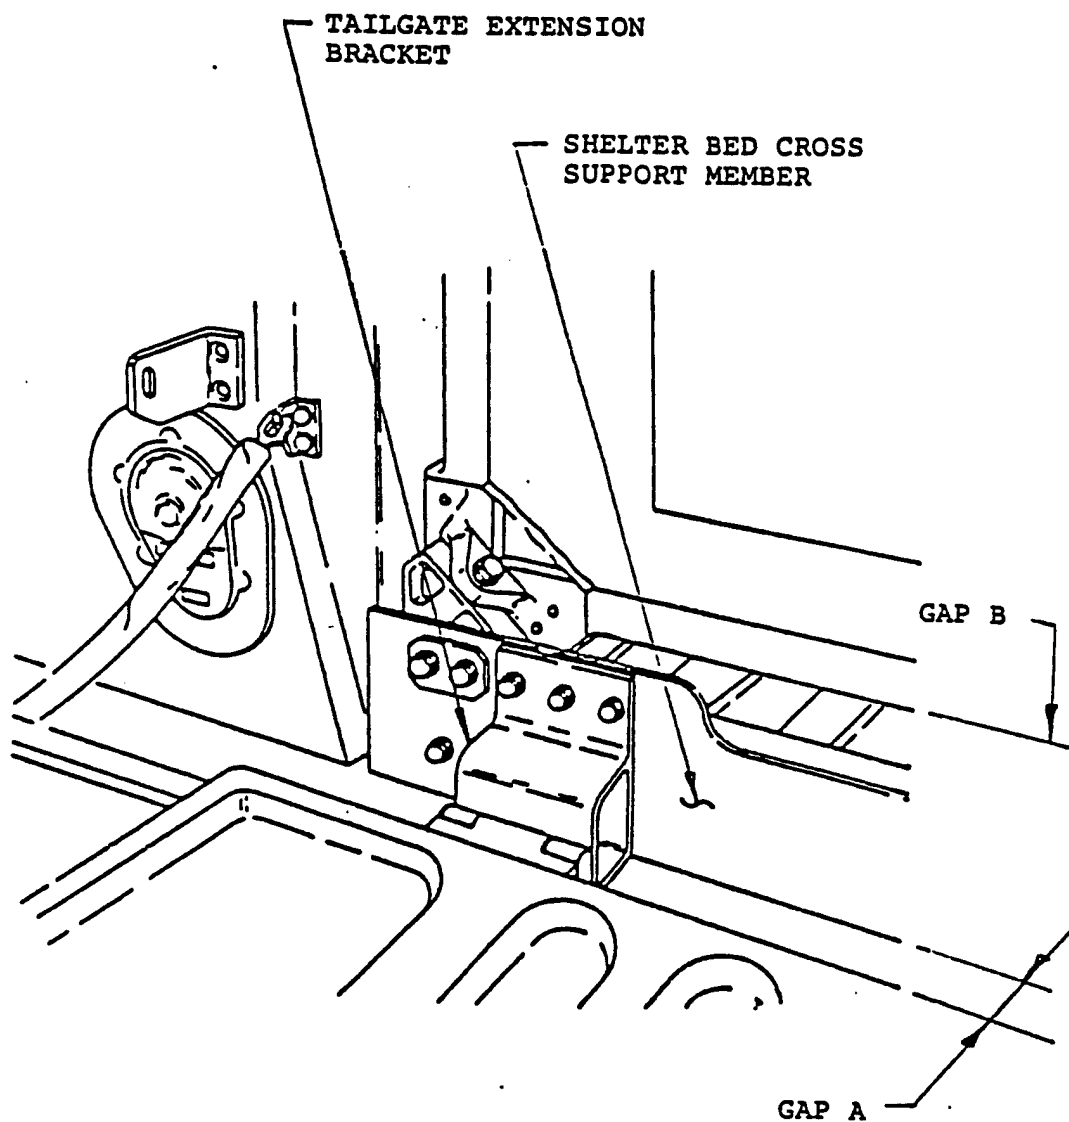
Figure 3.2.7. Shelter carrier tailgate tripping hazards.

A tripping hazard exists for HMMWV-HV shelter carrier crewmen while entering or exiting the communications (S-250) shelter. There are two hazard locations shown in Figure 3.2.7:

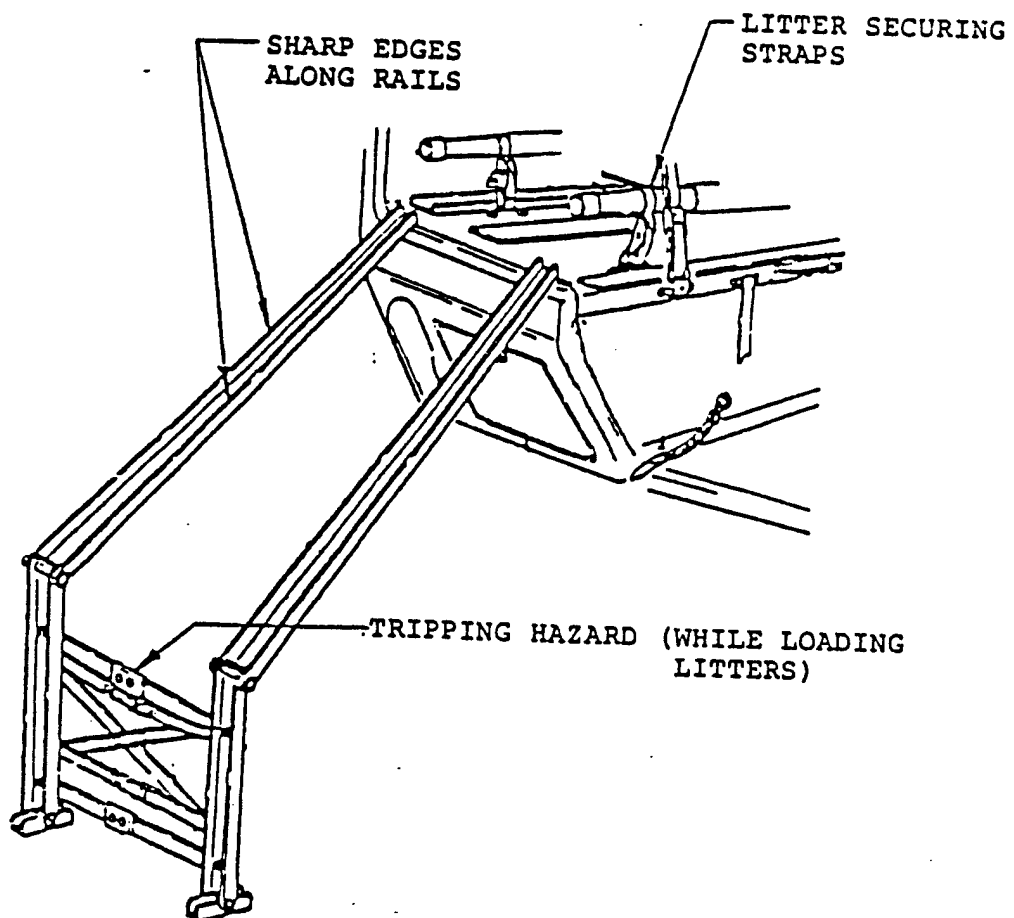
- 1) The securing straps are difficult to lock and set sufficient strap tension.
- 2) The securing strap hooks slide down the tapered litter handles and come loose.

a. Sharp edges cut the aidman's hands while lifting the litters away from the ramp rails and while litters are slid up the ramp. Aidmen may lose control of the litter due to either the ramp disconnecting from the vehicle or their tripping over the structure at the ramp base. Litter loading is delayed due to the interference caused by the litter catching on the litter restraint straps.

a. Litter ramp rail edges should be rolled. The litter ramp attachment to vehicle lugs should be altered to increase their ability to stay secured. Loading procedures should be revised to have litter bearers load litters using a side-carry loading method. This method would avoid the litter ramp structure tripping hazard and would also allow for both litter bearers to apply the lifting and pushing forces required to load the litter.

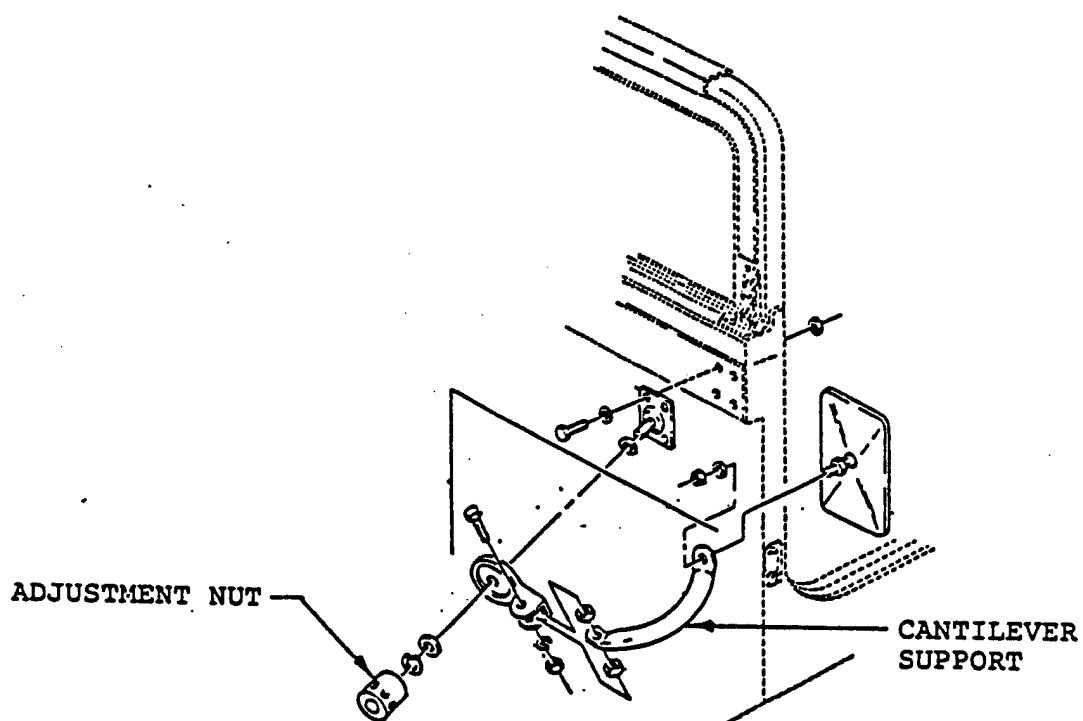
The side mirrors on the HMMWV ambulances and shelter carrier are too small and vibrate excessively. The hardware for mirror adjustment to the window frame mount vibrates loose, and the mirror falls to the side of the vehicle due to the length of the support. Operators claim the passenger side mirror is poorly positioned and does not provide a view. Shelter carrier drivers complain they do not have adequate rearward view to monitor their trailer status.

The mirror is supported by a single support that is approximately 20 inches (50 cm) long and is cantilevered from the mounting and adjusting hardware (see Figure 3.3.3). Vibration acting on the same plane as the adjustment nut tends to loosen the nut.

Excessive vibration blurs operator's rearward view. Loose hardware disables the use of the mirror. The small size of mirrors, approximately 5 by 7 inches (12.5 by 17.5 cm), limits effectiveness.

b. Increase size of mirrors. (Crewmen would prefer mirrors similar to those found on M35, 2.5-ton vehicles.

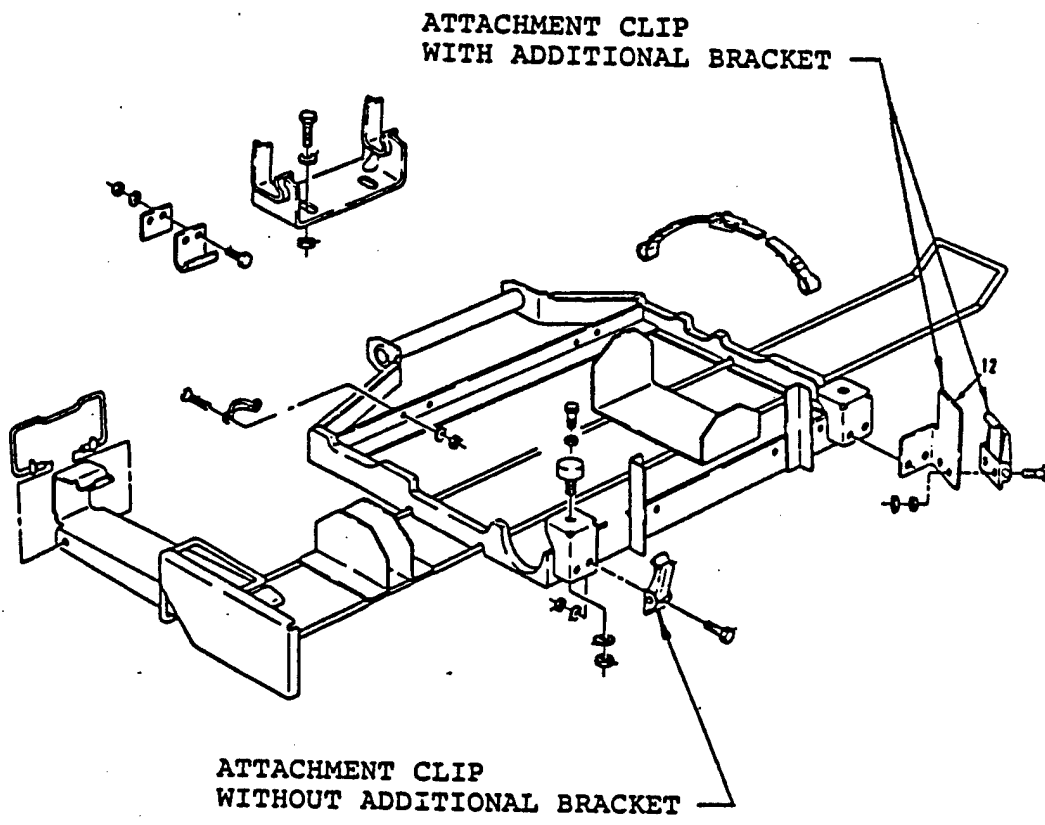
DESCRIPTION  
Figure 3.3.6. Pioneer tool rack attachment.

Falls/injuries and/or vehicle damage likely.

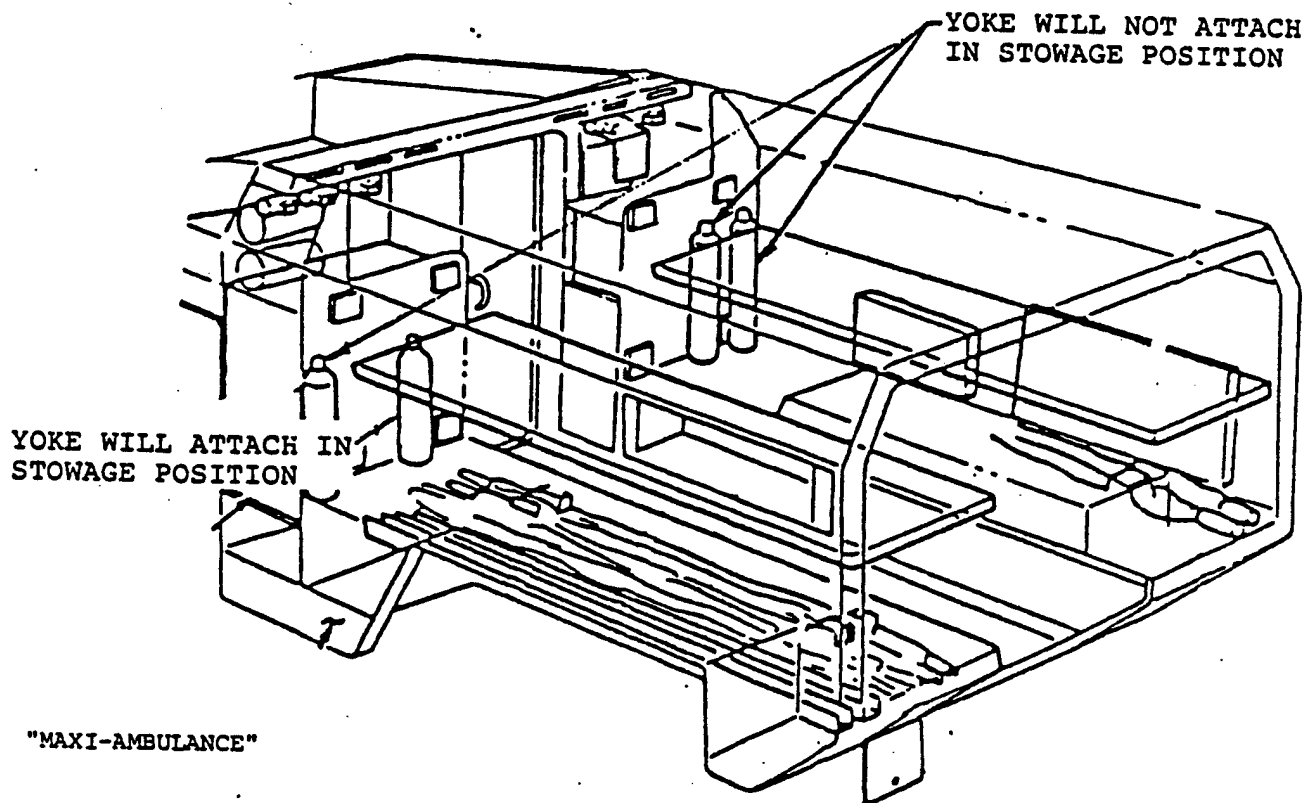
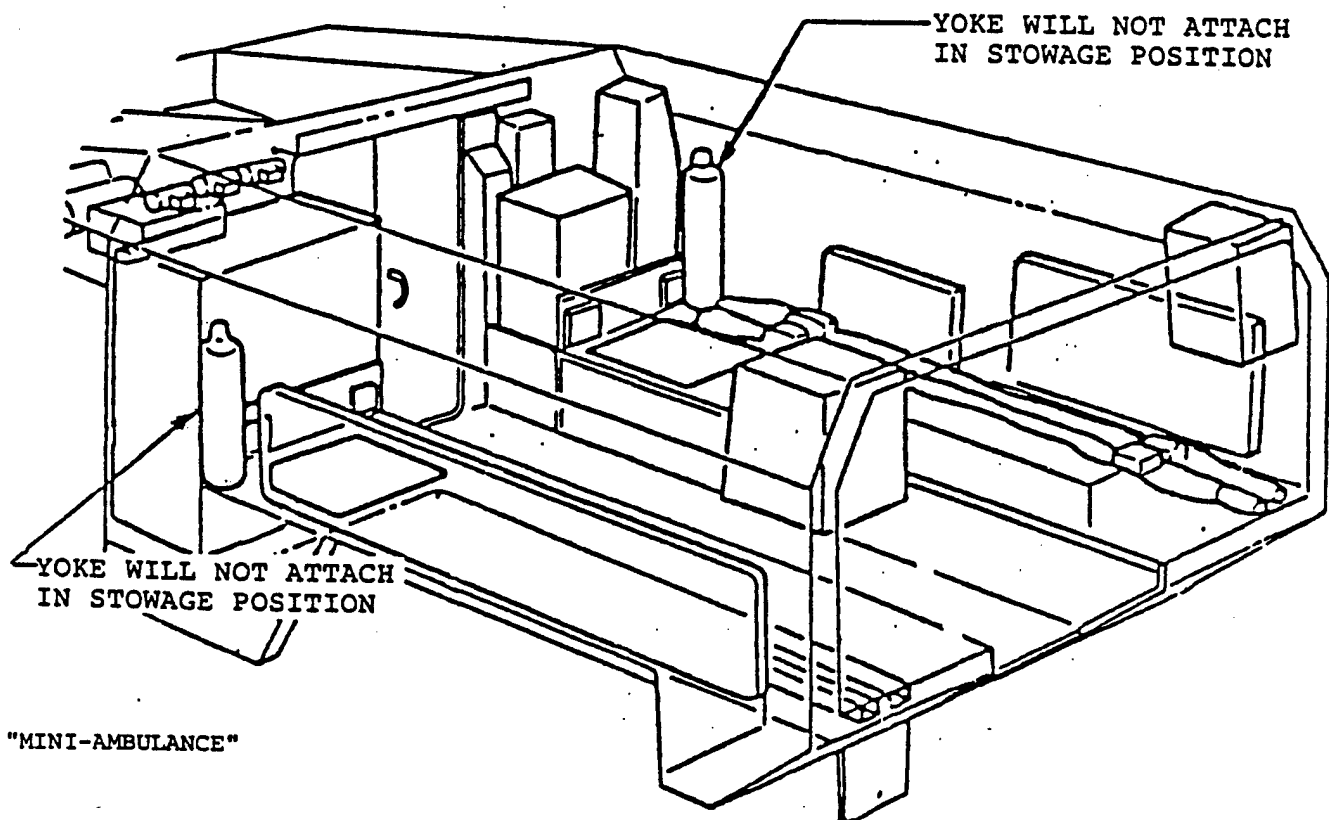
Oxygen bottles are not usable unless they are removed from rack and cannot be stowed until after yokes are removed. Bottles that are not secured during use or layed on the patient's litter may be thrown about a moving vehicle and cause injury to aidmen or patients.

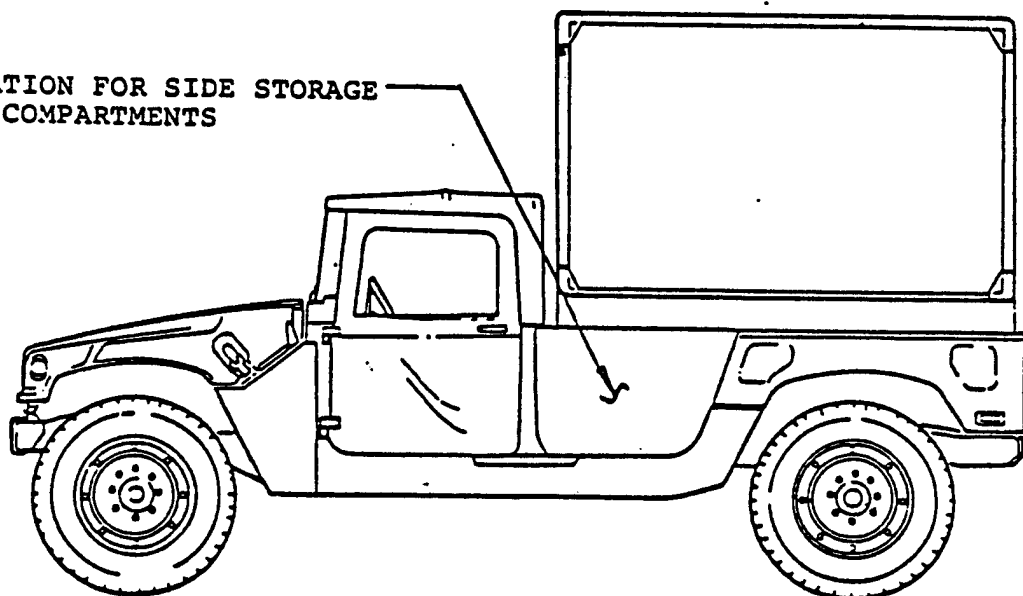
DESCRIPTION  
Figure 3.4.3. Shelter carrier stowage.

Equipment that is stowed in the shelter is not restrained and moves freely about the floor of the shelter while negotiating terrain. This movement results in damage to the equipment and a stepping/tripping hazard to anyone entering the shelter. Time and effort are also wasted by crewmen removing heavy equipment from the shelter.
