TECHNICAL REPORT

NO. 12776

WINTER TESTING OF VEHICLE
EXHAUST DUST EJECTION SYSTEM, RUBBER
TIRE HUBS, AND PERSONNEL HEATER SYSTEM
ON THE M60 A3 TANK

JUNE 1982

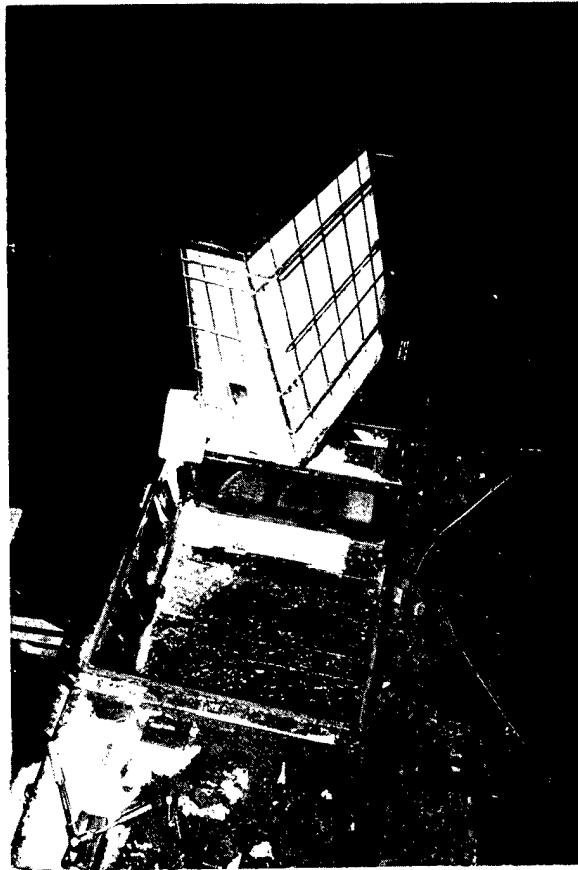
Both the VEDES and ACBM air filter elements would clog up with snow when the vehicle was operated in freshly fallen or powder (very light and dry) snow. The VEDES filter element did clog up fast, however. Figure 1 shows the VEDES filter compartment after 5 miles of driving in a heavy snow storm. The restriction indicator reached 30 inches of water.

Figure 1. VEDES filter element and filter compartment after 5 miles of driving in a heavy snow storm.

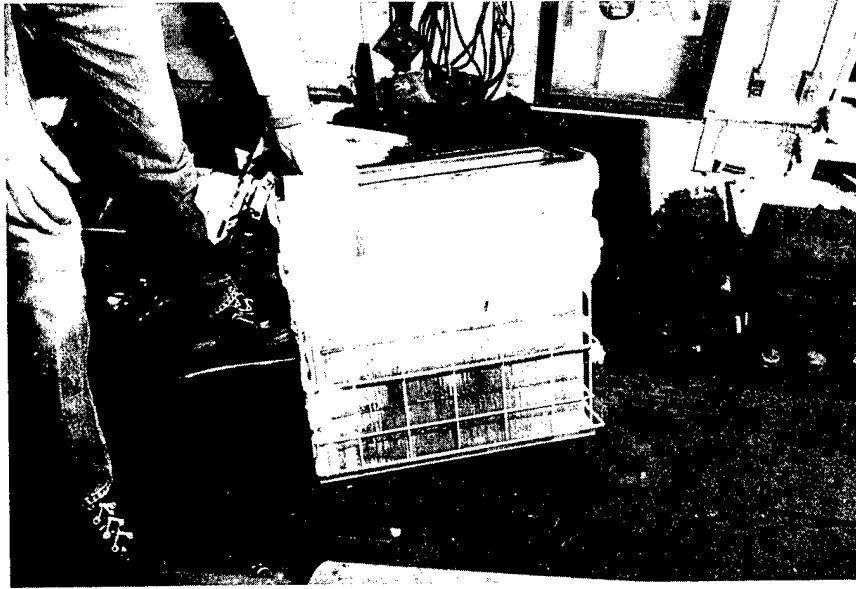
1. A heavy layer of snow had accumulated on the VEDES filter element. The snow covered approximately 75% of the filter media on both sides of the filter element. Figure 2 shows the filter element covered with snow.

Figure 2. VEDES filter element after 50 miles of operation in powder snow.

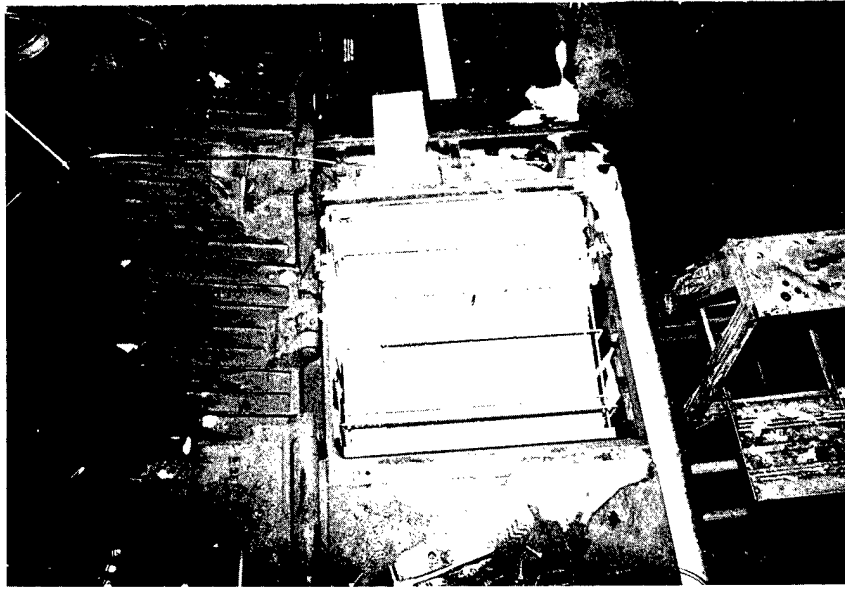
Figure 5. ACBM filter element after 50 miles of operation in powder snow.

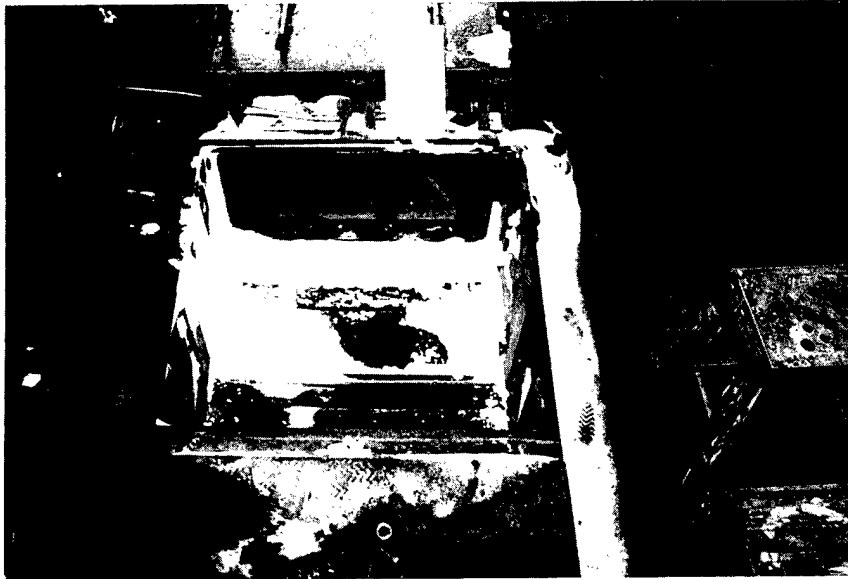
Figure 6. ACBM filter compartment after 50 miles of operation in powder snow.

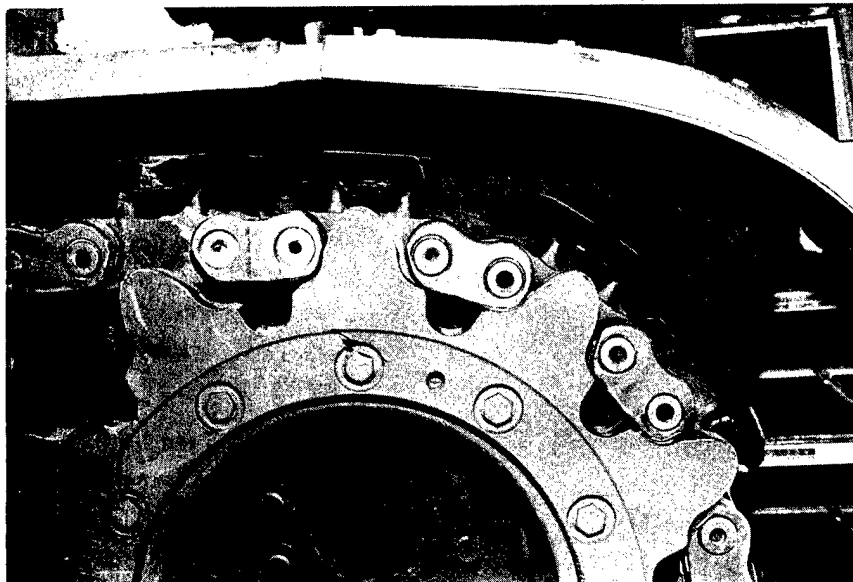
it was noted that there was a mismatch between the RTH sprockets and the track end connectors. This mismatch caused wear to the sprocket teeth and end connectors as seen in Appendix A. Appendix A shows wear to three selected end connectors on both sides of the track as well as the wear to the RTH sprockets.

One set of tracks was worn out after 250 miles of operation. The track was replaced with a spare, and end connector and sprocket wear were recorded. Figure 12 shows the excessive wear between the sprocket teeth and end connectors after 250 miles.

Figure 12. Track and sprocket misalignment and excessive end connector wear (250 miles).

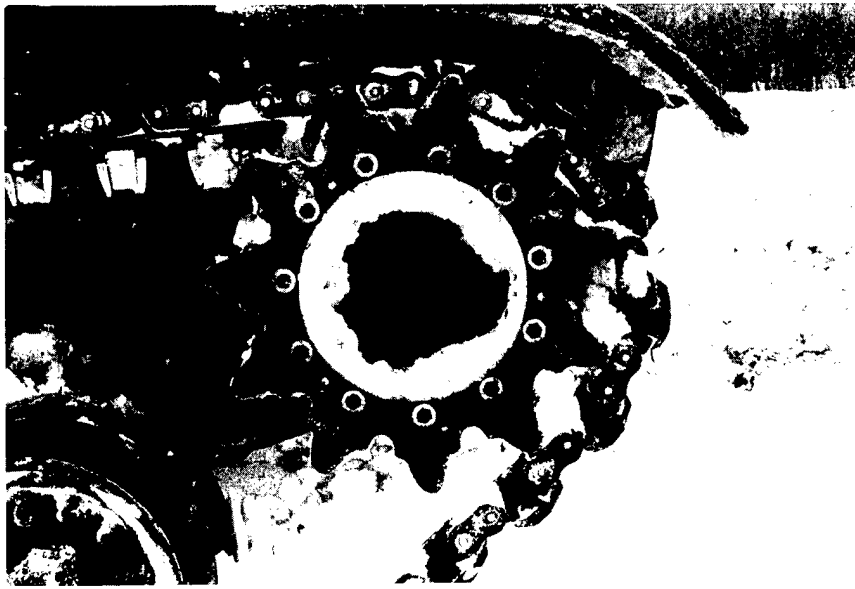
Snow was definitely a problem for the rubber tire hubs. The hubs would pack with snow and cause the track to jump over the drive sprocket teeth. The driver had to be careful not to jump the track.

Figure 13. Snow build-up between the track and sprocket caused the track to climb over the sprocket teeth.

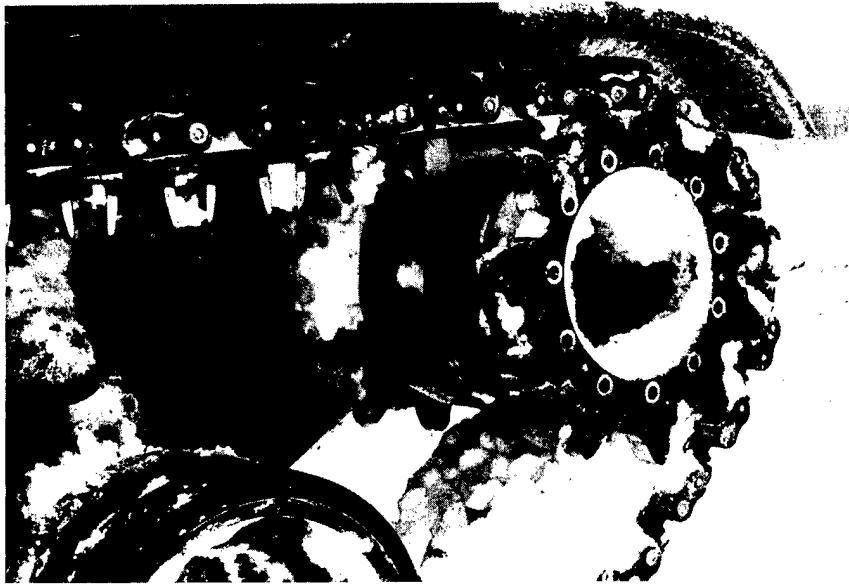
Figure 15. Snow build-up between the track and sprocket.
