## Bioengineering as a Tool for Restoring Ecological Integrity to the Carson River

**PURPOSE:** This technical note describes a case study involving the following: (a) use of bioengineering (a combination of vegetation and engineered structures and materials) and rock structures to restore an eroded bank of the Carson River, Nevada, and (b) restoration of ecological amenities that existed prior to disturbances by man and a major flood event.

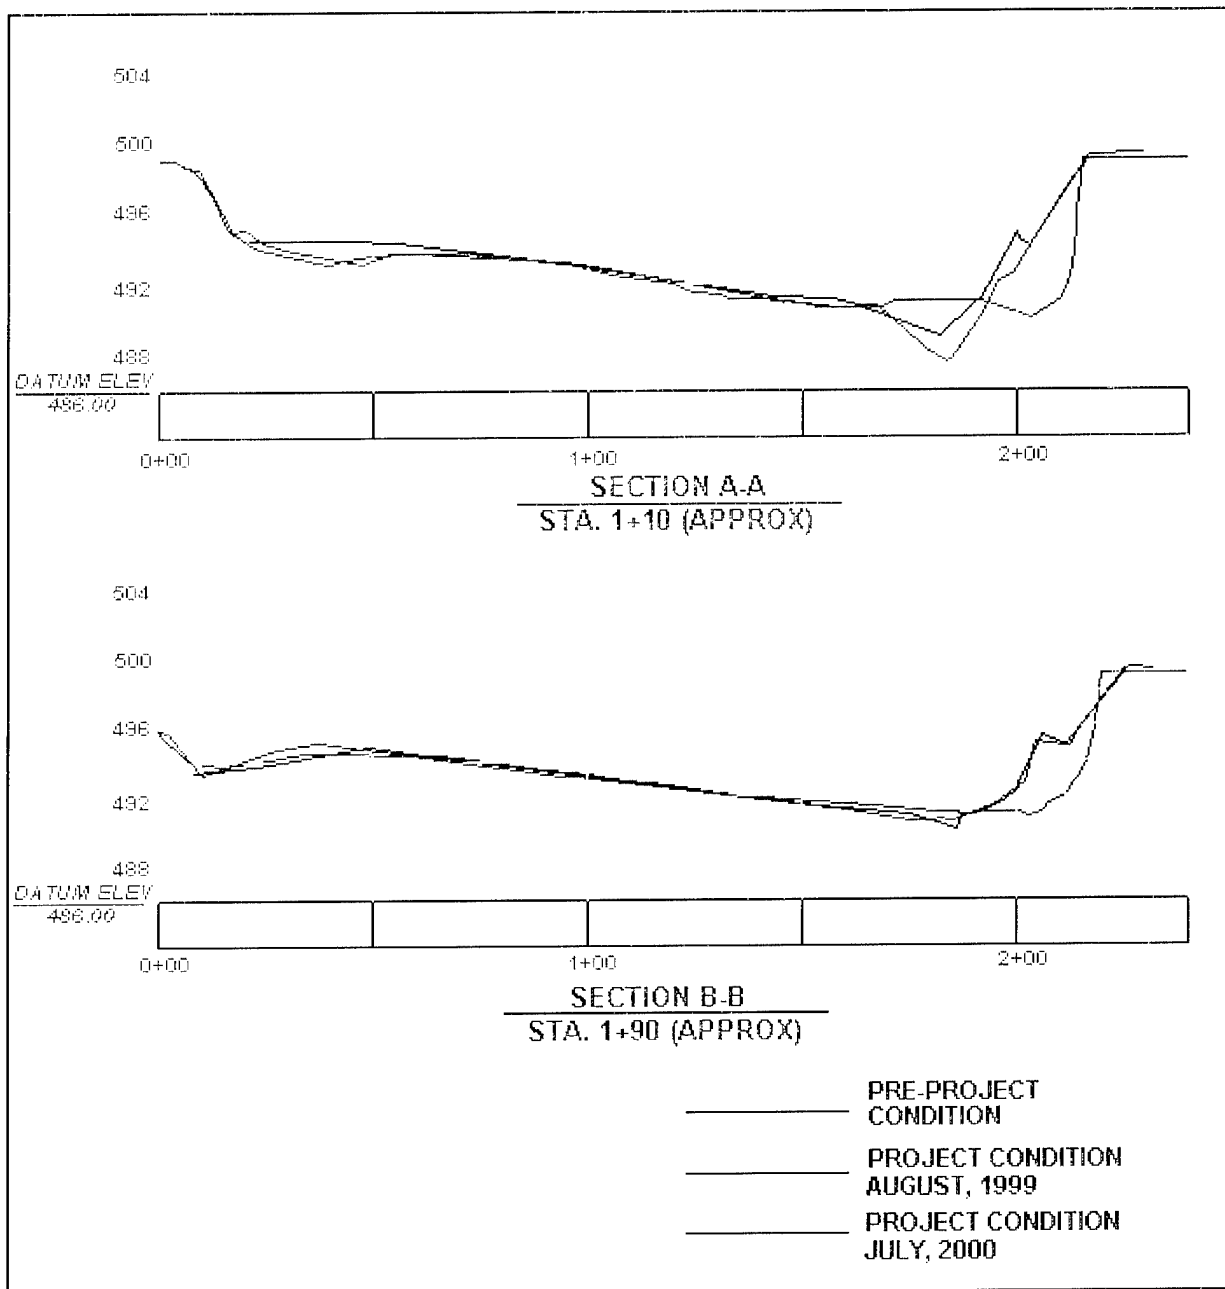
*Channel morphology.* The cross-sectional survey information taken between 1998 and 2000 illustrates that with one exception, the thalweg moved away from the bendway bank and that sediment accumulated between the barbs as designed (Figures A1 to A3, Appendix A). There has been 1 ft of scour in the thalweg at the most downstream station (1 + 10) and there is some evidence that scour and the change in depth of the thalweg have removed a portion of the sediment that accumulated during the prior year. At this same station, the right bank has changed in contour. The gravel bar associated with the right bank has lost material as expected and now approximates pre-project conditions. The remaining cross sections appear to be relatively stable, with only insignificant changes to the channel morphology.

Figure A-1. A-A and B-B cross sections as though looking upstream. Note how thalweg has shifted to the left and sediment has accumulated on the right bank, the eroded bank of the bendway
