# OPERATION PLUMBBOB

Project 30.7

TEST OF GERMAN UNDERGROUND  
PERSONNEL SHELTERS

Issuance Date: June 25, 1962

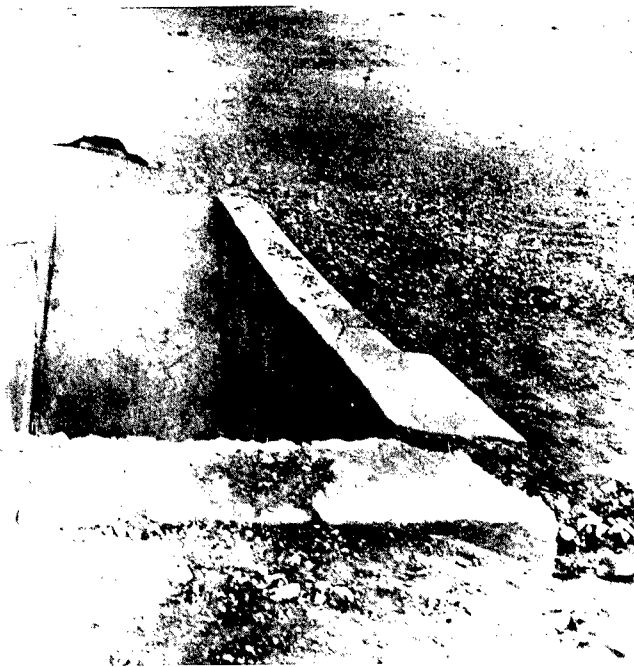
Fig. 3.13—Blast damage to ramp walls of entrance facing GZ (structure RAa).

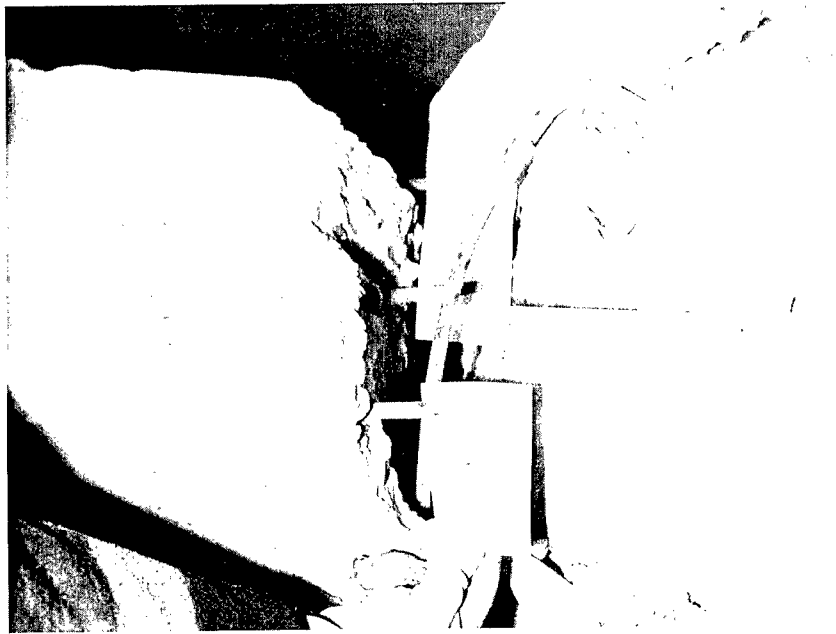
Fig. 3.18—Detail of necked-down reinforcement at intersection of exterior wall and parapet wall facing toward GZ (structure RAa).

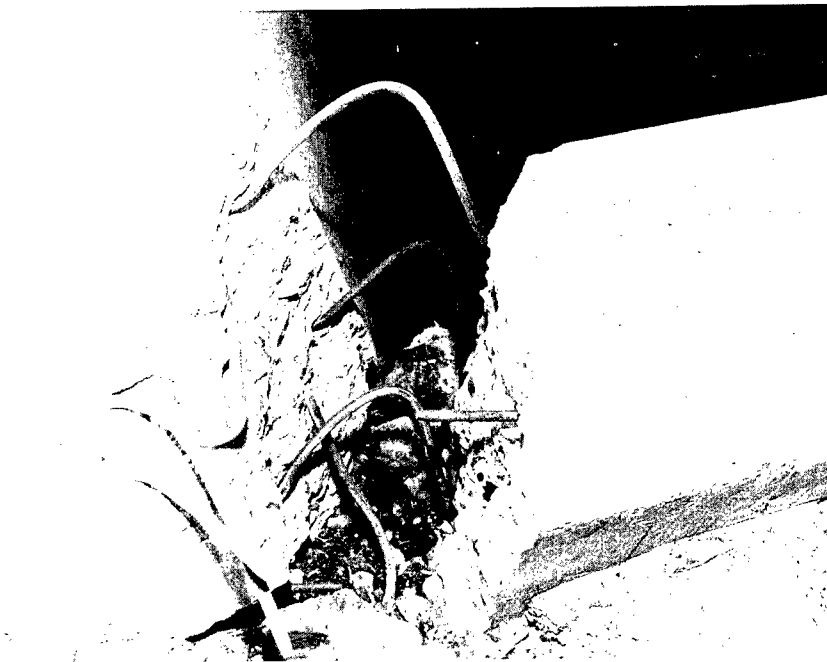
Fig. 3.19—Detail of crack at intersection of interior wall and parapet wall facing toward GZ (structure RAa).

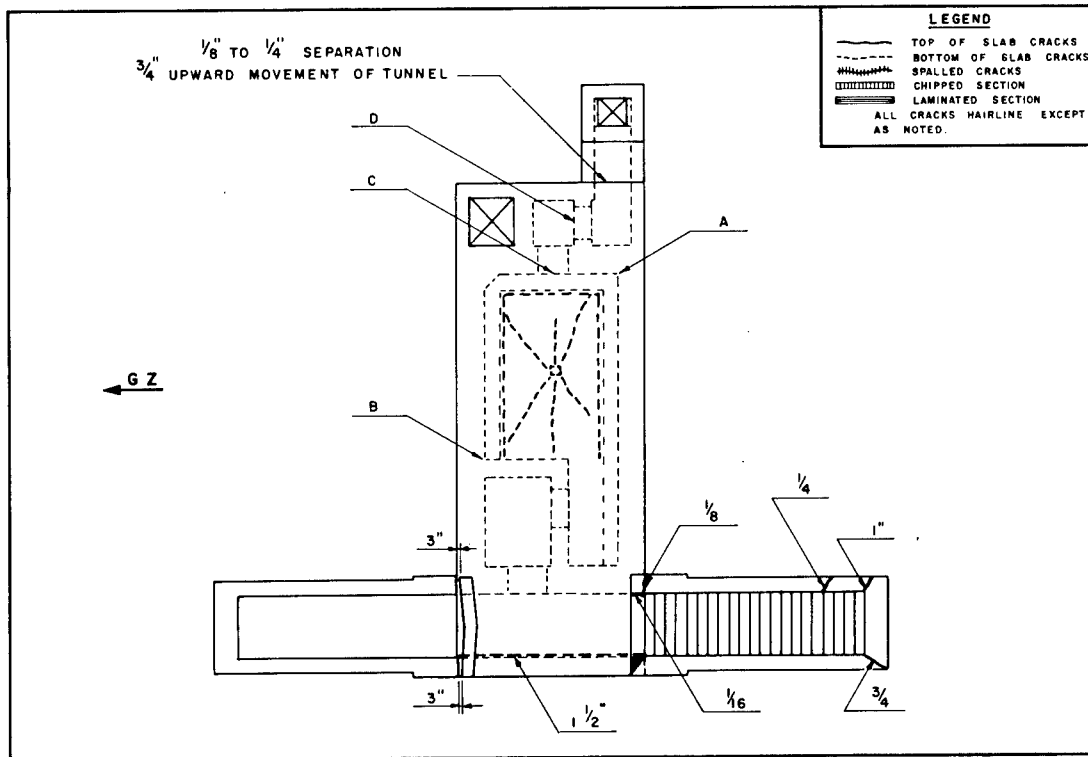
Fig. 3.25—Roof-slab crack pattern (structure RAb).

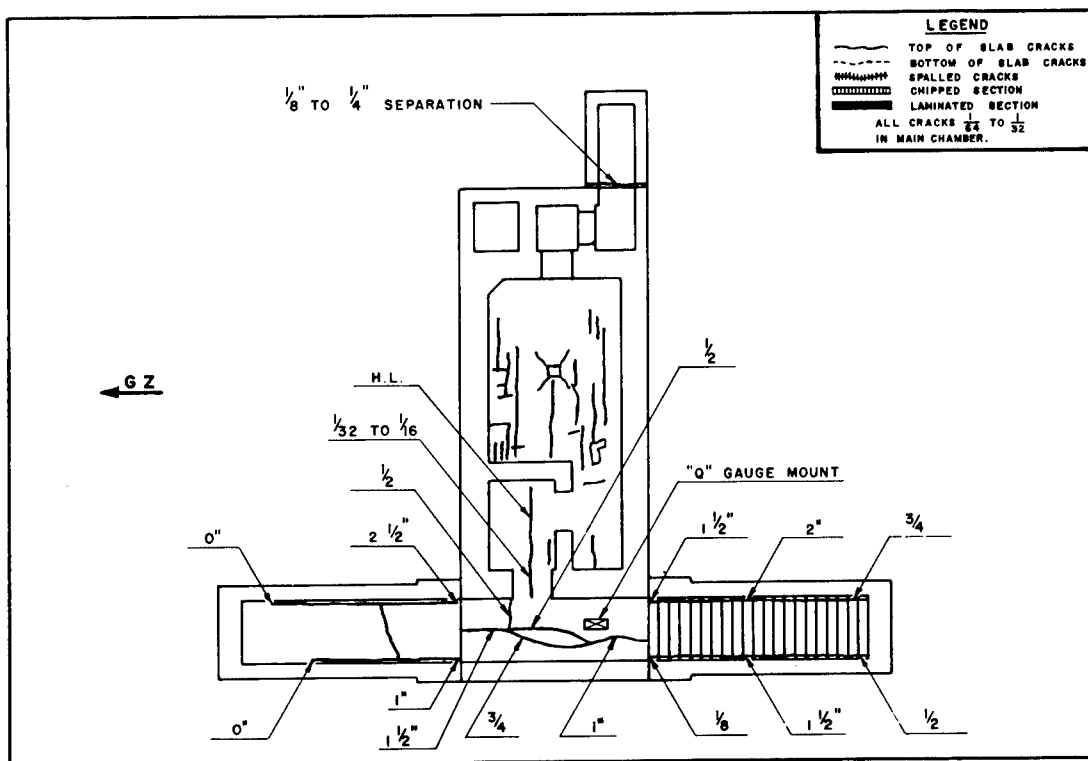
Fig. 3.26—Floor-slab crack pattern (structure RAb).

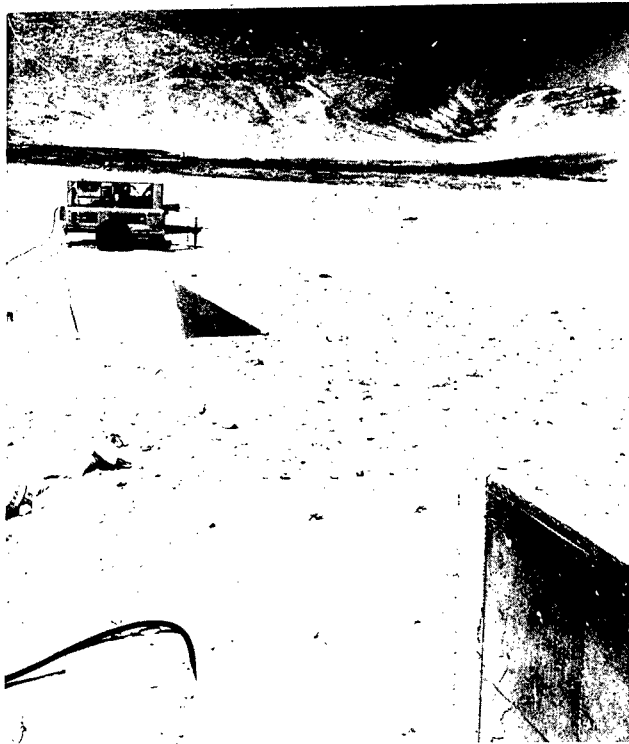
Fig. 3.48—Detail of cracks at intersection of parapet wall and interior wall and entrance facing away from GZ (structure RAc).

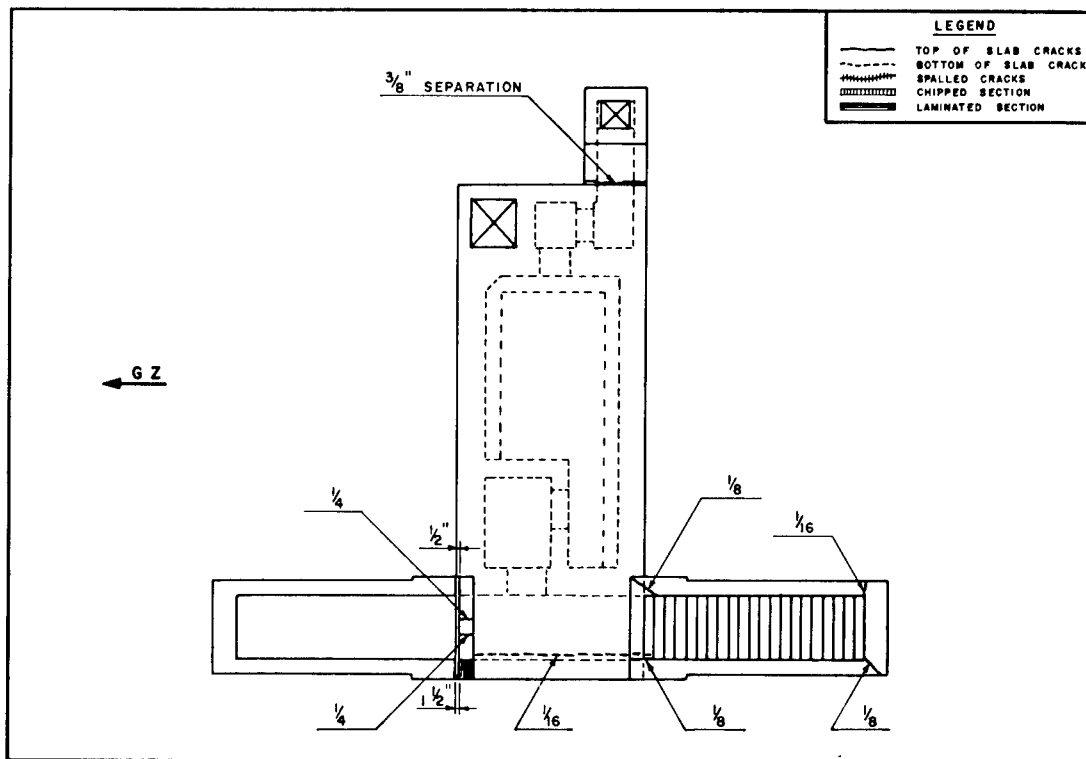
Fig. 3.54—Roof-slab crack pattern (structure RAd).

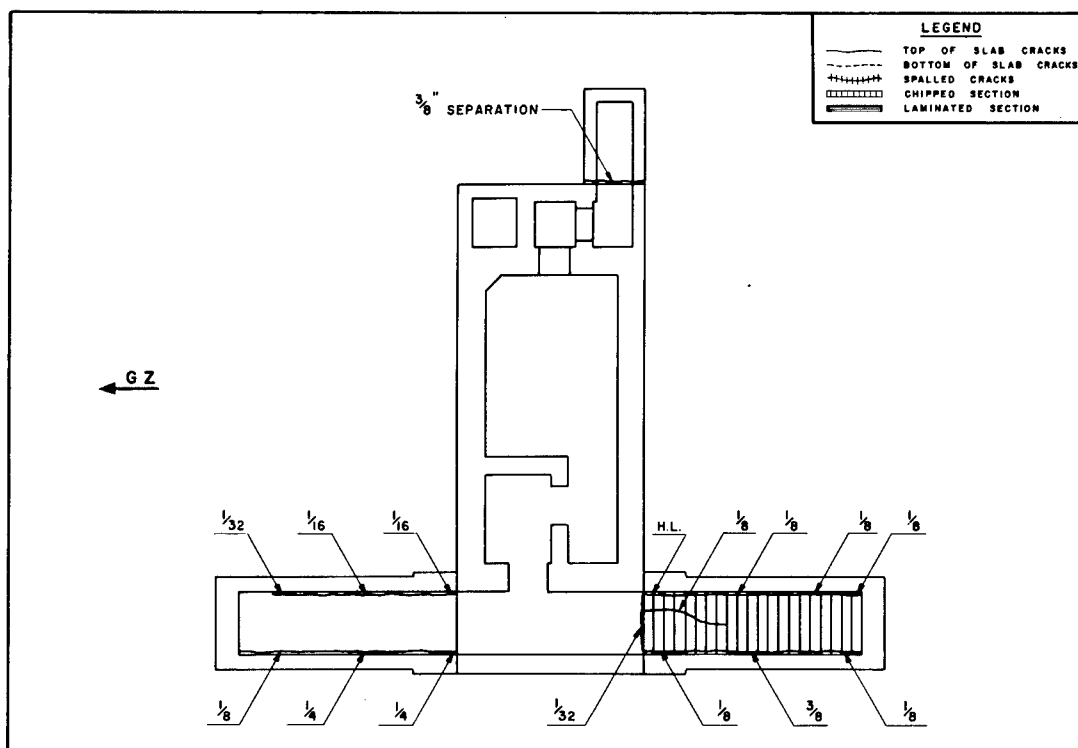
Fig. 3.55—Floor-slab crack pattern (structure RAd).

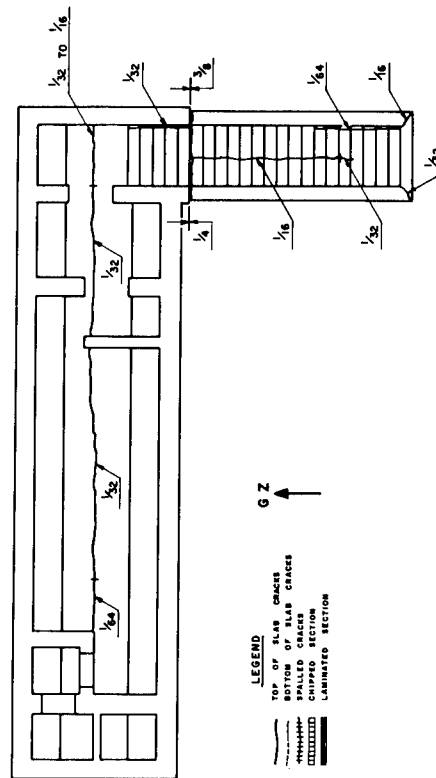
Fig. 3.59—Floor-slab crack pattern (structure CAa).

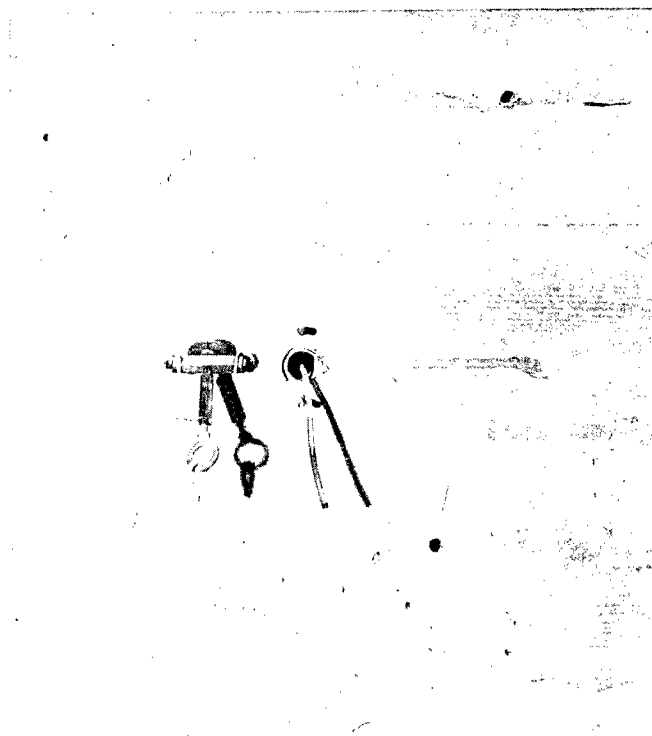
Fig. 3.65—Crack in side of main chamber facing away from GZ (between displacement gauge tie point and Carlson gauge) (structure CAa).

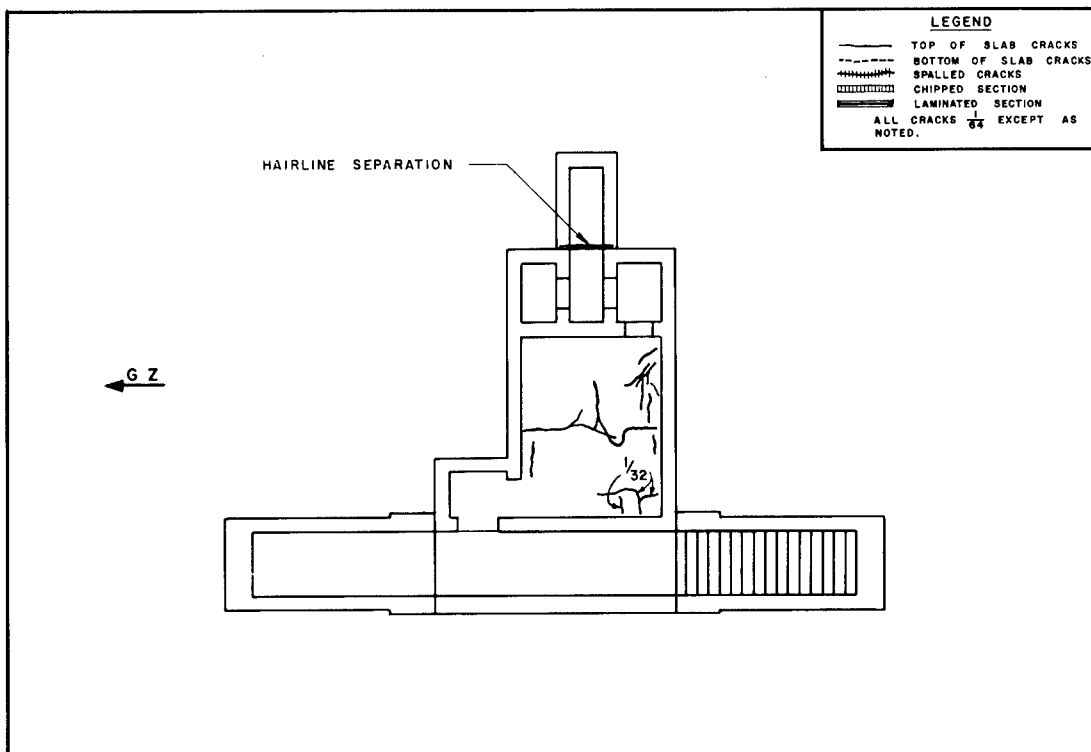
Fig. 3.93—Floor-slab crack pattern (structure RCb).

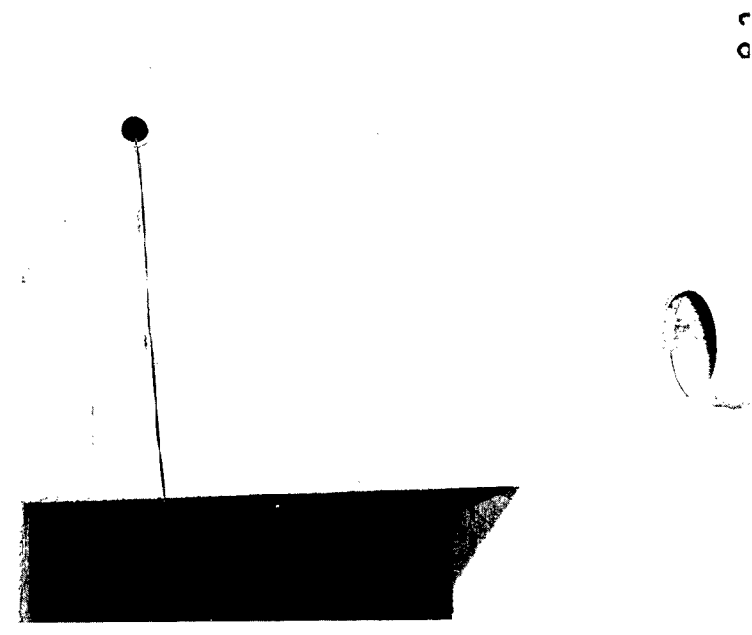
Fig. 3.98—Diagonal cracks above entrance to exit chamber (structure RCb).

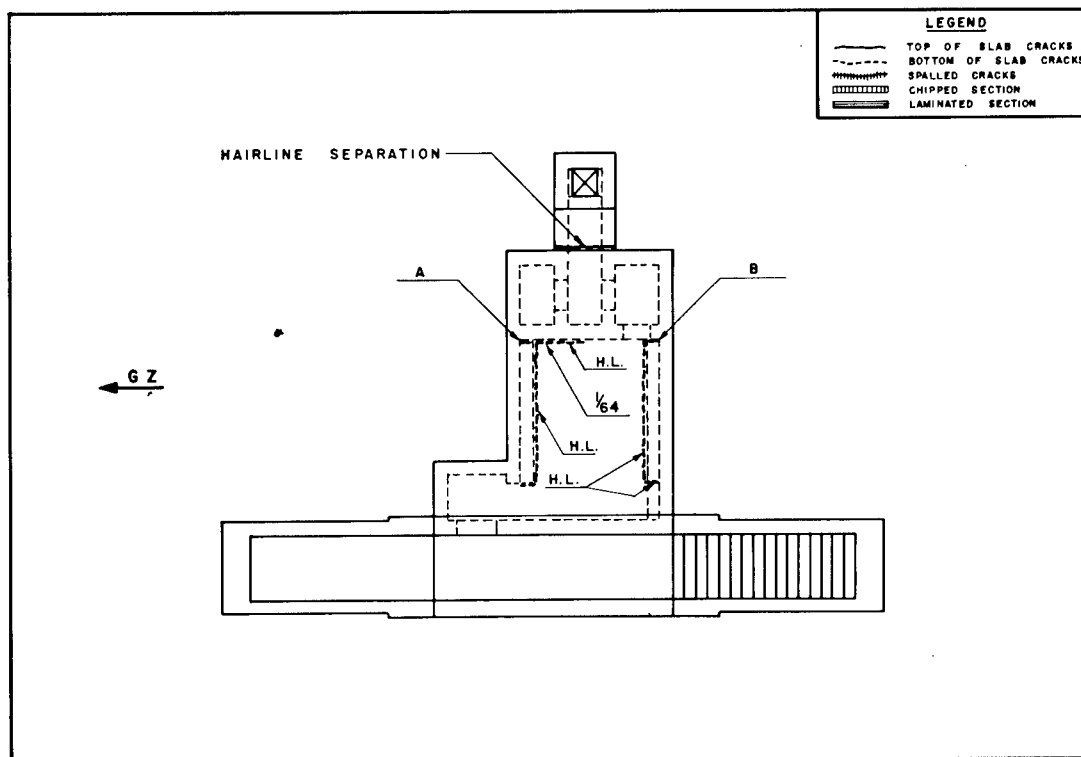
Fig. 3.99—Roof-slab crack pattern (structure RCc).

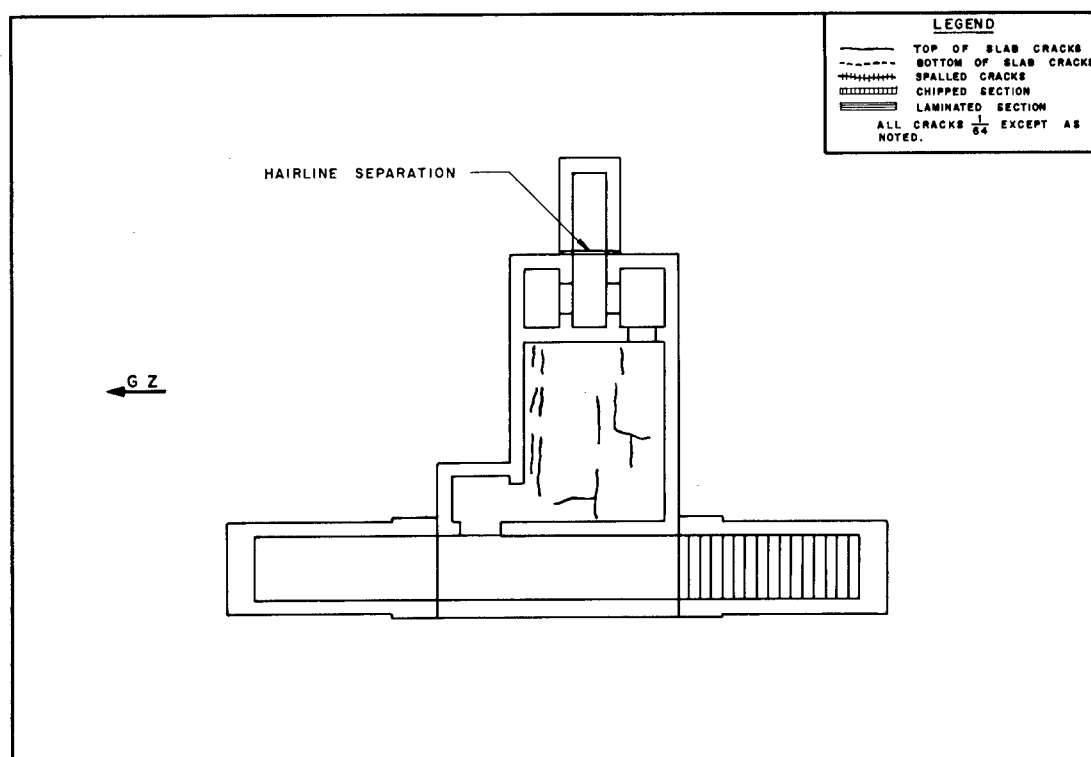
Fig. 3.100—Floor-slab crack pattern (structure RCc).

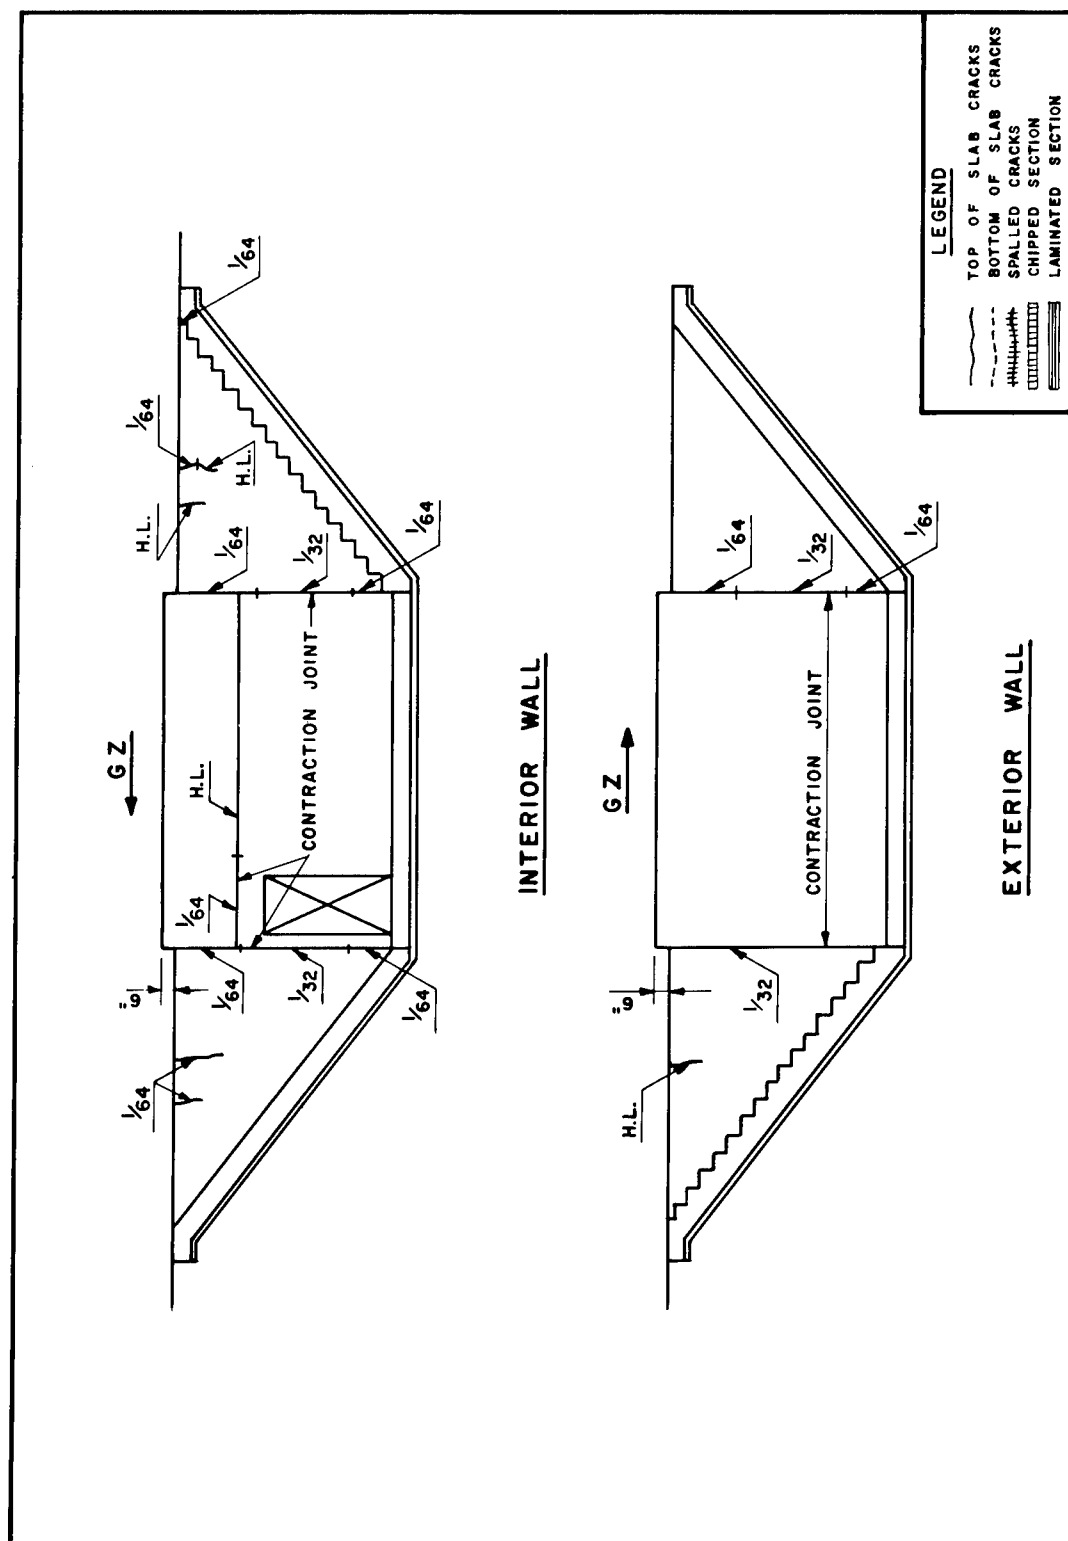
Fig. 3.101—Entrance crack pattern (structure RCc).
