**(CAVITATION DAMAGE OF MECHANICAL  
PUMP IMPELLERS OPERATING IN  
LIQUID METAL SPACE POWER LOOPS)**

*by R. S. Kulp and J. V. Altieri*

Prepared under Contract No. NAS 3-2541 by  
PRATT & WHITNEY AIRCRAFT DIVISION  
UNITED AIRCRAFT CORPORATION  
Middletown, Conn.

CAVITATION DAMAGE OF MECHANICAL PUMP IMPELLERS  
OPERATING IN LIQUID METAL SPACE POWER LOOPS

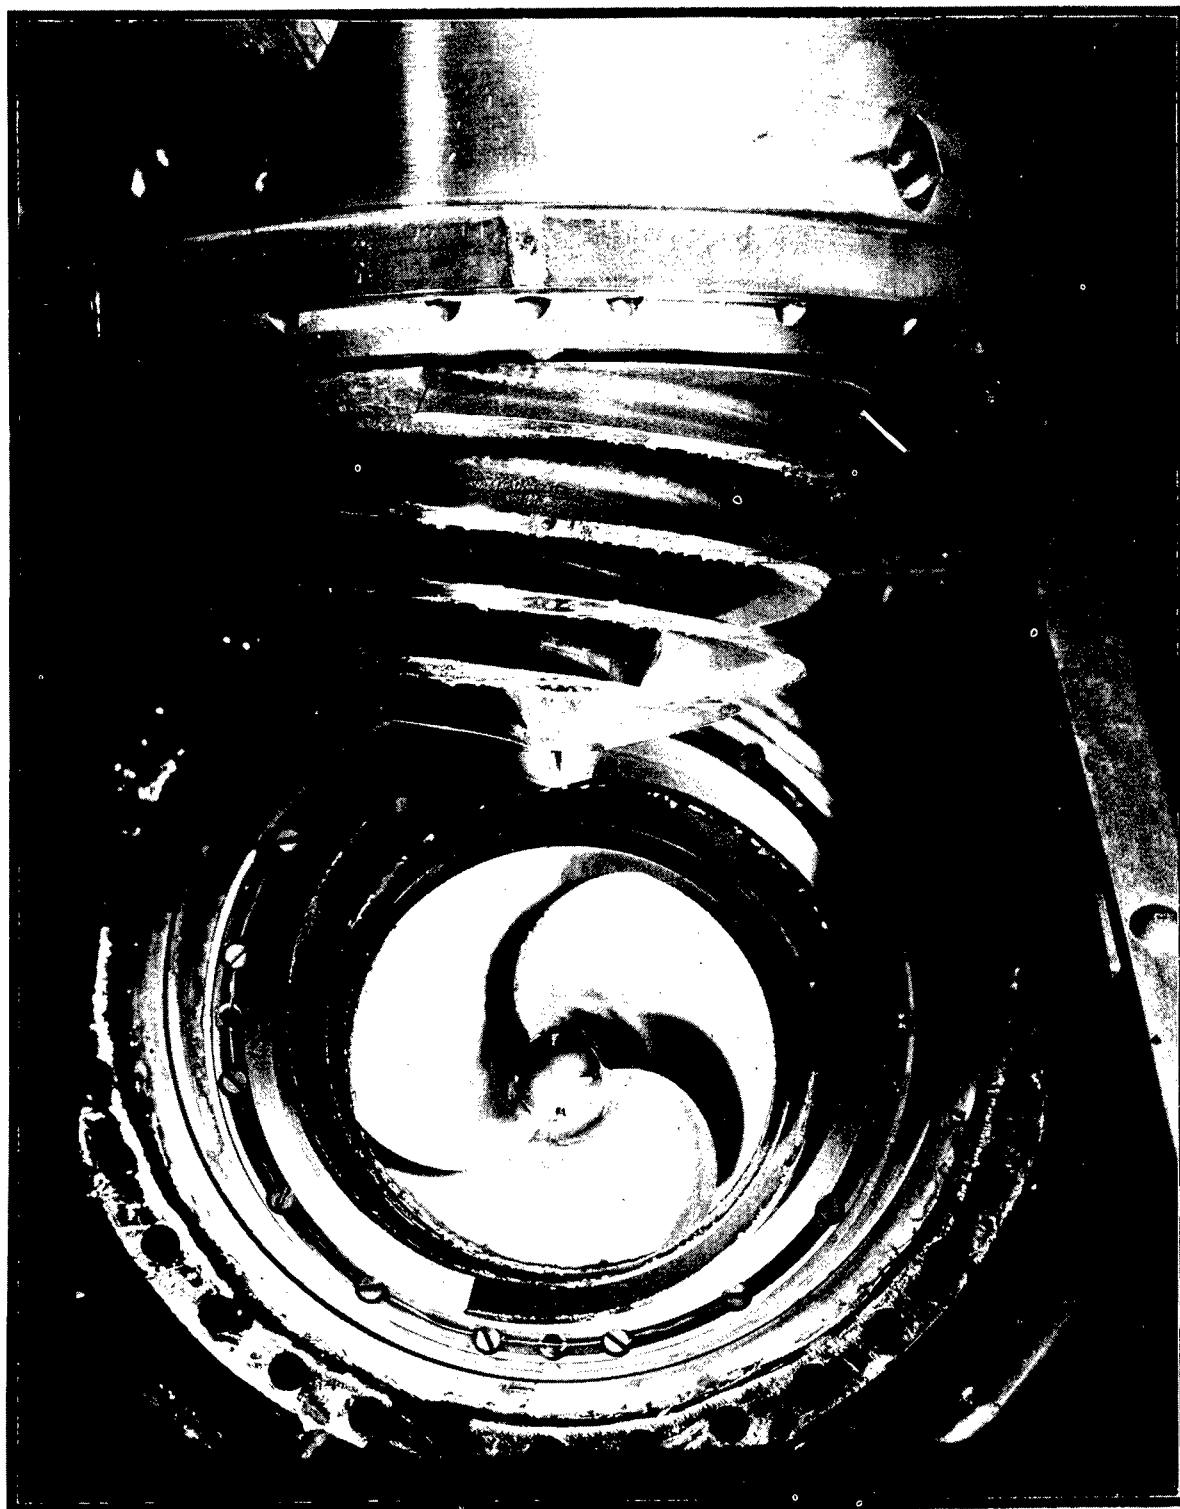
FIG 49

When the turbopump was removed from the test loop, it was immediately apparent that the cause of increased vibration was rubbing contact between the impeller and scroll insert. A photograph of the impeller shortly after removal from the scroll is shown in Fig. 49. Two views of the impeller were obtained in this figure by placing a mirror at an angle under the pump. Several areas of cavitation damage were also noted, one of which can be seen in Fig. 49.

IMPELLER DAMAGE AS SEEN AFTER LIQUID METAL TEST

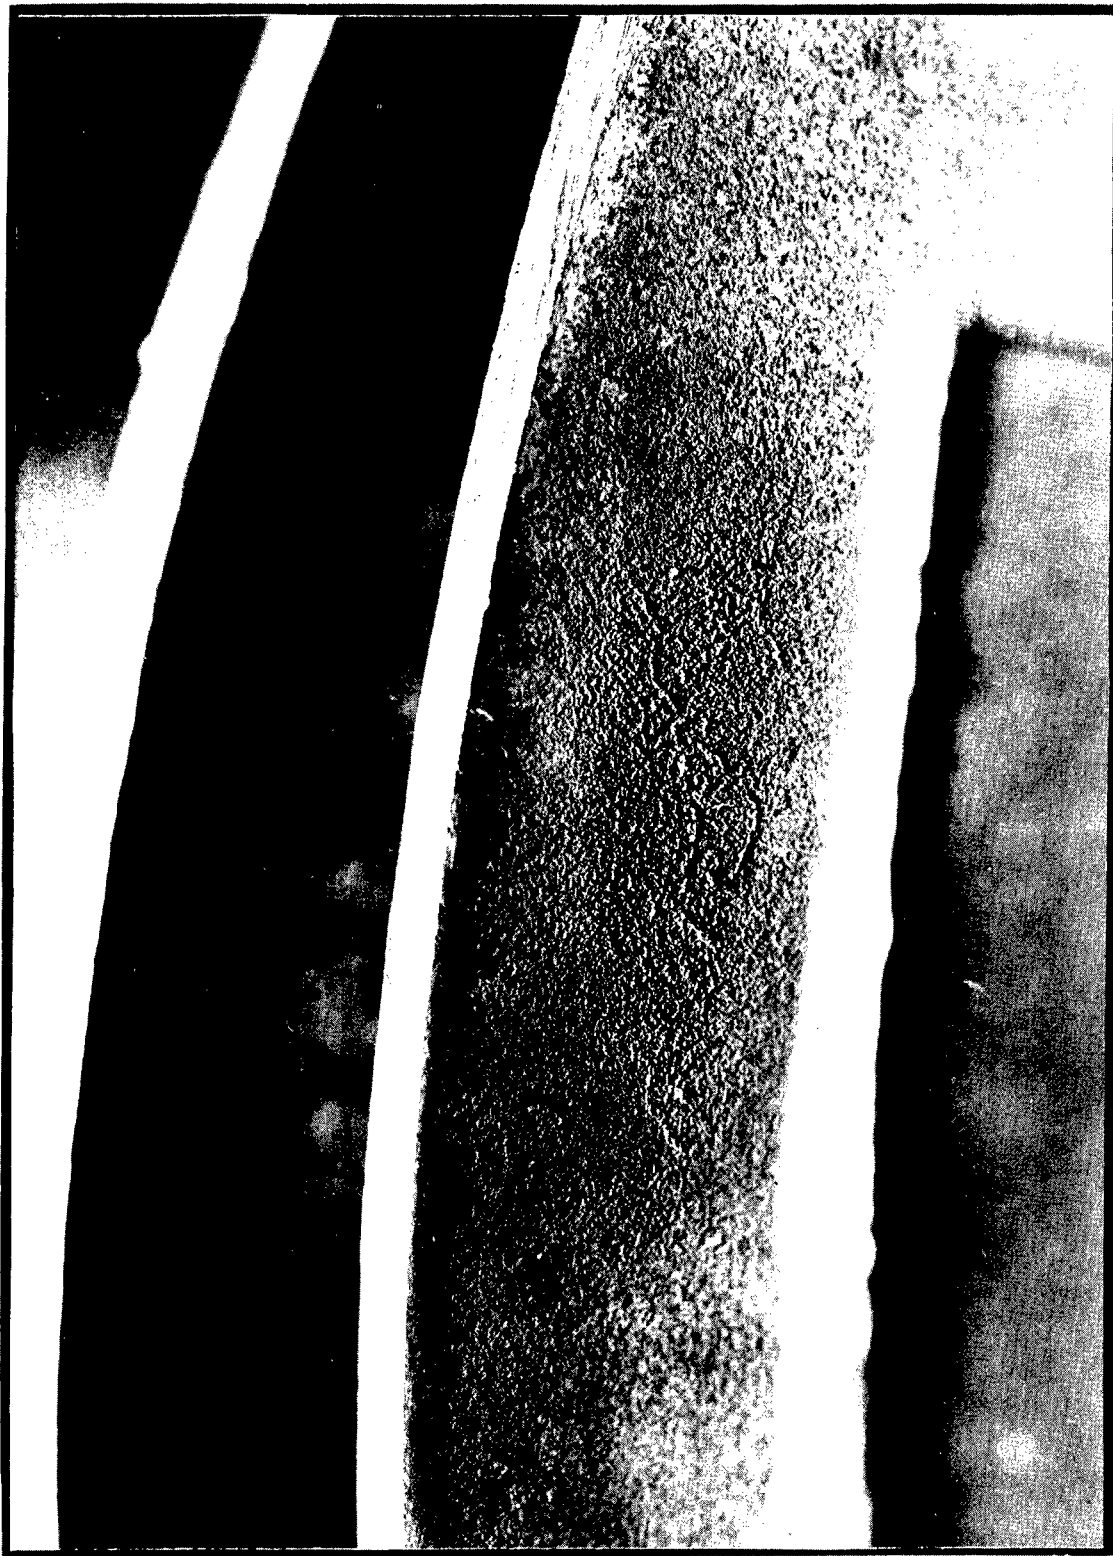
CAVITATION DAMAGE ON VANE 1

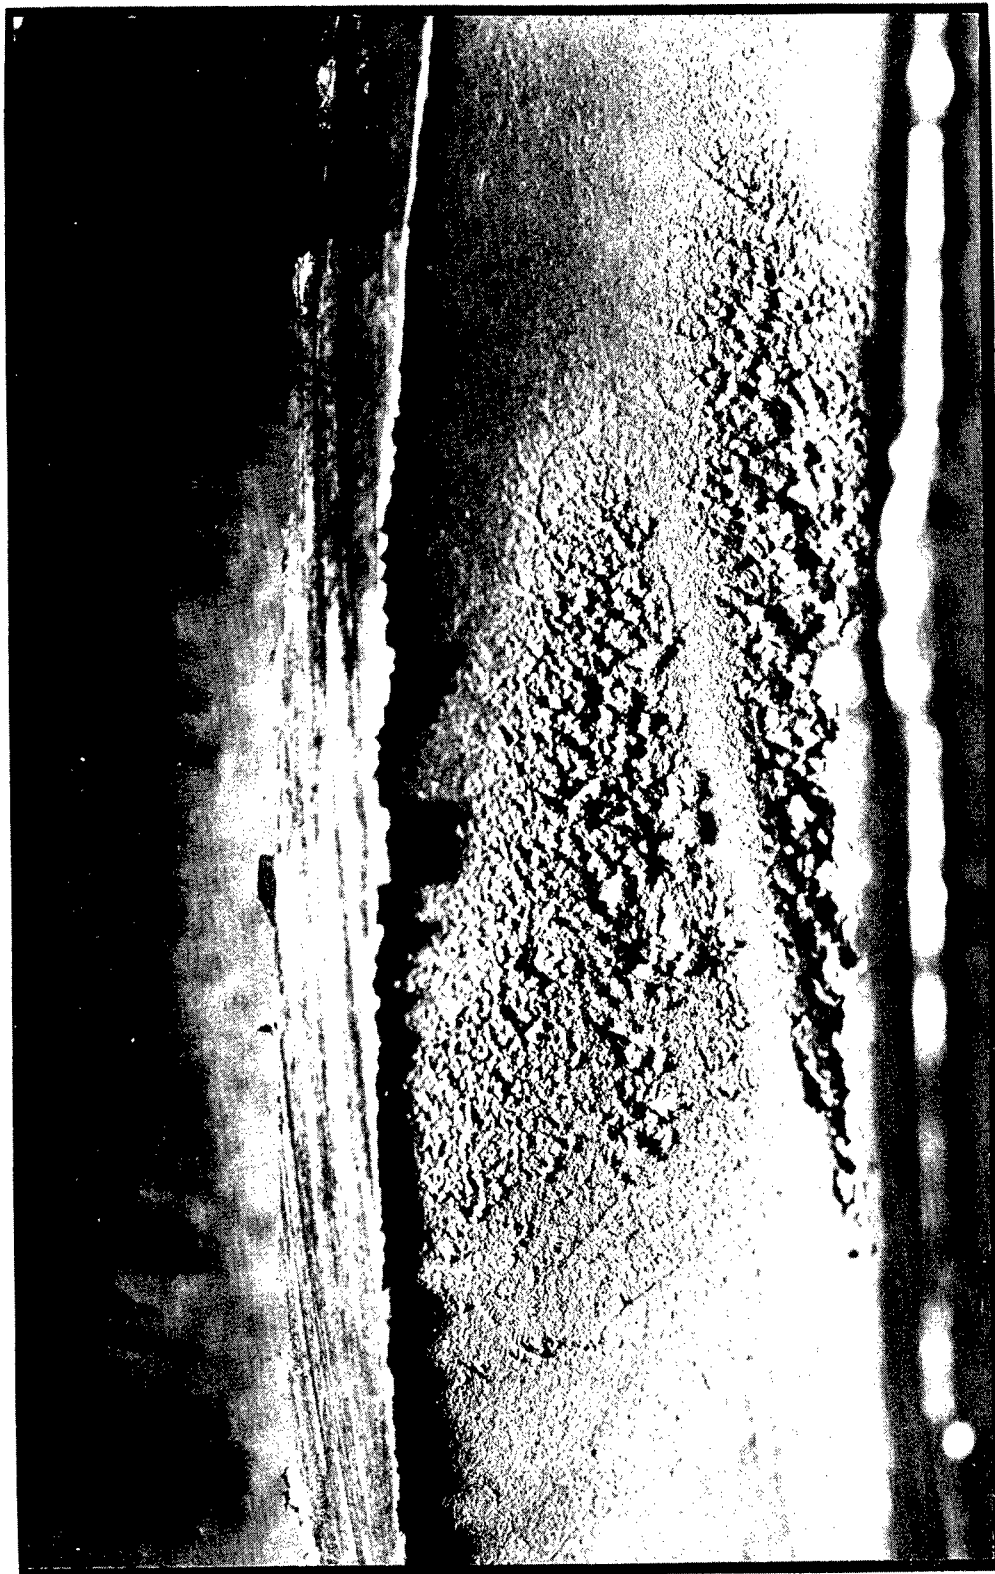
FIG 55

CAVITATION DAMAGE ON VANE 2

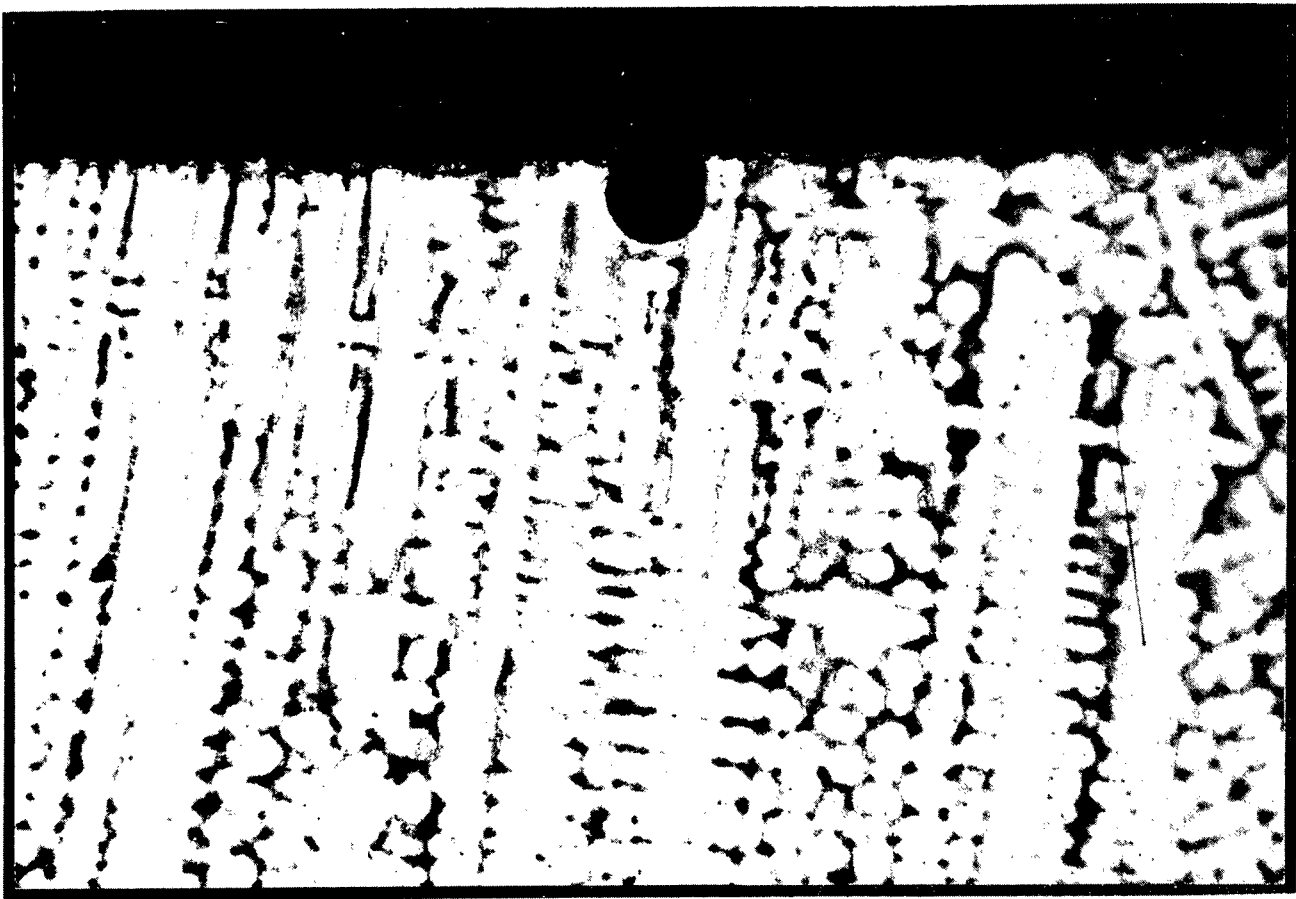
FIG 67

SMALLER PIT OF FIG. 65 IN CROSS SECTION

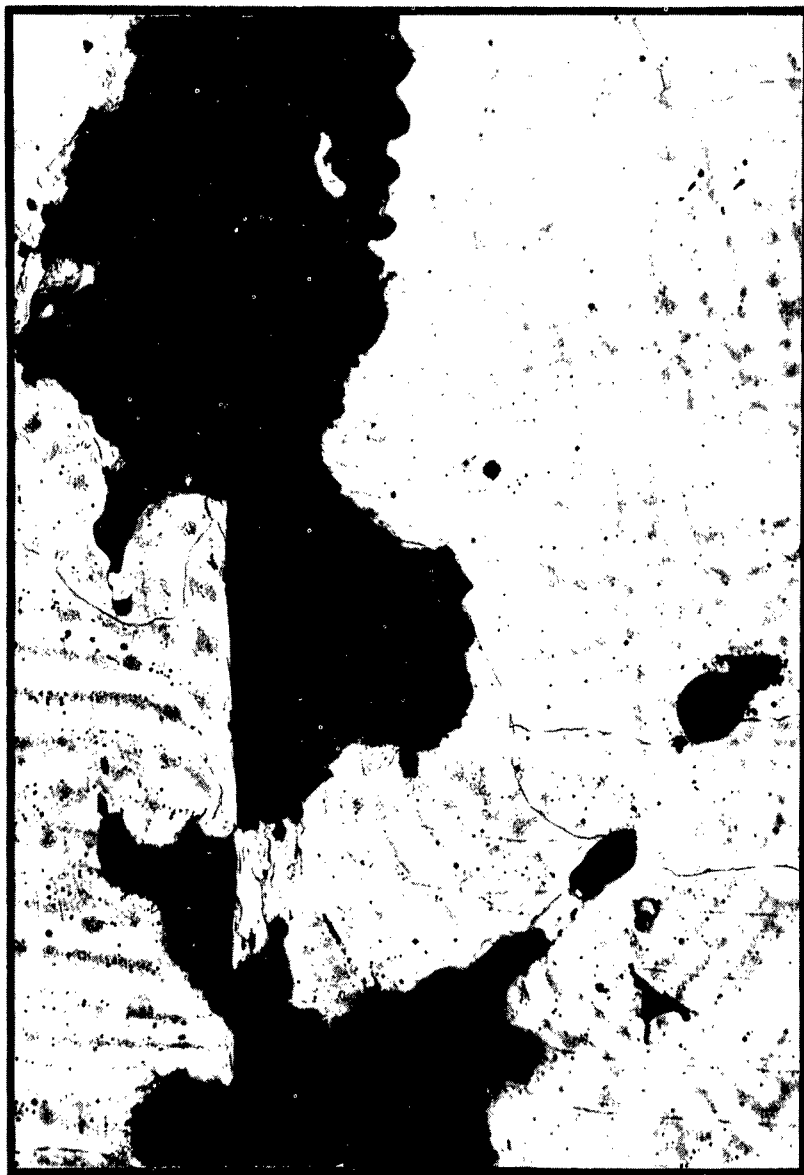
FIG 71

PHOTOMICROGRAPH OF VANE 2 CAVITATION DAMAGE

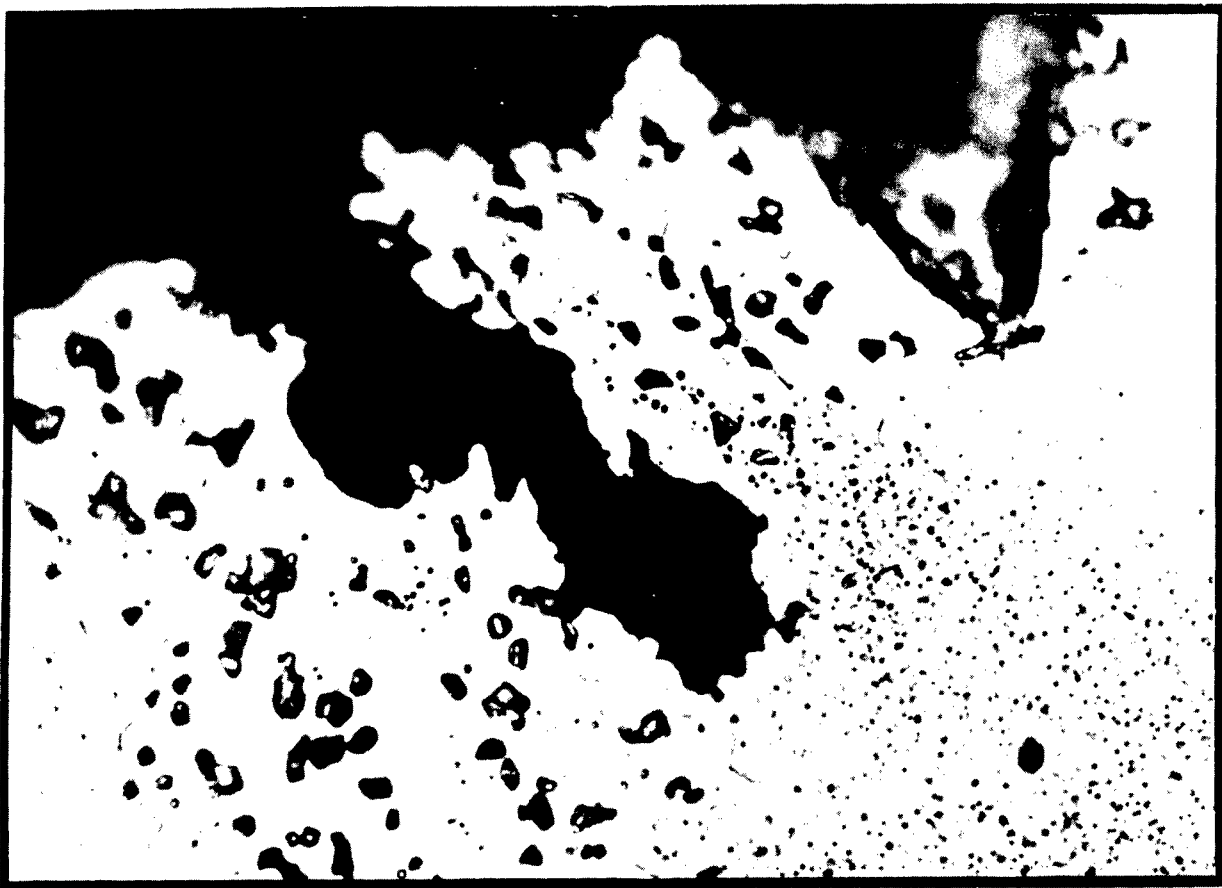
FIG 73

PHOTOMICROGRAPH OF VANE 2 CAVITATION DAMAGE  
AT 2000X
