AIRCRAFT ACCIDENT REPORT

RUNWAY OVERRUN DURING LANDING
AMERICAN AIRLINES FLIGHT 1420
MCDONNELL DOUGLAS MD-82, N215AA
LITTLE ROCK, ARKANSAS
JUNE 1, 1999

**NTSB/AAR-01/02
PB2001-910402
Notation 7195A
Adopted October 23, 2001**

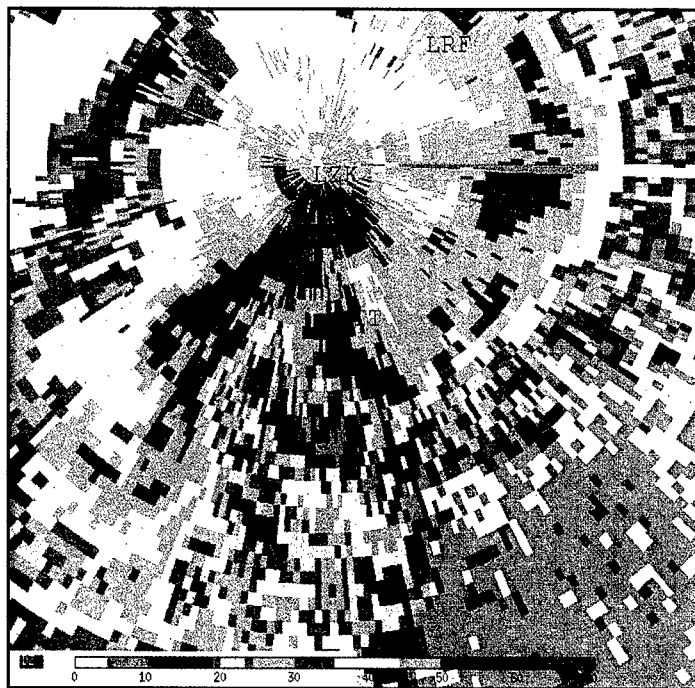
Figure 9. 0.4° Base Reflectivity Scan at 2345:57

The WSR-88D's 0.4° elevation scan of base reflectivity that was completed at 2345:57 indicated that the area over the airport and the approach end of runway 4R reached reflectivities of 54 dBz, or level 5 (intense) activity, and that the area approximately 5 miles west of runway 4R reached maximum reflectivities of 61.5 dBz, or level 6 (extreme) activity. Figure 9 shows the base reflectivity product for this time period.

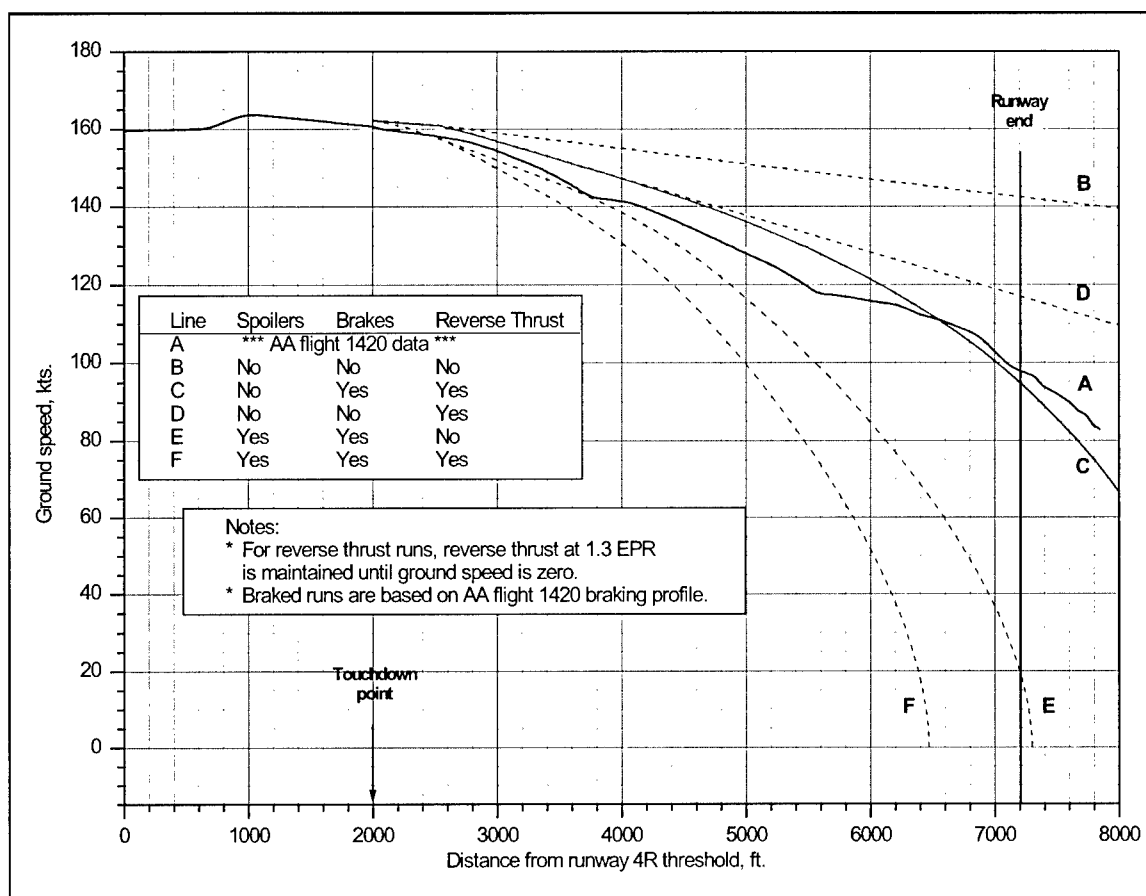
Figure 16. Effects of Spoilers, Brakes, and Reverse Thrust on Stopping Distance

With no braking, spoilers, or reverse thrust, the airplane would depart the runway with a ground speed of about 142 knots, which is 45 knots faster than the flight 1420 airplane. With no spoilers or brakes but with a constant, symmetrical reverse thrust at 1.3 EPR, the airplane would leave the runway at 117 knots, which is 20 knots faster than the flight 1420 airplane. With no spoilers but with 1.3 EPR reverse thrust and the flight

1420 braking profile, the airplane would have departed the runway at 95 knots. This computer run matched the flight 1420 data best and indicated that the accident airplane experienced a braking coefficient of at least 0.21 to 0.23 at speeds between 160 and 140 knots, respectively.⁹⁶ Figure 16 shows the results of the computer runs compared with the flight 1420 profile.

Two additional computer runs demonstrated that proper spoiler deployment is critical to deceleration and stopping distance. Without reverse thrust and with the spoilers deployed and the flight 1420 braking profile, the airplane would depart the runway at 20 knots, which is 75 knots less than the airplane with no spoilers but with reverse thrust and braking. With constant reverse thrust, deployed spoilers, and the flight 1420 braking profile, the airplane could have stopped about 700 feet before the end of the runway.
