Failure Analysis of Three Si₃N₄ Balls

1 December 2001

M. J. O'BRIEN
Space Materials Laboratory
Laboratory Operations

6. AUTHOR(S) M. J. O'Brien and N. Presser			5d. PROJECT NUMBER		
			5e. TASK NUMBER		
			5f. WORK UNIT NUMBER		
7. PERFORMING ORGANIZATION NAME(S) AND ADDRESS(ES) The Aerospace Corporation Laboratory Operations El Segundo, CA 90245-4691			8. PERFORMING ORGANIZATION REPORT NUMBER TR-2001(8565)-1

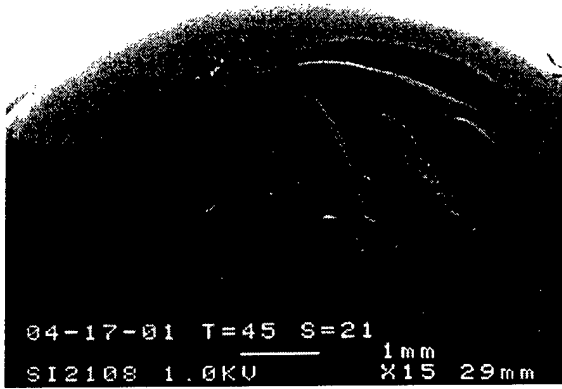
Fig 1

Figure 1 is a low-magnification view of the entire spall from a perspective perpendicular to the spall. The circular Wallner lines seem to radiate on the left and right from an initiation site labeled "A," with the concave sides of the Wallner lines pointing back towards this initiation site. The site labeled "A" is a broad, flat "plateau."

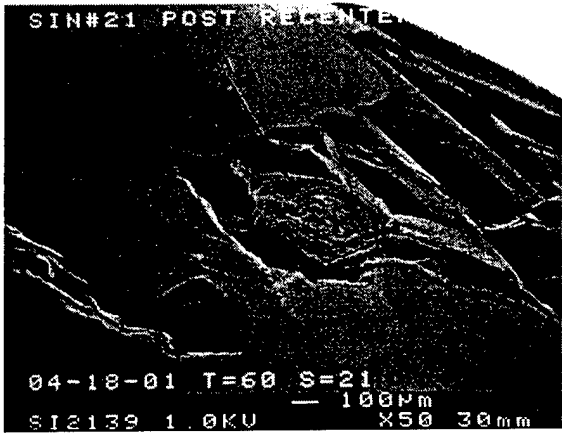
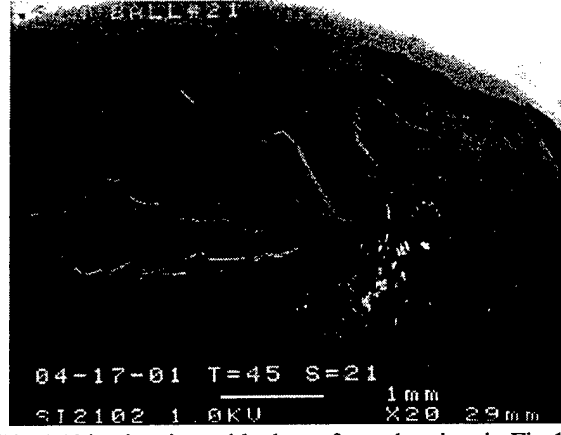
Figure 2 is another low-magnification view centered on site "A" showing the neighboring Wallner lines more distinctly. Figure 3 is a slightly higher magnification view at 50x centered to the right-hand side of the site "A" and Figure 4 is a companion view at 20x centered to the left-hand side of the site "A." Figures 3 and 4 are taken at oblique angles to highlight the concave Wallner lines, which again point back towards the site "A," which is therefore identified as the initiation site.

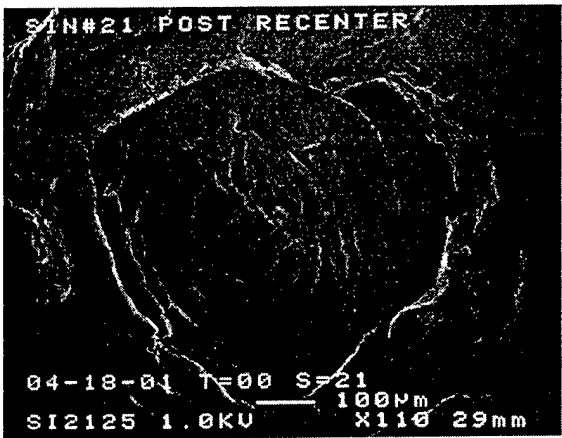
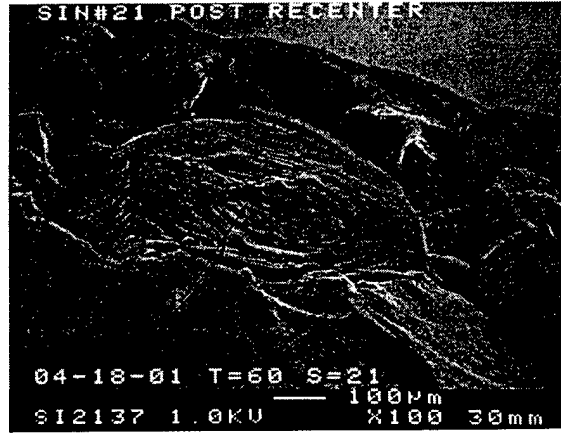
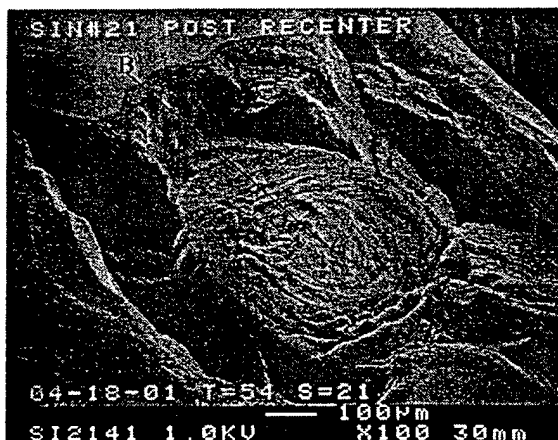
Figures 5, 6, and 7 are a series (at magnifications of 110x, 100x, and 100x) centered on the site "A." Figure 5 is from an orthogonal perspective, and Figures 6 and 7 from oblique perspectives. The circular Wallner lines seen in site "A" form a "bull's eye" pattern around a central point, labeled "B," which is within the region labeled "A" and approximately in its center. The pattern of Wallner lines implies that site "B" is the upstream location where failure initiated.

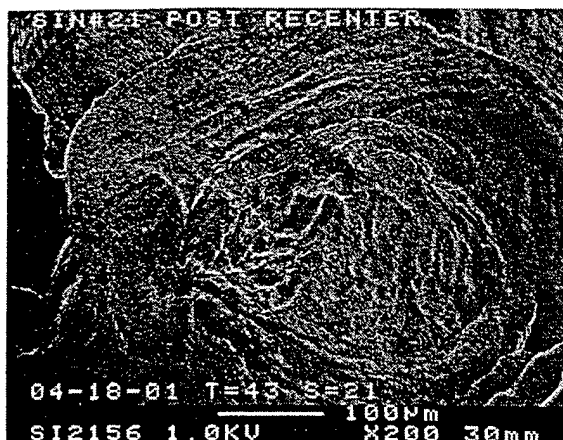
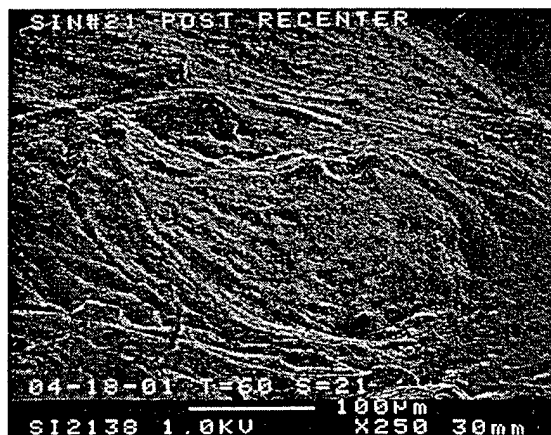
Figures 8 and 9 are views at 200x and 250x centered at site "B." Detailed inspection of site "B" at still higher magnifications did not seem to reveal a clear cause for the initiation of the fracture on site "B."

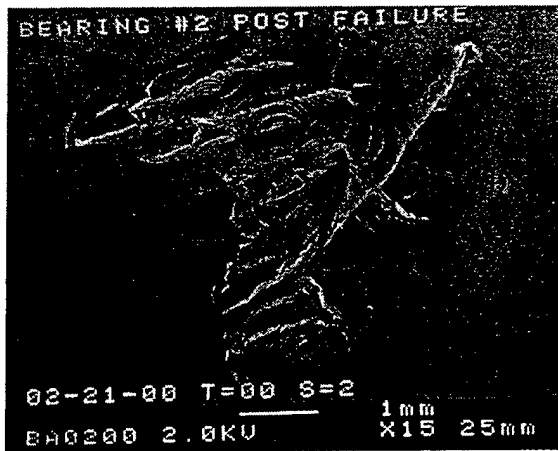
Fig 10.

Figure 10 is a low-magnification view of the entire spall from a perspective orthogonal to the spall. The circular Wallner lines are evident in the upper and middle parts of the spall, and the concave lines seem to radiate back to a point in the lower part of the spall. To orient the discussion of subsequent fractographs that show finer detail, four features are labeled in Figure 10. Feature "A" is a region of Wallner lines in the middle of the spall. Feature "B" is a region of Wallner lines in the lower part of the spall. Feature "C" is a void in a triangular pocket defined by the intersection of three cracks. The long diagonal line labeled "D" is a deep "trench-like" fracture that is not obvious from this perspective.

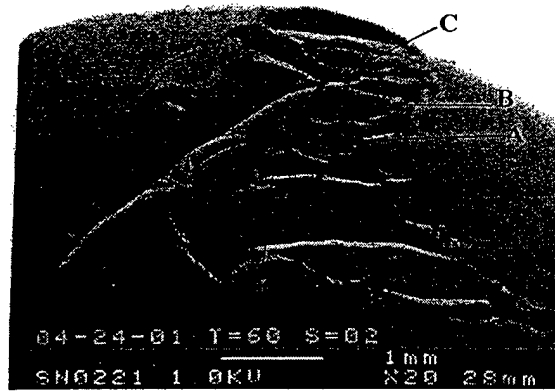
Fig 11

Figure 11 is a low-magnification oblique view showing better the Wallner lines in the upper region of the spall. Features "A" and "B," which are the regions of Wallner lines, are labeled and reinforce the observation that the upstream location of the fracture initiation is in the lower part of the spall with the middle and upper parts of the spall downstream from the initiation site. The location of the void

is labeled "C," although the triangular pocket is not obvious in this view. The long and deep fracture, labeled "D," is more obvious in this view. An interesting feature, labeled "E," is a patch of virgin surface that did not spall away.

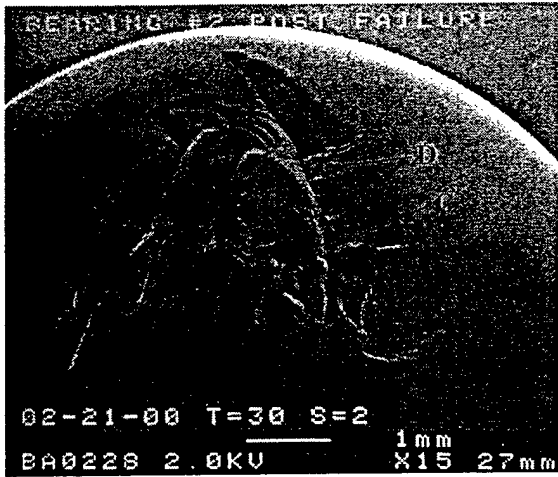
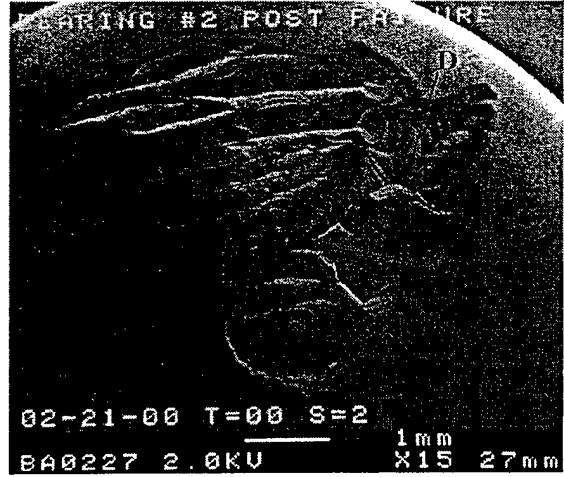
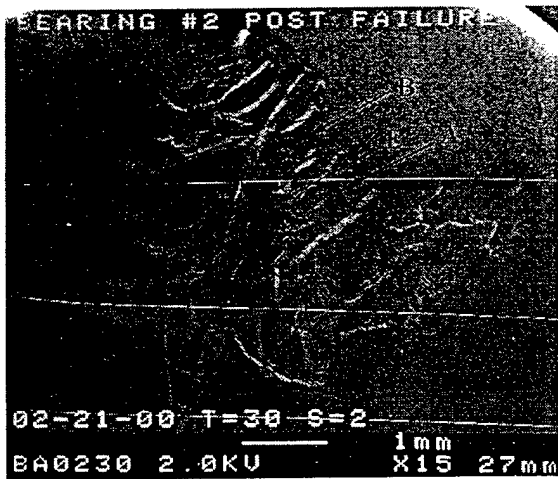
Figures 12, 13, and 14 are low-magnification views taken by successively rotating the line of sight. The concavity of the regions of Wallner lines, labeled "A" and "B," again reinforce that fracture initiation occurred in the lower part of the spall. The location of the void, labeled "C," is labeled in the lower part of the spall. The deep fracture, labeled "D," is seen to intersect the void. Actually, these three views cumulatively show that three separate fractures intersect at the void. To provide a landmark, the location of the unspalled virgin surface is labeled "E."

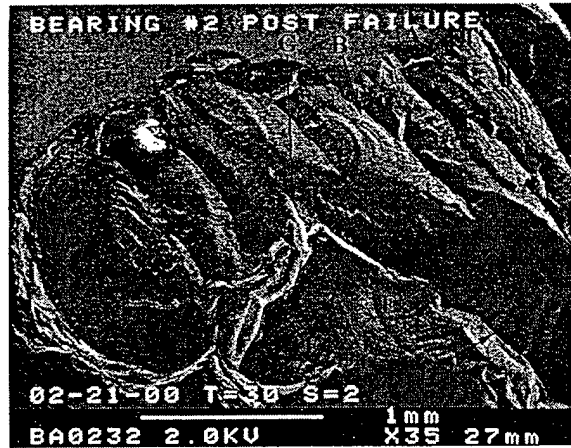
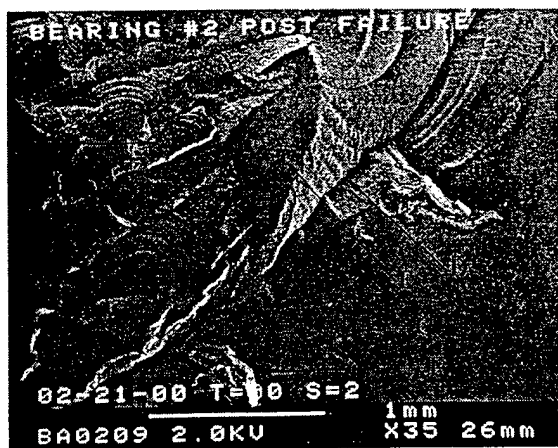
Figures 15 and 16 are orthogonal views of the lower part of the spall at higher magnifications. The Wallner lines, labeled "A" and "B," show that fracture initiated between region "B" and the lowermost part of the spall. That is, region "A" is downstream of region "B," which, in turn, is downstream of the site of fracture initiation. Void "C" is located in this area upstream of the region "B" and is considered a possible candidate responsible for initiation of the spall. The deep crack, "D," radiates from the void, as do two other cracks, labeled "F" and "G".

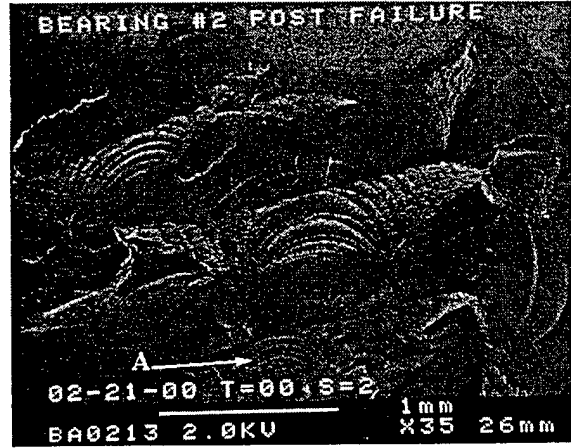
Fig 17

Figure 17 is an higher magnification orthogonal view of the middle and upper parts of the spall. The Wallner lines labeled "A" are visible, although the other region of Wallner lines, "B," is just beneath the lower edge of the frame and is not visible. Again, the concave sides of the Wallner lines point upstream to the site in the lower part of the spall where fracture initiated.

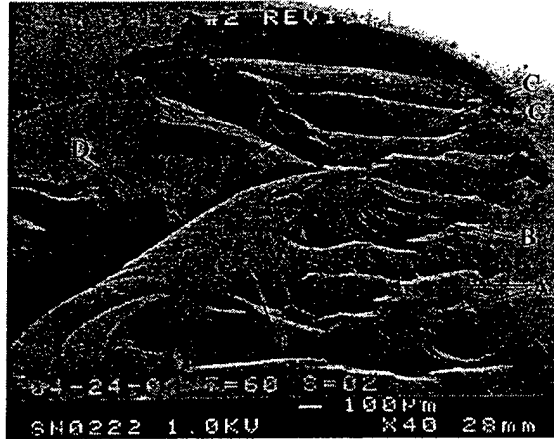
Fig 18

Figure 18 is an oblique view taken from a line of sight from the upper part of the spall. The Wallner lines, "A" and "B," are labeled. The void, "C," is not visible, but its location is labeled. The three cracks, "D", "F," and "G," are seen to be radiating from the location of the void. As a landmark, the unspalled spot of virgin surface is labeled "E".

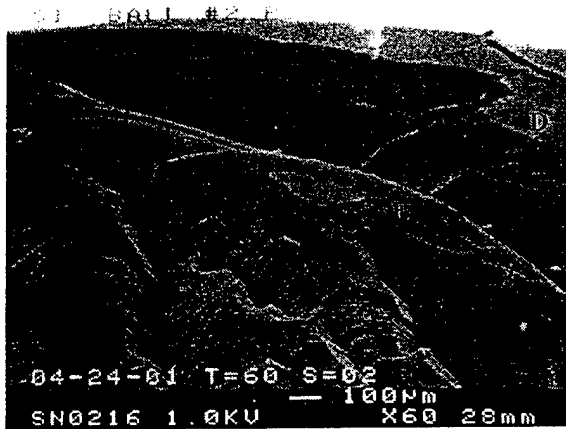
Fig 19

Figure 19 is an oblique view of the middle part of the spall whose line of sight is rotated from the line of sight used in Figure 18. The Wallner lines, "A" and "B," and the unspalled spot, "E," are labeled. The deep crack, "D," is seen running diagonally across the back of the fractograph.

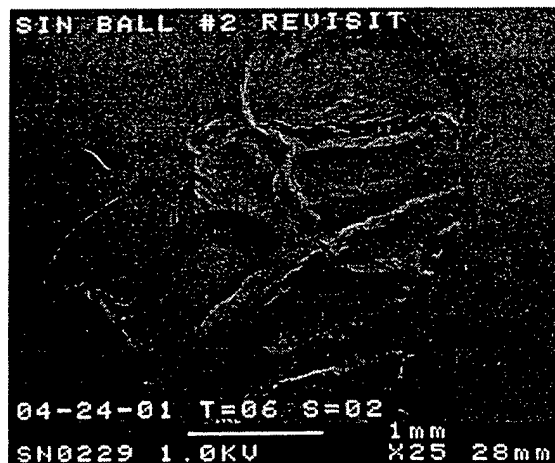
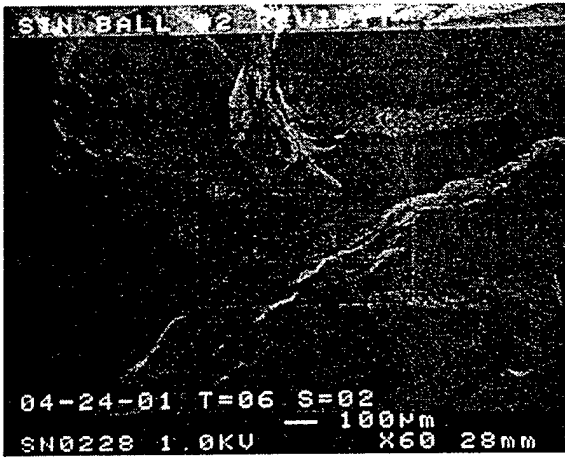
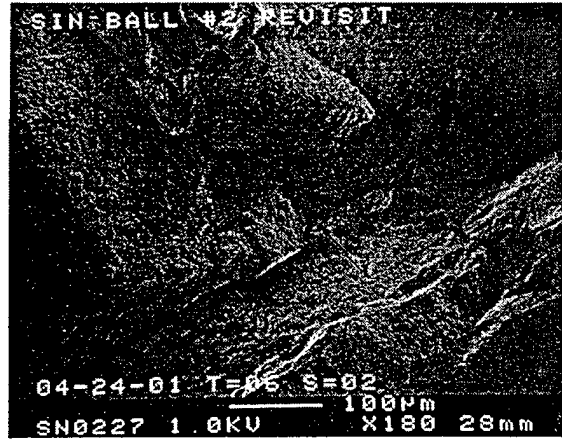
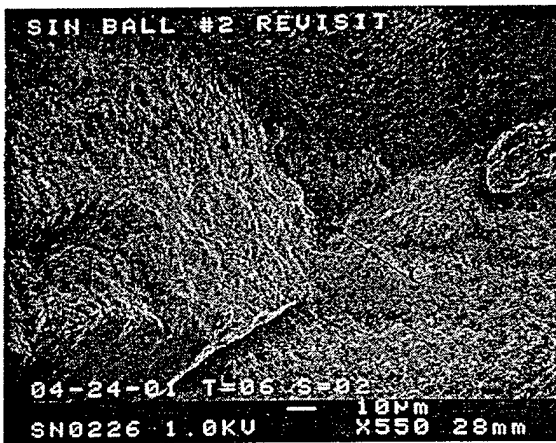
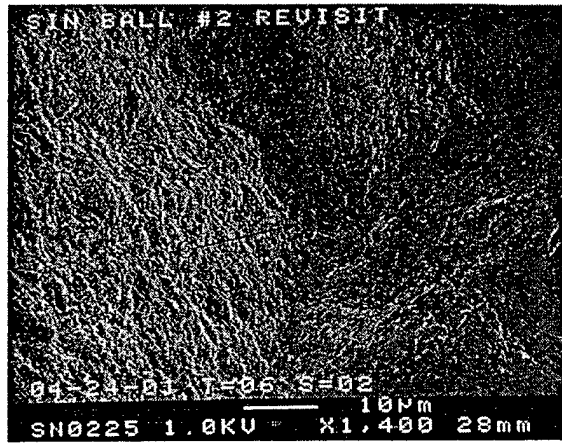
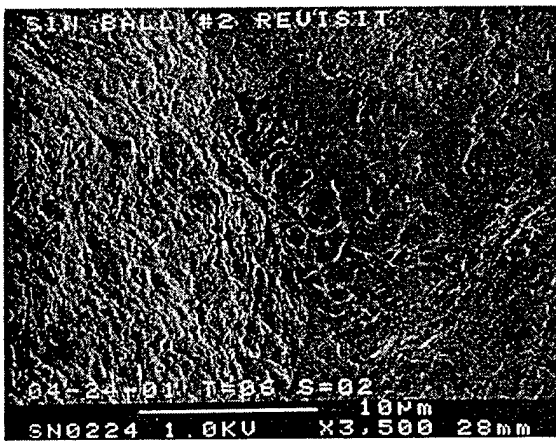
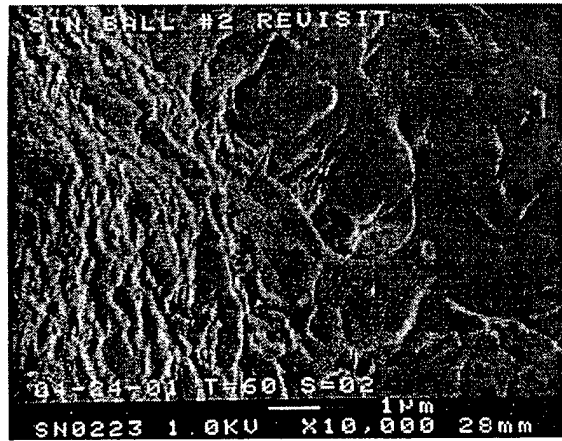
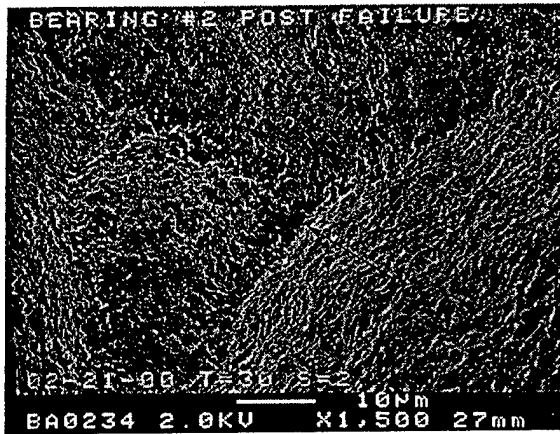
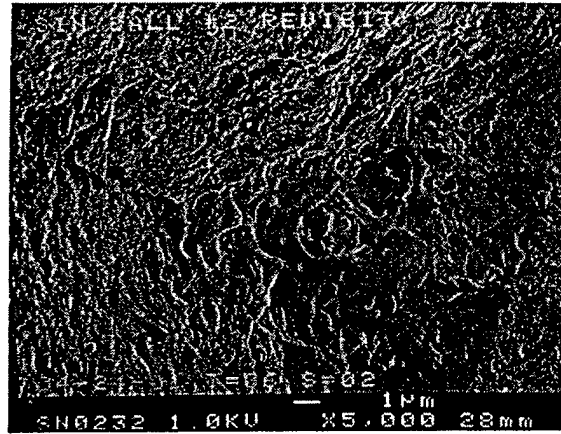
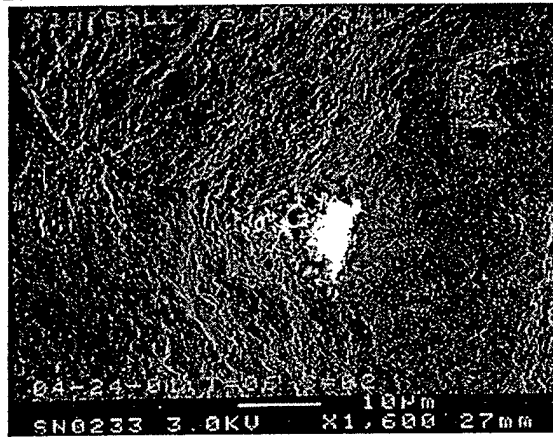
Figures 20, 21, 22, 23, 24, 25, and 26 are progressively higher magnification views (at 25x, 60x, 180x, 550x, 1400x, 3500x, and 10,000x, respectively) from an orthogonal perspective and centered on the void, "C," which is at the junction of the three cracks, "D," "F," and "G." Figure 27 is a view of the void at 1500x from a different perspective that "sights" down the bore of the void. Figure 28 is a view at an intermediate magnification of 5000x from still another perspective. Figure 29 is a micrograph at a slightly higher accelerating voltage, 3 kV, that shows that the region immediately around the void charges, although material further away does not.

The void, which is approximately 2 μm in diameter, sits in a triangular region whose appearance differs from the fracture surface around it, which is seen most clearly in Figures 25, 26, and 28. This change in appearance may imply that the triangular region is not the same chemistry as the material around it. For example, the region may be a pocket of segregated glassy material at the triple junction between adjacent grains of crystalline Si_3N_4 . The observation that the triangular region charges implies that the region has a higher electrical resistivity than the material around it. A higher electrical resistivity is consistent with a pocket of glassy material rich in the sintering aids used in this Si_3N_4 . The glassy sintering aids might be expected to be more insulative than the bulk Si_3N_4 ceramic.

Alternatively, the change in appearance might imply that the triangular region possessed a different history than the material around it during the fracture process. For example, if the void does happen to represent the initiation of the spall, then the region may be the site where a sub-critical pre-crack developed and slowly grew by fatigue over several million Hertzian loading cycles until it reached the critical size at which the rest of the spall fractured. During the course of the fatigue cycles, asperities may have been smoothed away as the opposing faces of the pre-crack opened and closed, giving the change in appearance compared to the larger fracture surface around it.

It is uncertain, however, whether the void represented the initiation site for the fracture, whether the void developed as damage late in the fracture, or whether the void was unrelated to the fracture. If the void was responsible for fracture initiation, it may be a small sintering pore where the ceramic did not fully densify.

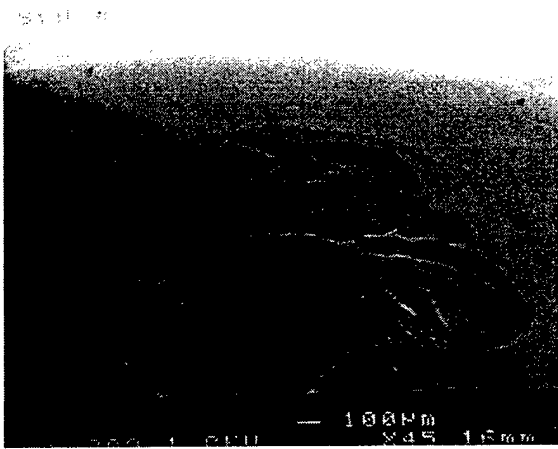
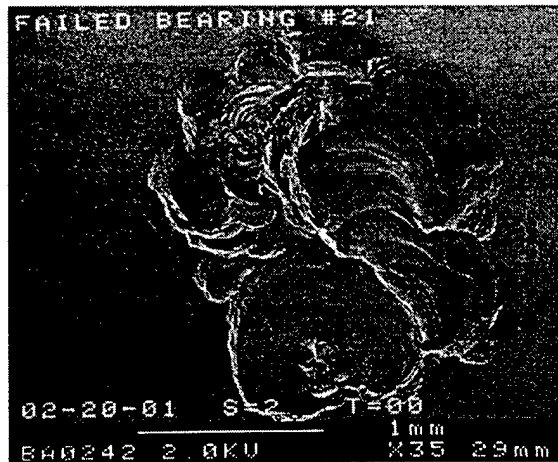
Figures 30, 31, and 32 are low-magnification views of the entire spall. The circular Wallner lines seem to radiate from a failure that originated in a broad, flat "plateau." The Wallner lines radiate down several "stepped" regions, with the concave sides of the Wallner lines pointing back towards the plateau from which the failure seems to have initiated. The concavity reinforces the notion that the plateau is "upstream" in the fracture, and the several stepped regions are "downstream." The feature "C" is labeled in Figure 32 but explained later in this discussion.

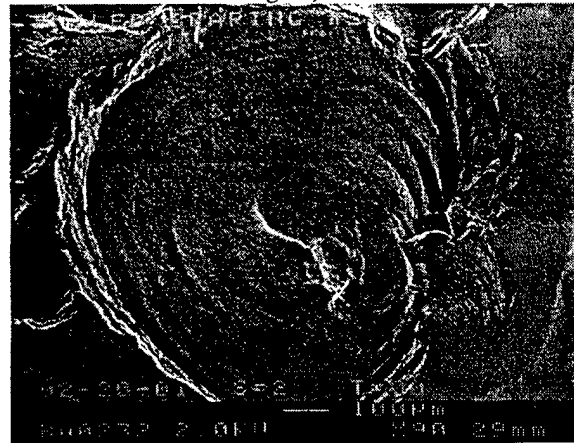
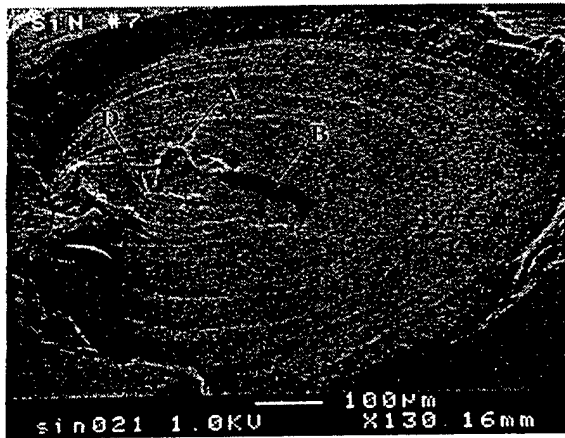
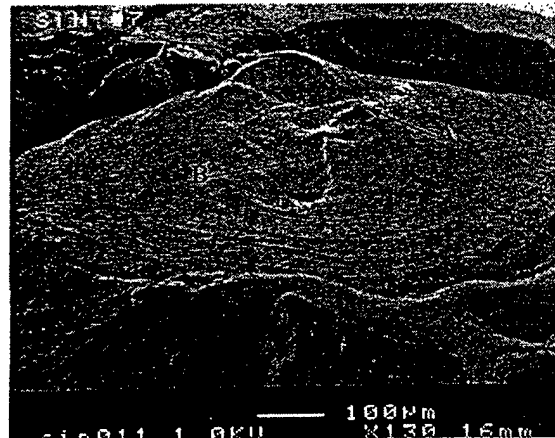
Figures 33, 34, and 35 are higher magnification views of the plateau from which fracture is believed to have initiated. The Wallner lines form a "bull's eye" pattern around a central point. The "thumb-

shaped" feature labeled "A" is a landmark used to orient subsequent discussion. Running off from point "A" is a crack-like feature labeled "B," which charges slightly in Figure 33. Another landmark is labeled "D."

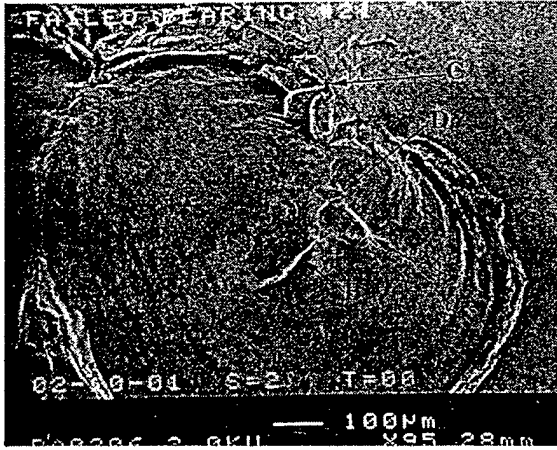
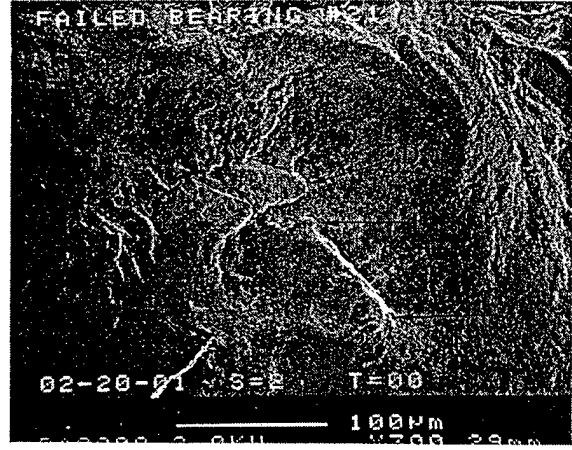
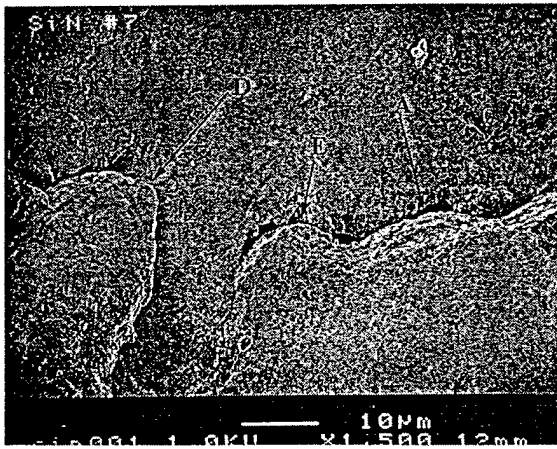
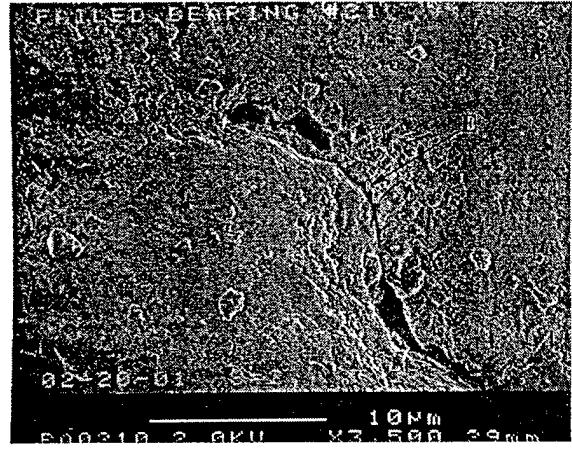
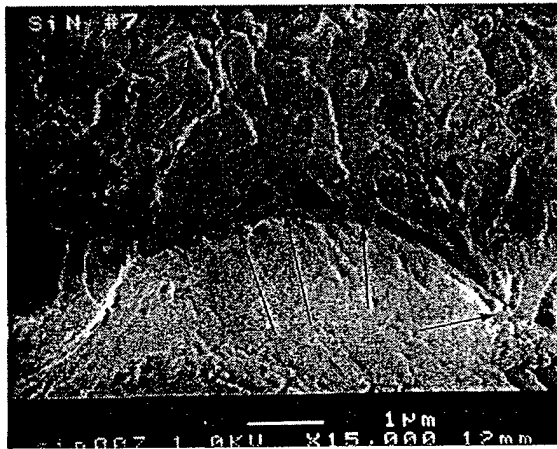
Figures 36, 37, 38, 39, and 40 are progressively higher magnification views (at 95x, 300x, 1500x, 3500x and 15,000x, respectively) of a separate crack-like feature, labeled "E," from an orthogonal perspective. Feature "E" is at the base of feature "A" near feature "D." Feature "A" is labeled in Figures 36, 37, and 38 for orientation. The feature "E" is just inboard of the tightly spaced Wallner lines in the upper right hand corner of Figure 37, which reinforces the notion that feature "E" is in the right location to be the site for fracture initiation.

Figures 39 and 40 show an interesting feature in the crack-like feature "E." Ligaments span the crack-like feature. The ligaments have a distinctive elliptical shape that might be characteristic of the neck that forms during sintering and pore consolidation. The neck's elliptical shape might be interpreted as the negative radius of curvature that forms at the junction between two sintered particles. That is, the ligaments may be the remnants of a string of small sintering voids that did not fully densify. If so, then the ligaments might be expected to be glassy pockets rich in the liquid-phase sintering aids used in this ceramic. It is uncertain, however, whether the ligaments represented the initiation site for the fracture, whether the ligaments developed as damage late in the fracture, or whether the ligaments were unrelated to the fracture.

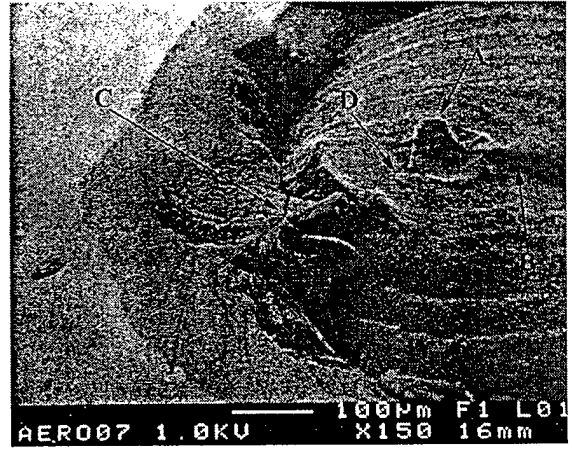
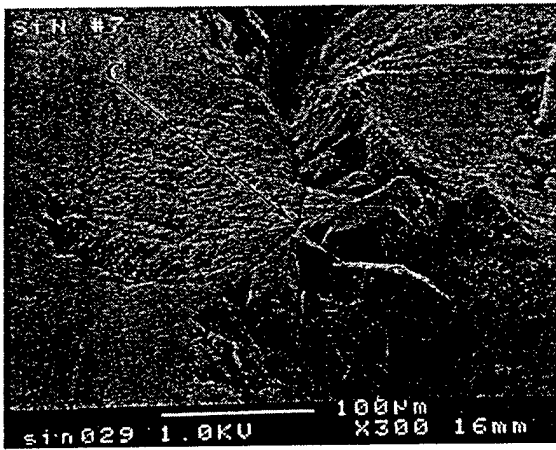
An interesting "star burst" pattern, labeled "C," is visible in Figures 32, 36, 41, and 42. The high-magnification view in Figure 42 shows several cracks radiating from a central "pit." It is uncertain whether the star burst represents the fracture initiation or whether it occurred early or late in the fracture.
