**NBS CIRCULAR 550**

**Mechanical Failures  
of Metals in Service**

For many years the National Bureau of Standards has made examinations of metal parts that have failed in service for evidence bearing on the causes of failure. Thirty-five such cases, representing the most frequently observed types of failures are described, and the factors of design, fabrication, or use contributing to these failures are presented. The characteristics by which the various types of fractures can be recognized are discussed, and recommended precautions that should be observed to reduce mechanical failures of metals in service are included.

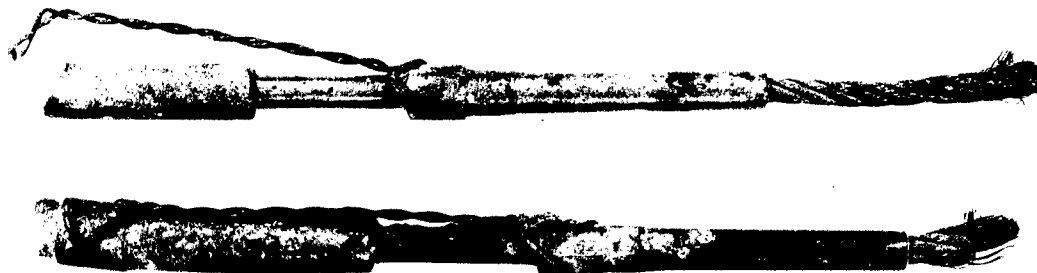
**Case 6:** Turnbuckle from aircraft control system (brass). Removed from an airplane that had been involved in an accident. It was evidently not the primary failure. The part had broken while heated to a very high temperature. The fracture surface shows extremely coarse grains and little ductility. The temperature at the time of failure was sufficiently high to reduce the strength of the grain boundaries in the metal, which resulted in fracture, with little or no ductility.

FIGURE 6.1. Parts of two broken turnbuckles removed from a crashed airplane.  $\times 1$ .

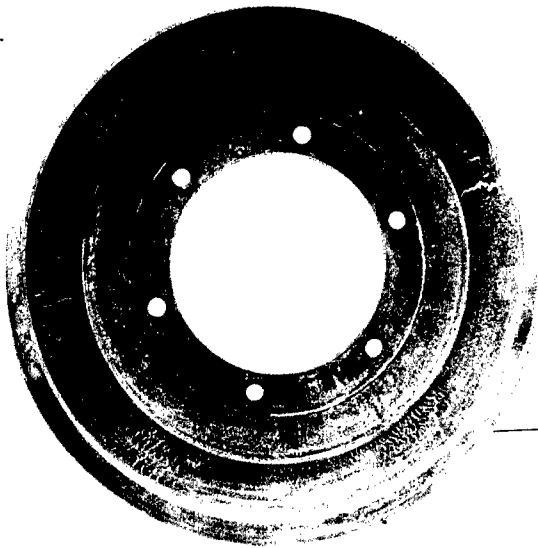
iron to martensite in some spots. As martensite occupies more volume than pearlite, the transformation set up high internal stresses in the metal, which, combined with the applied stress, were sufficient to cause cracking adjacent to the transformed areas. This type of cracking is often referred to as heat checking.

FIGURE 9.1. *Cracked brake drum, as received.*

The cracks are easily visible because of the brake lining material that had been scraped off and forced into them.  $\times \frac{1}{4}$ .

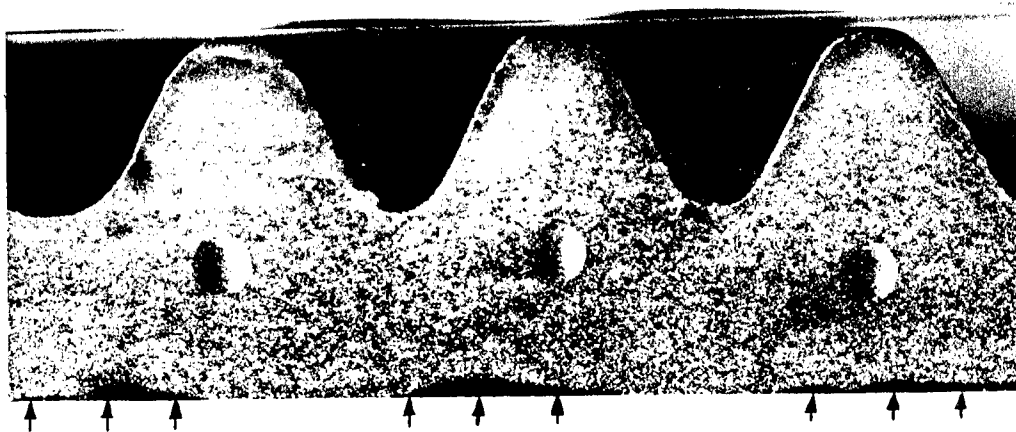
FIGURE 9.2. *Etched section of drum showing numerous transformed areas (dark) indicated by arrows along the inner surface at bottom.*

The hardness of the original material was 265 Vickers, whereas that in the dark areas was as high as 450 Vickers.  $\times 2$ .

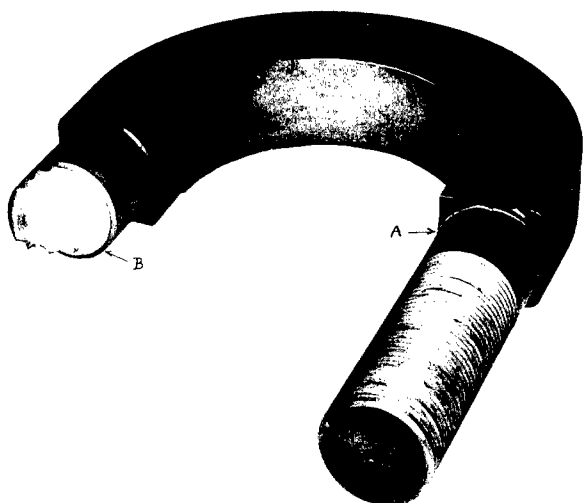
FIGURE 13.1. *Fractured yoke with the initial fracture, A fitted together.*

The fracture at B resulted from the eccentric loading after the initial fracture.  $\times \frac{1}{16}$ .

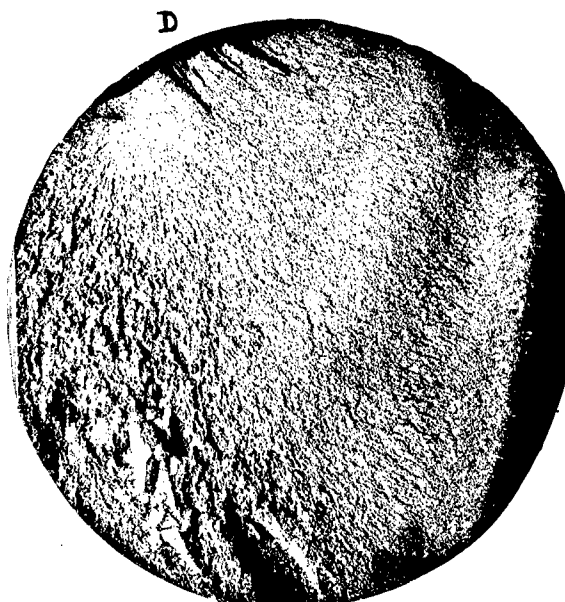
FIGURE 13.2. *Surface of the initial fracture.*

The dark area near D is a crack that occurred during fabrication or heat treatment, and caused the brittle fracture under load. The darkening is due to oxide scale, which shows that the steel was heated to a high temperature after the cracks were formed.  $\times 1$ .

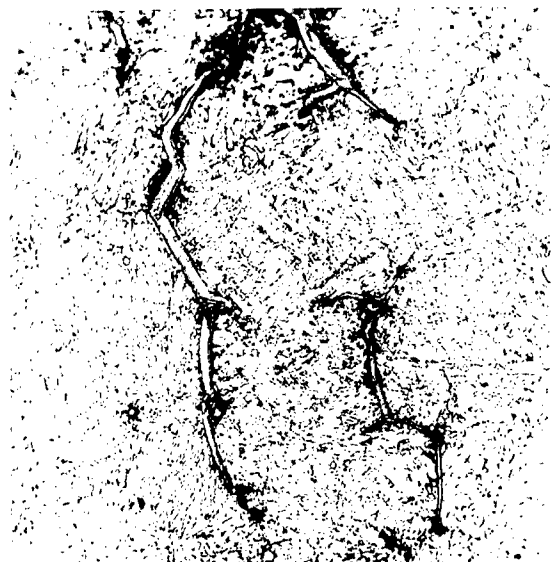
FIGURE 13.3. *Inner end of a crack similar to those which caused the fracture.*

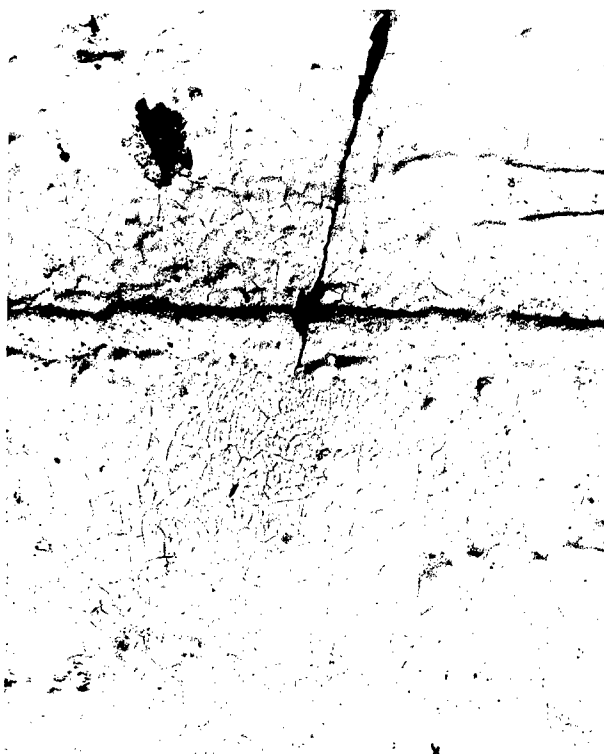
FIGURE 14.3. Area near the end of a fracture.

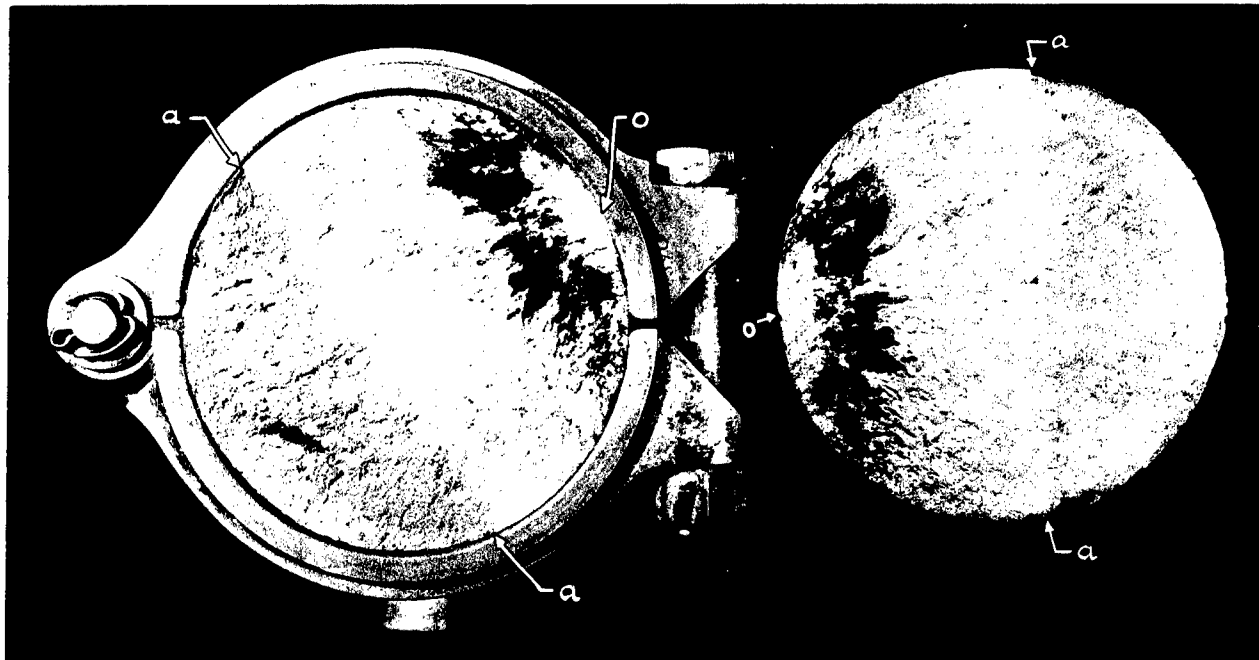
FIGURE 16.1. *Surfaces of the fracture which originated under the hub ring clamp at arrow O.*

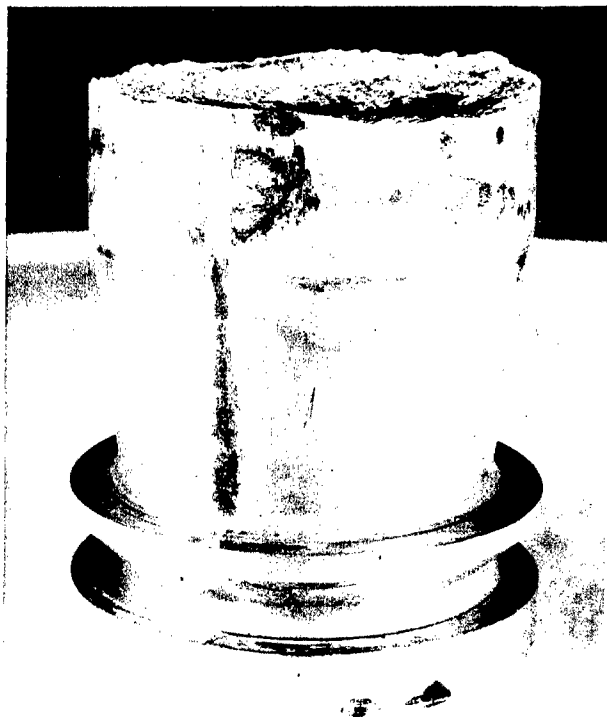
FIGURE 16.2. *Surface of the blade near the origin of the fatigue crack.*

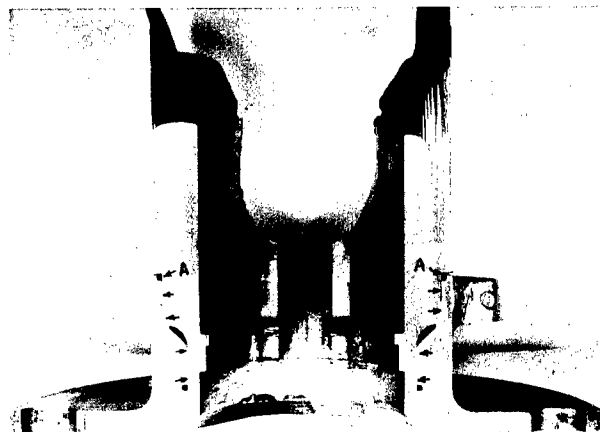
FIGURE 21.2. *Cross section of the hub showing the method of assembly.*

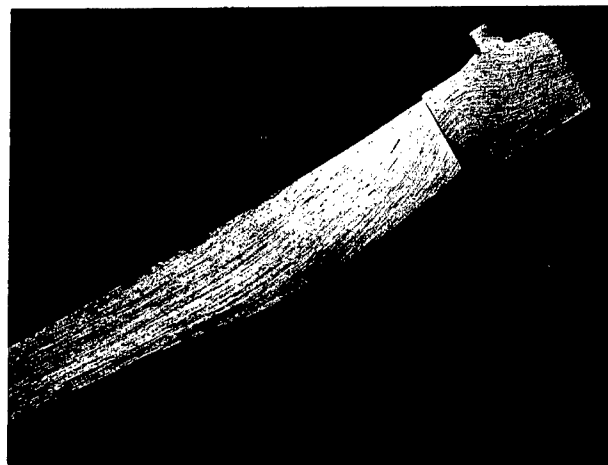
FIGURE 22.4. Longitudinal section of the blade intersecting the fatigue crack.

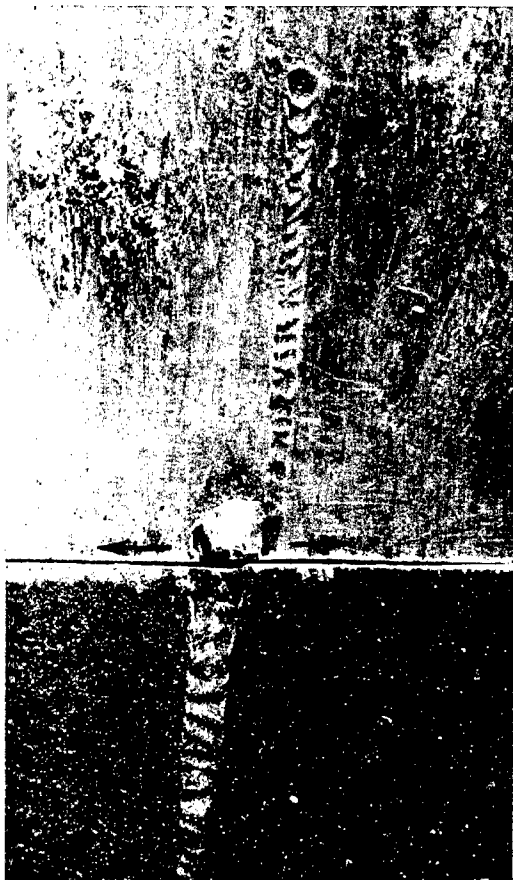
FIGURE 23.4. *Longitudinal section through the defect shown in figure 23.3.*

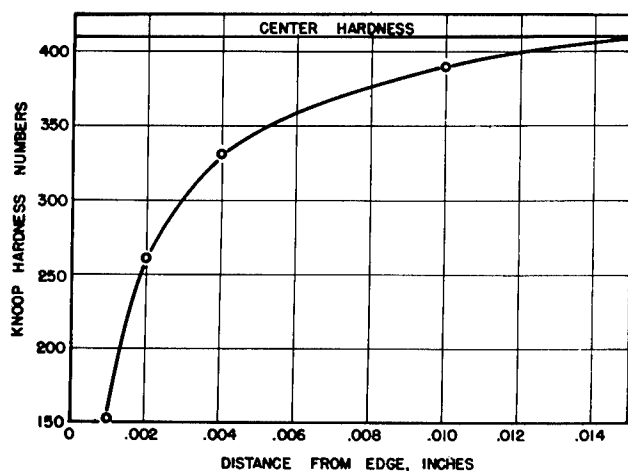
FIGURE 29.3. Results of microhardness measurements made on a cross section of the tube.

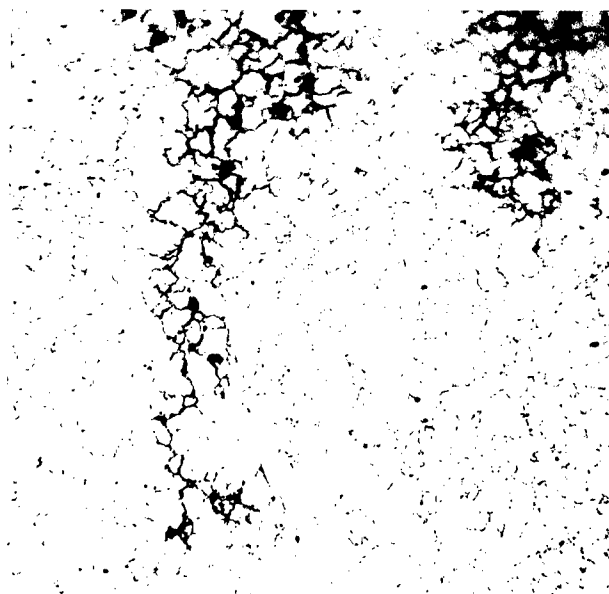
FIGURE 31.3. Transverse section of the plunger near the fatigue fracture.

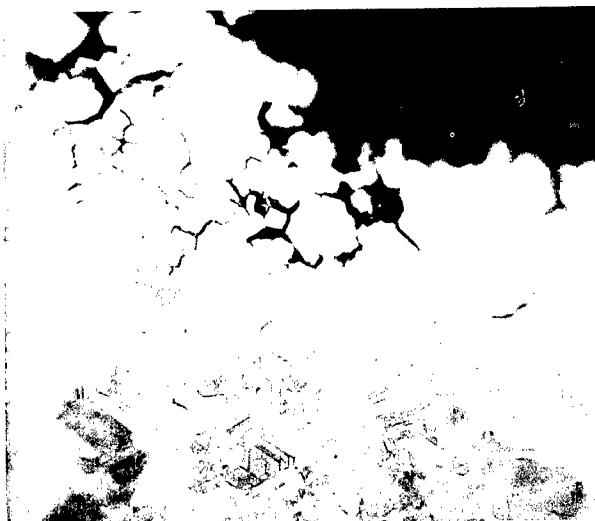
FIGURE 34.2. *Longitudinal section near the fracture, showing the intercrystalline cracks typical of stress-corrosion failures.*

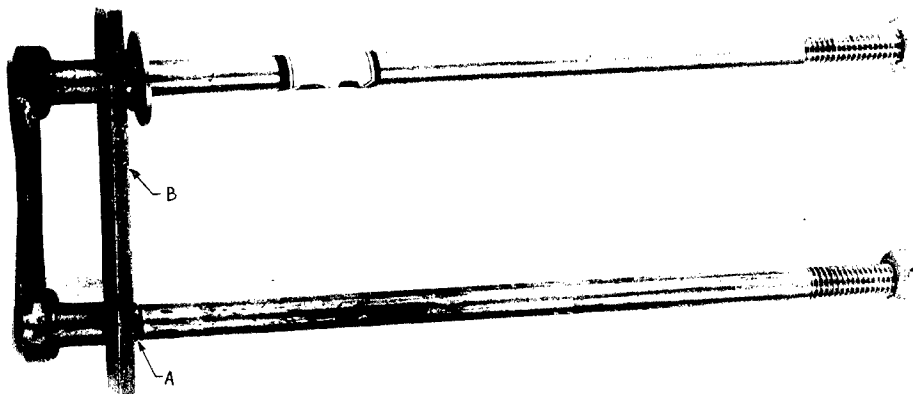
FIGURE 34.1. *Window washer's anchor with one bolt broken at arrow A.*

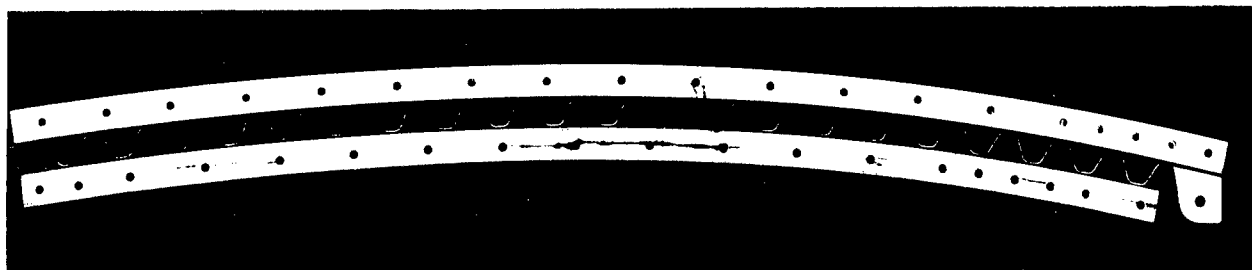
FIGURE 35.1. Cracks in the lower angle as revealed by a dye penetrant inspection method. The longitudinal cracks were caused by a tensile stress in the transverse direction.  $\times \frac{1}{8}$ .

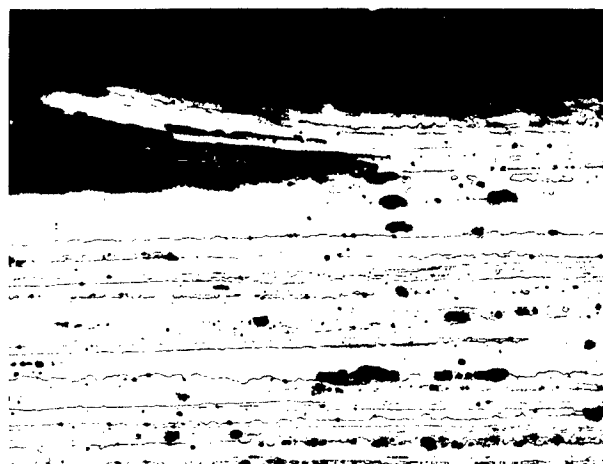
FIGURE 35.3. Longitudinal section perpendicular to the fracture shown in figure 35.2.
