NSWCCD-65-TR-2001/23 October 2001

**Structural Integrity and Damage Evaluation Routine
(SIDER) for Quality Control and Health Monitoring of
Structures**

Subj: COLLABORATIVE STRUCTURAL EVALUATION OF A HIGHWAY COMPOSITE
DECK BRIDGE

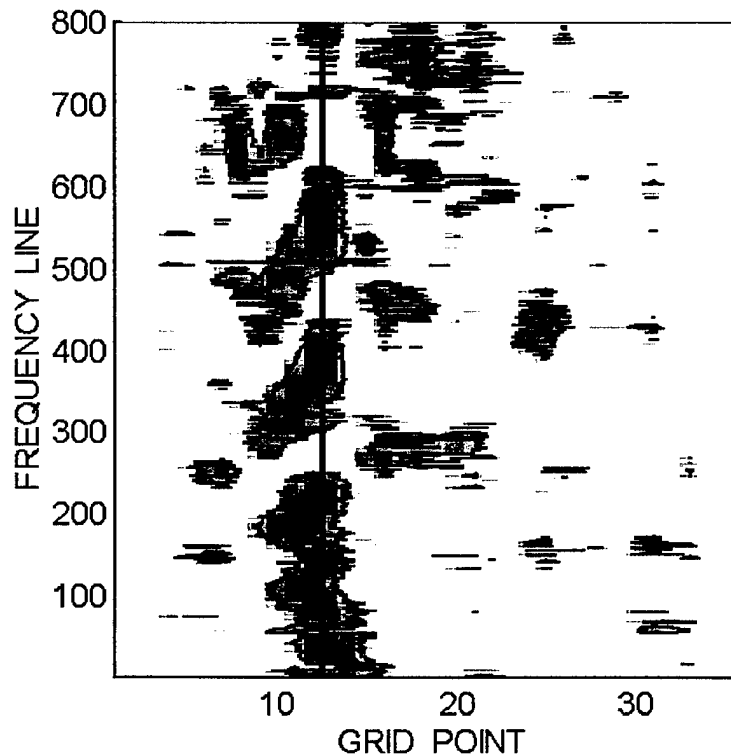
The procedure is repeated separately for every frequency and for every test point on the structure. For a one-dimensional structure (beam), the resulting output can be shown as a contour plot of frequency versus position. Figure 1 shows the results of an experimental BGSM for a 0.914 m long \times 76.2 mm wide \times 6.33 mm thick steel beam with simulated damage created by milling a 0.13-mm deep groove across its width. The resulting damage index plot has a feature which shows consistently at nearly all frequencies at the location of damage (grid point 12.5). It should be noted that one advantage of using the BGSM is that it does not require a footprint of information about a presumably undamaged structure (either finite element or experimental). This means that the BGSM is suited to the inspection of structures that have been in service for some period without a prior inspection.

Figure 1. Experimental Broadband Damage Index for a 6.33-mm Thick Steel Beam with a 2.8-mm wide, 0.13-mm Deep Groove at the Position Marked

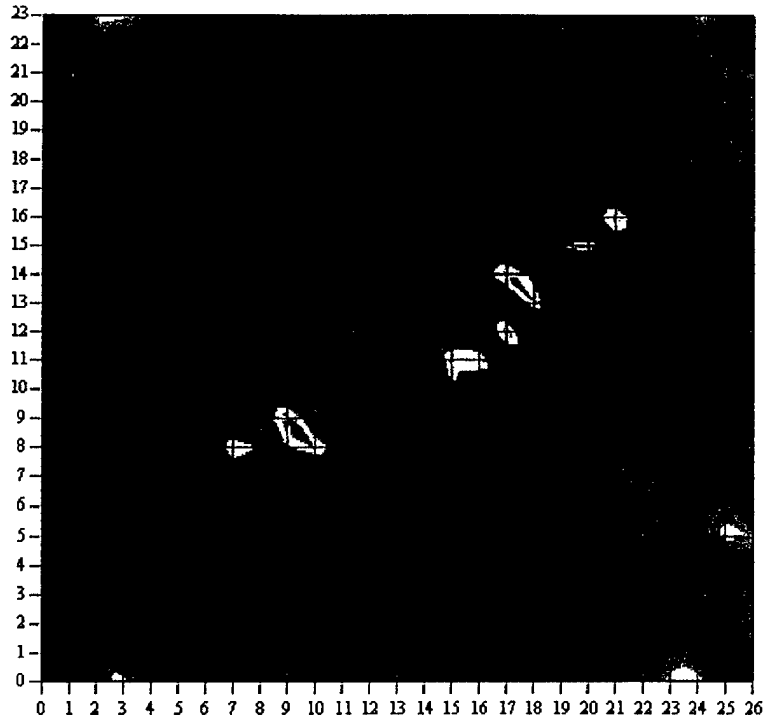
Figure 2 shows the reduced summary plot for one of the foam core panels that was impacted at its center with a 4-inch diameter spherical tup at an energy level of 1344 ft-lbs. The SIDER procedure indicates that, in addition to the damage at the impact site, there is other damage approximately along the diagonals of the panel. After this vibration examination was complete the panel was end-loaded to destruction. The panel failed along the lines identified by the SIDER analysis.

Figure 2. SIDER Summary Plot for Foam Panel after Impact at 1344 ft-lbs

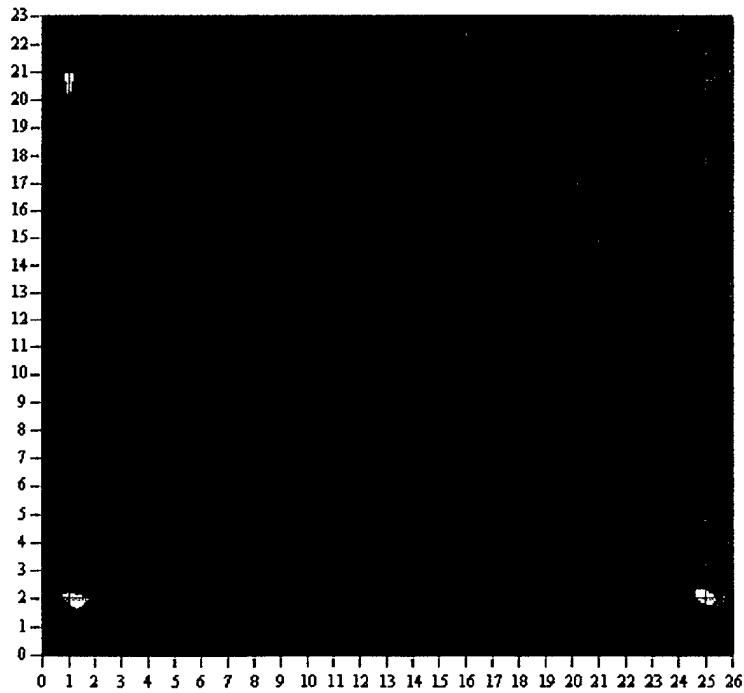
In comparison, Figure 3 shows the SIDER summary plot for a panel that had not been impacted. The plot does not show any features of significance, suggesting uniformity and a lack of damage.

Figure 3. SIDER Summary Plot for Foam Panel that was not Impacted

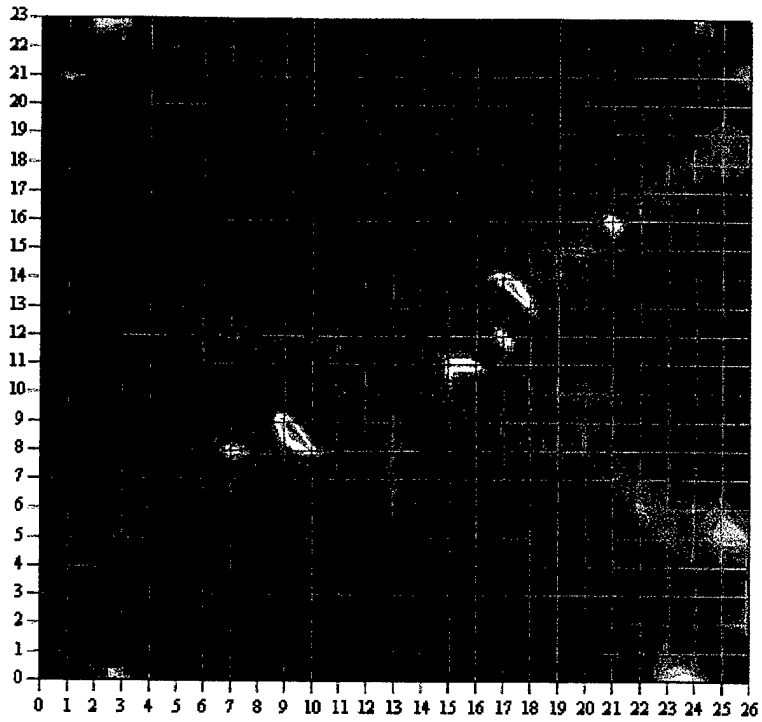
Figures 4 and 5 show the same information as Figures 2 and 3, but after statistical enhancement. The damage on the impacted panel is much easier to interpret, and the plot for the undamaged panel is much ‘cleaner’.

Figure 4. Enhanced Plot for Damaged Foam Panel

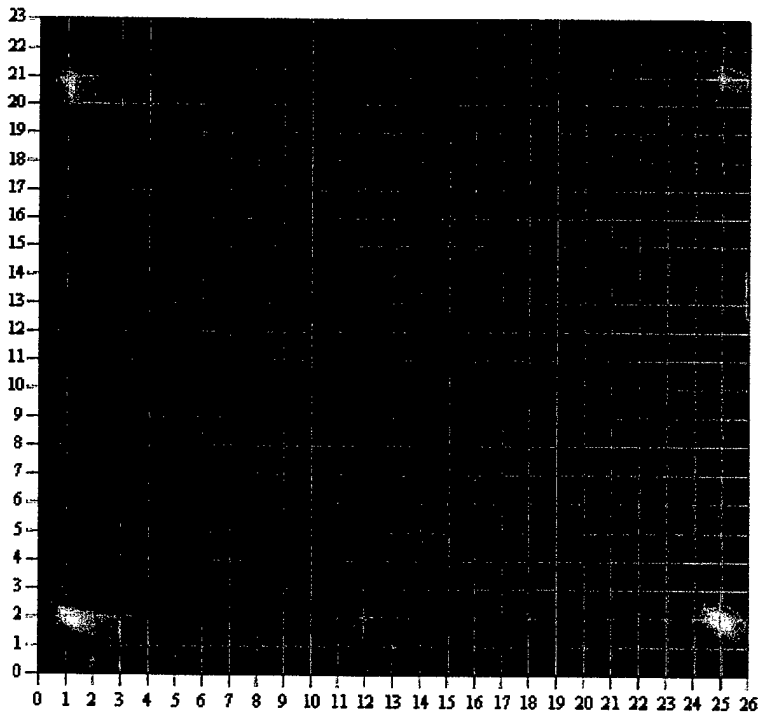
Figure 5. Enhanced Plot for Undamaged Foam Panel
