SUMMARY REPORT  
FOR

NAVAL SURFACE WARFARE CENTER, CARDEROCK DIVISION

LVS MOD DEMO VEHICLE  
ARMOR PROTECTION KIT INSTALLATION

NATC PROJECT NO. 17859

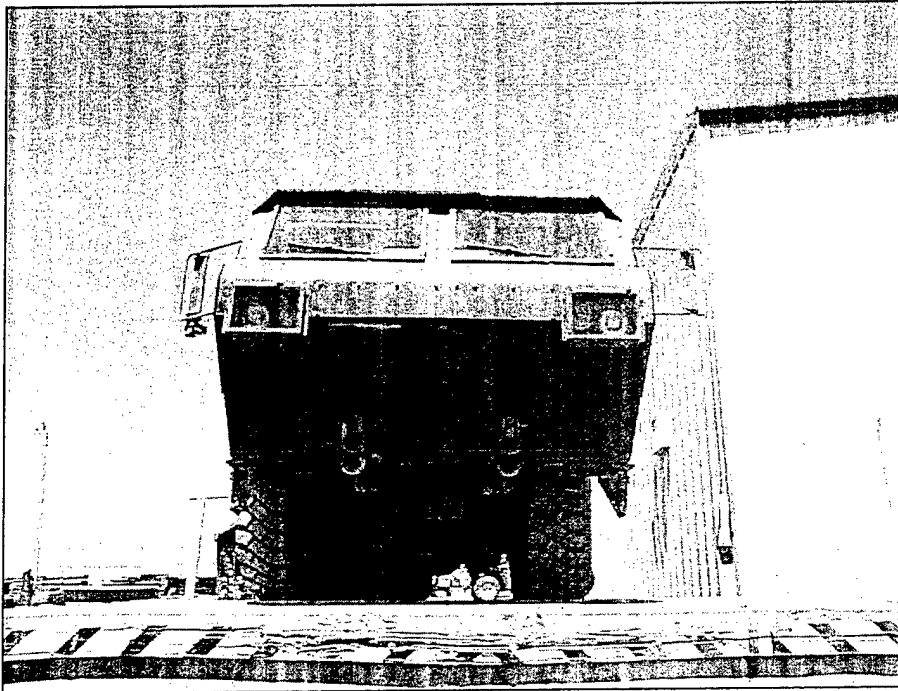
1. The black out lights were not connected through the armor kit (Photograph number 20238-001),
2. The upper clearance lights were not connected through the armor kit (Photograph number 20238-001),
3. Visibility is limited/restricted by the new cab enclosure (Photographs numbered 20238-030 and 031),
4. The air flow is restricted to the cab (Photographs numbered 20238-030 and 031),
5. The window locks may protrude into the occupant's head/body during an accident (Photograph number 20238-016),
6. The door handle (inside cab) is hard to reach next to the seat (Photographs numbered 20238-019 and 020),

7. There is no exit point for the occupants during an accident; i.e., the window can not be kicked out (Photographs numbered 20238-001 through 004),
8. The dead bolt door locks automatically lock during vehicle operation (Photographs numbered 20238-017 and 018),

PHOTOGRAPH NO. 20238-001  
LVS ARMOR PROTECTION KIT  
FRONT VIEW

It is recommended that these items be addressed should this kit become a LVS option.

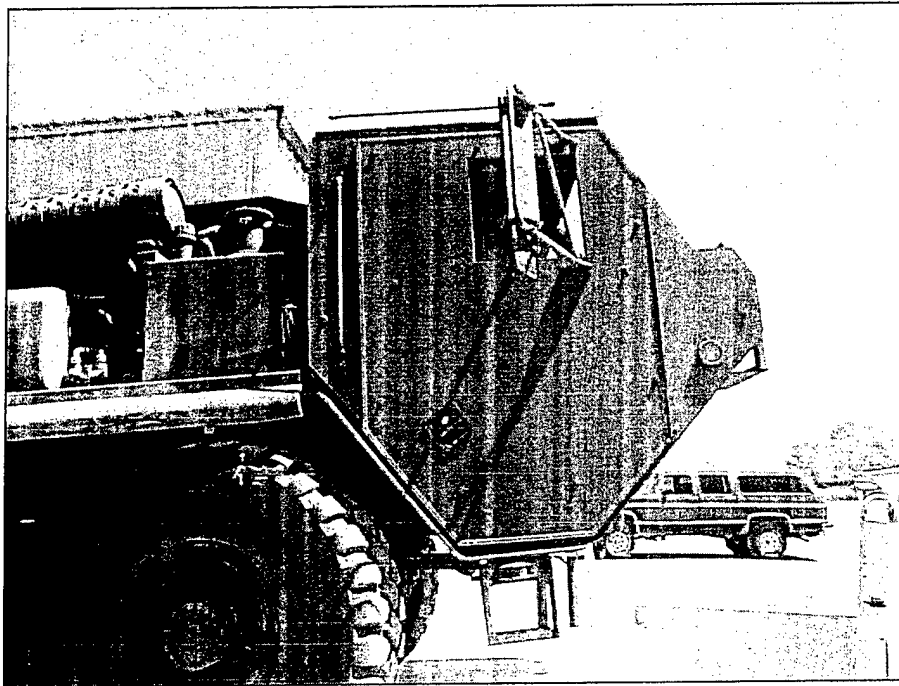
PHOTOGRAPH NO. 20238-002  
LVS ARMOR PROTECTION KIT  
PASSENGER SIDE VIEW

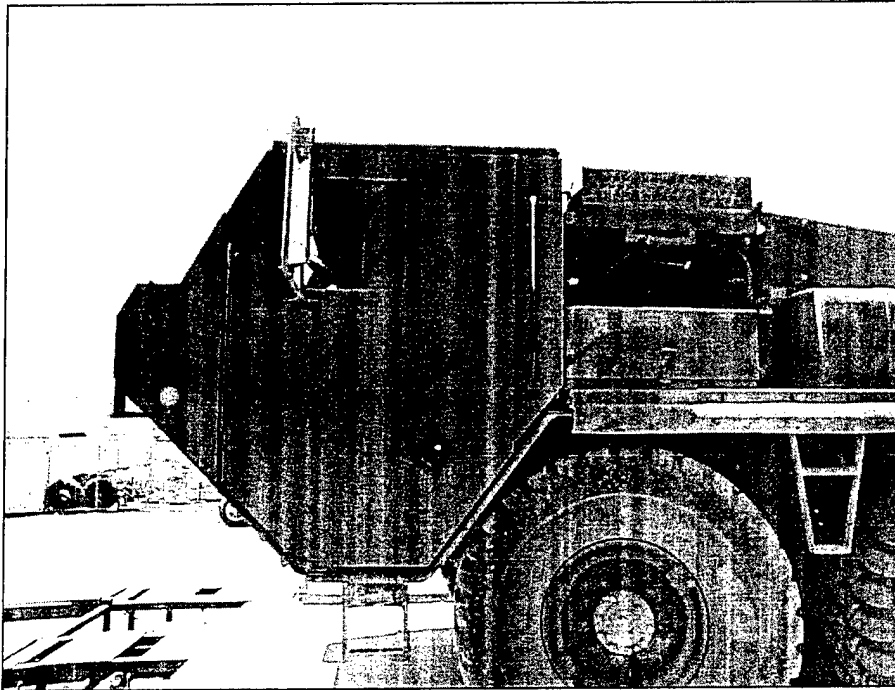
12. The underbody plate will act as a mud trap and corrosion issues are probable (Photographs numbered 20238-003 and 029),
13. The doors are too heavy for the hinges; occupants get trapped inside the vehicle due to hinges getting off track (Photograph number 20238-010),

PHOTOGRAPH NO. 20238-003  
LVS ARMOR PROTECTION KIT  
DRIVER SIDE VIEW

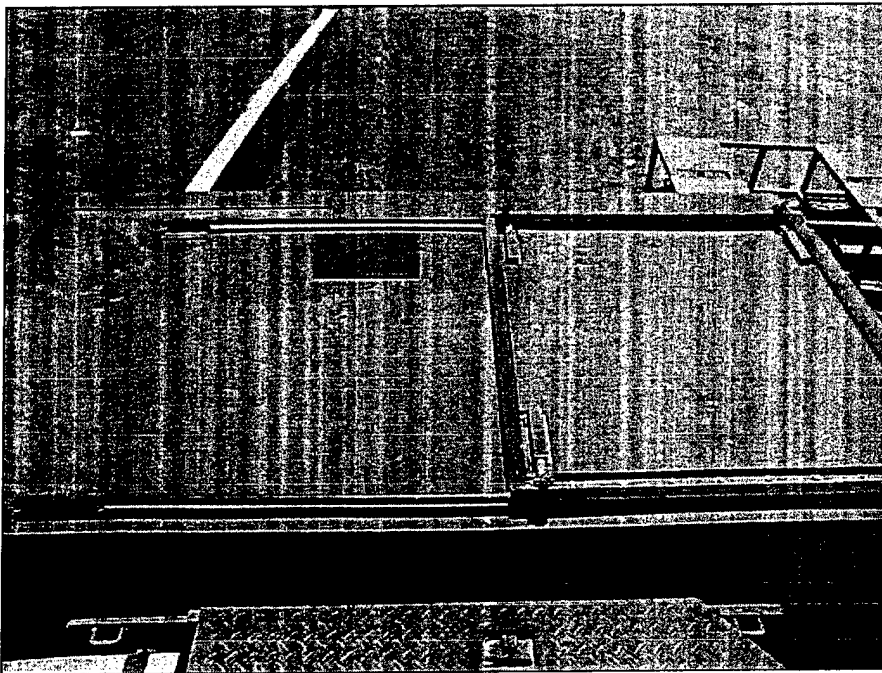
9. The bolts in the roof are protruding into the cab area creating a probability of head injury (Photographs numbered 20238-013 and 015),
10. The roof hatch is hard to lift and does not seem to slide; no 95th percentile provisions (Photographs numbered 20238-004 and 005),

PHOTOGRAPH NO. 20238-004  
LVS ARMOR PROTECTION KIT  
TOP CENTER VIEW

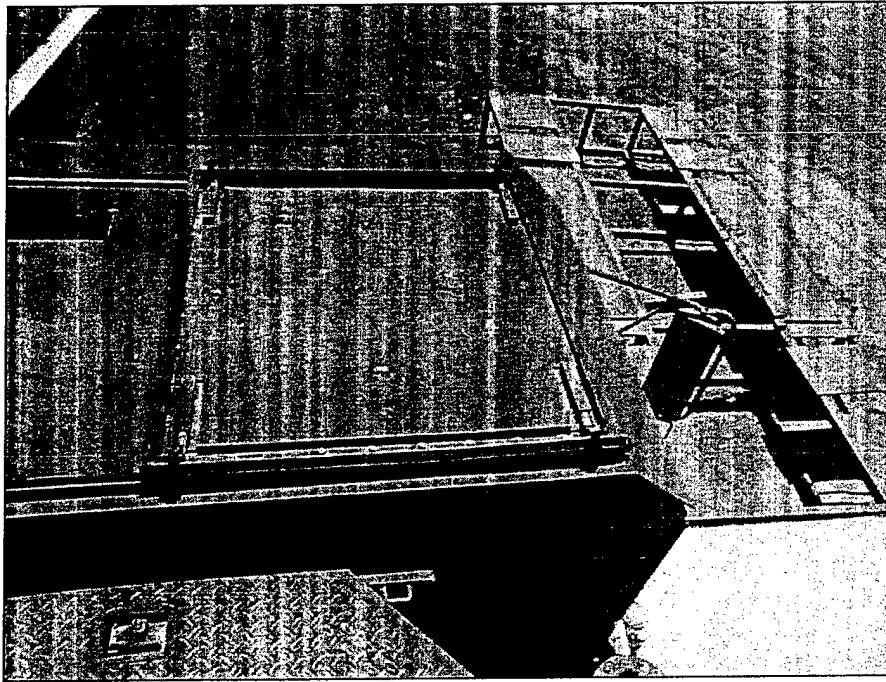
PHOTOGRAPH NO. 20238-005  
LVS ARMOR PROTECTION KIT  
TOP PASSENGER SIDE VIEW

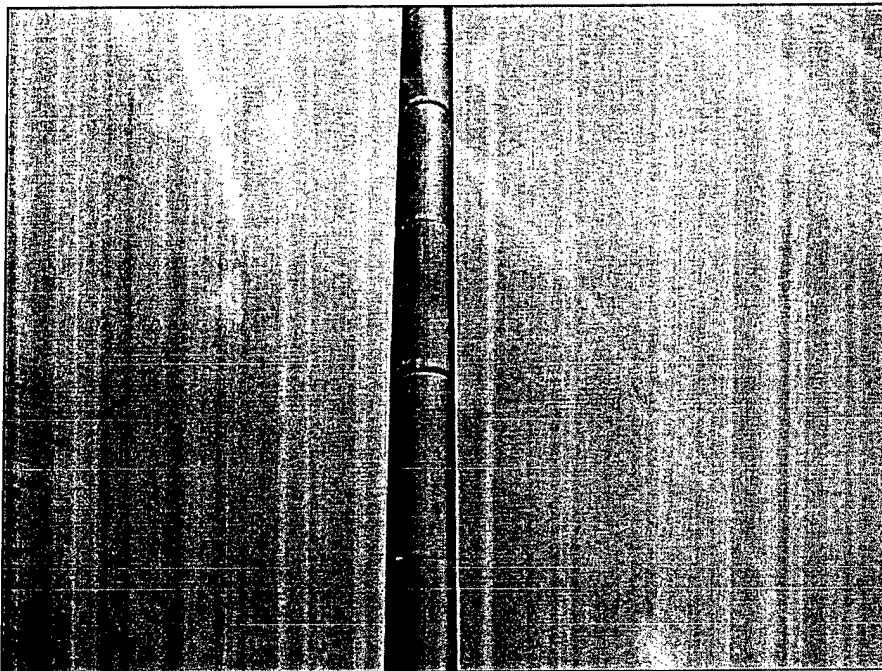
PHOTOGRAPH NO. 20238-010  
LVS ARMOR PROTECTION KIT  
DRIVER SIDE DOOR HINGE

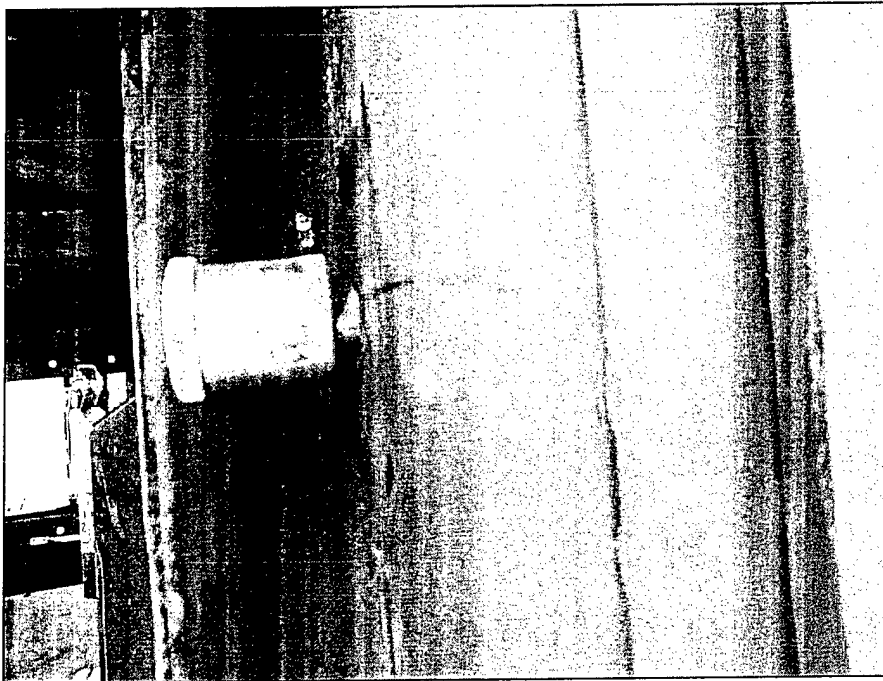
16. The driver and passenger side upper door pins are loose (Photograph number 20238-011),
17. There is a gap in the armor plate on both sides; only one bolt holds the armor kit on, the other bolt is only through the sheet metal (Photograph number 20238-012),

PHOTOGRAPH NO. 20238-011  
LVS ARMOR PROTECTION KIT  
UPPER DOOR PIN LOOSE – CONTACT MARKS FROM DOOR

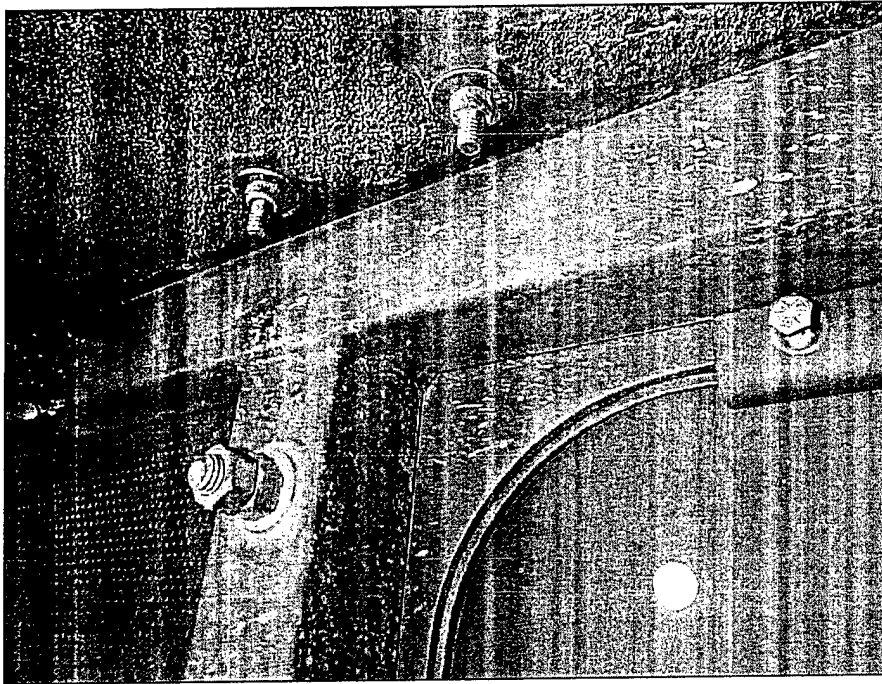
11. The entire cab has protruding bolts into the cab space creating a probability of head injuries (Photographs numbered 20238-013, 014, 015, 023, 024, 025 and 027),

PHOTOGRAPH NO. 20238-013  
LVS ARMOR PROTECTION KIT  
PROTRUDING BOLTS – DRIVER'S SIDE ROOF

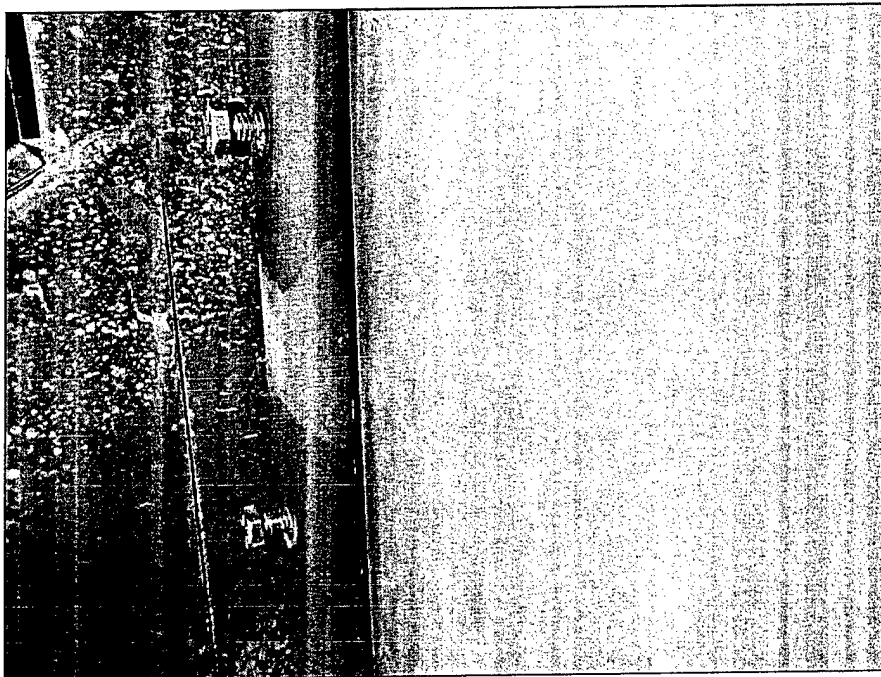
PHOTOGRAPH NO. 20238-014  
LVS ARMOR PROTECTION KIT  
PROTRUDING BOLTS BEHIND DRIVER'S SEAT

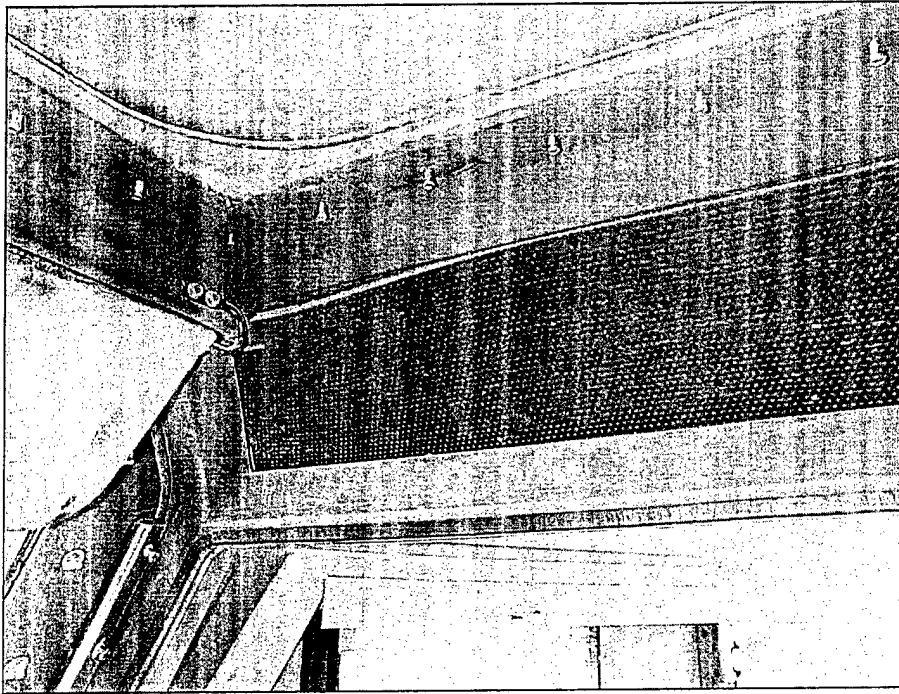
PHOTOGRAPH NO. 20238-015  
LVS ARMOR PROTECTION KIT  
PROTRUDING BOLTS – PASSENGER'S SIDE HATCH

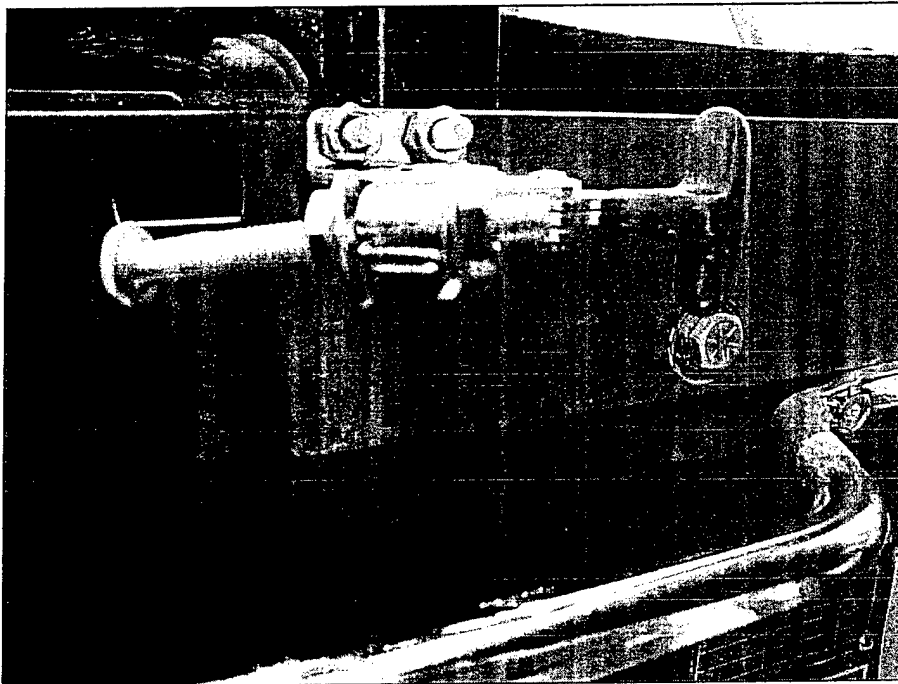
PHOTOGRAPH NO. 20238-016  
LVS ARMOR PROTECTION KIT  
WINDOW LOCKS NOT TIGHT/OPERATIONAL

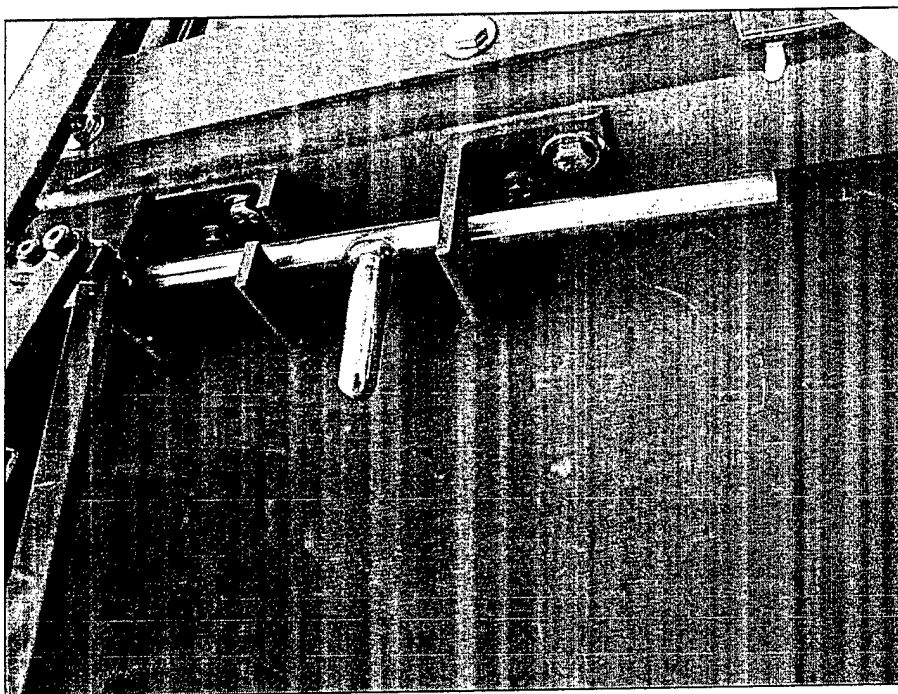
PHOTOGRAPH NO. 20238-017  
LVS ARMOR PROTECTION KIT  
DEAD BOLT DOOR LOCK NOT TIGHT - RATTLES

PHOTOGRAPH NO. 20238-018  
LVS ARMOR PROTECTION KIT  
DEAD BOLT DOOR LOCK NOT TIGHT - RATTLES

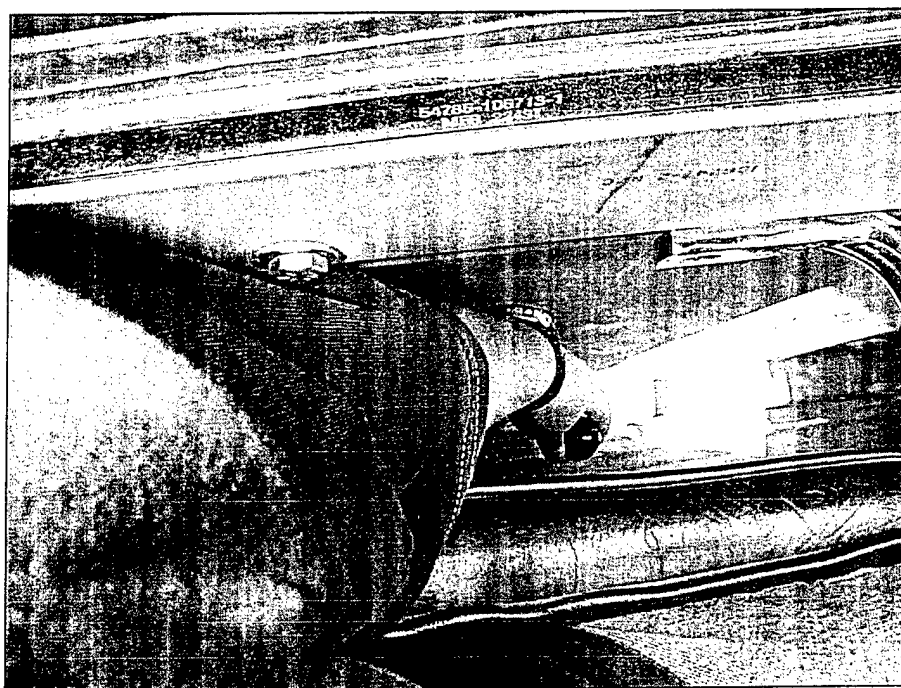
PHOTOGRAPH NO. 20238-019  
LVS ARMOR PROTECTION KIT  
DOOR HANDLE LOCATION

PHOTOGRAPH NO. 20238-020  
LVS ARMOR PROTECTION KIT  
DOOR HANDLE LOCATION

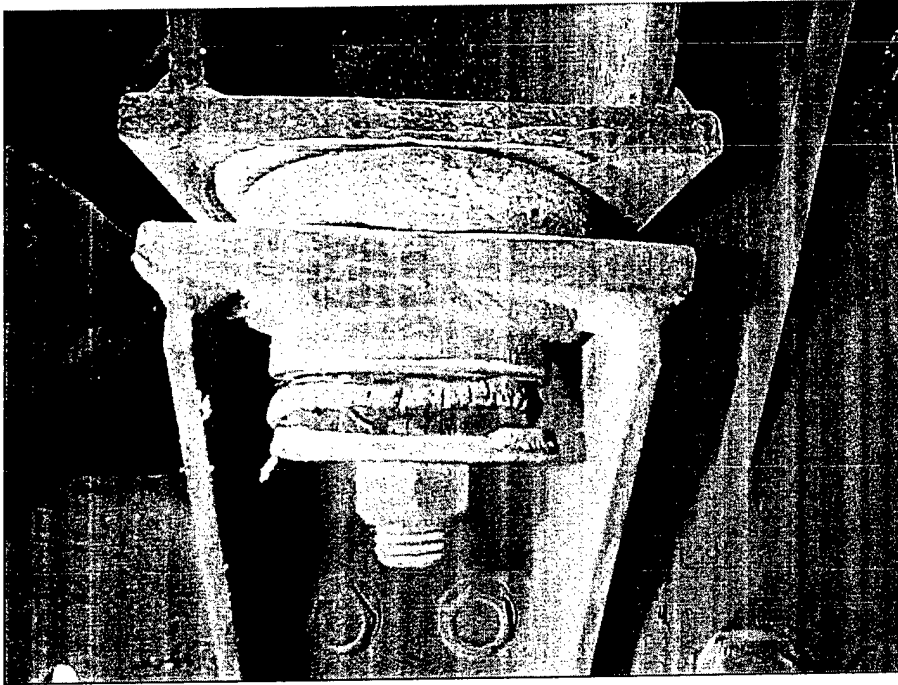
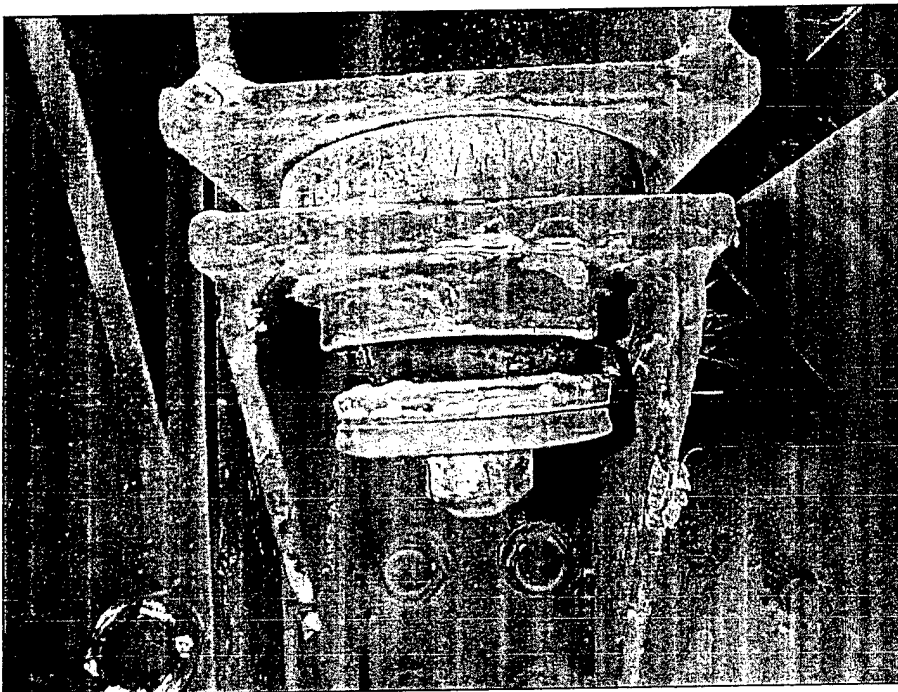
19. There is no access to clean the headlights; space will serve as a mud trap (Photograph number 20238-028), and
20. The cab mounts are deteriorating due to the additional weight (Photographs numbered 20238-021 and 022).

PHOTOGRAPH NO. 20238-021  
LVS ARMOR PROTECTION KIT  
DRIVER SIDE CAB MOUNTS

PHOTOGRAPH NO. 20238-022  
LVS ARMOR PROTECTION KIT  
PASSENGER SIDE CAB MOUNTS

1. Address the twenty-one items identified should further development be merited.
2. Perform accelerated fatigue testing of the vehicle.
3. Redesign the cab mounts to consist of a stiffer material.

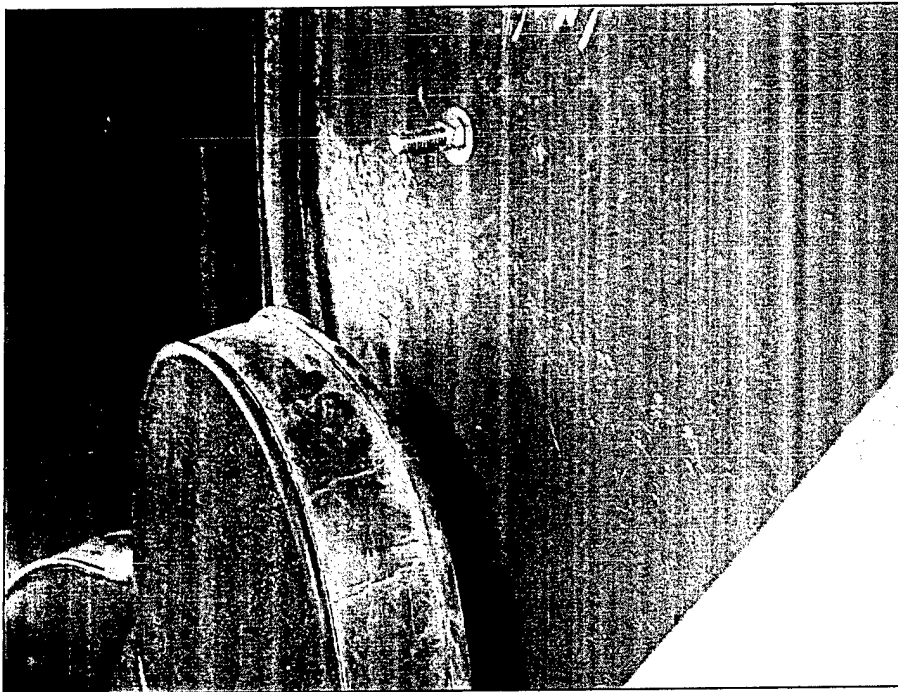
PHOTOGRAPH NO. 20238-023  
LVS ARMOR PROTECTION KIT  
PROTRUDING BOLTS PASSENGER SIDE

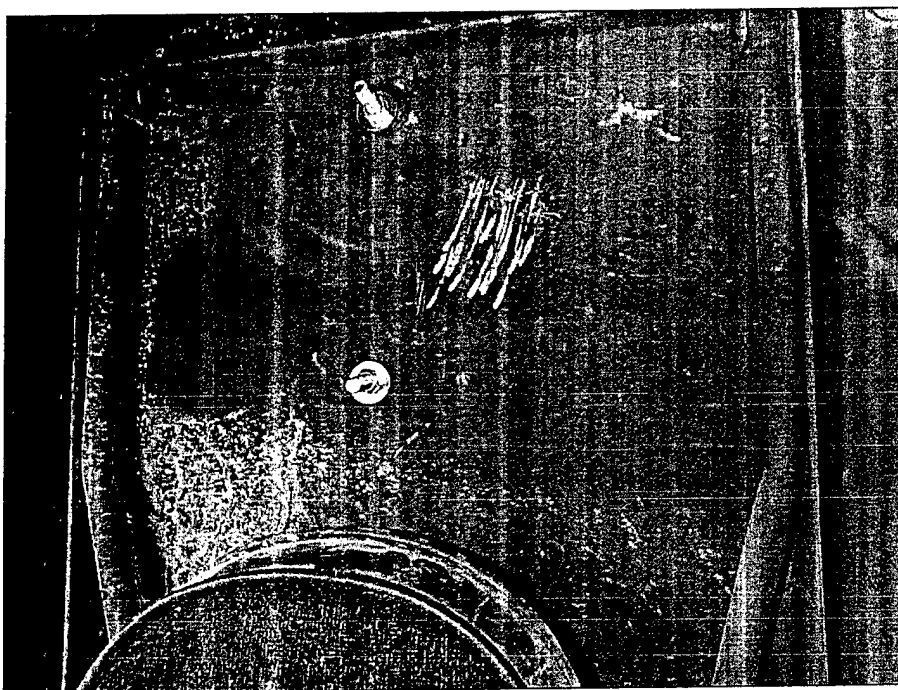
14. The armor kit is bolted through the gunner's platform; platform not operational (Photographs numbered 20238-024 and 027),
15. The cab structure tube is crushed due to no support for bolts (Photograph number 20238-025),

PHOTOGRAPH NO. 20238-024  
LVS ARMOR PROTECTION KIT  
PROTRUDING BOLTS PASSENGER SIDE

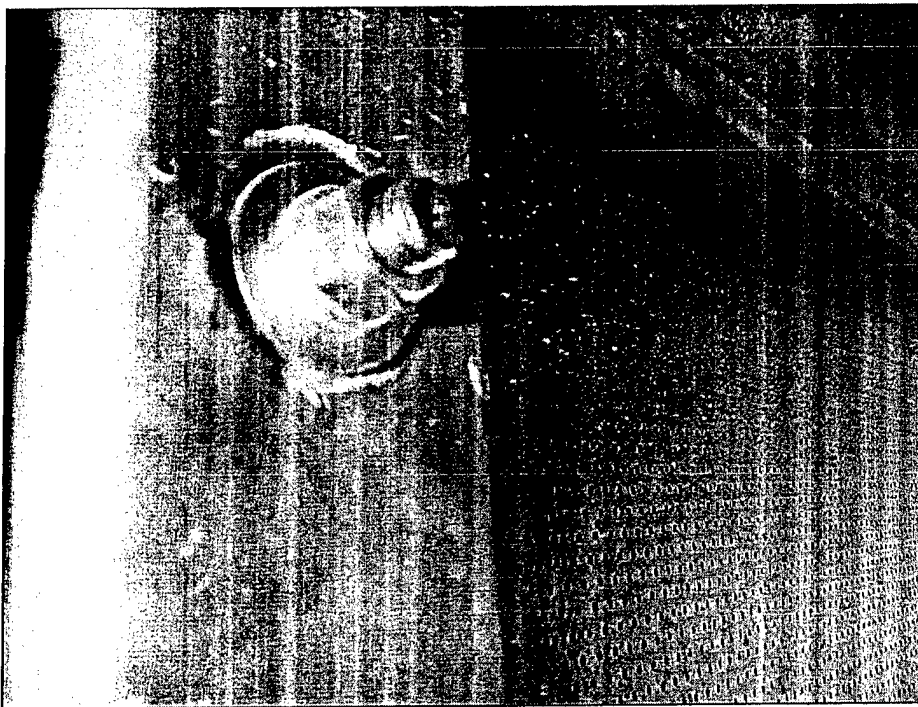
PHOTOGRAPH NO. 20238-025  
LVS ARMOR PROTECTION KIT  
CRUSHED CAB STRUCTURE TUBE

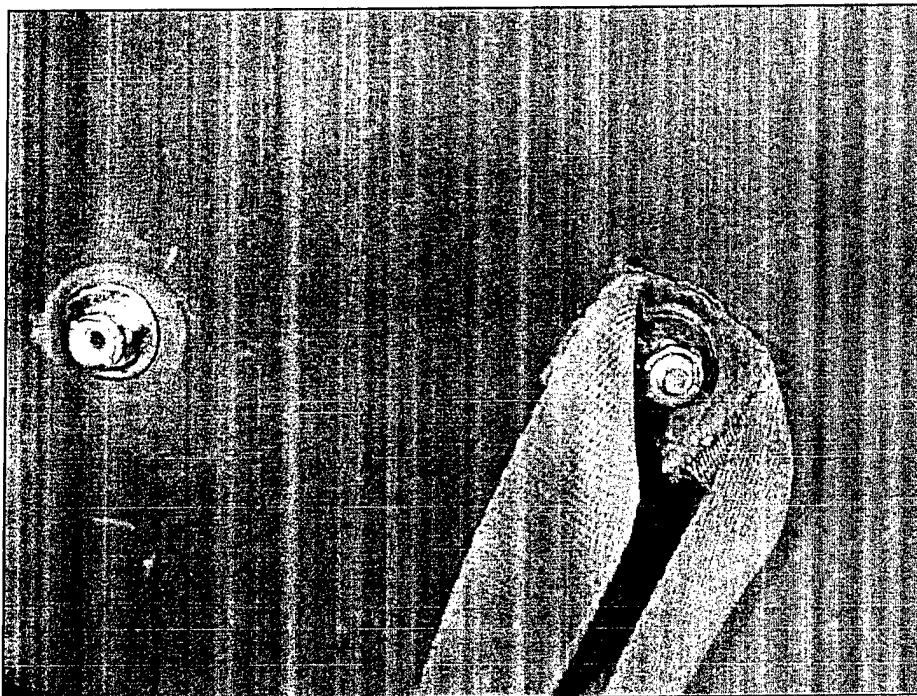
18. There is no thread engagement on the nylon bolts inside the cab in the front and gunner's hatch areas (Photograph number 20238-026),

PHOTOGRAPH NO. 20238-026  
LVS ARMOR PROTECTION KIT  
NYLON BOLT NOT ENGAGED

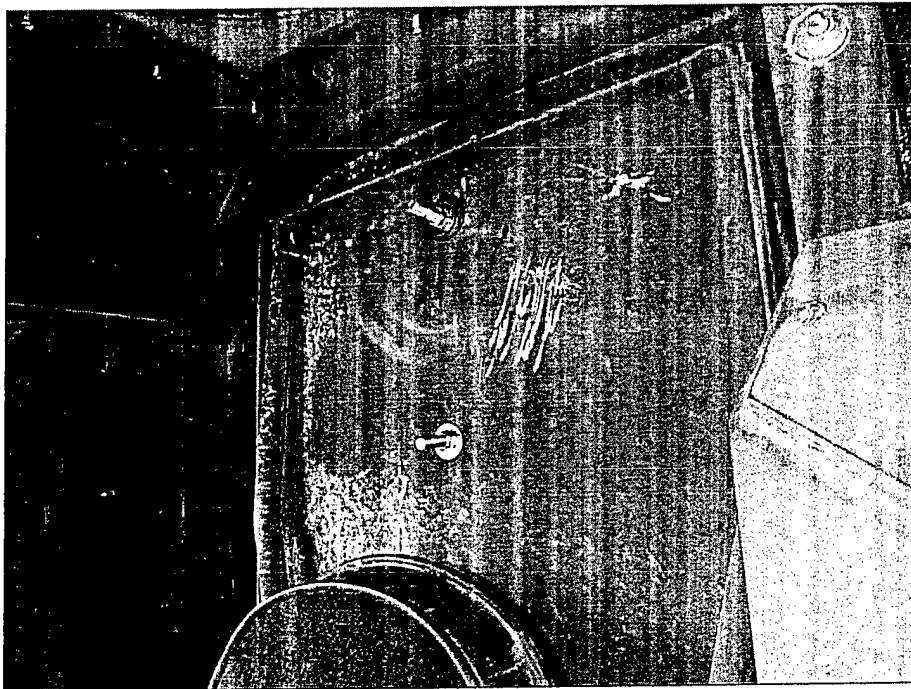
PHOTOGRAPH NO. 20238-027  
LVS ARMOR PROTECTION KIT  
GUNNER'S PLATFORM BOLTED TO ARMOR

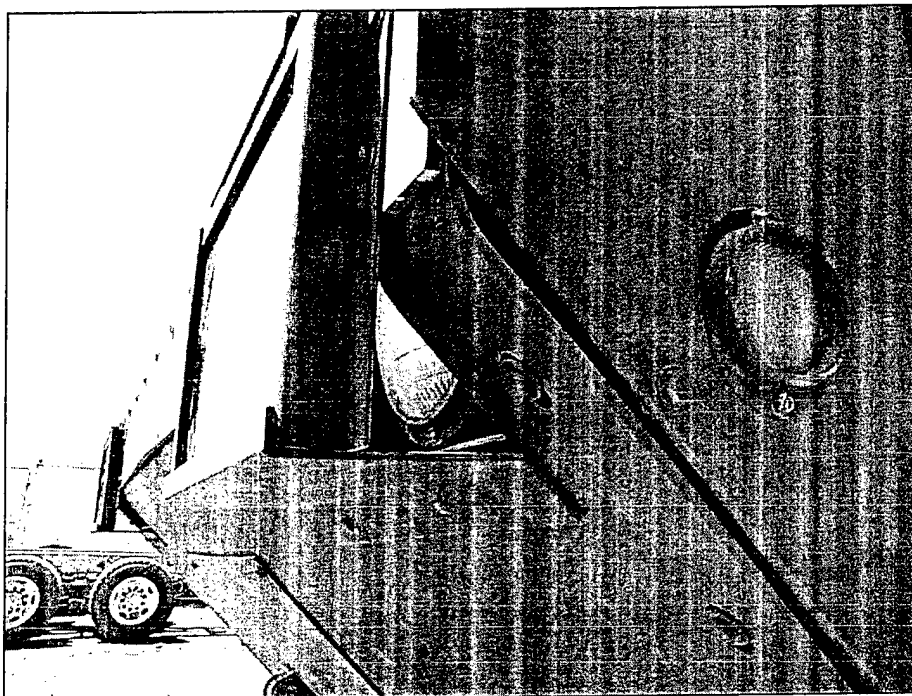
PHOTOGRAPH NO. 20238-028  
LVS ARMOR PROTECTION KIT  
HEADLIGHT ACCESS ELIMINATED/ MUD TRAP AREA

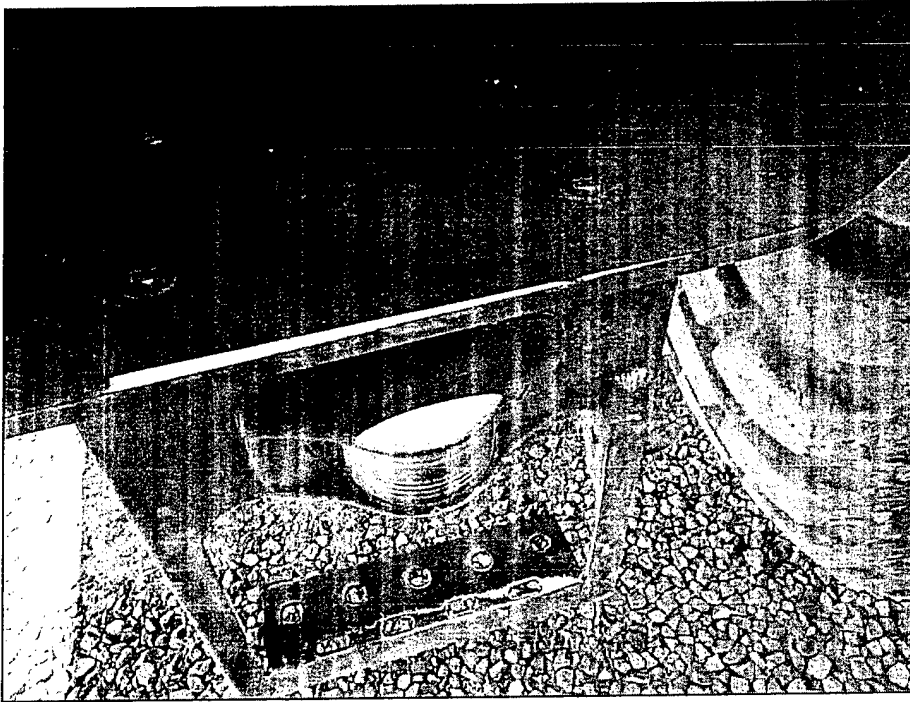
PHOTOGRAPH NO. 20238-029  
LVS ARMOR PROTECTION KIT  
NO TRACTION ON ARMOR PLATE STEP

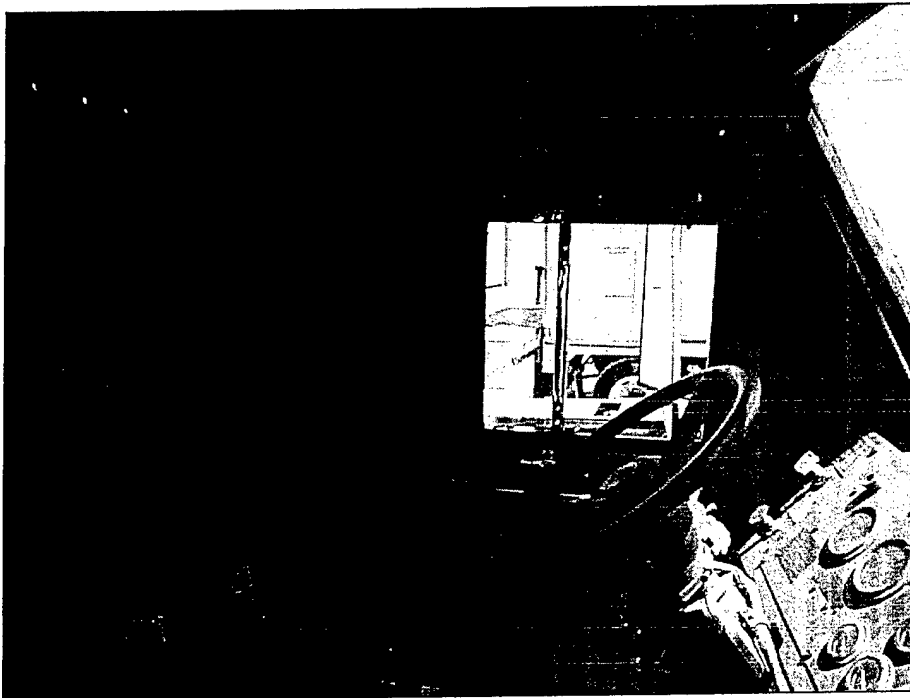
PHOTOGRAPH NO. 20238-030  
LVS ARMOR PROTECTION KIT  
DRIVER'S VISIBILITY
