**Degradation of Peel and Tensile
Strength of Bonded Panels
Exposed to High Humidity**

DSTO-TR-1272

**Airframes and Engines Division
Aeronautical and Maritime Research Laboratory**

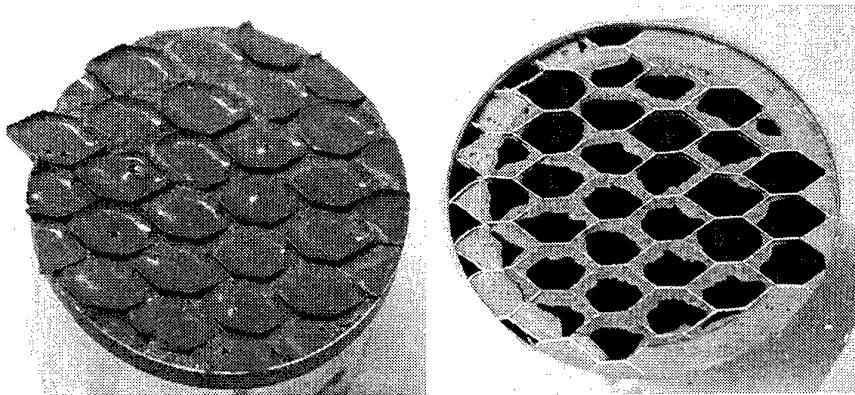
Figure 3 Failure surfaces resulting from tensile testing of the Dura-Core honeycomb and JD Lincoln adhesive control specimen, indicating a mixture of cohesive failure and fillet bond pull-out.

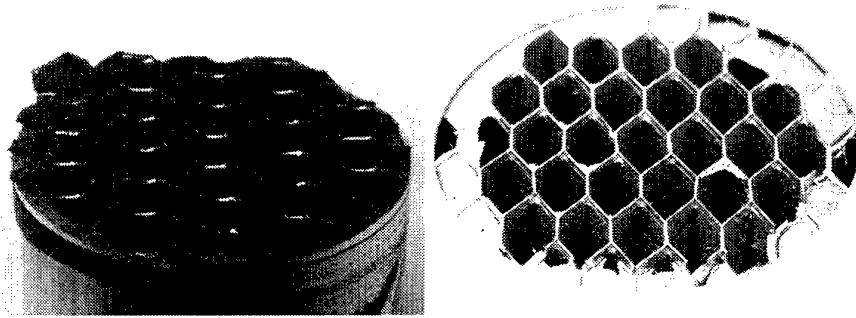
Figure 4 Failure surfaces resulting from tensile testing of the Dura-Core honeycomb and JD Lincoln adhesive conditioned 30 days at 70°C/100%R.H., indicating fillet bond pull-out.

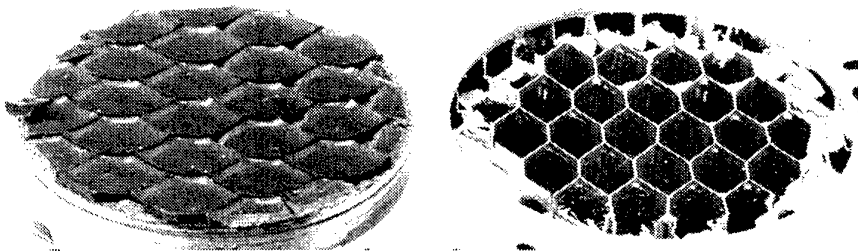
Figure 5 Failure surfaces resulting from tensile testing of the Dura-Core honeycomb and JD Lincoln adhesive conditioned 150 days at 70°C/100%R.H., indicating fillet bond pull-out.

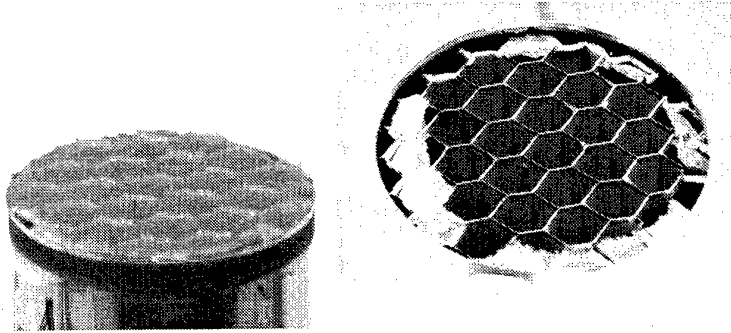
Figure 7 Failure surfaces resulting from tensile testing of the Untreated honeycomb and AF130-2 adhesive conditioned 30 days at 70°C/100%R.H., indicating fillet bond pull-out.

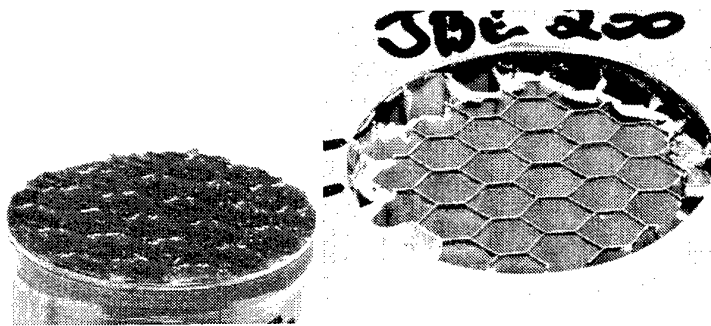
Figure 8 Failure surfaces resulting from tensile testing of the Untreated honeycomb and AF130-2 adhesive conditioned 150 days at 70°C/100%R.H., indicating fillet bond pull-out.

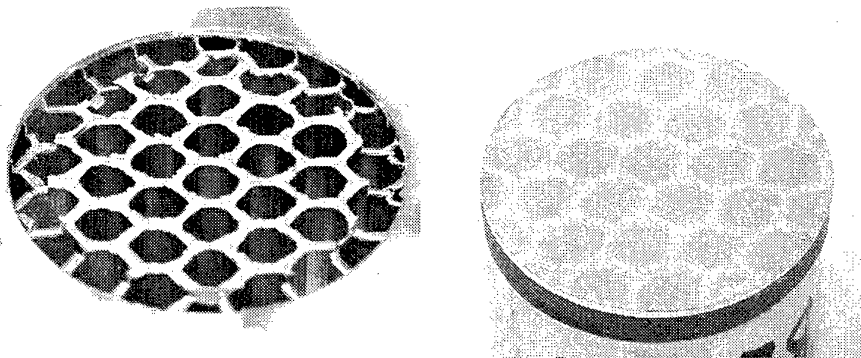
Figure 9 Failure surfaces resulting from tensile testing of the Untreated honeycomb and AF131-2 adhesive control specimen, indicating cohesive fillet bond failure.

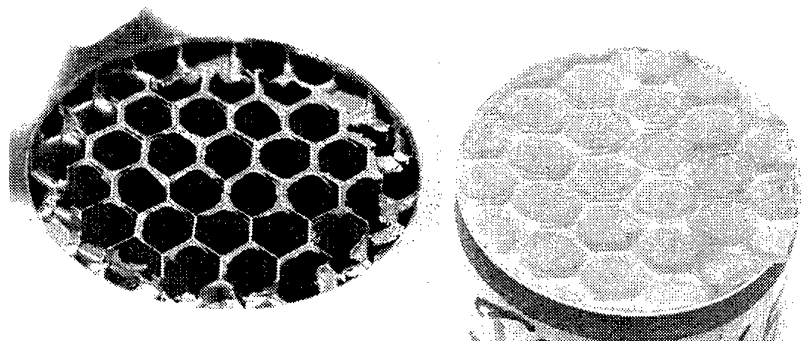
Figure 10 *Failure surfaces resulting from tensile testing of the Untreated honeycomb and AF131-2 adhesive conditioned 30 days at 70°C/100%R.H., indicating fillet bond pull-out and cohesion failure.*

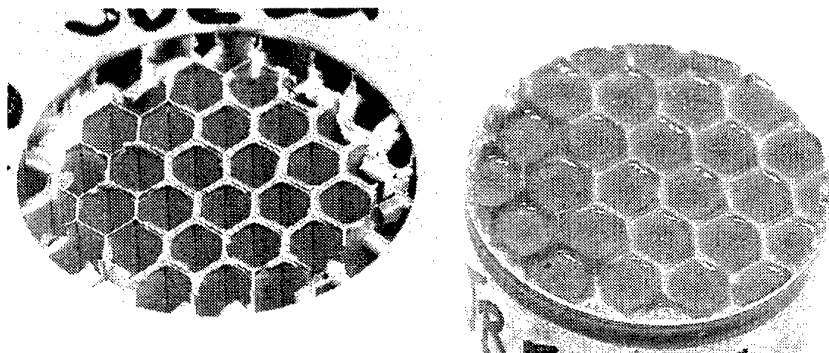
Figure 11 *Failure surfaces resulting from tensile testing of the Untreated honeycomb and AF131-2 adhesive conditioned 150 days at 70°C/100%R.H., indicating fillet bond pull-out and cohesion failure.*

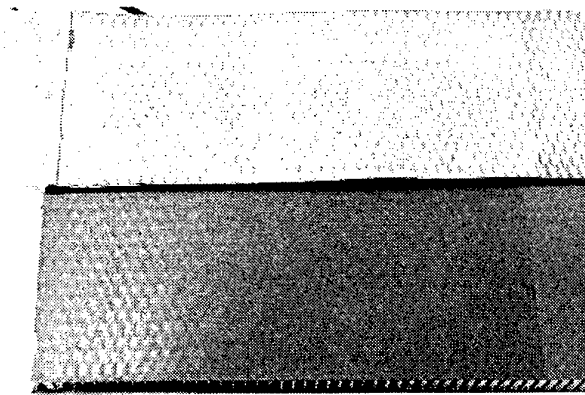
Figure 12 Failure surfaces resulting from peel testing of the Dura-Core honeycomb and JD Lincoln adhesive control specimen, indicating a mixture of cohesive failure and skin to adhesive failure.

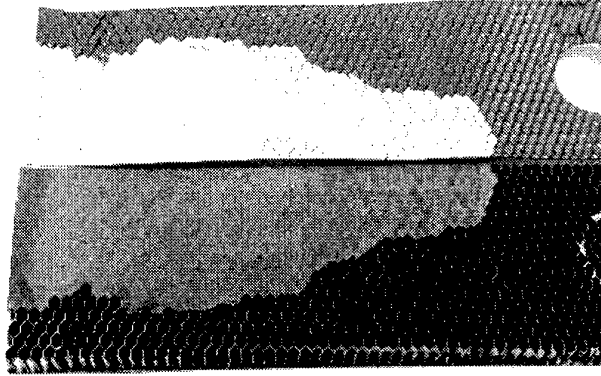
Figure 13 Failure surfaces resulting from peel testing of the Dura-Core honeycomb and JD Lincoln adhesive conditioned 30 days at 70°C/100% R.H., indicating fillet bond pull-out and skin to adhesive failure.

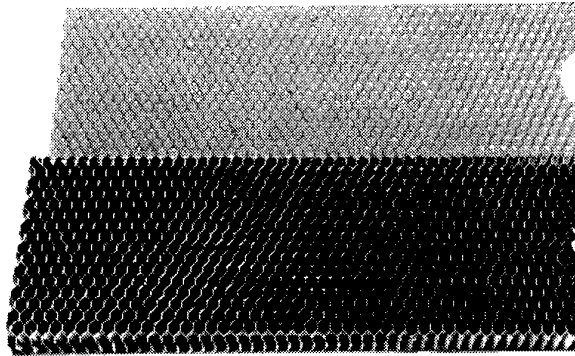
Figure 14 Failure surfaces resulting from peel testing of the Dura-Core honeycomb and JD Lincoln adhesive conditioned 150 days at 70°C/100% R.H., indicating fillet bond pull-out.

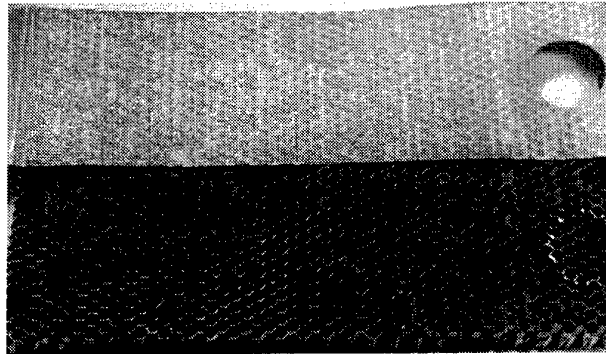
Figure 15 Failure surfaces resulting from peel testing of Untreated honeycomb and AF130-2 adhesive control specimen, indicating a mixture of cohesive failure and skin to adhesive failure.

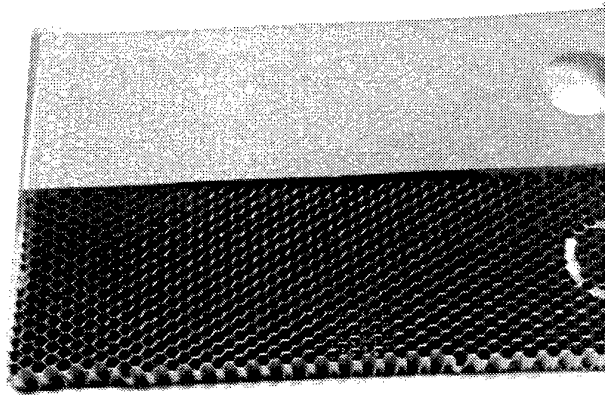
Figure 16 Failure surfaces resulting from peel testing of the Untreated honeycomb and AF130-2 adhesive conditioned 30 days at 70°C/100% R.H., indicating fillet bond pull-out.

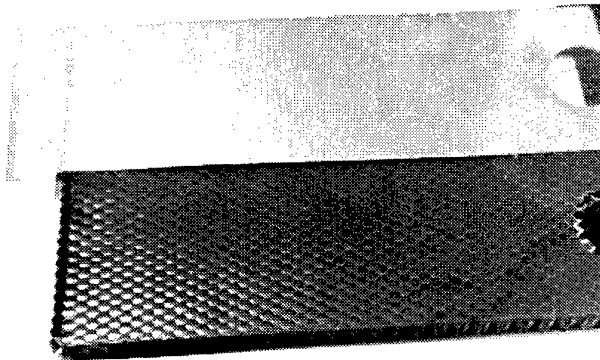
Figure 17 Failure surfaces resulting from peel testing of the Untreated honeycomb and AF130-2 adhesive conditioned 150 days at 70°C/100% R.H., indicating skin to adhesive disbond.

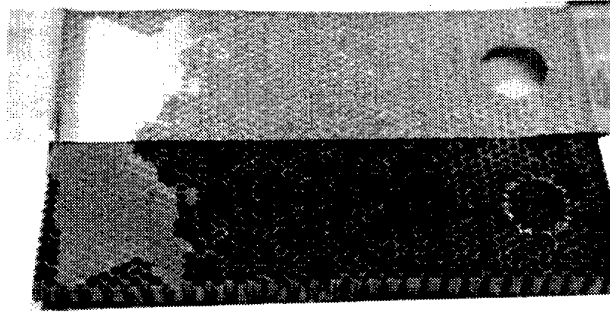
Figure 19 Failure surfaces resulting from peel testing of the Untreated honeycomb and AF131-2 adhesive conditioned 30 days at 70°C/100%R.H., indicating fillet bond pull-out, cohesion failure and skin adhesive disbond.

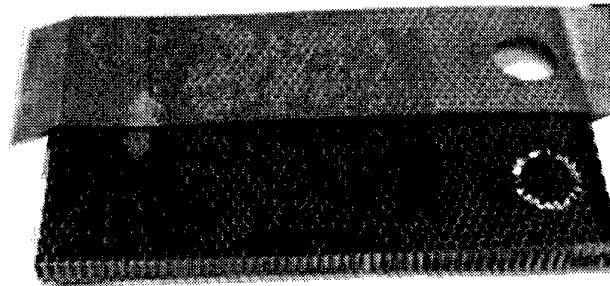
Figure 20 Failure surfaces resulting from peel testing of the Untreated honeycomb and AF131-2 adhesive conditioned 150 days at 70°C/100%R.H., indicating fillet bond pull-out and cohesion failure.

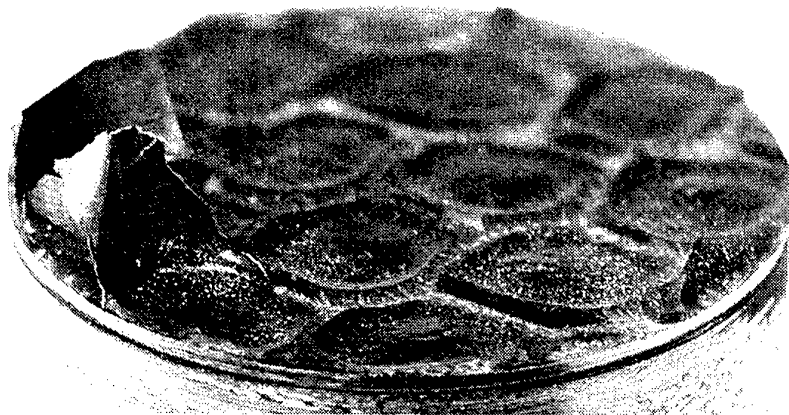
Figure 27 Failure surface of the portable adhesion test stub taken from the Stab-Tip after immersion in 50°C ionised water for 13 months, indicating regions of fillet bond pull-out.

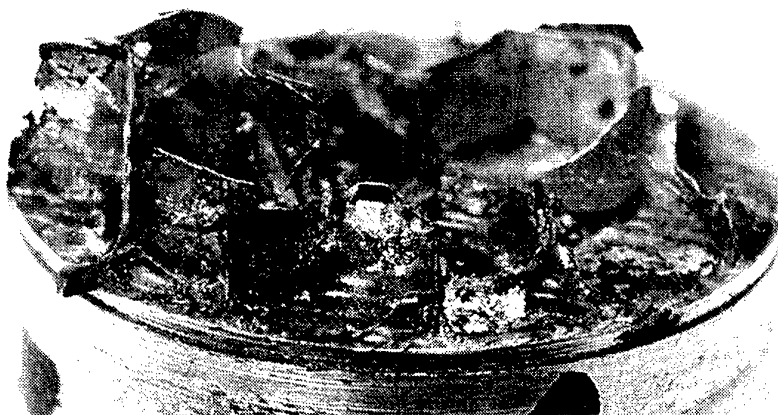
Figure 28 Failure surface of the portable adhesion test stub taken from the Stab-Tip after immersion in 50°C ionised water for 13 months, indicating regions of core corrosion leading to core fracture.

number of holes in the panel being present. In one location moisture ingress into the core had led to corrosion and consequent failure during tensile loading. However, in the majority of cases a mixture of cohesive fillet bond fracture and core fracture was observed. This mode is typically observed for the lighter gauge core material used to fabricate the Stab-Tip panel.

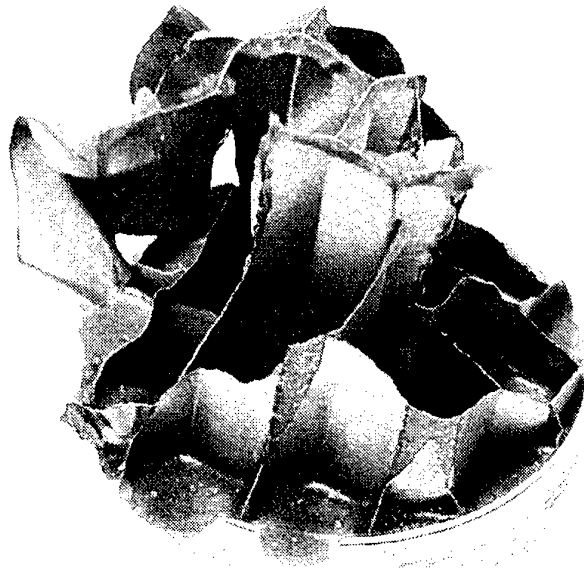
Figure 29 *Failure surface of the portable adhesion test stub taken from the Stab-Tip prior to immersion in 50°C ionised water, indicating regions of honeycomb core fracture.*

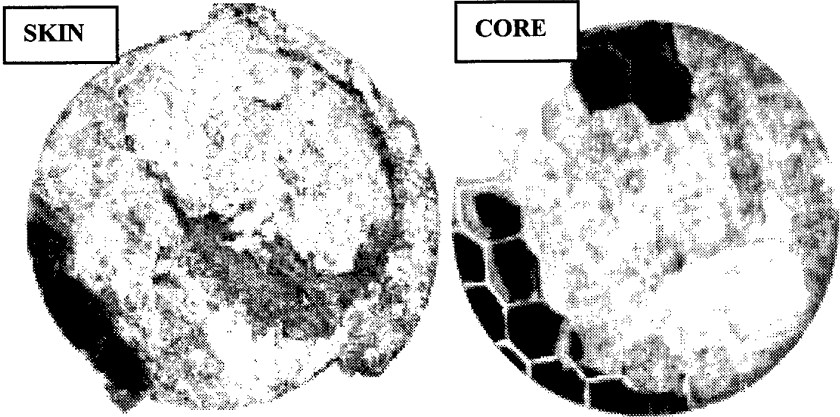
Figure 31 Failure surface images from the tensile test taken in location 4, refer Table 3, of the Sta-Tip Cap where skin to adhesive corrosion has degraded the honeycomb panel strength.

The Stab-Tip Cap indicated an area where significant strength reduction was caused by corrosion between the fillet adhesive and aluminium skin. This example of corrosion failure suggests that regions susceptible to moisture ingress on bonded panels should be considered carefully during routine aircraft maintenance and inspection. NDI of the Stab-Tip Cap also suggested that the Tap-Hammer test is potentially difficult to apply in a consistent and reliable manner to identify disbanded panel regions. The area identified by the Tap-Hammer test indicated Tensile strength values were normal. The Stab-Tip Cap inspection also highlighted the deficiency in the use of injection repairs. The reduction in tensile strength and observation of the failure mode suggested that the injected potting compound had not adequately wetted the core and skin, leading to a weak adhesive bond. The low strength value recorded also suggested that strength of the potting compound was low, as indicated by regions where the potting compound had fractured cohesively.

- 2) Due to the poor durability of honeycomb sandwich panels that have been rebuilt or repaired using either AF-130-2, AF131-2 or JD Lincoln adhesive and Alcore Duracore or Untreated honeycomb, special attention should be given to ensuring perimeters of panels are carefully sealed to prevent any moisture ingress.

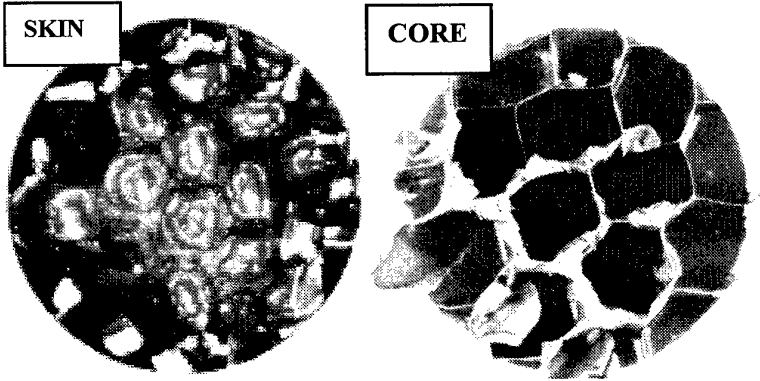
Figure 32 Failure surface images from the tensile test taken in location 3, refer Table 3, of the Sta-Tip Cap, where an ineffective injection repair has degraded the honeycomb panel strength.

- 3) During inspection and maintenance, regions of panels containing old or existing injection repairs should be carefully inspected for potential disbonds and corrosion.
