V-22 *Osprey* Hydraulic System
(D-2002-114)

Department of Defense
Office of the Inspector General

Report No. D-2002-114

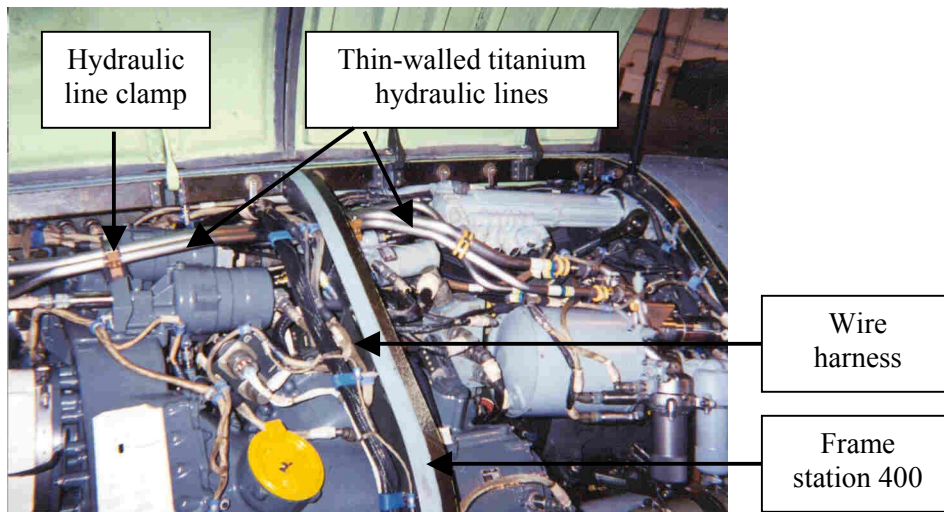
The V-22 nacelles, located at the end of each wing, house the aircraft's engine and rotor system. The nacelles are densely populated with engine and rotor system components, including actuators, wire harnesses, and lines (including thin-walled titanium hydraulic lines¹²) that are intricately routed and in close proximity to one another. Because the hydraulic system is designed to operate at 5,000 pounds of pressure per square inch, it provides the opportunity to use smaller actuators and allows for a more compact packing of the nacelle. To achieve a lower aircraft weight, thin-walled titanium hydraulic lines are used in the nacelles and other locations throughout the V-22. Figure 2 illustrates the compact and heavily populated environment of the V-22 nacelles and identifies the frame station 400 as well as one of the many hydraulic line clamps, thin-walled titanium hydraulic lines, and wire harnesses within the V-22 nacelles.

Figure 2. Outboard Right Nacelle of an LRIP Aircraft

VMMT-204 maintenance personnel, the Line Clearance IPT, and the Panel indicated that the hydraulic system problems experienced by the V-22 Program were primarily caused by a compact nacelle design, which made it difficult to minimize the impact of vibration, and a manufacturing variance referred to as “artisan latitude.” Vibration and artisan latitude can result in hydraulic line chafing that degrades the reliability of the hydraulic system.
