NRL/MR/6110--02-8632

Green Thread Pipe Evaluation at Lualualei, HI and Jim Creek, WA

*Chemical Dynamics and Diagnostics Branch
Chemistry Division*

August 16, 2002

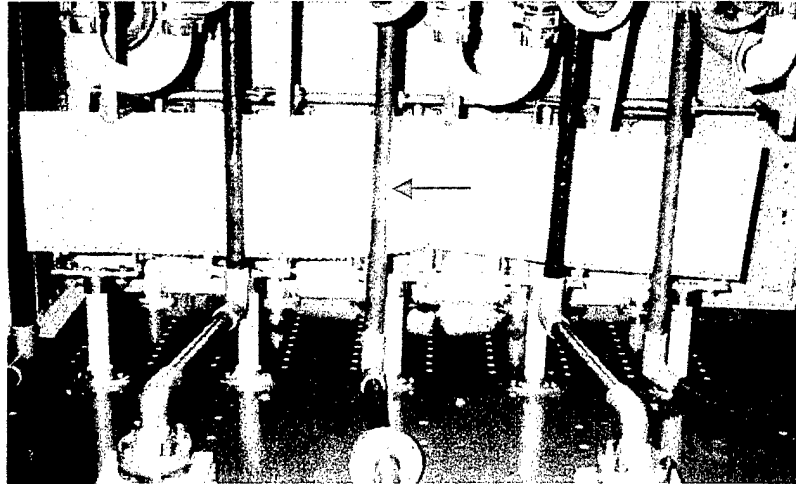
Figure 2. 1998 Photograph of the fiberglass pipe for PA 2 showing the color variations change in 1998 for PA2.

The coloration of the fiberglass pipe was photographed for use in future assessments of the aging process of the fiberglass pipe under VLF operating conditions. The discoloration of the pipe was mapped for all the cabinets. Figure 2 shows the color variations obtained for PA 2 in 1998. In general, the outlet pipes have a darker amber color than the inlet side pipes, but there were significant variations in the color for both inlet and outlet due to the variations in batch production of the pipe. There appeared to be color discontinuities in some of the piping where a splice has been used to join two pieces of pipe (indicated by arrow).

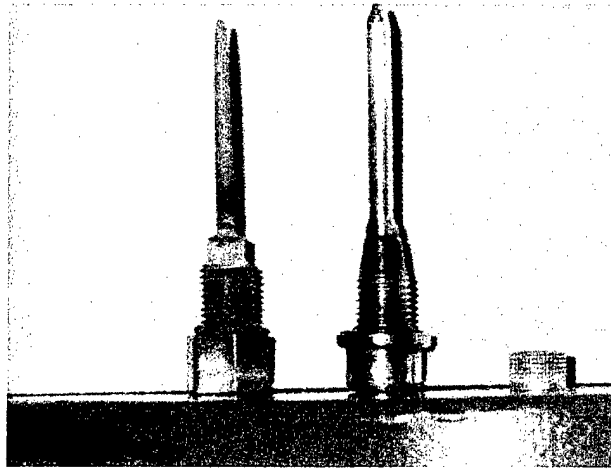
At that time, selected copper targets were removed from six of the piping segments to allow for the collection of water and also for the collection of swipe samples in the vicinity of the fiberglass pipe. This procedure was performed on pipe segments that were dark amber and those that were light green/amber in color so as to gain some variation, if it exists, in dissolved copper concentrations in the cooling water that is in intimate contact with the fiberglass pipe (keeping in mind that the water is mixed back in the PA tanks). Copper concentrations obtained from the swab samples ranged from 0.03 to 0.06 mg/l. In discussions with site personnel in May 2000, they stated that there was no increase in the erosion rate of the copper targets since the fiberglass pipe had been installed nor had targets been replaced since the installation of nitrogen generation system. As was the case with the Lualualei site, replacement targets were of a slightly different design so a comparison could not be made between the “in use” target and its replacement (see figure 4).

Figure 4. Targets from Jim Creek: on left side, old style target that had been in use for several years; new style target on right.

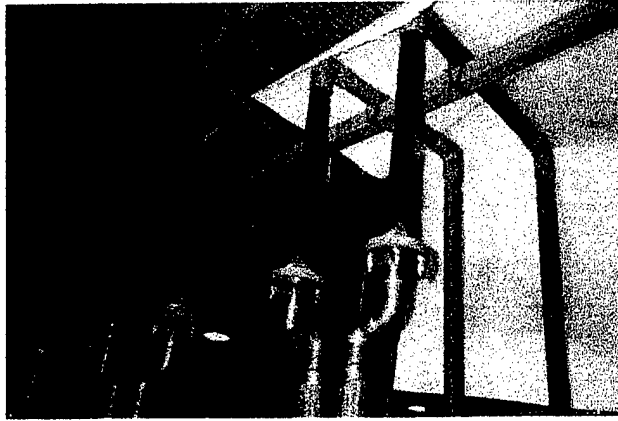
The fiberglass pipe (figure 5) was installed in February 1997 and had been in service for approximately 13 months (May 1998). The upper summer time operating temperature for the cooling water is approximately 110°F. The color variations in the fiberglass pipe at that time were less intense at Jim Creek than those at Lualualei, HI. Once again, the variations in color adhere to the rule that the warmer the pipe (i.e., higher temperature of the cooling water) the darker the color. However, similar to the Lualualei site, there are light green/amber fiberglass pipe on the hotter exiting water with multiple variations to the general color distribution. There are cases where there is a light green/amber section of pipe immediately attached to the exit flange, the next segment of pipe is dark amber and the remaining segment of pipe is light green/amber. The

Figure 5. 1998 photograph of fiberglass pipe discoloration for 13V1001 (starboard side).

explanation is probably in the quality control of the fiberglass pipe batches, pipe age and ambient temperature of the situation. As can be seen in figures 5 and 6, the color of the fiberglass pipe has darkened but retained the same color differentials. It may take a very long in service time (many years) before the Jim Creek site fiberglass pipe obtains a relatively even dark color like Lualualei.

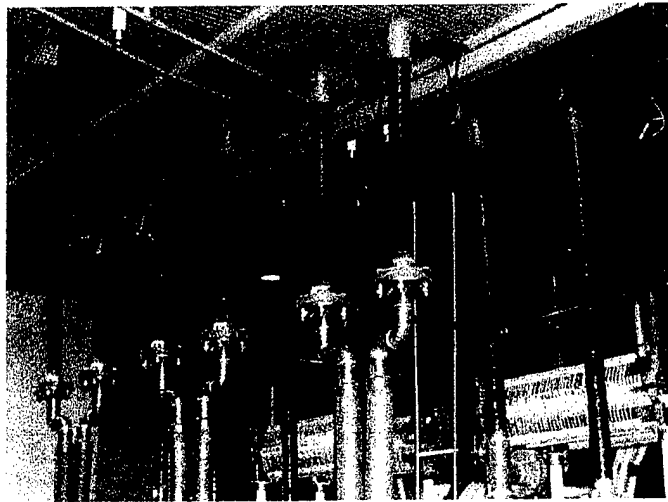
Figure 6. 2002 photograph of the fiberglass pipe discoloration for 13V1000 (starboard side).

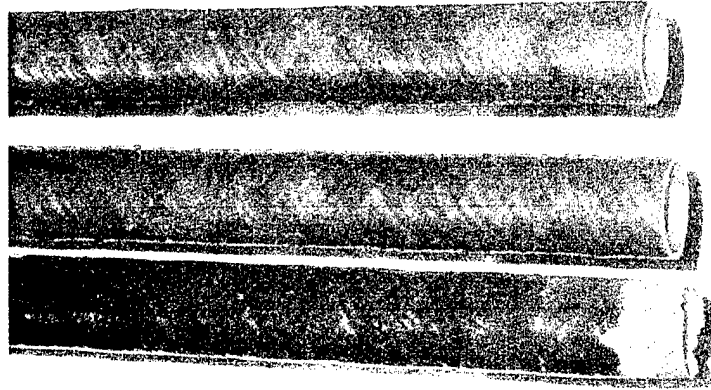
Figure 7 shows how different the color changes can be obtained for the Green Thread pipe over a period of time. Several pieces of Green Thread pipe were stored in

Figure 7. Green Thread pipe stored in warehouse at Lualualei site, March 2001.

the warehouse away from the transmission site at Lualualei. The temperature in the storage building at Lualualei was in the high 90s in March 2001. There is no air conditioning in that building but the room was filled with sunlight. We have an example of darker amber, medium amber and a medium yellow-green color. In this case, heat and UV light play a role in the color conversion. In contrast, several pieces of fiberglass pipe that were left at the Jim Creek site after installation over 4 years ago still have the light yellow/green and darker green color (Figure 1). There is no air conditioning for the Jim Creek storage site but the temperature in the storage area probably rarely exceeds 80° F. There is no incident sunlight in the Jim Creek storage room. The pipe is virtually “in the dark” unless someone enters the room and turns on the light or opens the outside storage doors. This pipe from Jim Creek is also an excellent example of the quality control for color. There is already a piece of pipe which exhibits a much darker quality (green) which will turn more quickly into a dark/amber color when subjected to increased temperatures.

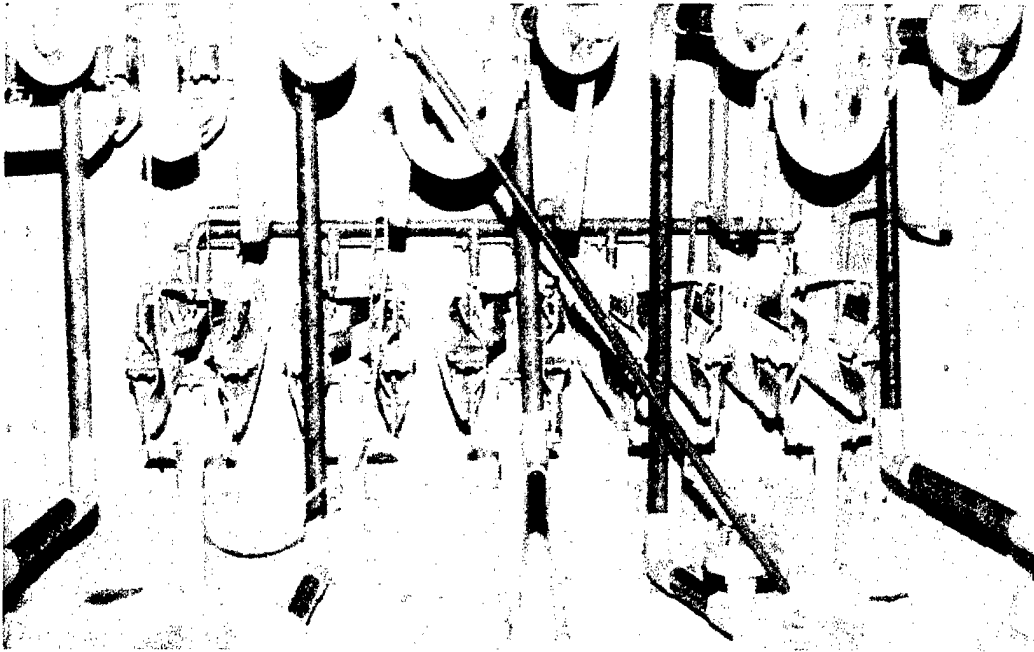
Figure 1. 1998 photograph of PA 1 (right side) fiberglass pipe showing color variations.

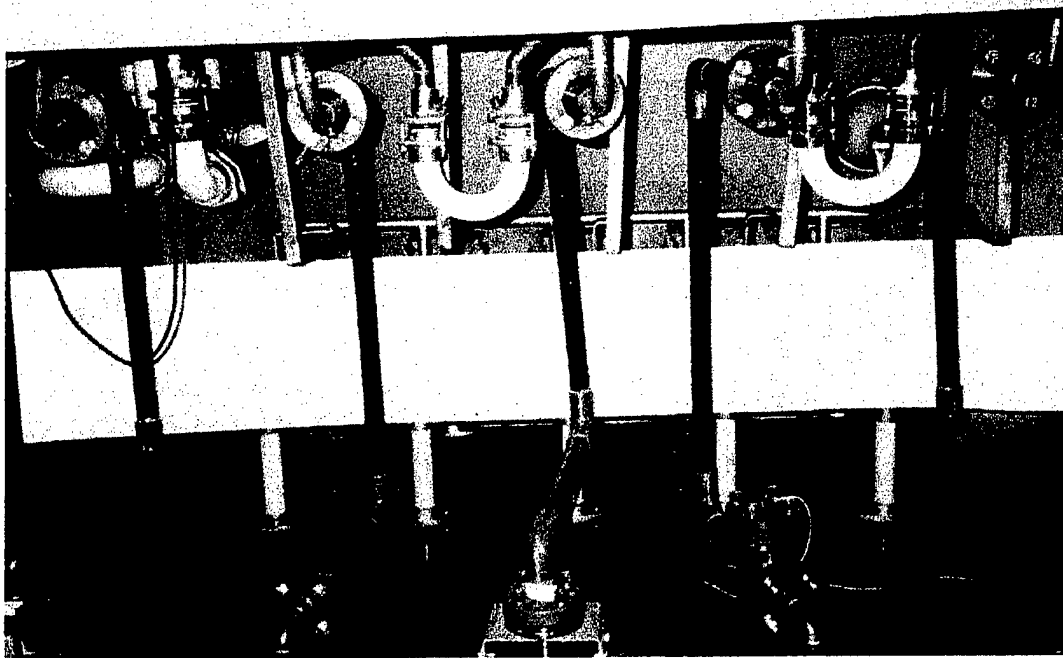
Figure 3. 2000 photograph of PA 1 (right side) fiberglass pipe showing that the color variations are almost nonexistent.

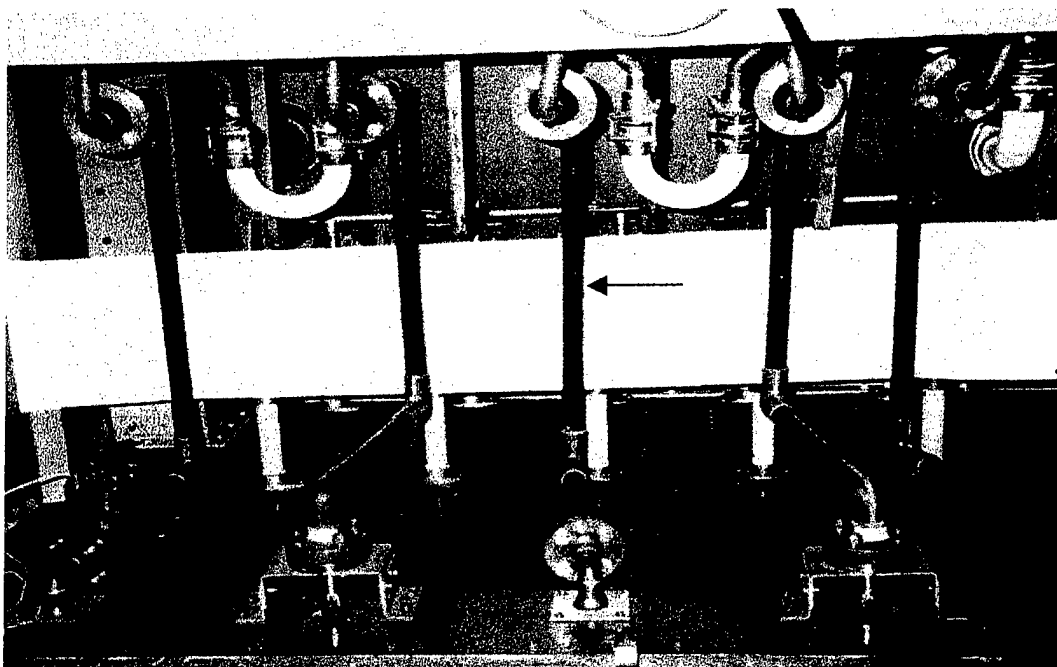
Figure 4. 2000 photograph of PA 2 (left side) fiberglass pipe showing color variations. Only slight indication of discontinuity (arrow) of color in center pipe shown in figure 2.

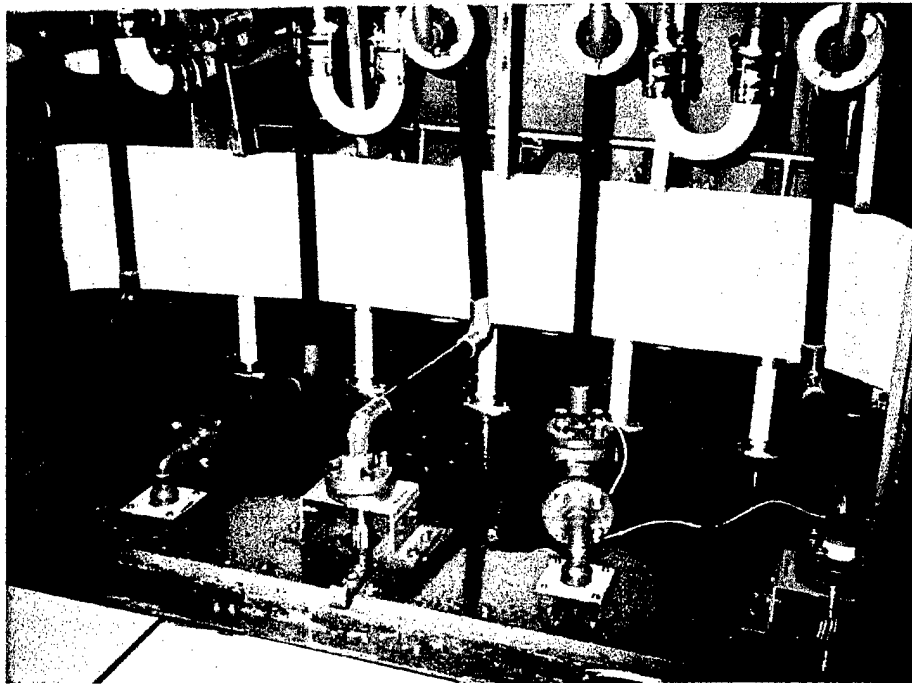
Figure 5. 2001 photograph of PA 1 (right side) fiberglass pipe showing that the color variations are almost nonexistent.

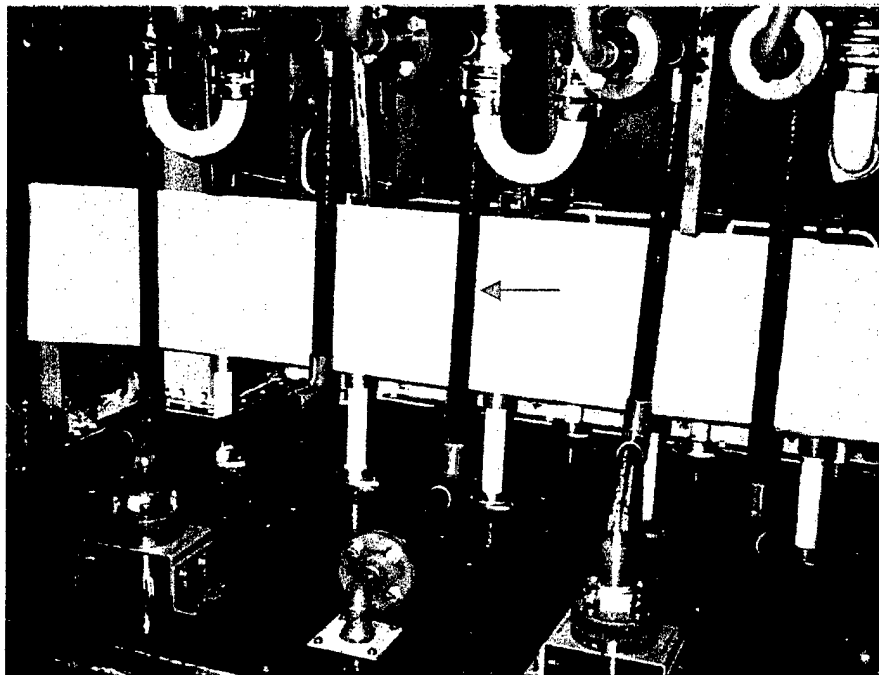
Figure 6. 2001 photograph of PA 2 (left side) fiberglass pipe showing no color variations. Arrow indicates where discontinuity occurred in Figures 2 and 4.

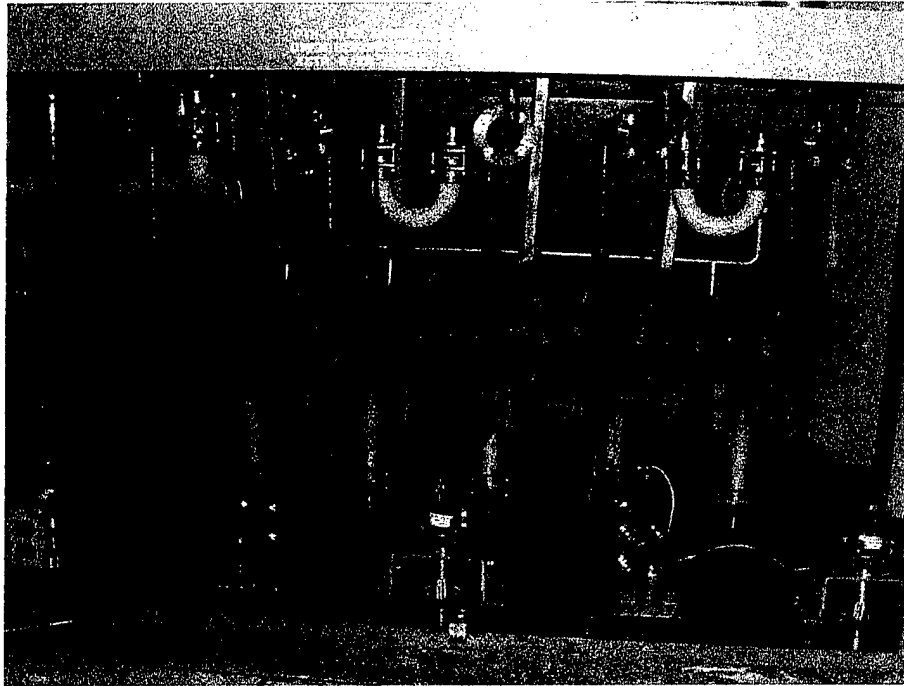
Figure 7. 2002 photograph of PA 1 (right side) fiberglass pipe showing that the piping exhibits almost even darkened coloring.

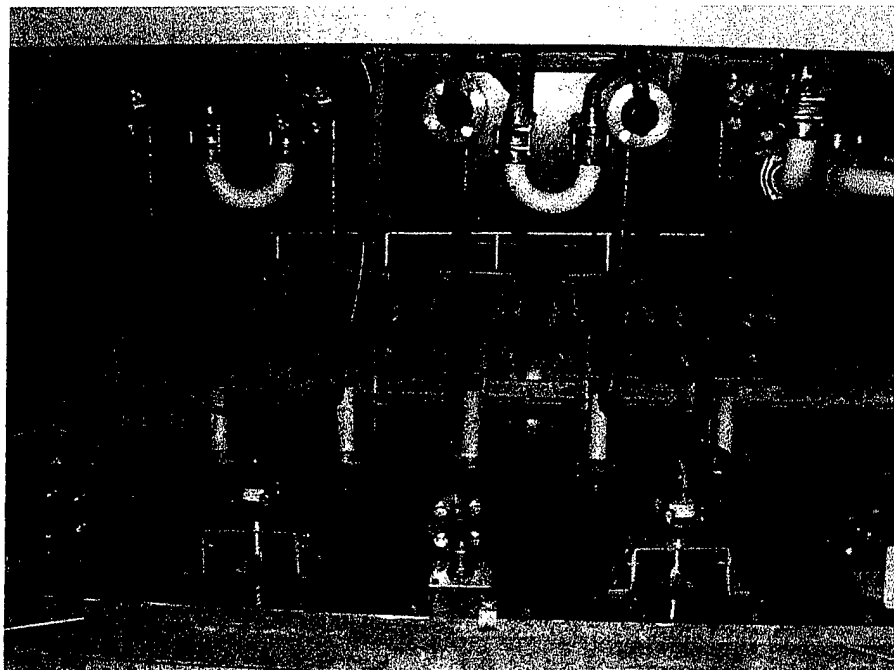
Figure 8. 2002 photograph of PA 2 (left side) fiberglass pipe showing no color variations.

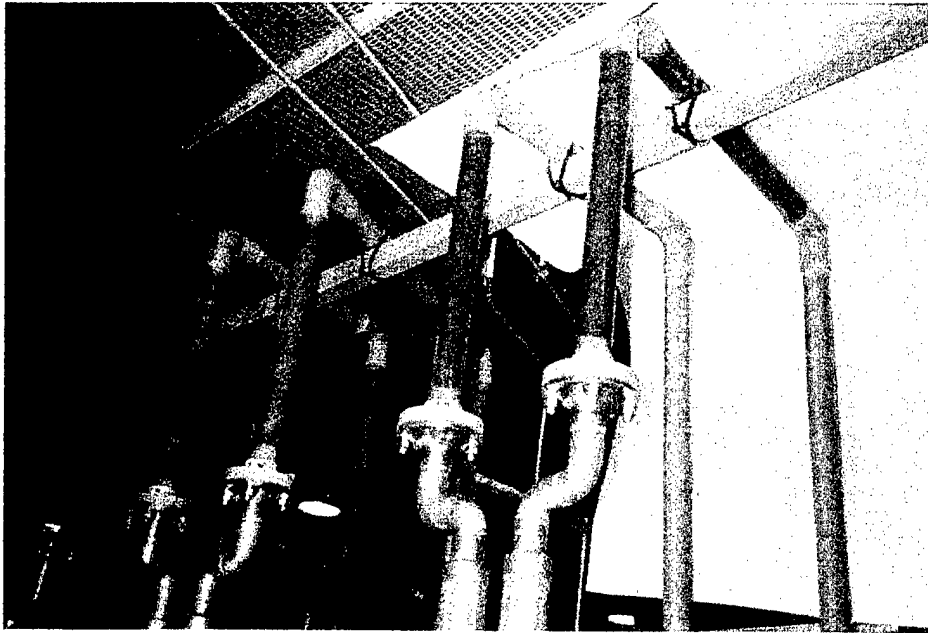
Figure 9. 1998 photograph of fiberglass pipe discoloration for 13V1001 (starboard side)

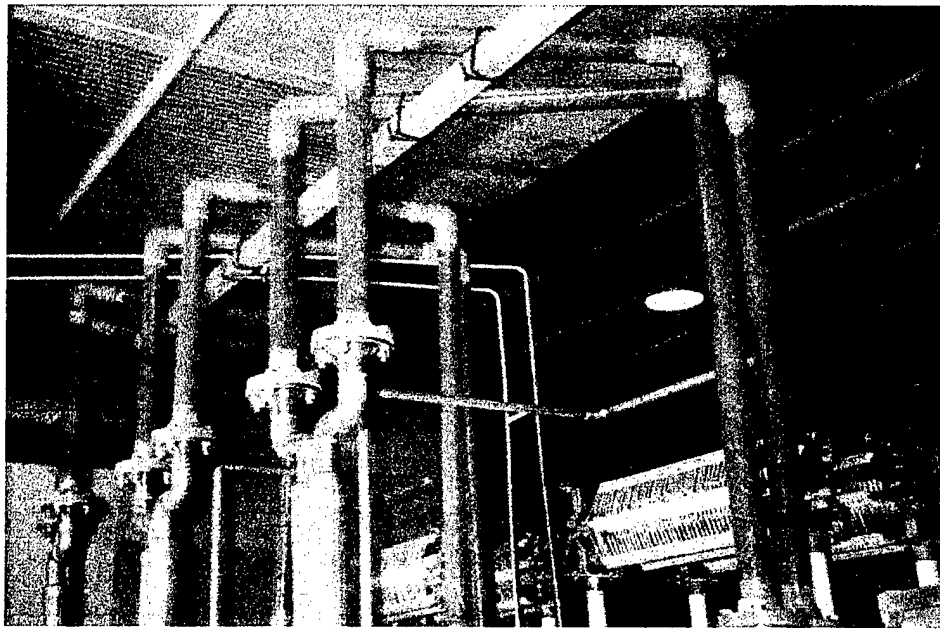
Figure 10. 1998 photograph of fiberglass pipe discoloration for port side PAs. Relatively even color distribution as compared to figure 7.

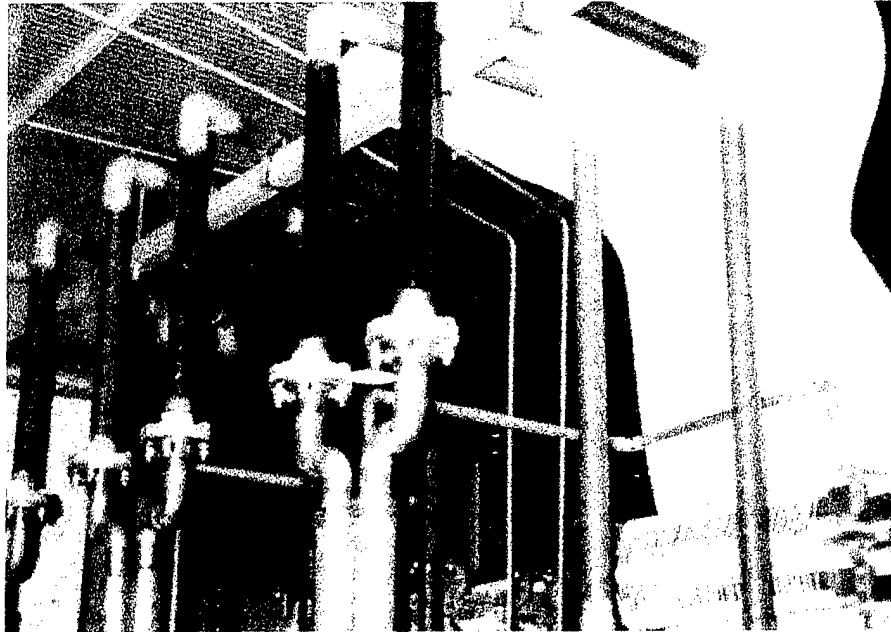
Figure 11. 2000 photograph of fiberglass pipe discoloration for 13V1001 (starboard side)

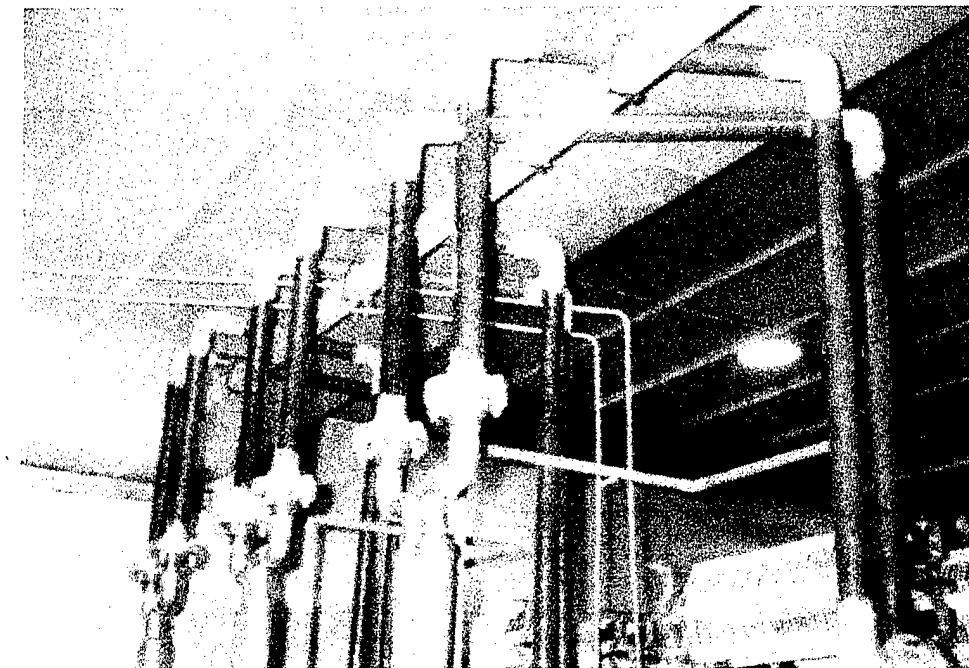
Figure 12. 2000 photograph of fiberglass pipe discoloration for port side PAs.

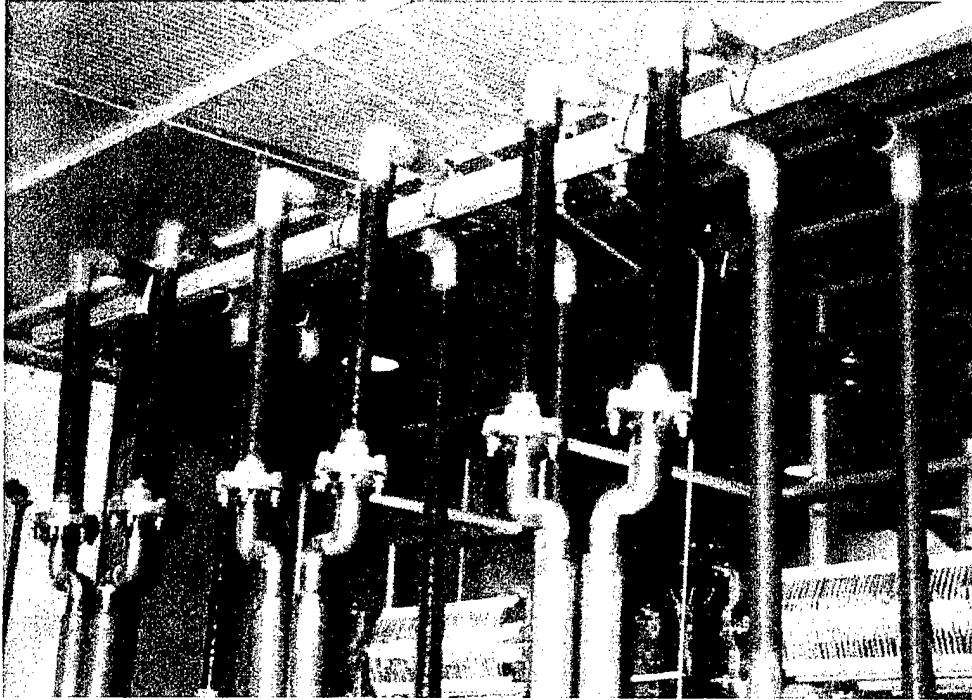
Figure 13. 2001 photograph of fiberglass pipe discoloration for 13V1001 (starboard side).

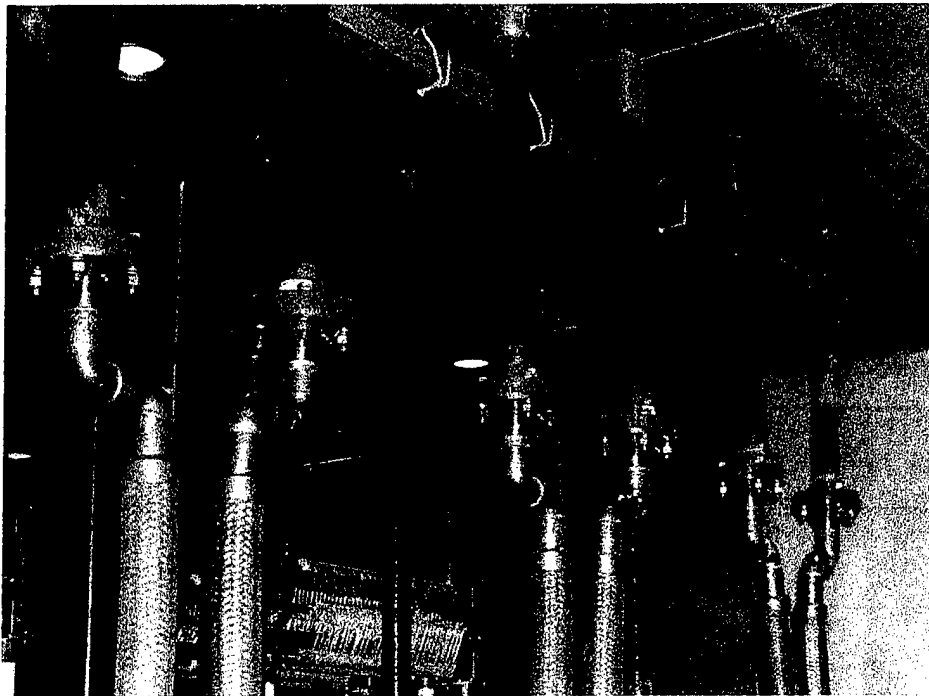
Figure 16. 2002 photograph of fiberglass pipe discoloration for portside PAs
