**AFRL-PR-WP-TR-2002-2061**

**JP-8+100 ENGINE DEMONSTRATION  
Industry Version**

**MARCH 2002**

**Final Report for 23 June 1995 – 30 July 2000**

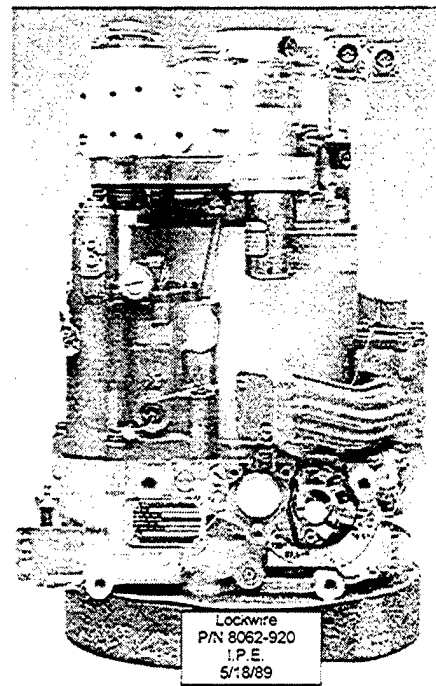
**Figure 1 ESN 538103/5, 5A, 5B, and 5C Clean Layout Results: Main Engine Control**

**Observations:** The MEC was found to be in generally excellent condition. It was very clean internally. Seals, O-rings, wear surfaces, and bearings exhibited no unusual wear or distress. No safety issues or early removal for cause were identified.

**Disposition/Recommendation:** Recommend that the MEC can be run for additional blocks of testing.

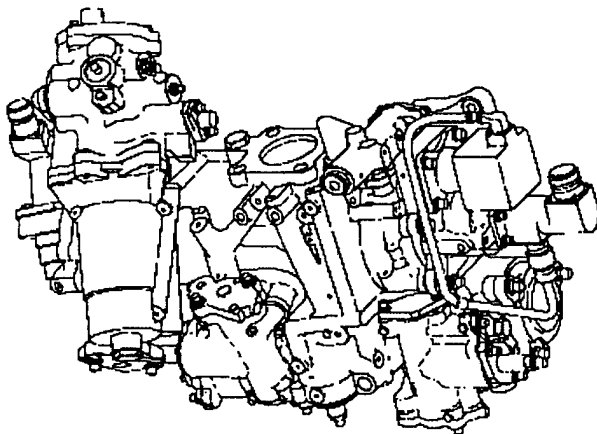
**Figure 2. ESN 538103/5, 5A, 5B, and 5C Clean Layout Results: Augmentor Fuel Control**

**Observations:** Posttest component within acceptance test procedure (ATP) limits. Handling damage to A/B on/off solenoid connector precluded testing of that function. Disassembly of control revealed "very clean" piece parts.

**Disposition/Recommendation:** Reassemble with new solenoid and use for acceptance test. No restrictions on additional engine tests.

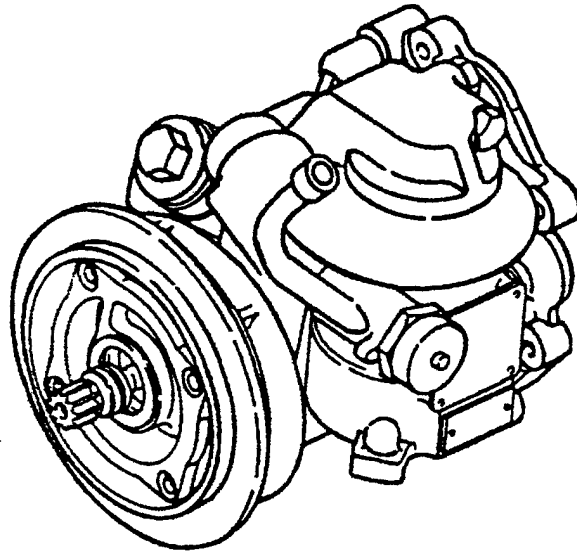
Figure 3. ESN 538103/5, 5A, 5B, and 5C Clean Layout Results: Main Fuel Pump

- No deterioration in performance.
- All elastomers in excellent condition.
- All parts in excellent condition except:
  1. Wear on filter bypass poppet seat not associated with JP-8+100.
  2. Impending bypass indicator would reset — not exposed to fuel.

- Reassemble pump. Return to Engineering Stores or engine operation.
- JP-8+100 fuel acceptance for Main Fuel Pump

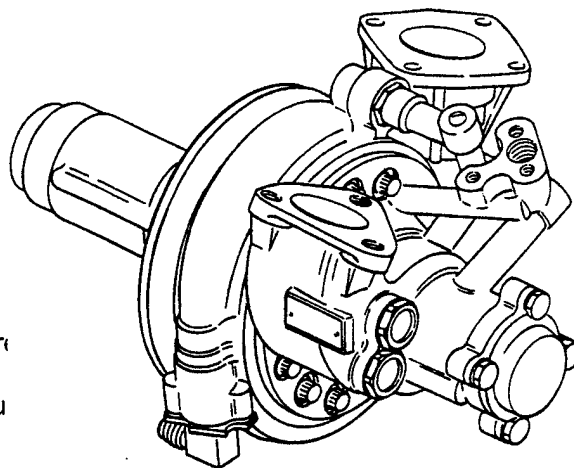
Figure 4. ESN 538103/5, 5A, 5B, and 5C Clean Layout Results: Augmentor Fuel Pump

- No deterioration in performance.
- All elastomers in excellent condition.
- All parts in excellent condition except inlet valve piston and stem damaged during disassembly.

- Reassemble pump and return to Engineering Store or engine operation.
- JP-8+100 fuel is acceptable for augmentor fuel pu

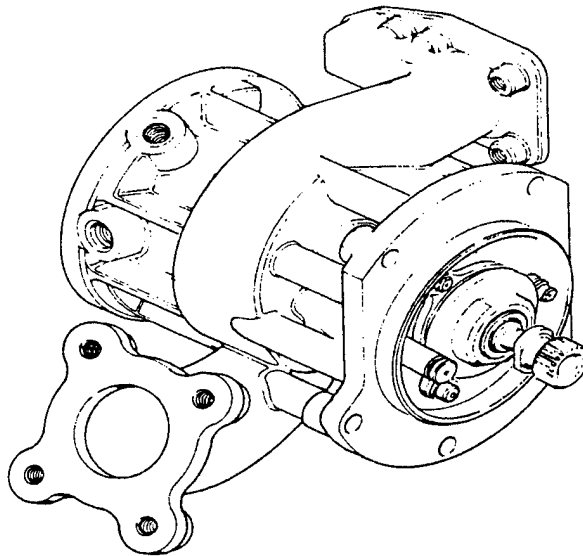
**Figure 5 ESN 538103/5, 5A, 5B, and 5C Clean Layout Results: Fuel Boost Pump**

Teardown is complete. All internal components are in excellent condition. There are indications of cavitation on "C" element blade tips, liner, and adjacent bearings.

- Wear measurements complete. All parts within T.O. limits.
- No degradation of elastomeric seals due to exposure to JP-8+100 fuel.
- One carbon seal broken during disassembly. No abnormal wear patterns observed.

- Rebuild pump and return to Engineering Stores.
- Fuel boost pump OK to use with JP-8+100 fuel.

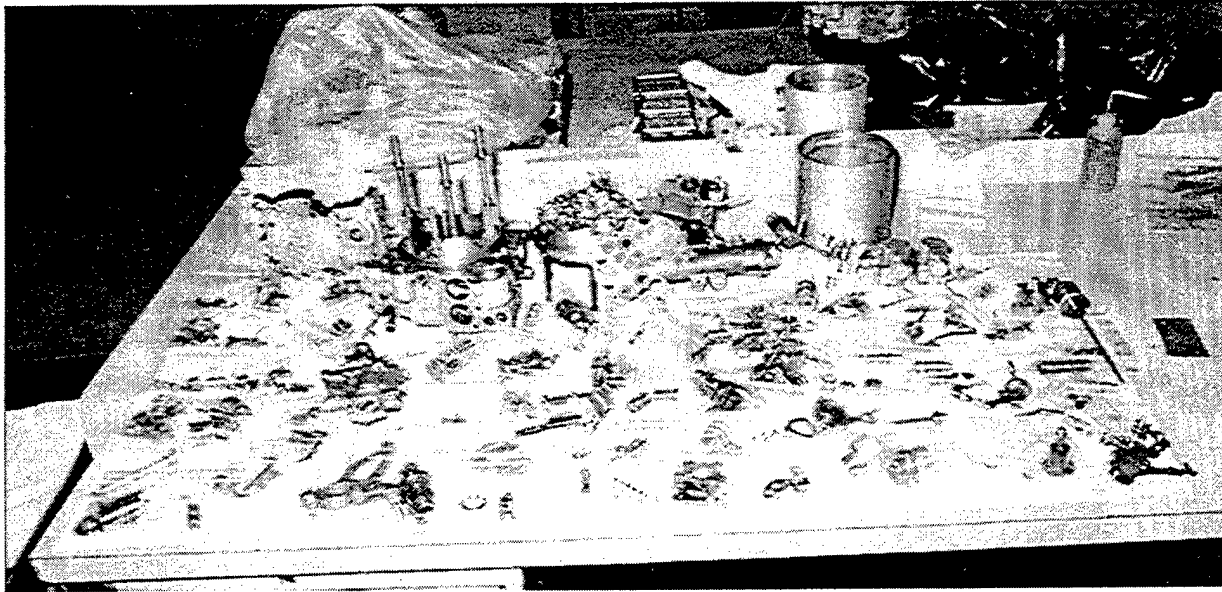
**Figure 6 Main Fuel Control, Dirty Layout** ESN 488109/6 - *Parts look very clean.*

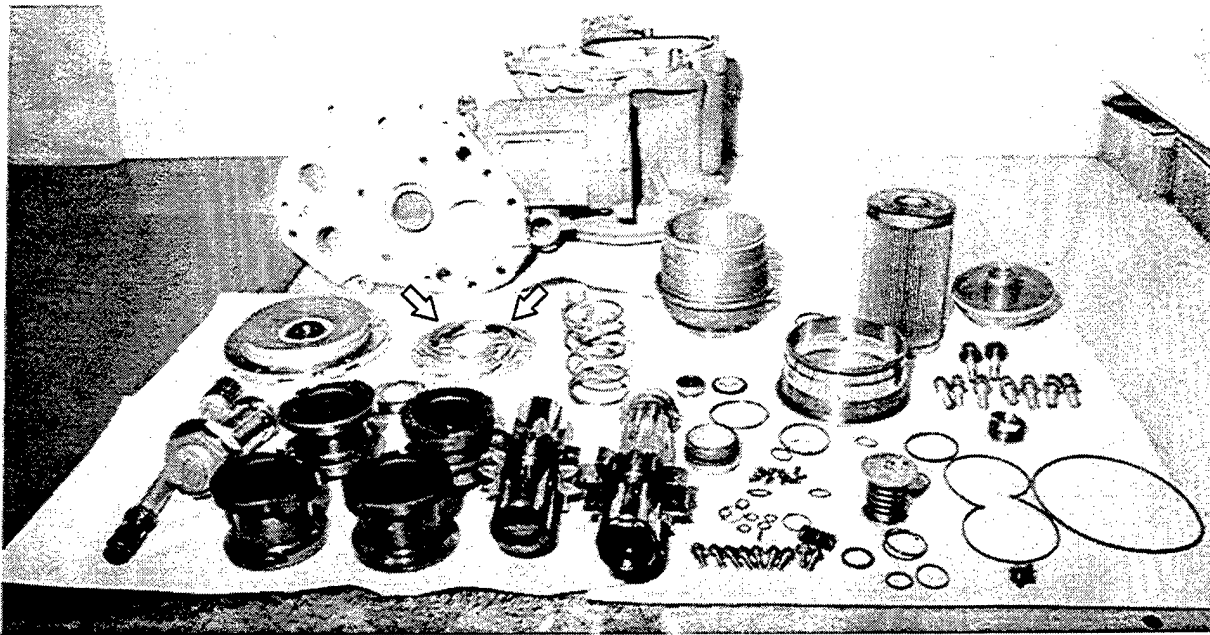
**Figure 7. Main Fuel Pump, Dirty Layout** ESN488109/6 - *Note chunks of rubber in impeller*
