## **Aircraft Accident Brief**

**EgyptAir Flight 990  
Boeing 767-366ER, SU-GAP  
60 Miles South of Nantucket, Massachusetts  
October 31, 1999**

**NTSB/AAB-02/01  
PB2002-910401  
Adopted March 13, 2002**

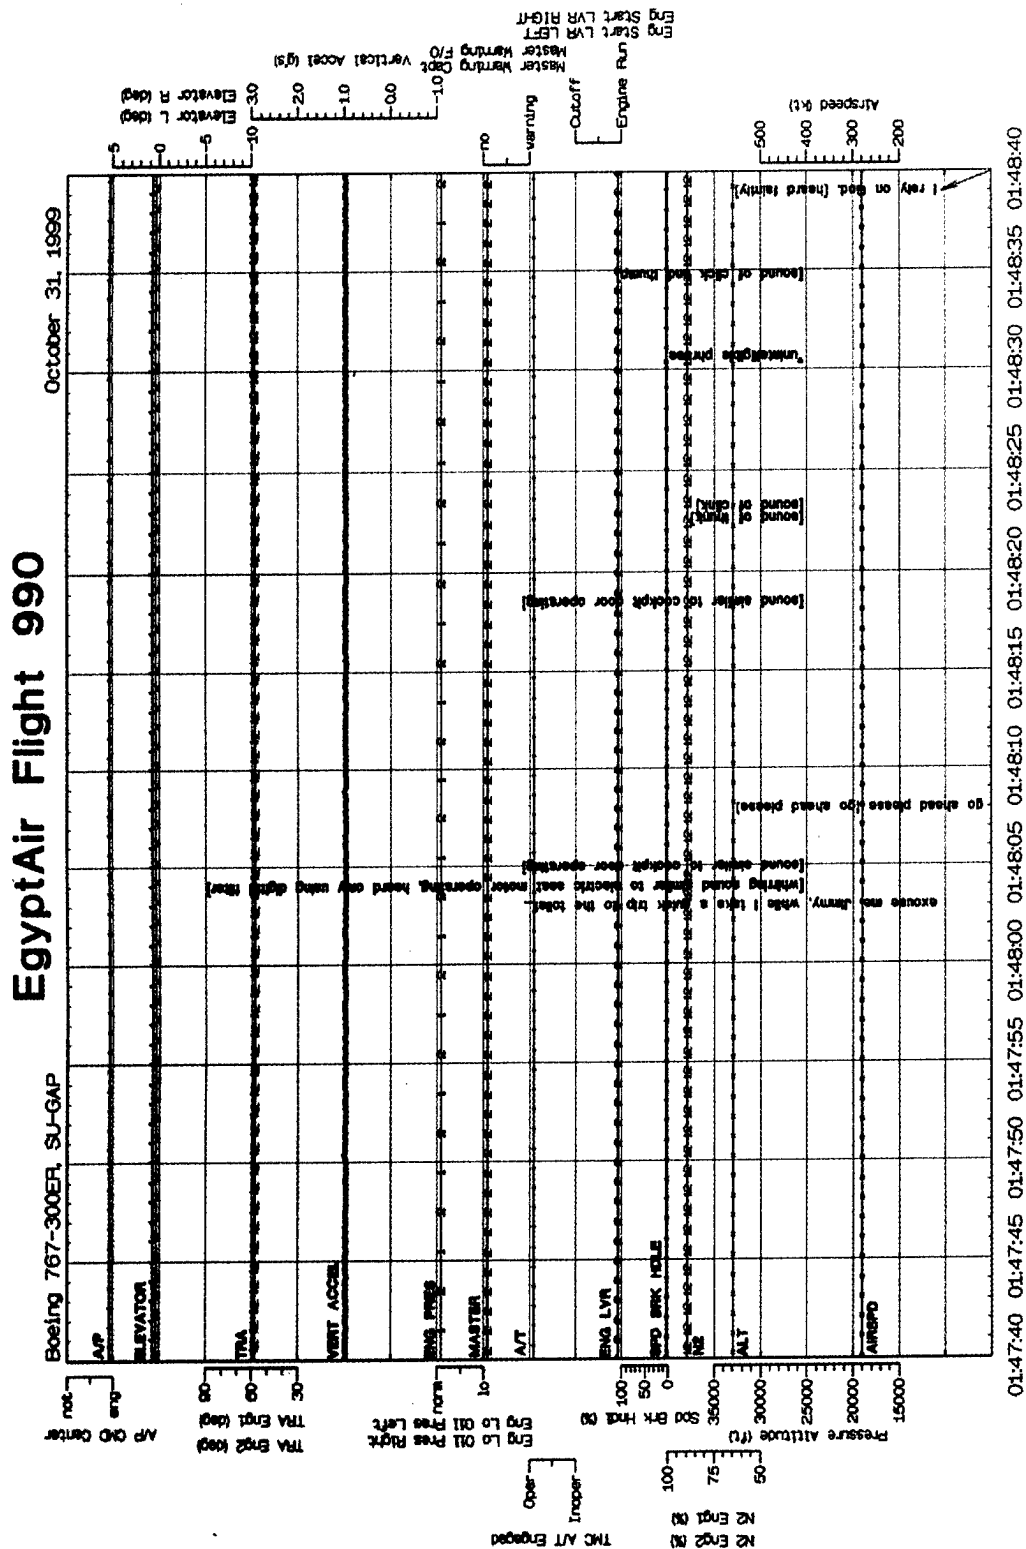
Figure 3a. A graph depicting selected FDR data from 1:47.40 to 1:48.40.

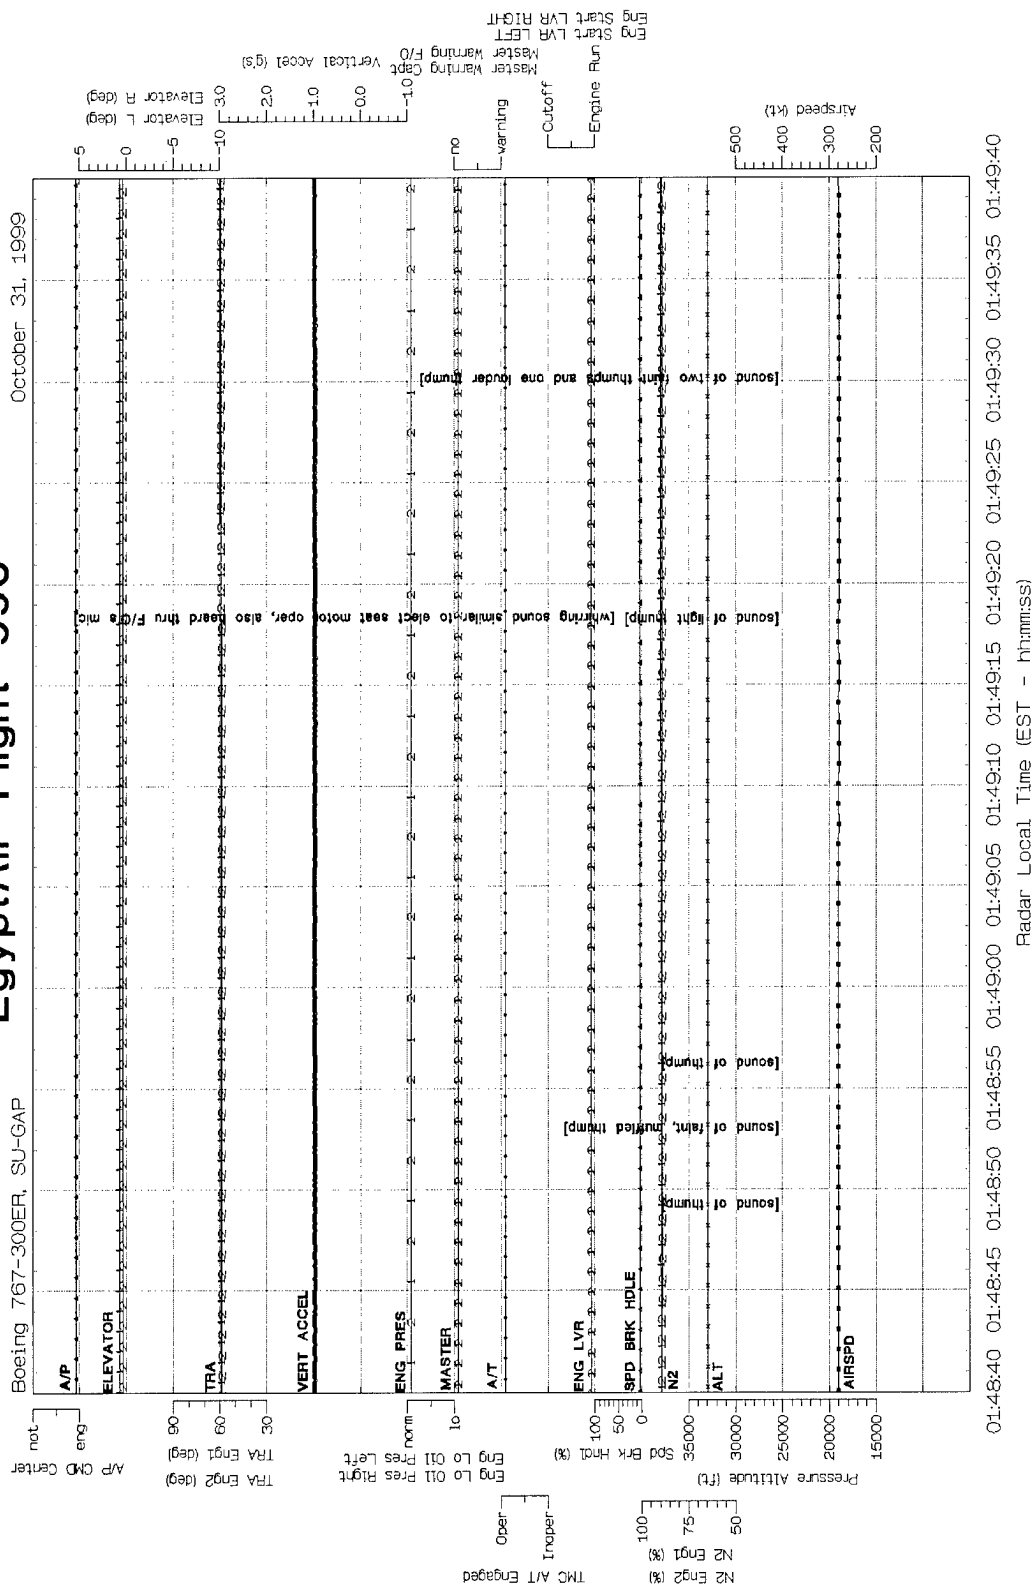
Figure 3b. A graph depicting selected FDR data from 1:48.40 to 1:49.40.

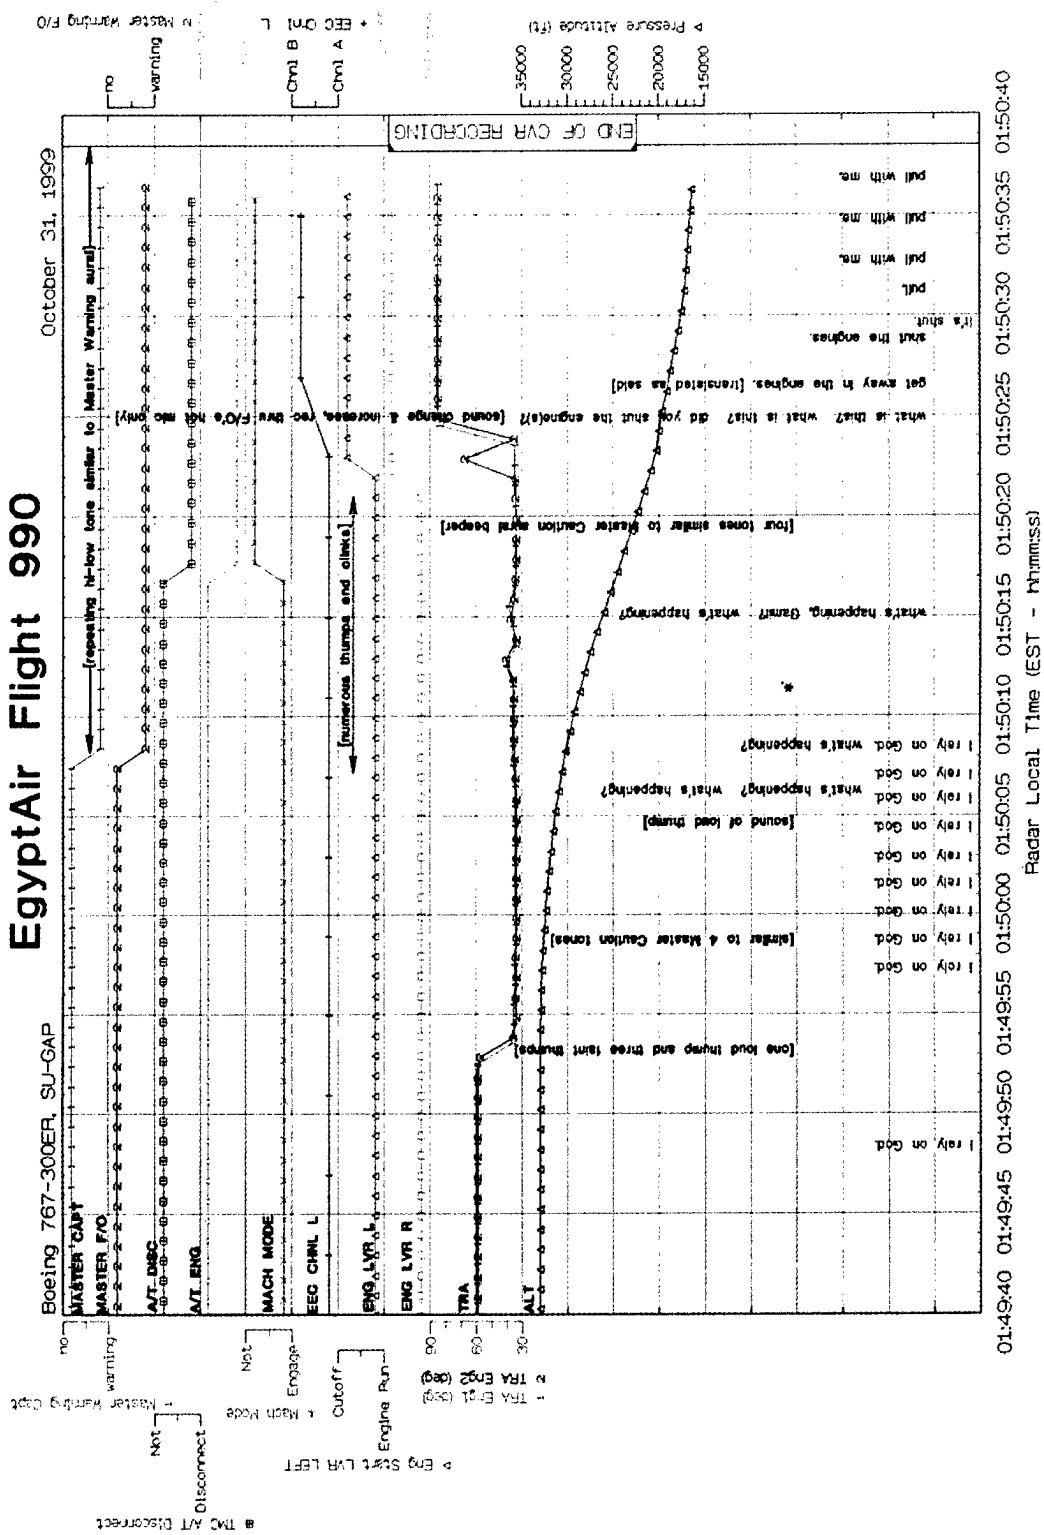
**Figure 3d.** A graph depicting selected FDR data from 1:49.40 to 1:50.40.

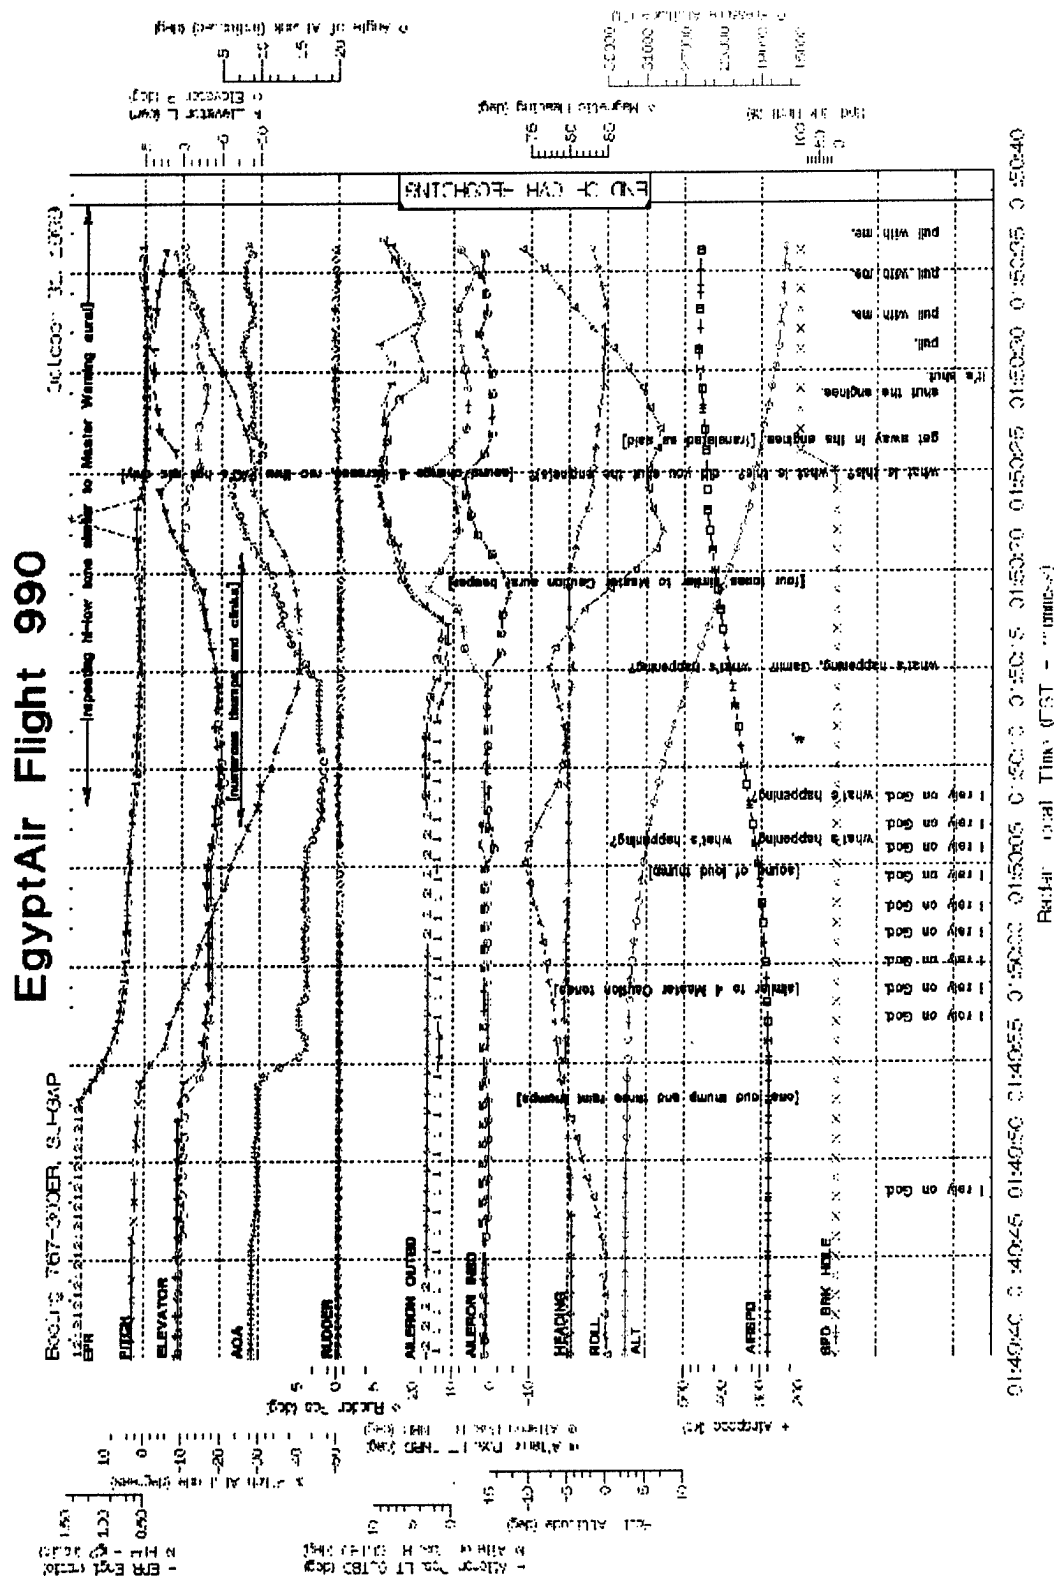
**Figure 3e.** A graph depicting selected FDR data from 1:49.40 to 1:50.40.

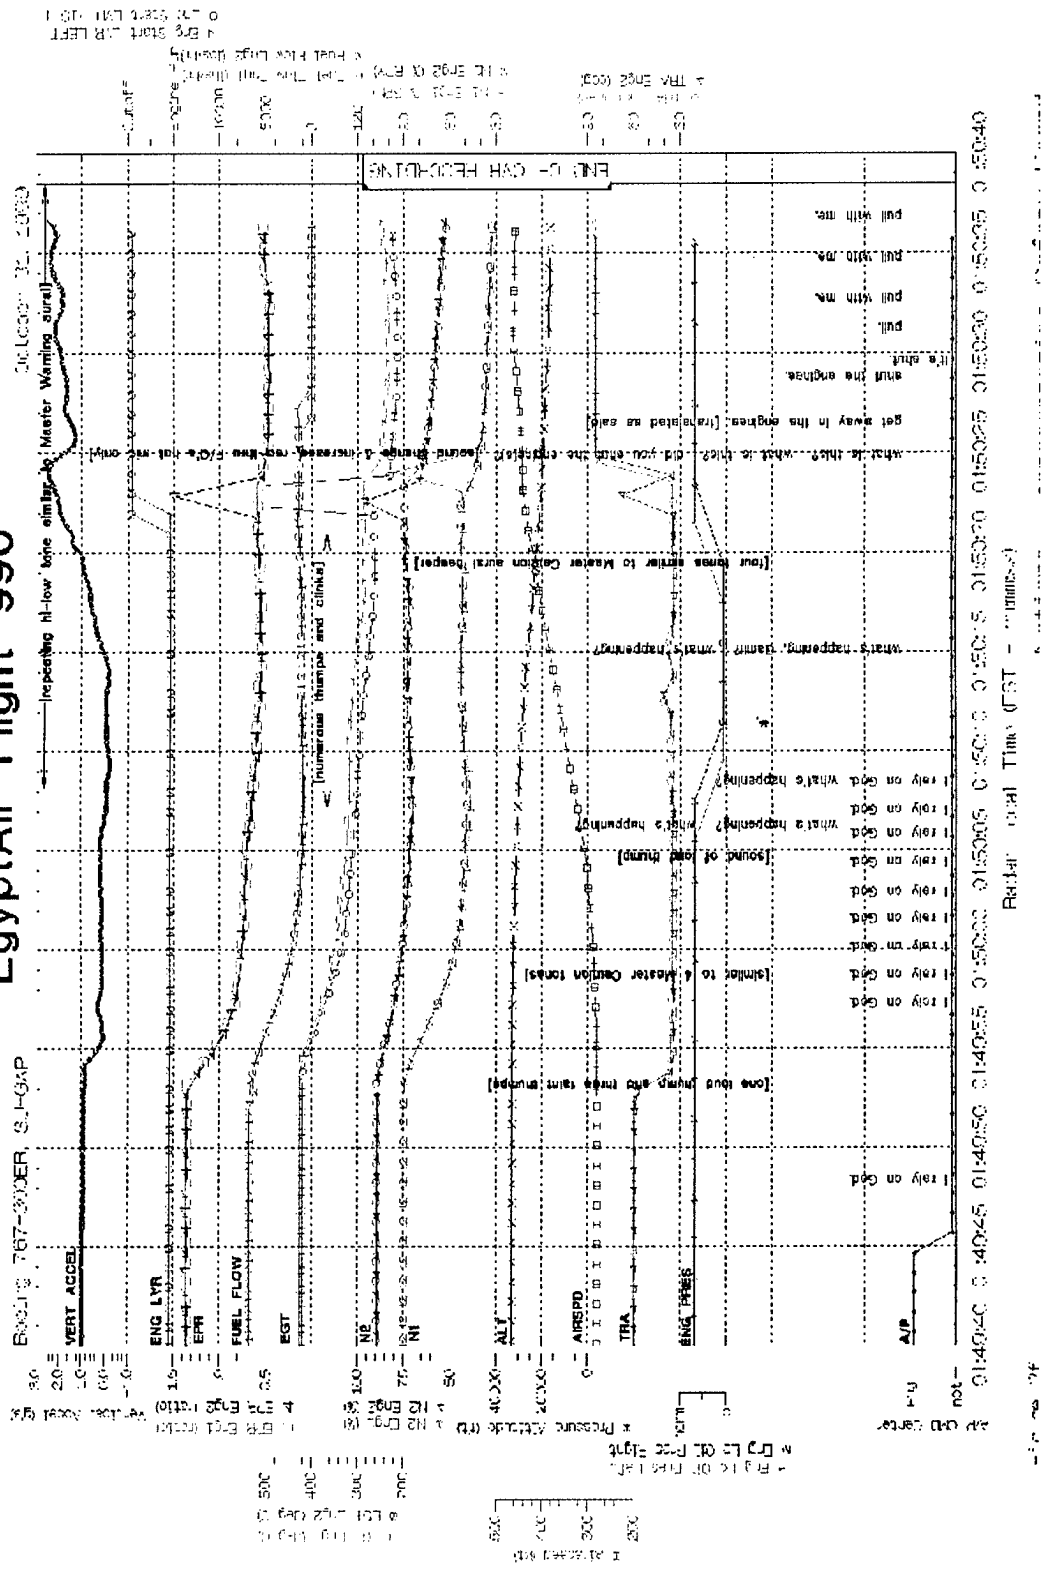
Figure 3f. A graph depicting selected FDR data from 1:49.40 to 1:50.40.

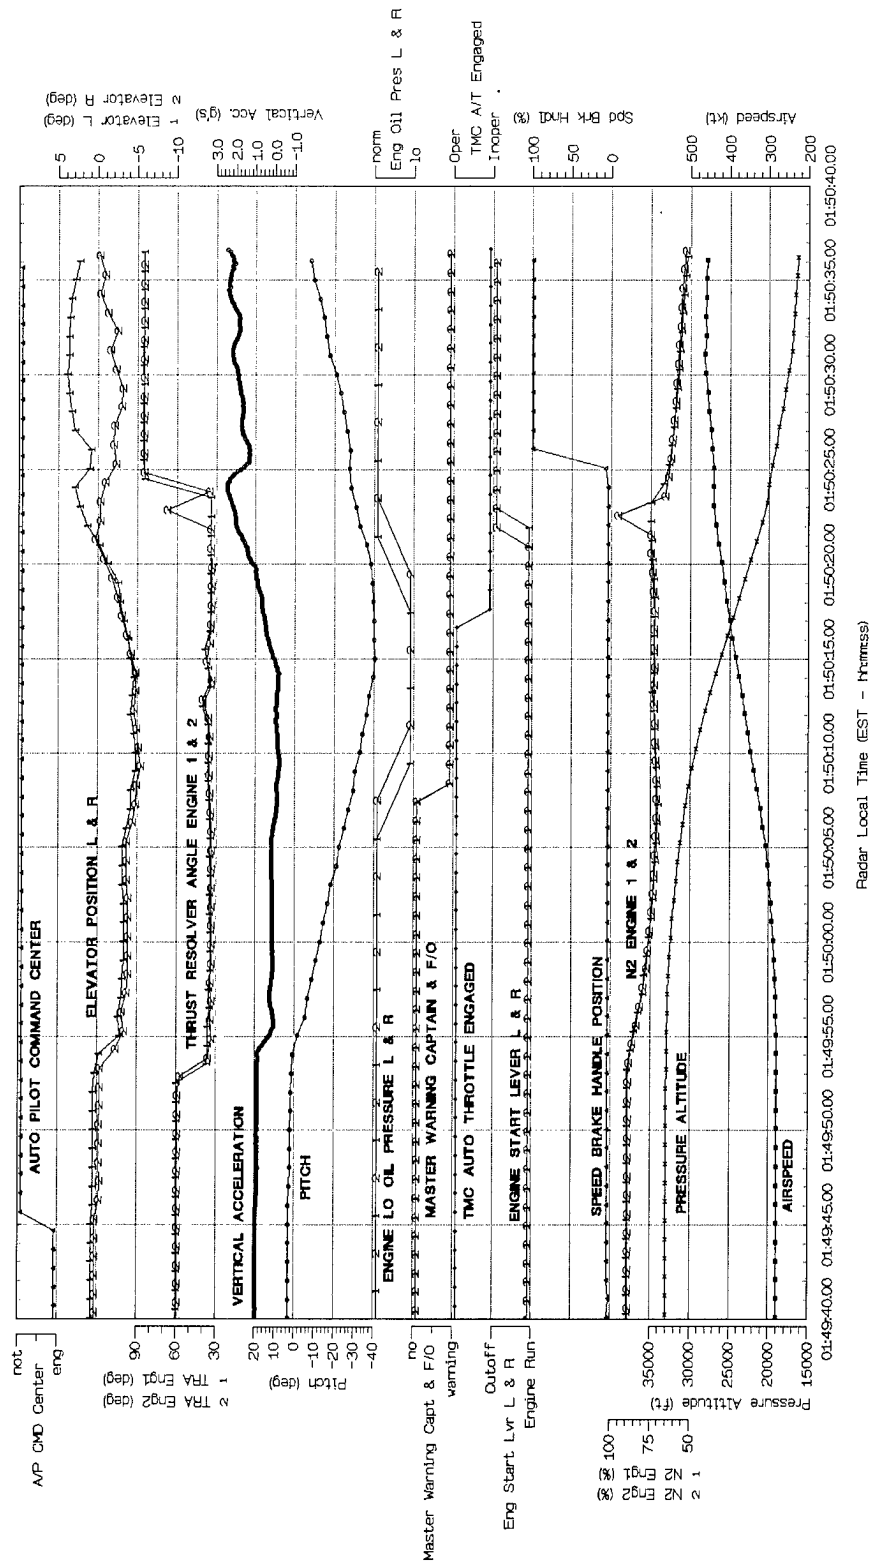
Figure 3h. A graph depicting selected FDR data from 1:49:40 to 1:50:40.
