**AFRL-VA-WP-TR-2002-3032**

**CORROSION MORPHOLOGY IN  
LAP JOINTS**

**JUNE 2000**

**Final Report for 01 April 1999 – 31 May 2000**

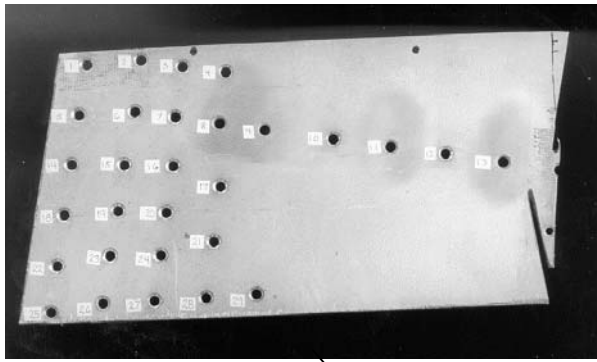
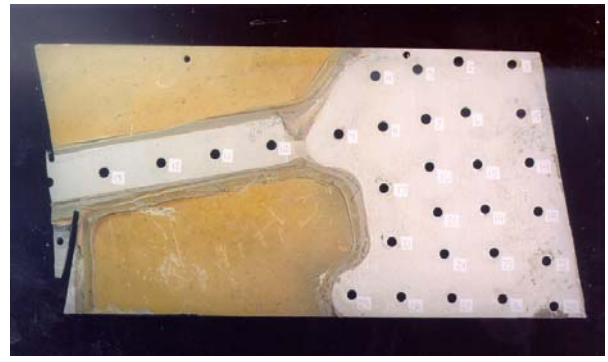
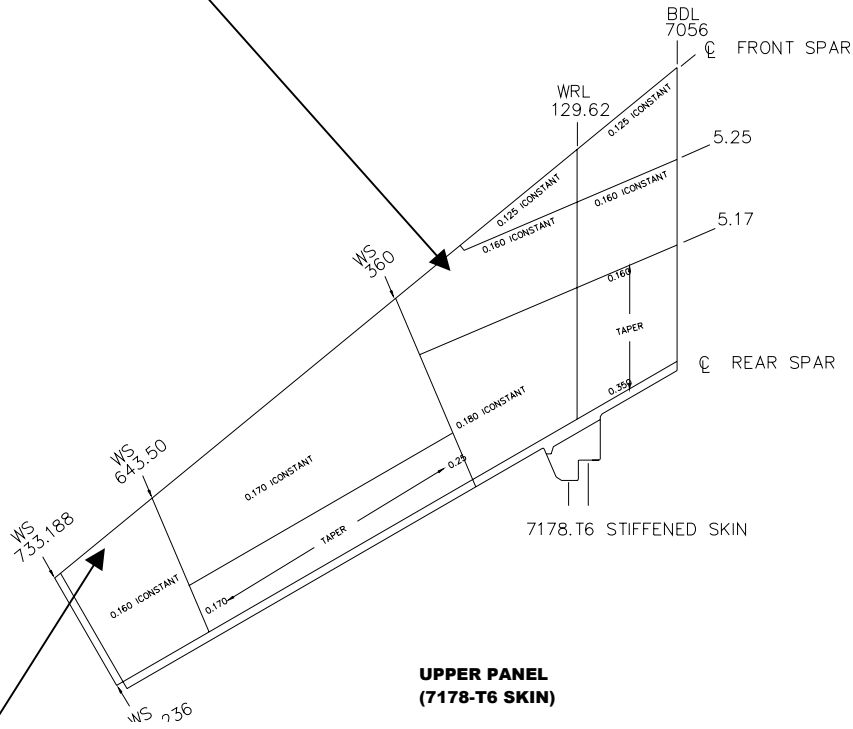
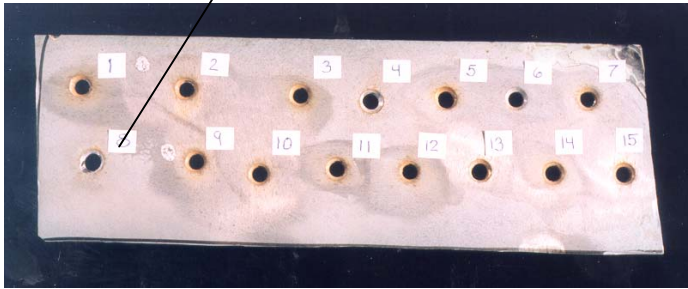
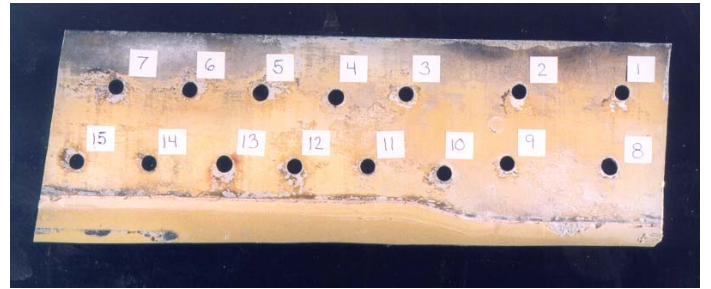
The photographs in Figure 1 show cut sections viewed from the outside and inside of the wing. Clearly visible are the grindout marks at the fastener holes, which were made during maintenance to remove corrosion in these areas. Several metallographic cross sections were made in areas on the panels where significant corrosion was suspected. Selection of the areas for metallographic cross sectioning was guided by fastener holes and other locations with grindout indications. In areas where corrosion was observed on the metallographic cross sections, metallographic crosscuts were made so that three-dimensional montages of the corrosion damage could be produced.

**Figure 1. Schematic Diagram and Sections of Upper Wing Skin Panel of KC-135 (A/C 69149)**  
 Photographs a and b show the exterior and faying surface of the inboard section.  
 Photographs c and d show the exterior and faying surface of the outboard section.

The inboard upper wing skin section lap joint showed no evidence of corrosion on the exterior surfaces other than the grindout marks (see Figure 1). Little corrosion was found on the faying surface. Upon careful examination of the fastener holes, metallographic cross sections were made at those locations where corrosion was visible. Figure 5 shows a three-dimensional montage of a section through the lap joint. It indicates the presence of only minor exfoliation near the exterior surface. Small corrosion penetrations also were observed on the walls of the fastener holes. Figure 6 shows an example of a fastener hole corrosion where both pitting and exfoliation were present just below the fastener hole chamfer.

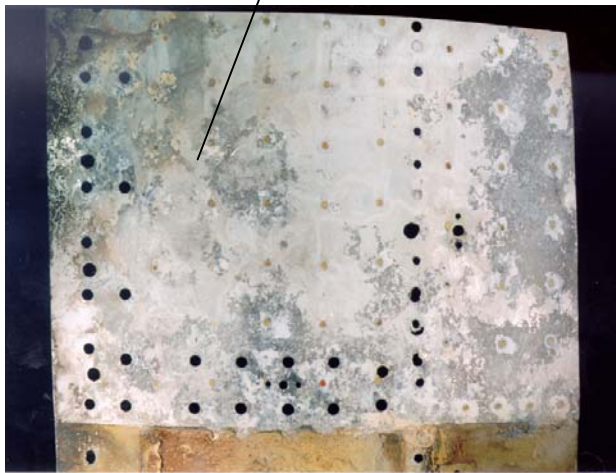
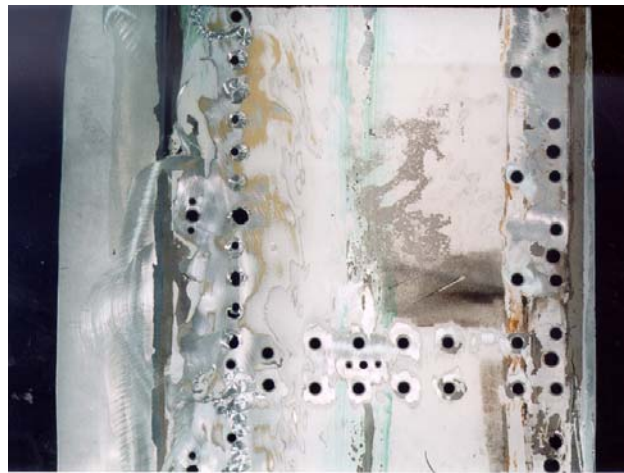
A fuselage lap joint section was removed from the fuselage adjacent to a manhole at BS 420 and S28 of A KC-135 (A/C 69149) (see Figure 2). Again, several areas could be identified where the material was ground off in an apparent attempt to remove corrosion. Based on the location of the ground areas and the amount of corrosion found on the faying surface, areas for metallographic examination were selected.

**Figure 2. Schematic Diagram of Fuselage Section of KC-135 (A/C 69149) with the Cutout Section Indicated by the Arrow**  
Photographs a and b show the matching faying surface and exterior surface of the section.

Examination of the 2024-T3 aluminum alloy lap joint sections in Figure 2 show the extensive grinding on the exterior surface and the presence of large amounts of corrosion products on the faying surface. In fact, when the lap joint panels were separated, powdery corrosion products that had build up in the joint fell out. Microscopic examination of metallographic cross section at various locations on the joint indicated that the alloy 2024 sheet contained clad on both sides and that the corrosion products had resulted from corrosion of the aluminum clad layer. Examination of several micrographs, such as shown in Figure 15, indicated extensive corrosion of the clad layer on the faying surface, but no corrosion in the 2024-T3 core material. It was further noted that corrosion of the clad was not uniform, but that shallow pits coalesced resulting in a scalloped surface texture.

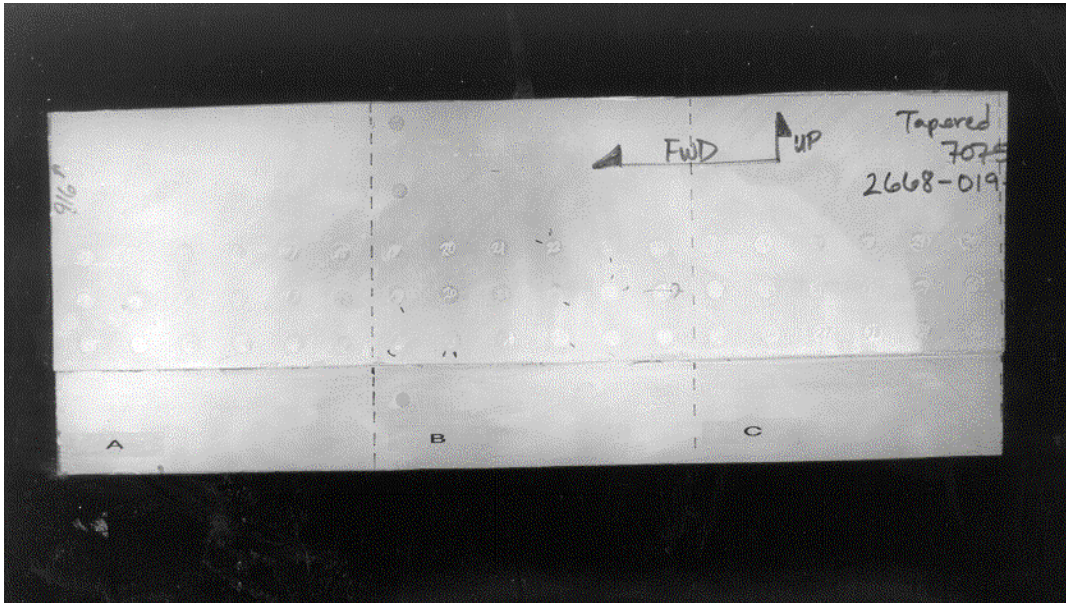
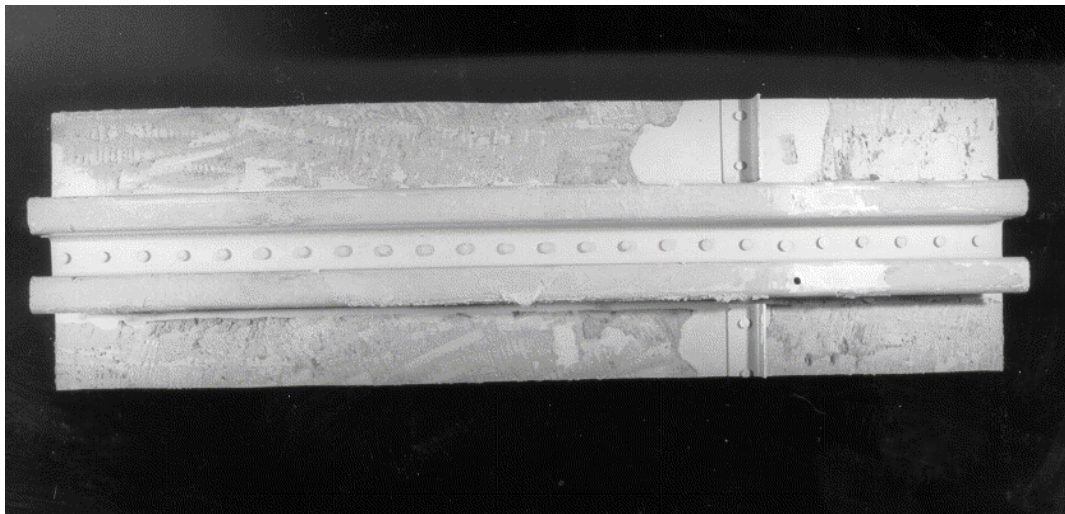
Finally, a fuselage crown section of tapered Al 7075-T6 was removed between BS916 and BS938 of a KC-135 (A/C 2668-019-B). A photograph of this cut section is shown in Figure 3.

**Figure 3. A Fuselage Crown Section Removed from an Area Between BS916 and BS938 of KC-135 (A/C 2668-19-B)**

The alloy 7075-T6 crown section lap joint showed no visual evidence of corrosion on the exterior or faying surface of the lap joint (see Figure 3). Metallographic cross-sectioning indicated some corrosion near the edge of most of the fastener holes. An example is shown in Figure 16a, where pitting corrosion is seen on a metallographic cross section through a fastener hole. Further, extensive corrosion of the clad layer on the outside of the skin surface was observed (see Figure 16b). The micrographs clearly indicate that corrosion of the clad layer starts as localized pitting and extends across the clad surface.

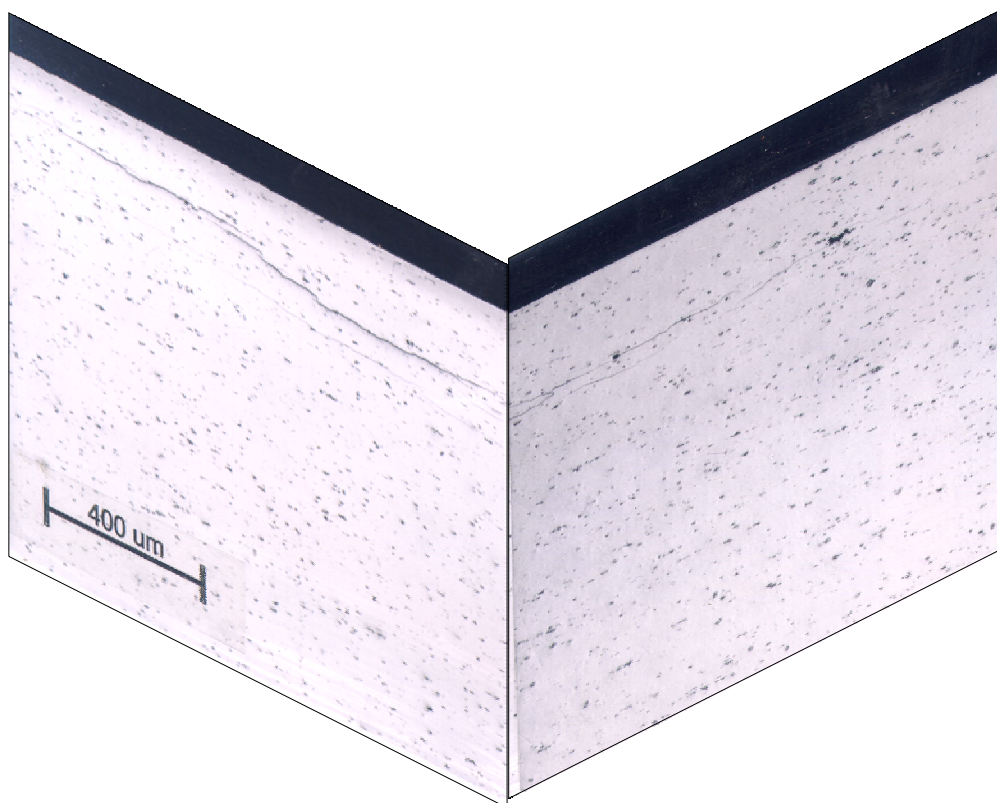
**Figure 5. Three-Dimensional Image of Metallographic Cross Sections near Exterior of Inboard Wing Section Lap Joint**

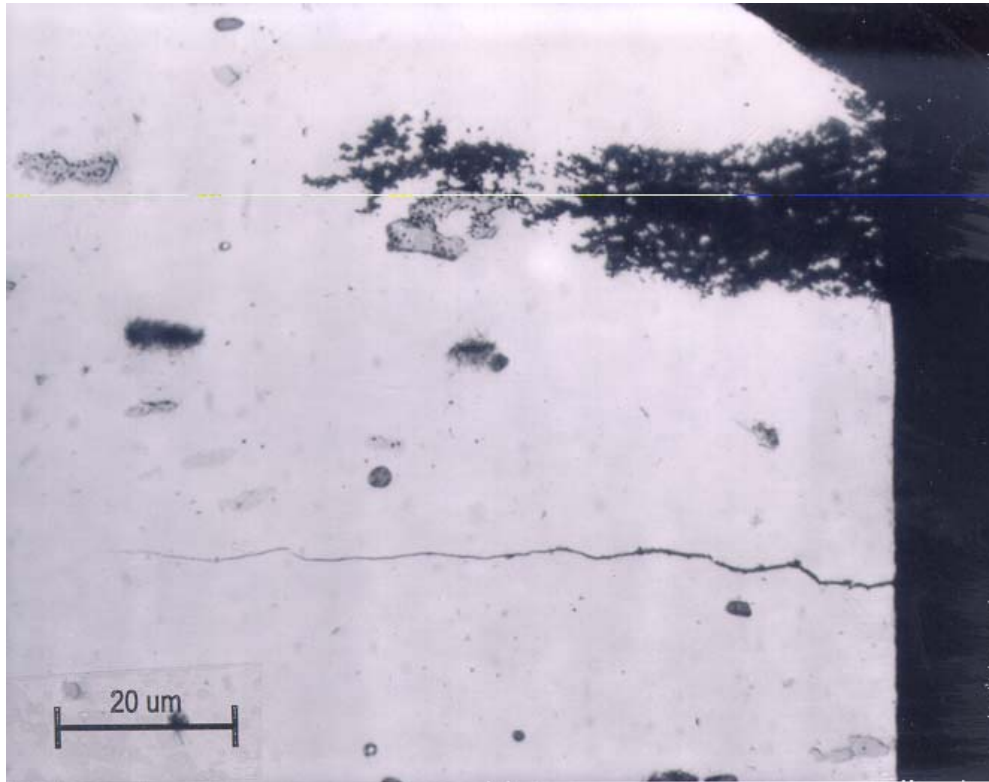
**Figure 6. Optical Micrograph of Metallographic Cross Section Through Fastener Hole in Inboard Wing Section Lap Joint, Showing Minor Pitting and Exfoliation Corrosion**

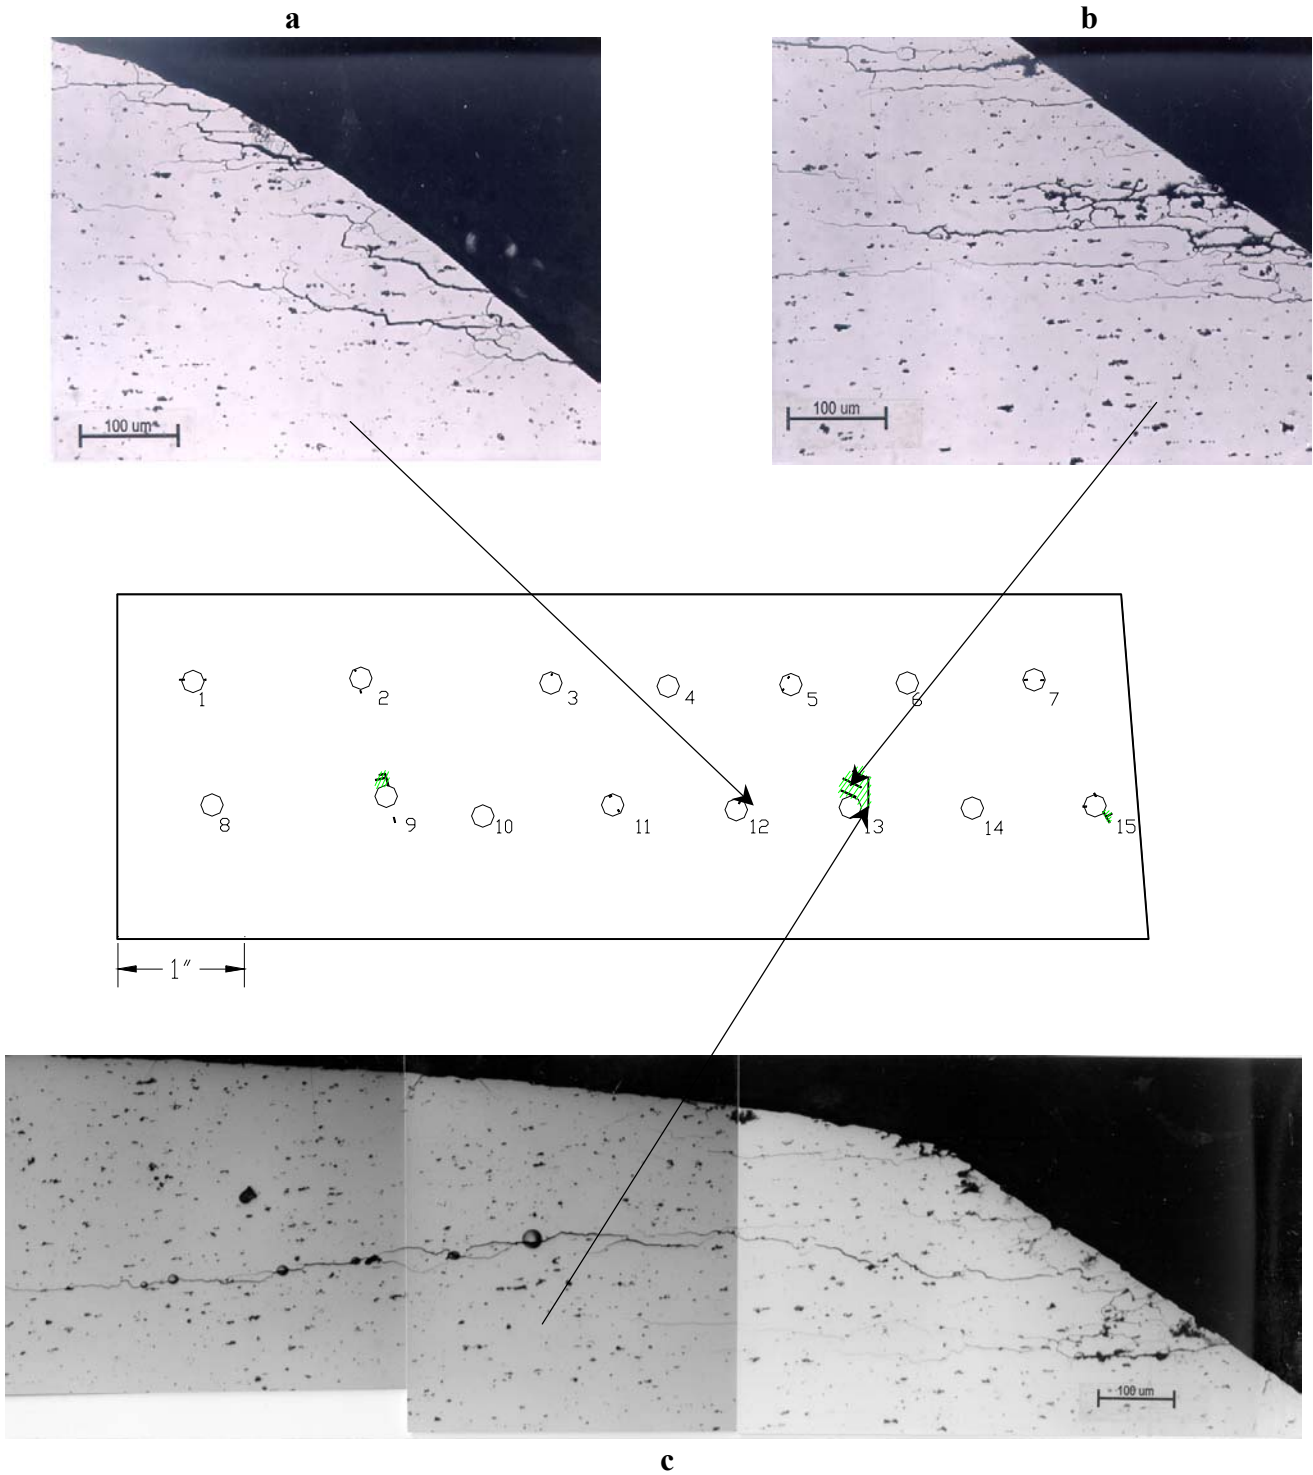
Although the outboard upper wing skin section lap joint did not show any sign of corrosion on the exterior and little corrosion on the faying surface, metallographic cross-sectioning revealed extensive exfoliation corrosion as well as pitting both at and in between the fastener holes. Figure 7 shows a schematic diagram of the exterior surface of the lap joint section and also optical of pitting and exfoliation corrosion in the areas indicated by arrows. Figure 8 shows a micrograph of a cross section through an area near fastener hole number 9 shown in Figure 7. Again pitting and exfoliation corrosion was found in the fastener hole walls and the top surface of the lap joint. The pitting corrosion showed some preferential dissolution that is characteristic for aluminum alloys (see Figure 9). Although the intergranular corrosion was extensive at some fastener holes, it appeared that little corrosion product had formed at the grain boundaries and, hence, the grains were not lifted. Because of the lack of corrosion product formation and grain exfoliation, detection, by any NDI technique, of this form of corrosion is expected to be difficult. The fact that intergranular attack was found under the grindout areas suggests that the NDI detection techniques following grindout had failed to find the corrosion damage. To gain insight in the morphology of the corrosion, three-dimensional montages were created by making perpendicular metallographic cross sections of the specimen. Examples of such three-dimensional montages in Figure 10 clearly demonstrate the fine nature of the intergranular corrosion and the lack of grain lifting or exfoliation. The micrographs further show that the corrosion was several grains deep in either direction, i.e., several 100  $\mu\text{m}$ .

**Figure 7. Schematic Diagram of Exterior Surface of Outboard Wing Lap Joint, Showing Areas of Exfoliation and Pitting Around the Fastener Holes**

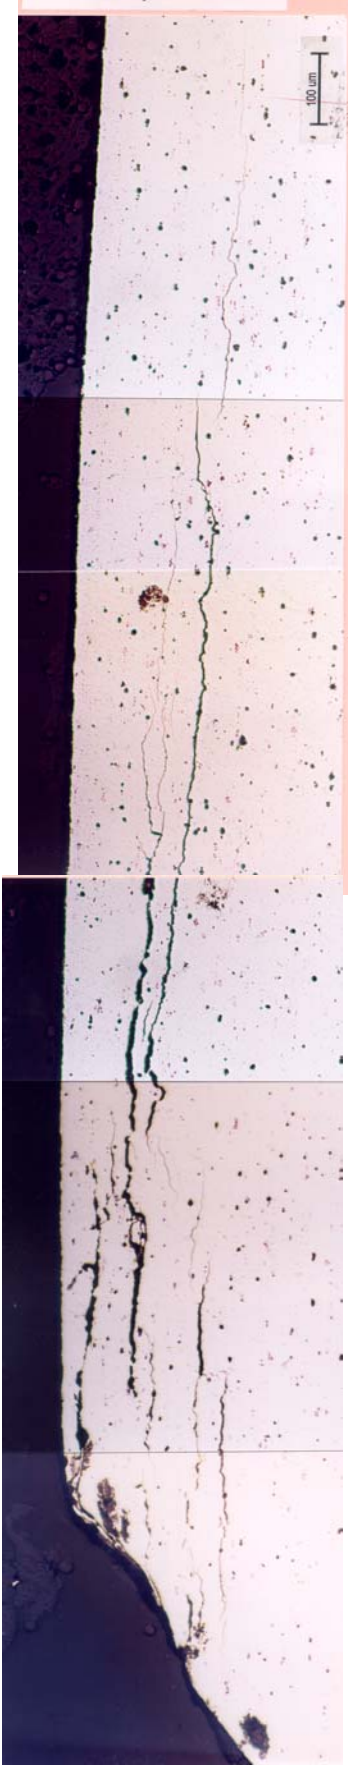
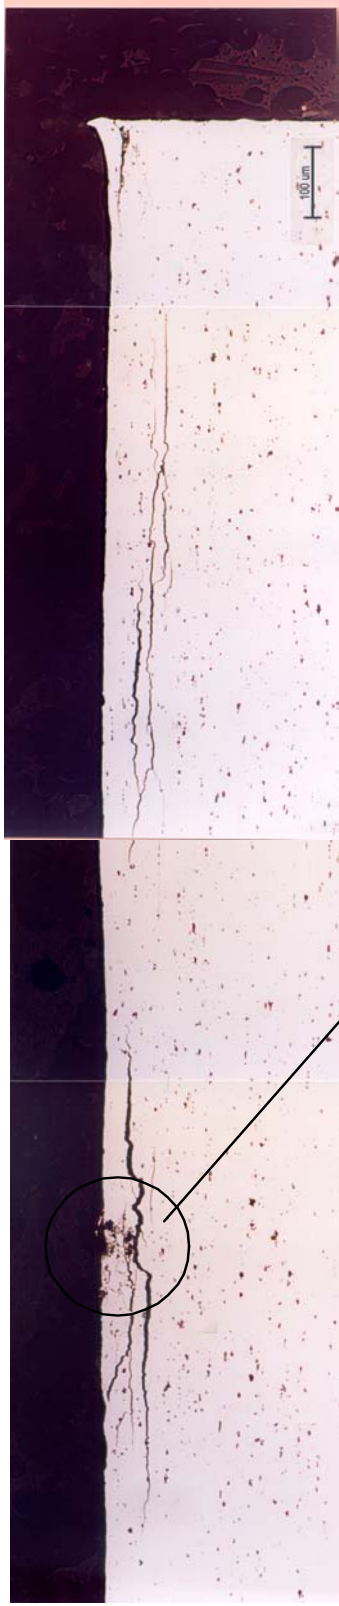
**Figure 8. Optical Micrograph of Metallographic Cross Sections of Outboard Wing Lap Joint near Fastener Hole 9 in Figure 7**

Exfoliation and pitting can be seen on the exterior of the upper wing skin.

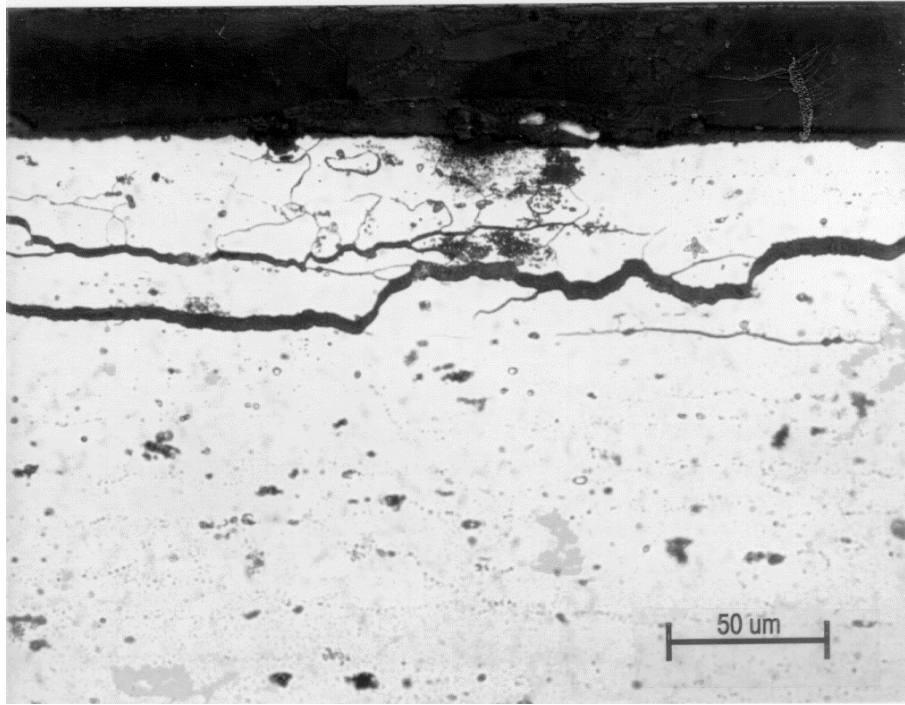
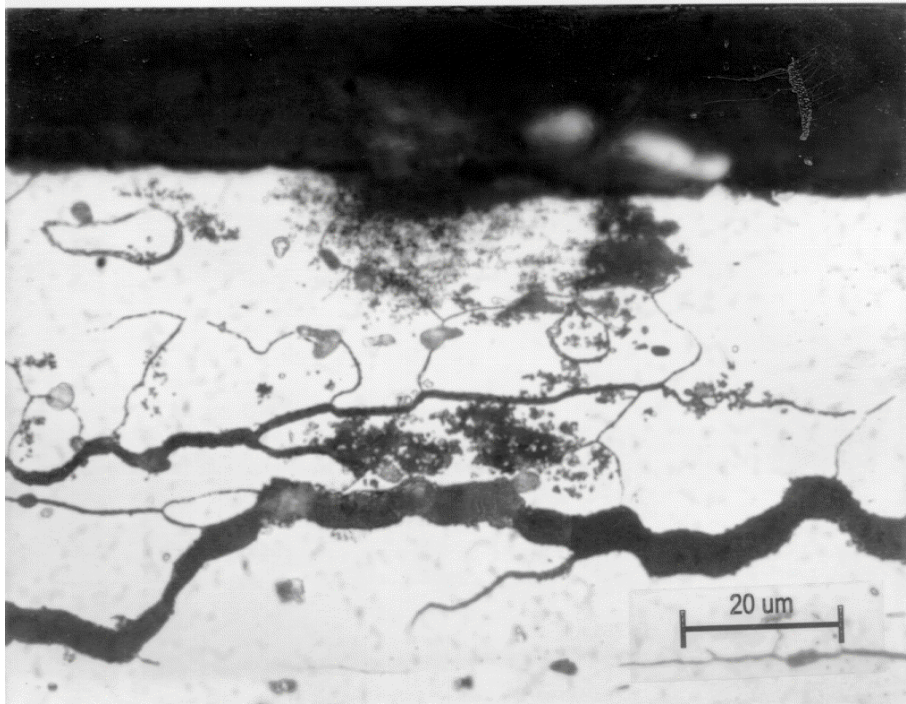
**Figure 9. Details of the Pit Indicated in Figure 8**

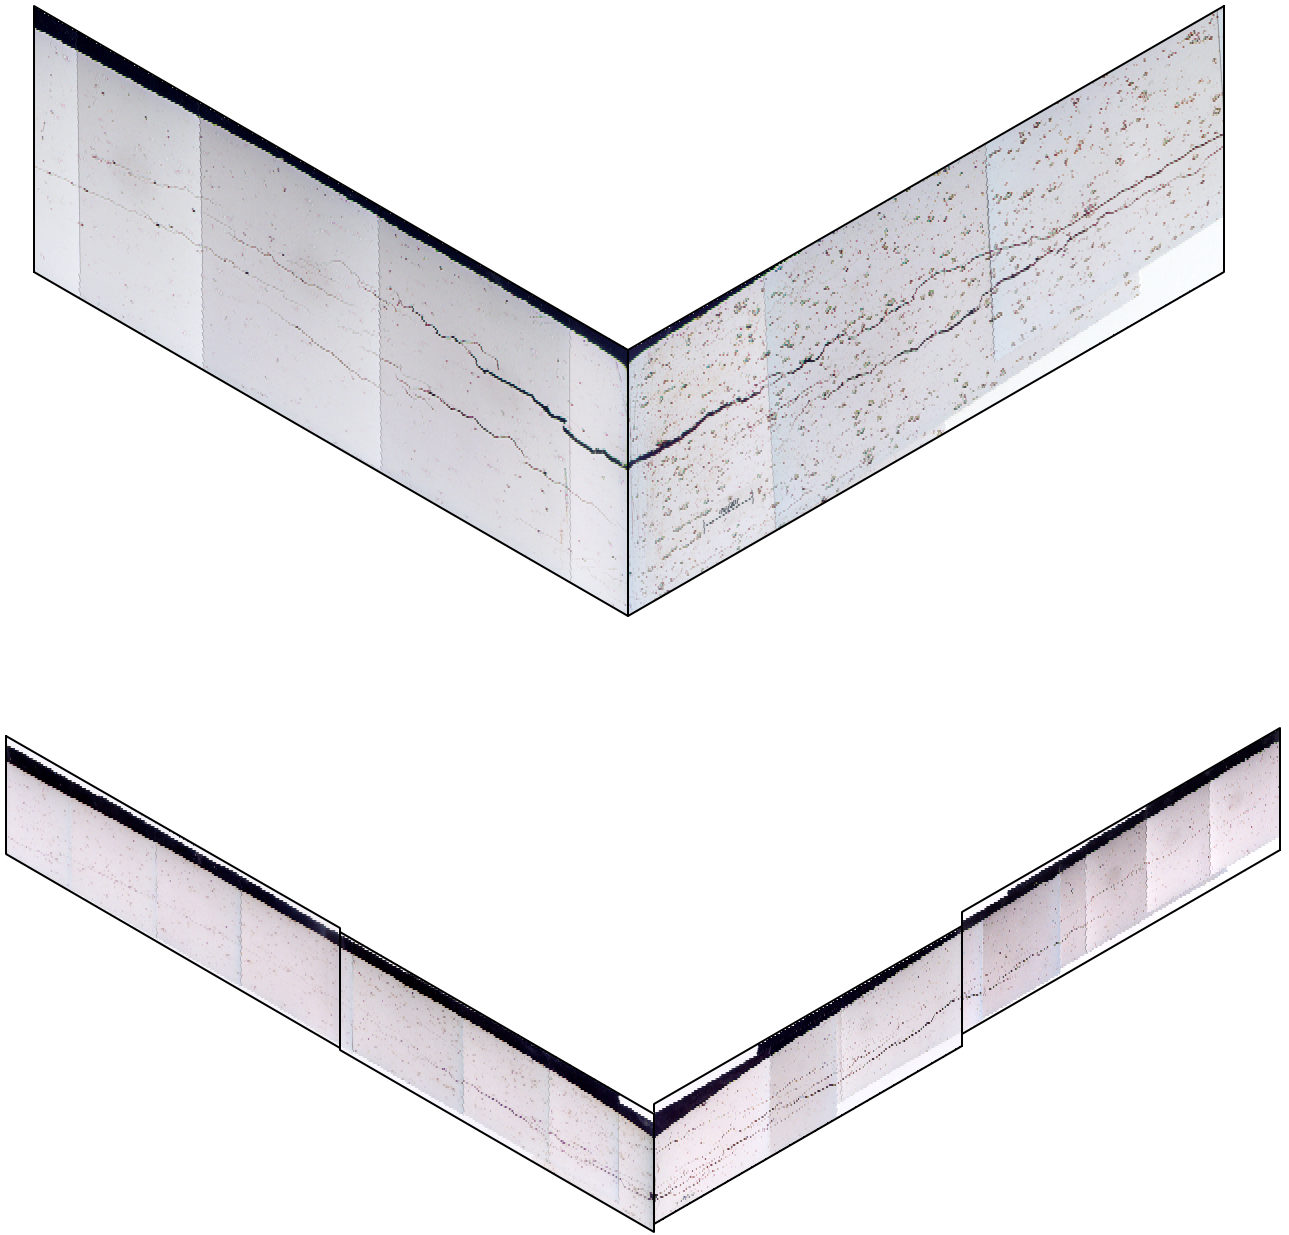
**Figure 10. Three-Dimensional Images of Exfoliation Corrosion near Fastener Hole 13 in Figure 7**

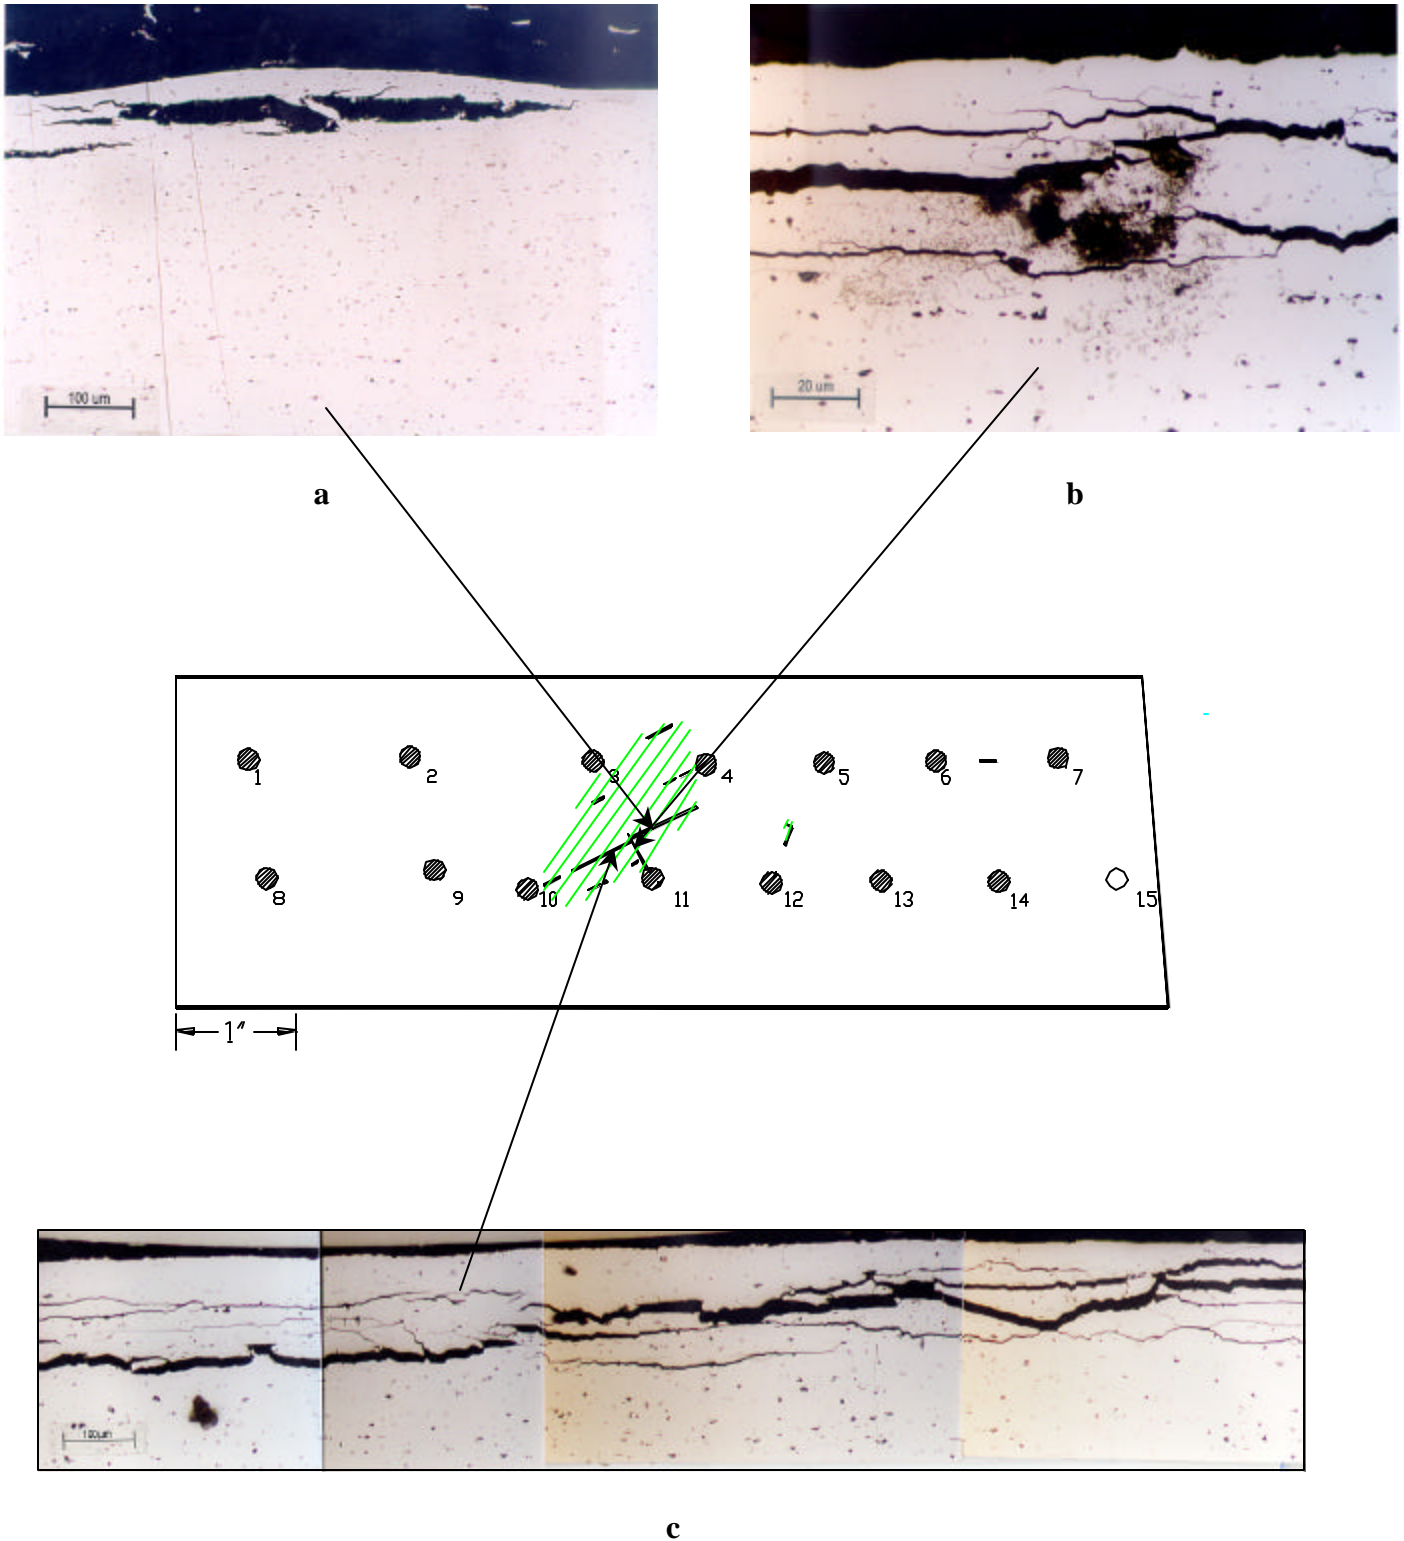
Figure 11 shows a schematic diagram of the faying surface of the lap joint, indicating that most of the corrosion occurred between the fastener holes. There was no evidence that the corrosion had originated from the fastener holes. When examining the corrosion on the faying surface, the morphology of the intergranular attack appears to be different from that observed near the exterior of the skin. The micrographs in Figure 11 show that voluminous corrosion products had formed along the grain boundaries, lifting up the grains and creating the so-called pillowing effect. Also, the micrograph in Figure 11b shows that after exfoliating, the grains continued to corrode by what appears to be a preferential dissolution process, forming the voluminous corrosion product ( $\text{Al}(\text{OH})_3$ ). To examine the extent of the intergranular attack, several metallographic cross cuts were made. Figure 12, which is a collage of optical micrographs, shows the extent and severity of exfoliation corrosion on the faying surface. Three-dimensional montages, such as in Figure 13, created from the metallographic crosscuts also demonstrate the large extent of the corroded area as well as a uniform depth of the corrosion attack of about 100 microns. The optical micrographs in Figures 12 and 13 further show definite pillow formation due to severe exfoliation corrosion.

**Figure 11. Schematic Diagram of Faying Surface of Outboard Wing Section, Showing Areas of Extensive Exfoliation Corrosion, Corrosion of the Exfoliated Grains and Pilling**

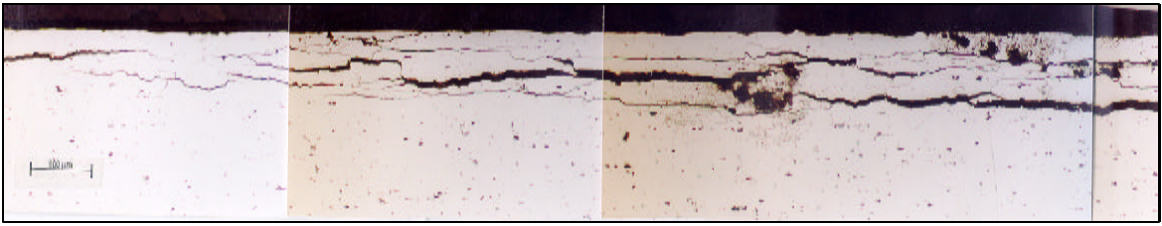
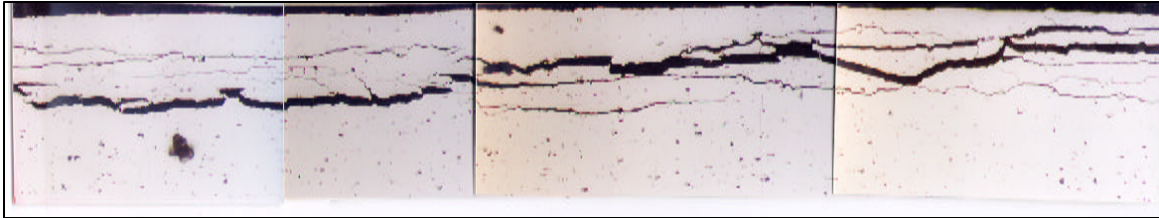
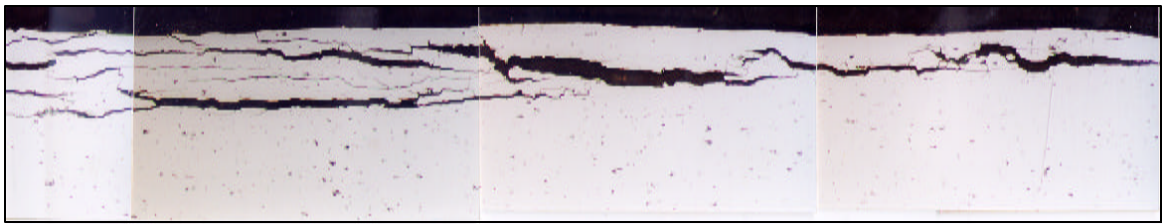
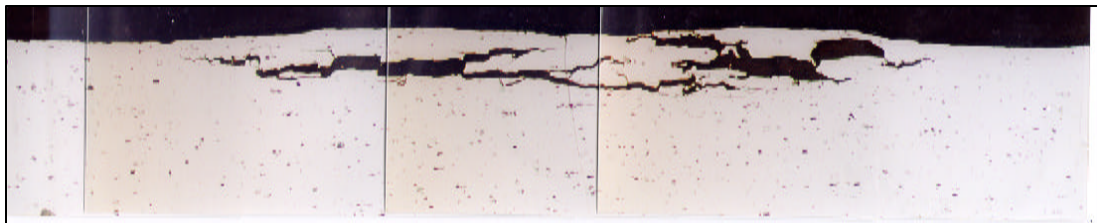
**Figure 12. Optical Micrographs of Metallographic Cross Sections Through the Upper Wing Skin of the Outboard Wing Section, Showing Exfoliation and Blistering on the Faying Surface**

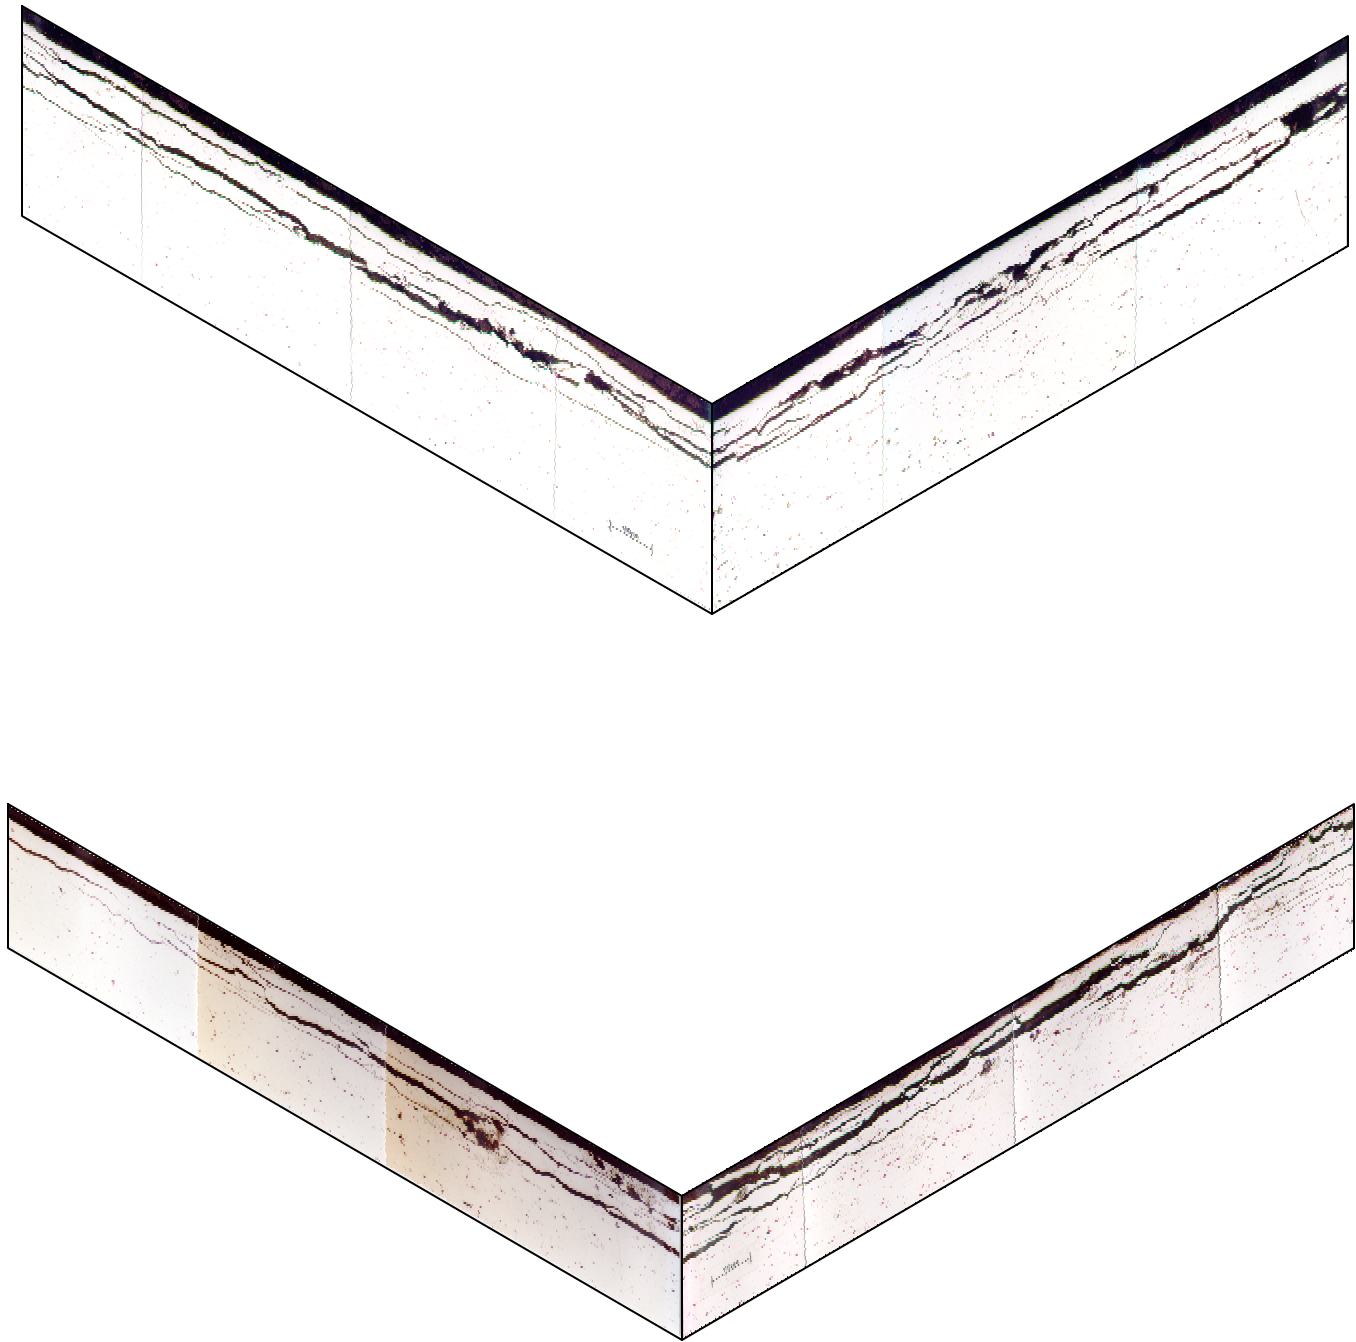
**Figure 13. Three-Dimensional Images of Exfoliation Between Fastener Holes on the Faying Surface of the Outboard Wing Section, Showing Extensive Grain Lifting and Pillowing**

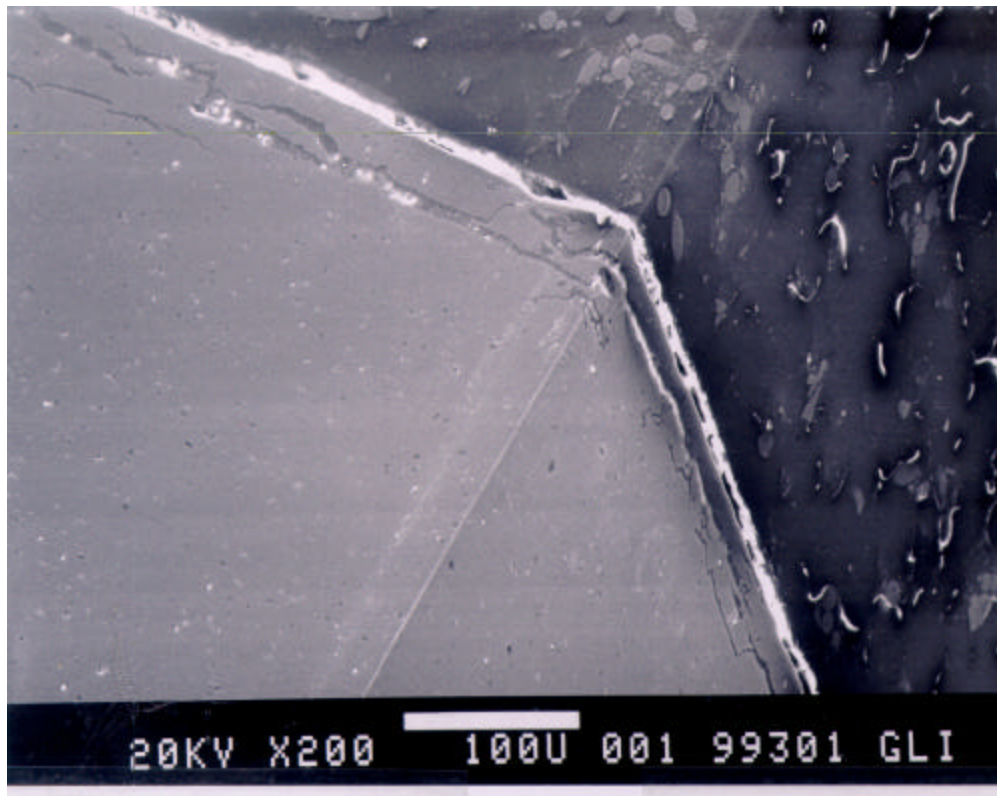
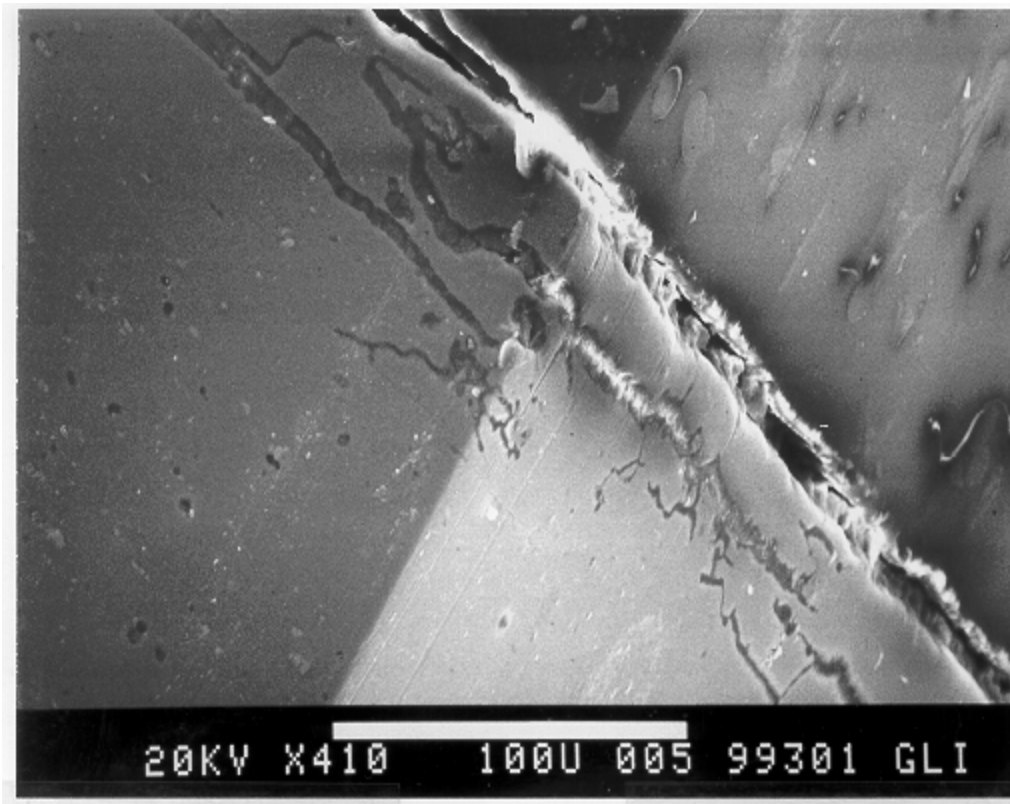
In addition to exfoliation corrosion, it was found that at specific locations, pockets of intergranular corrosion were found extending deeper into the material. An example of this form of corrosion attack is given in Figure 14, which shows scanning electron micrographs of perpendicular metallographically prepared surfaces. The micrographs show clearly the formation of localized intergranular corrosion under the general exfoliation attack.

**Figure 14. Scanning Electron Micrograph of Two Perpendicular Metallographic Cross-Sections of Outboard Wing Section, Showing Exfoliation and Intergranular Attack**

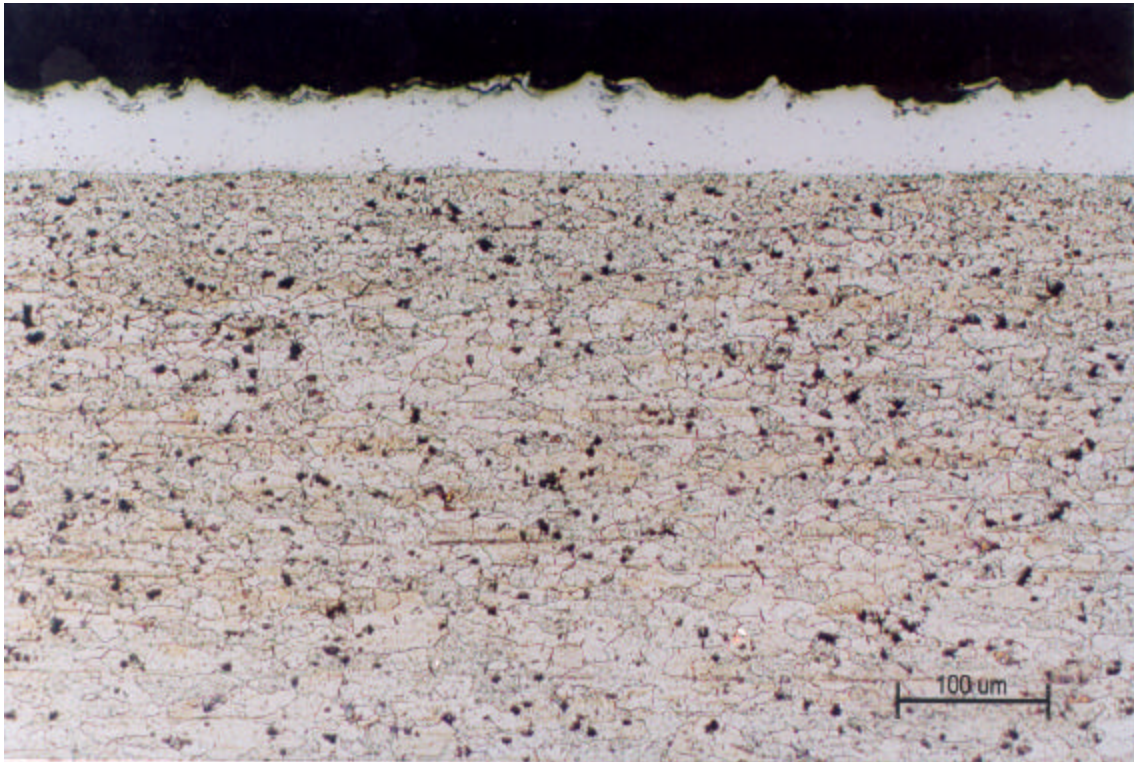
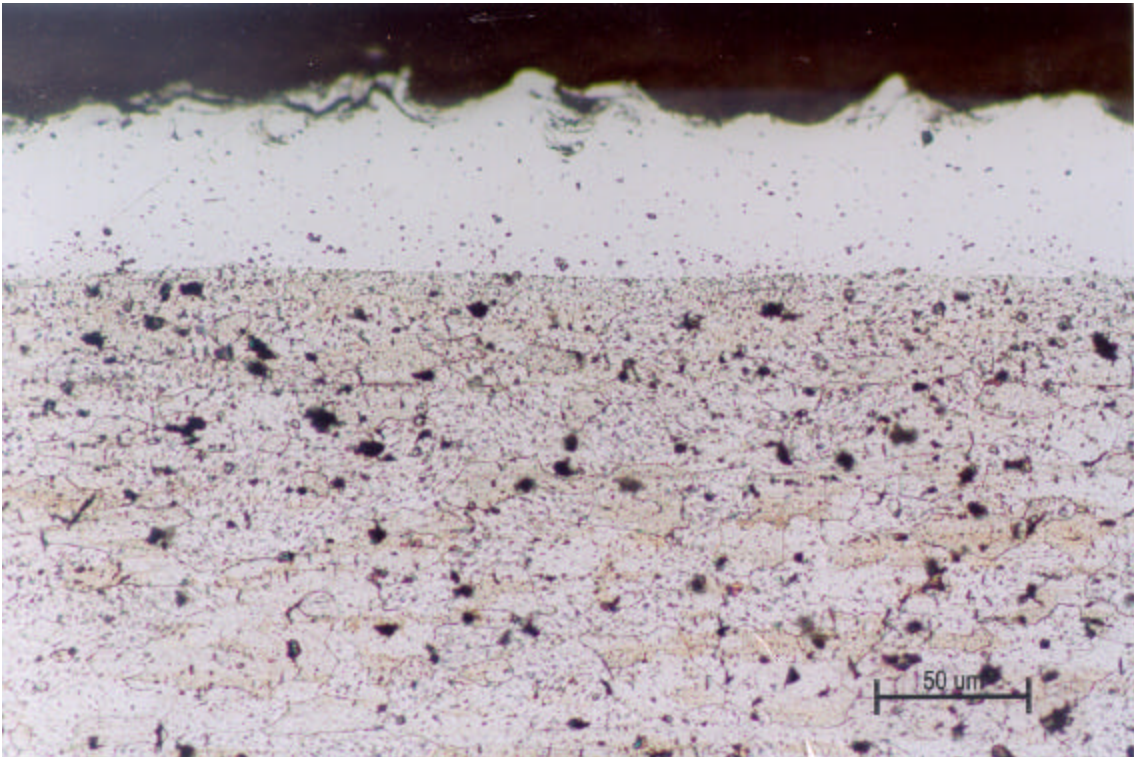
**Figure 15. Optical Micrographs of Metallographic Cross Sections Through Aluminum Alloy 2024-T3 Fuselage Lap Joint, Showing Pitting on the Clad Faying Surface**

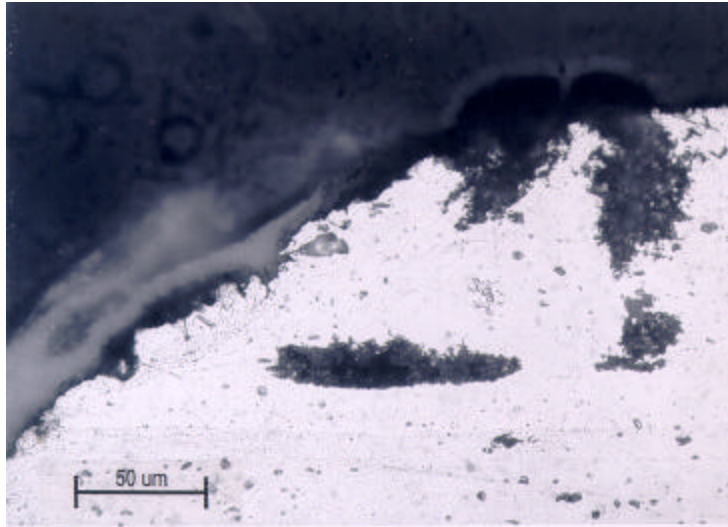
Photograph a shows pitting corrosion at a fastener hole on the outside surface.
