**AFRL-VA-WP-TR-2002-3032**

**CORROSION MORPHOLOGY IN  
LAP JOINTS**

**JUNE 2000**

**Final Report for 01 April 1999 – 31 May 2000**

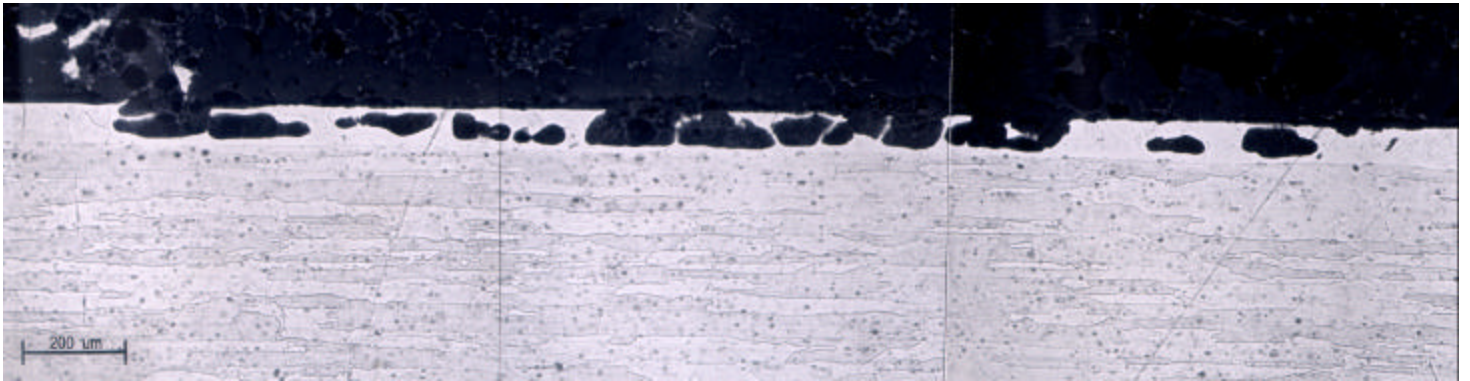
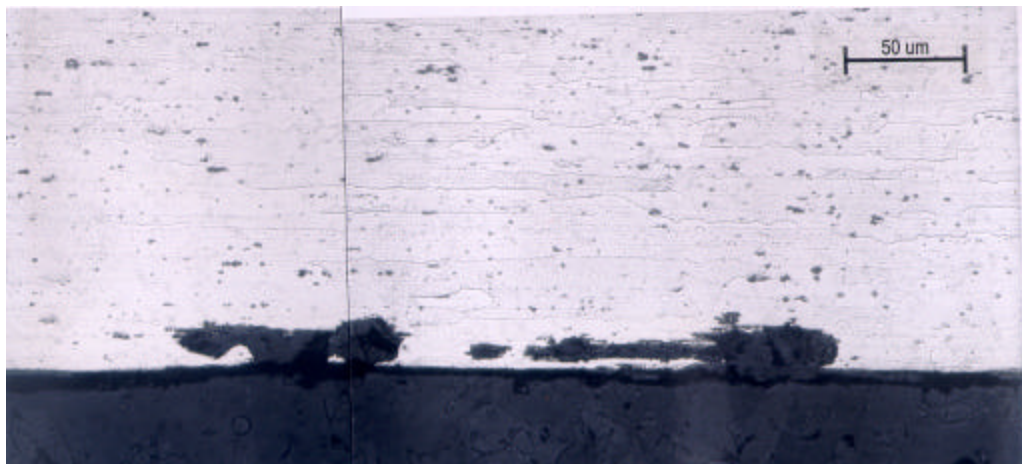
Photograph b shows corrosion of the clad layer on the outside surface. Photograph c shows pitting corrosion on the faying surface.
