**Failure Analysis, Cadmium Brush Plate Qualification and
Salt Fog Testing of the AH-64 Shock Strut Mount,
P/N 7-311113409**

ARL-TR-2870

November 2002

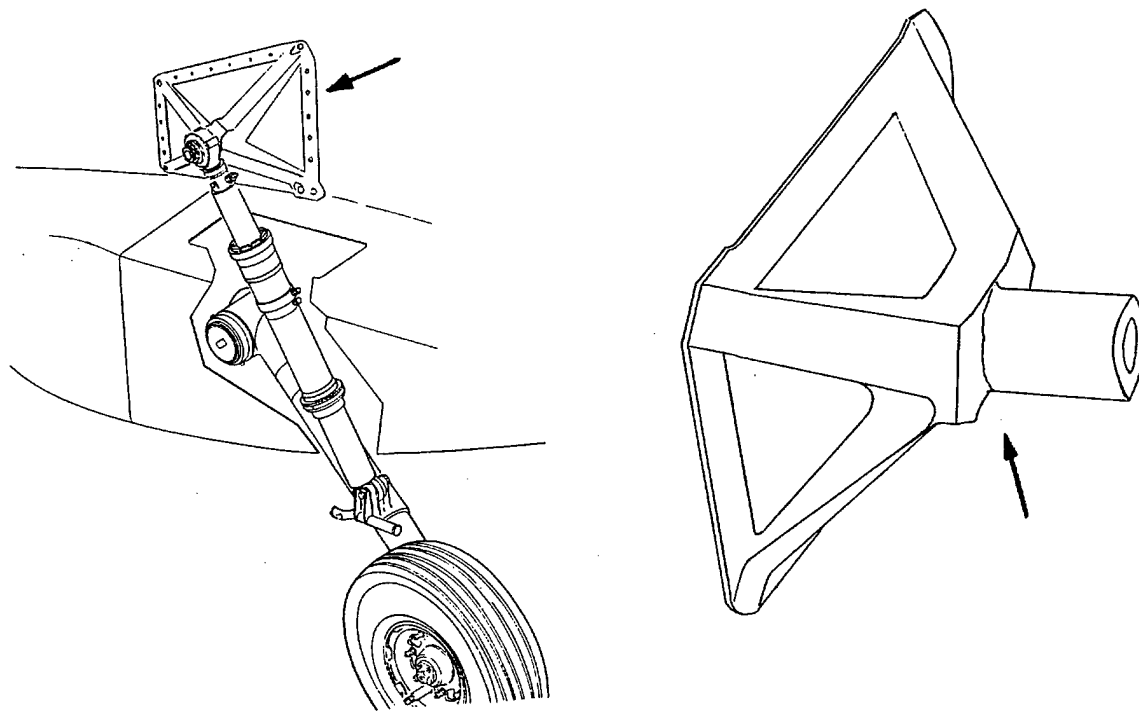
Figure 1. Schematic of the strut mount attached to the helicopter and the location of failure.

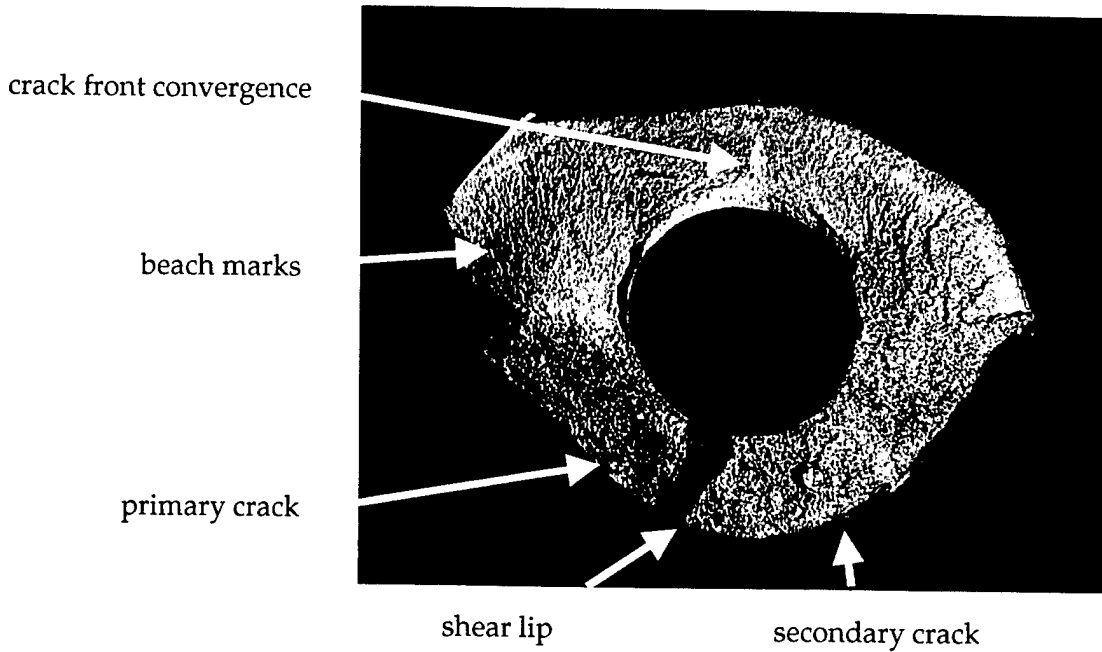
Figure 3. The fracture surface using oblique lighting. Note the shear lip separating the primary and secondary cracks, as well as the beach marks (mag. $\sim 1.4\times$).

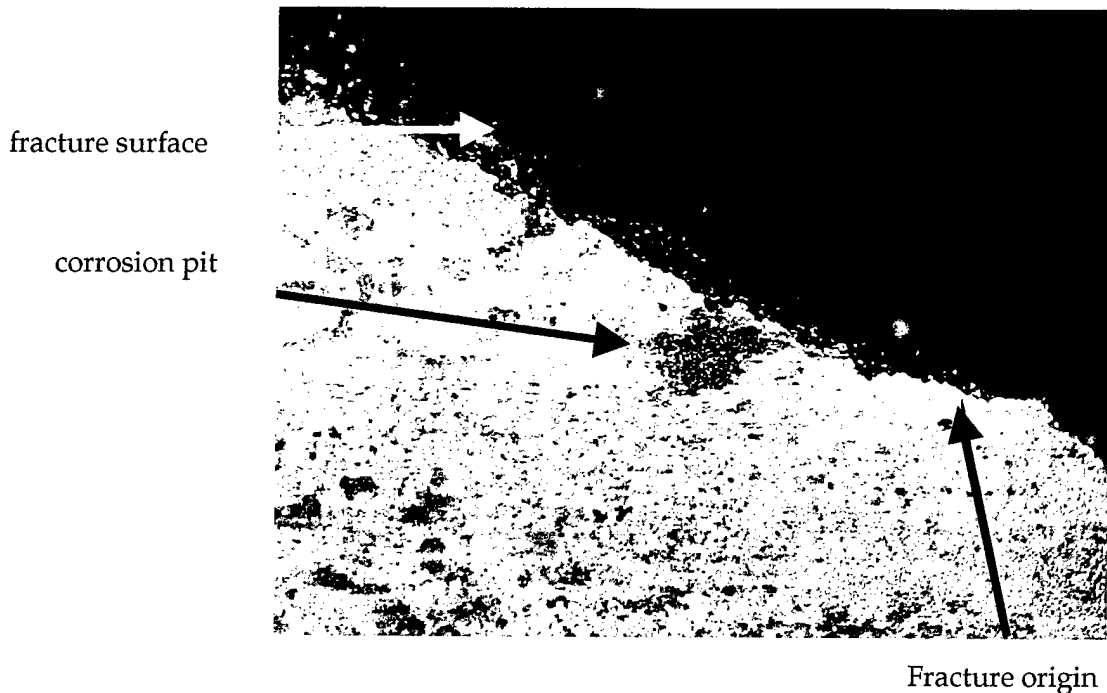
Figure 8. Corrosion pits adjacent to the primary origin (mag. 10×).

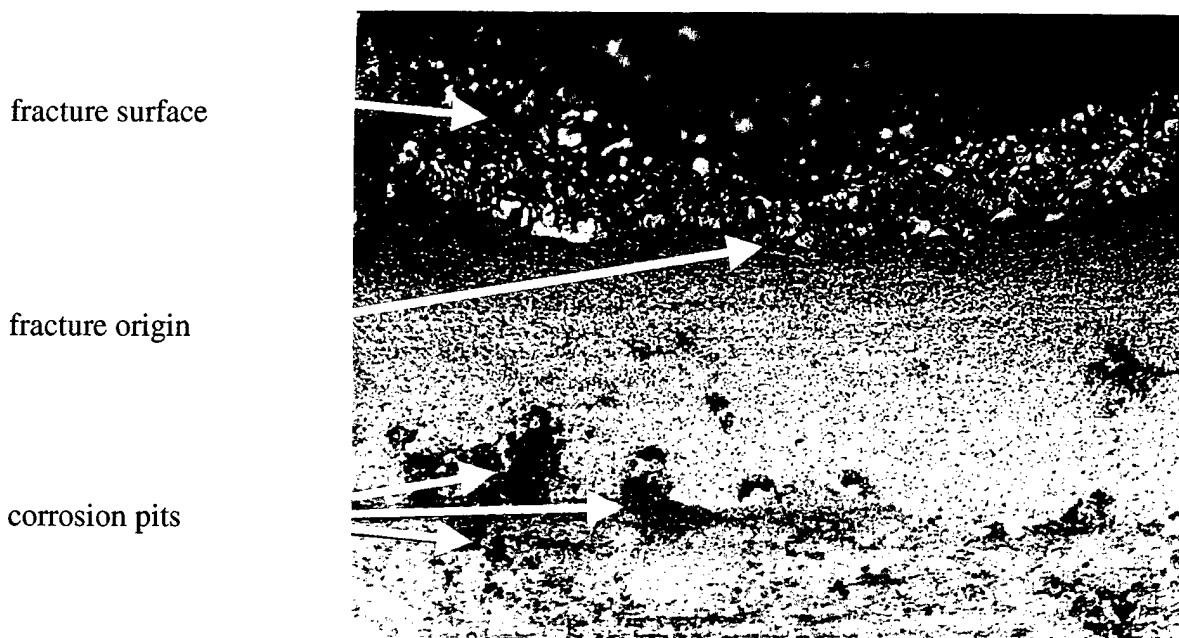
Figure 9. Corrosion pits adjacent to the secondary origin (mag. 10×).

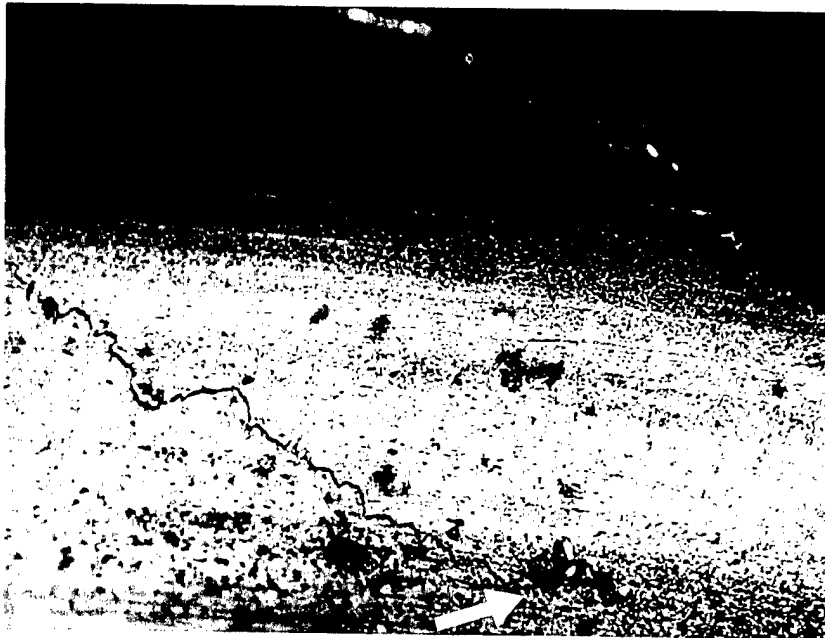
region. Also observed was a competing crack that was adjacent to the primary origin. Figure 11 shows the intergranular nature of this crack. There was also evidence of intergranular attack along this crack path. It was difficult to discern the exact location of the fracture origins; however, based upon the heavy corrosion in certain areas on both the primary and secondary crack surfaces, the general location of the origins was surmised.

Figure 11. Competing crack path adjacent to primary fracture surface. Note the intergranular nature of the crack, as well as the region of intergranular attack (mag. 15 \times).

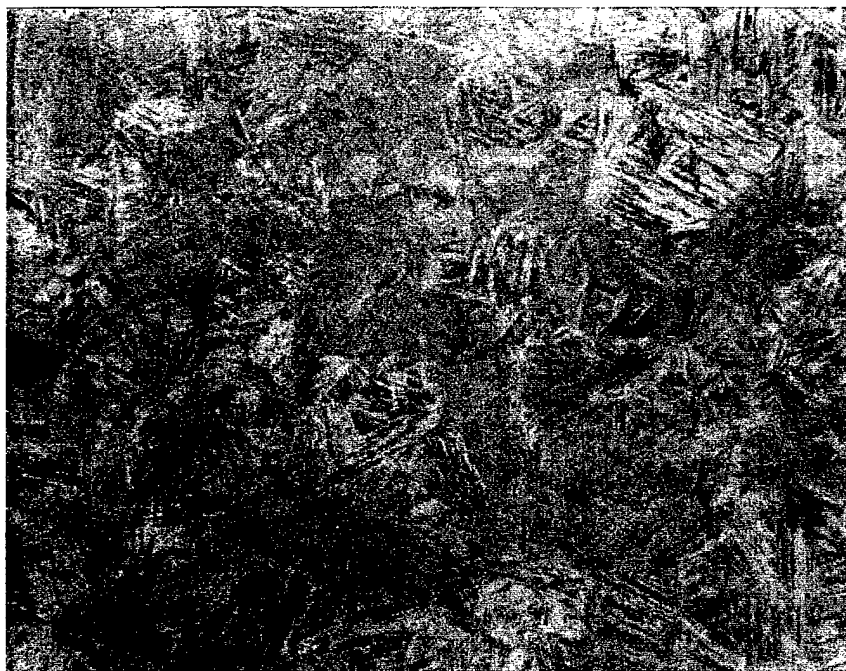
Figure 12. Microstructure of the material showing aged, low-carbon martensite in the longitudinal direction. Marble's Reagent (mag. 50 \times).

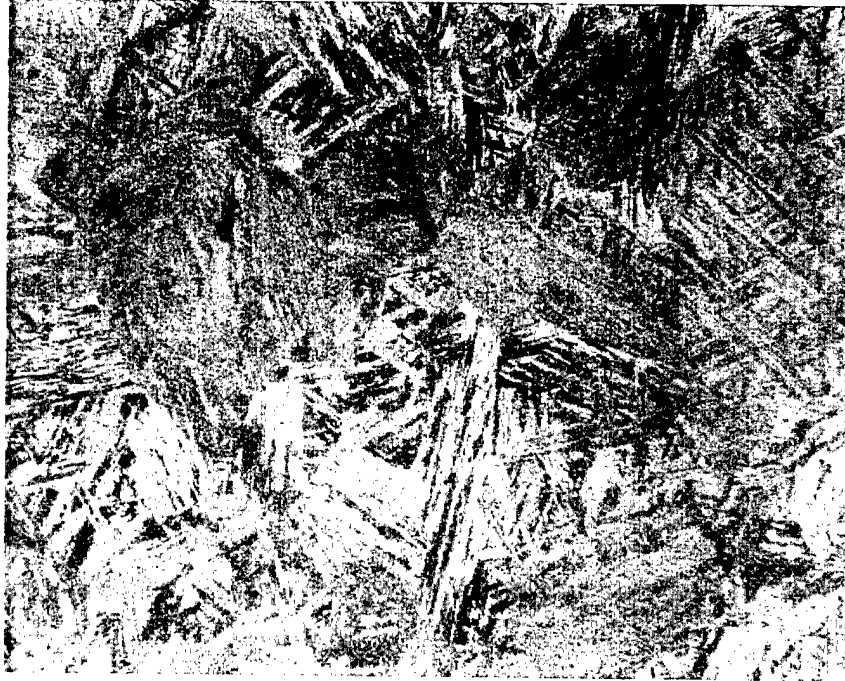
Figure 13. Microstructure similar to that in Figure 12 shown at higher magnification and in the transverse direction. Marble's Reagent (mag. 100×).

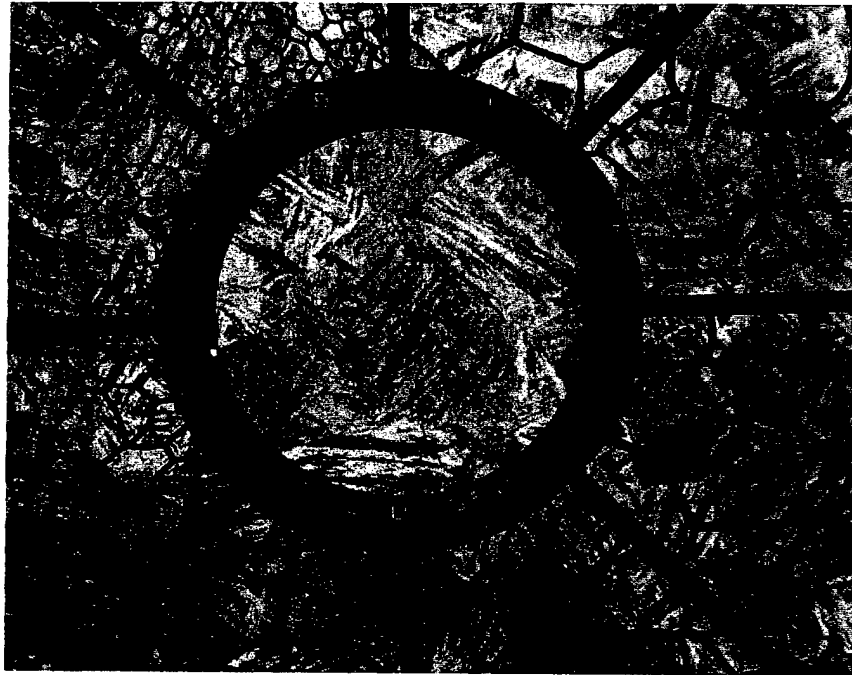
between nos. 2 and 3 at 100× magnification using the ASTM E112 charts over Figure 12. To verify this, a photomicrograph was taken using a grain size reticle, as shown in Figure 14. Again, the size was between nos. 2 and 3. The ASTM E112 charts indicate that the nominal diameter of the average grain is between 0.005 and 0.007 in, respectively for a grain size of nos. 3 and 2. A photomicrograph was subsequently taken of this structure at 100×, using an incremented reticle (Figure 15). As shown, the grain appear to have diameters ranging from 0.005–0.01 in, which correlated to the previous measurements. Subsequently, the intergranular fracture surface shown in Figure 18 (also see section 2.8) was also examined for grain size using the ASTM E112 “Fracture Grain Size” method. This technique is typically used for high-hardness, brittle steels with a predominantly martensitic structure, such as tool steels, high-carbon steels and martensitic stainless steels, and should be done with the specimen in the as-quenched or lightly tempered condition. Even though the Maraging 300 steel is a low-carbon alloy, the results obtained compared favorably to those from the other three methods. From Figure 18, the grain size ranged from ~100–200 μm , which correlated to a range of 0.004–0.008 in.

Figure 14. Microstructure of the material with grain size reticle overlay. The grain measured between nos. 2 and 3. Marble's Reagent (mag. 100×).

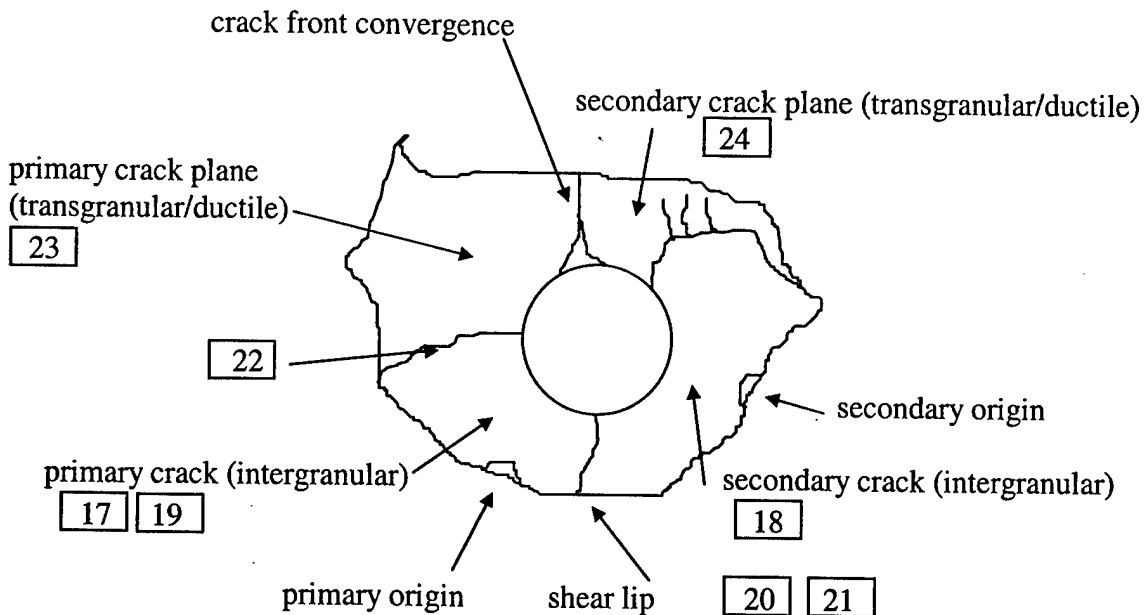
Figure 16. Schematic of fracture features as determined through SEM. Numbers in boxes correspond to figure locations.

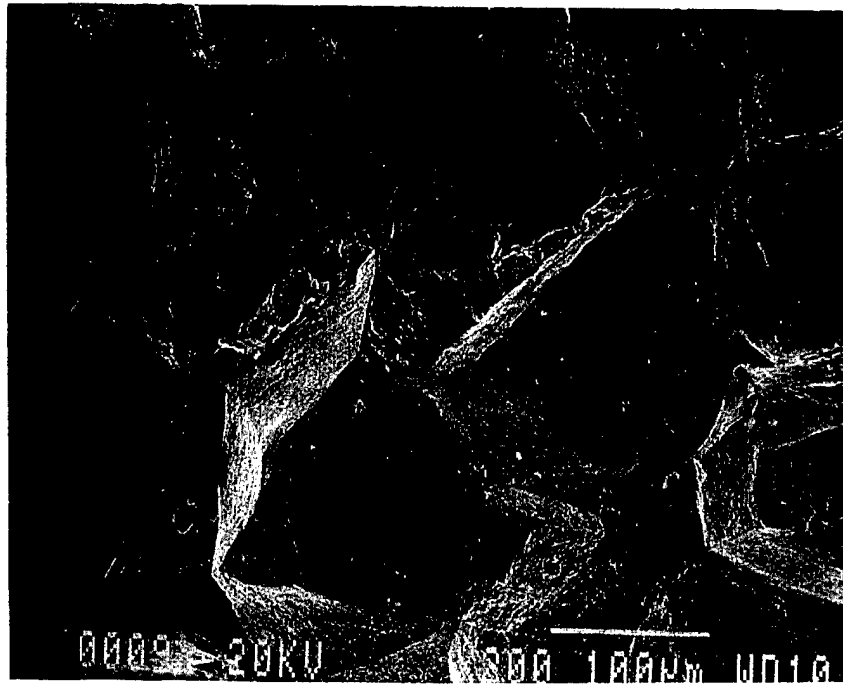
Figure 19. Magnified view of the intergranular morphology showing secondary cracking (mag. 200×).

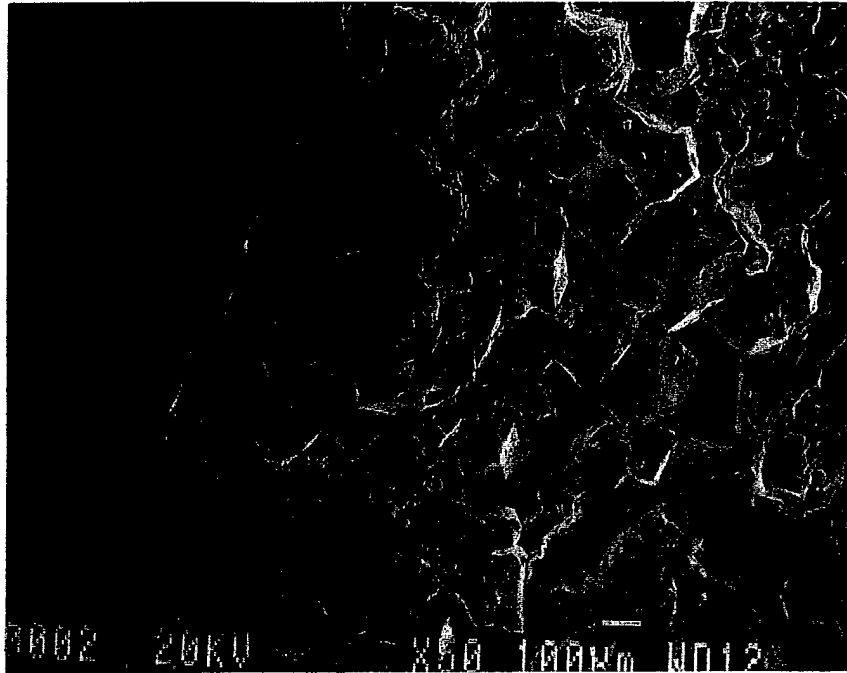
Figure 21. Interface between the secondary fracture surface and the shear lip (mag. 50×).

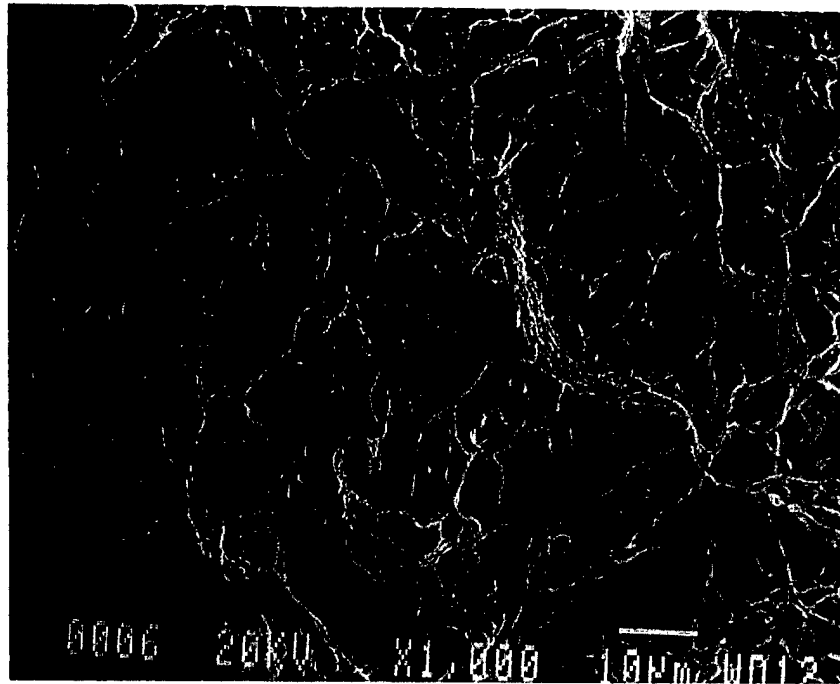
Figure 23. Morphology of the surface on the same plane as the primary fracture surface subjected to fast-fracture, consisting of a transgranular/ductile mode (mag. 1000 \times).

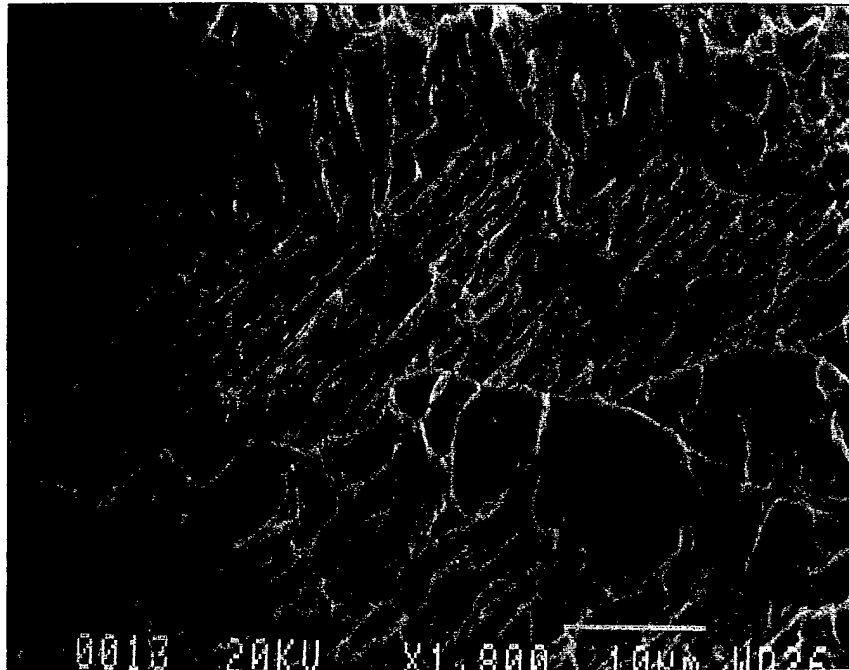
Figure 25. Transgranular/ductile morphology at higher magnification (mag. 1800×).

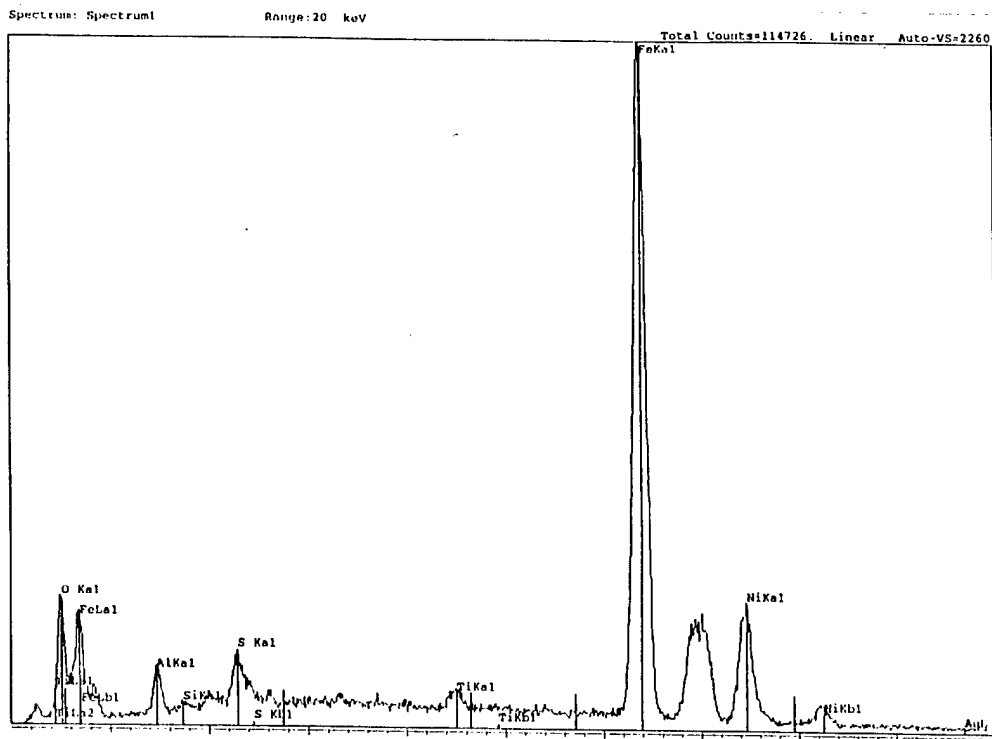
EDS was used in an effort to determine the presence of cadmium on the surface of the spindle. Exhaustive EDS spectra were generated along the spindle (and adjacent to the fracture origins), without revealing the presence of cadmium. Figure 26 is typical of the spectra generated in these regions. In contrast, analysis of the threaded region (where white, powdery corrosion products were noted) revealed the presence of cadmium as shown in Figure 27. The wear within the threads may not have been as severe as along the spindle, such that the cadmium was still somewhat intact. This was evidence that the part had been cadmium coated at one time.

Figure 26. Representative EDS spectra of the spindle of the failed part. No evidence of cadmium was noted along the spindle.

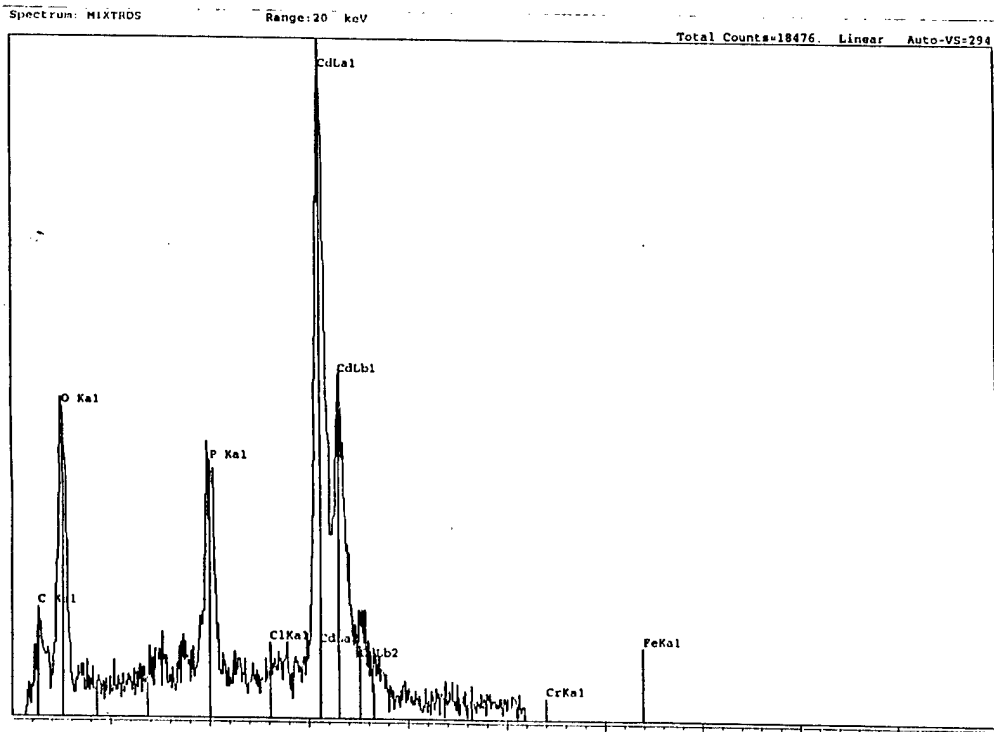
Figure 27. Representative EDS spectra within the threads of the failed part. Cadmium was noted within the threads.

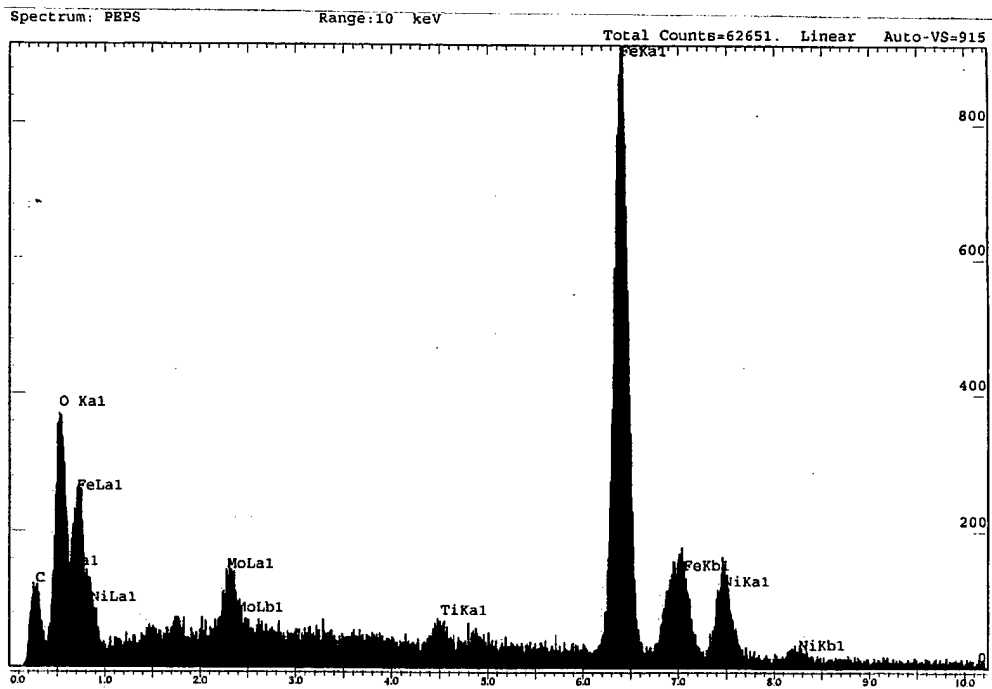
Figure 29. EDS spectra showing evidence of titanium within the precipitate shown in Figure 28. Other elements constitute the alloy.

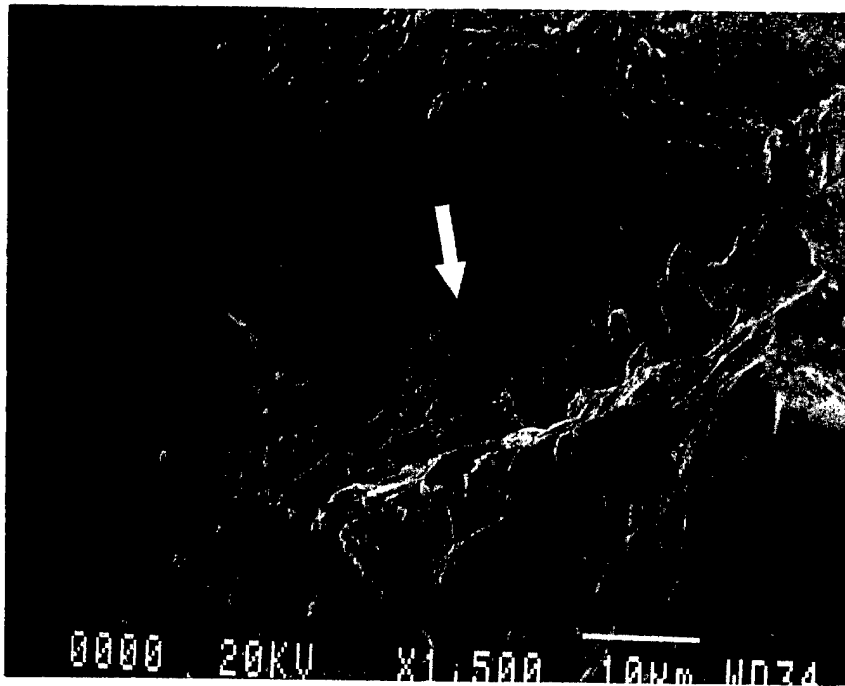
Figure 30. SEM micrograph of intergranular morphology of the primary fracture, showing the titanium-carbonitride precipitate that was examined using EDS (Figure 31) (mag. 1500×).

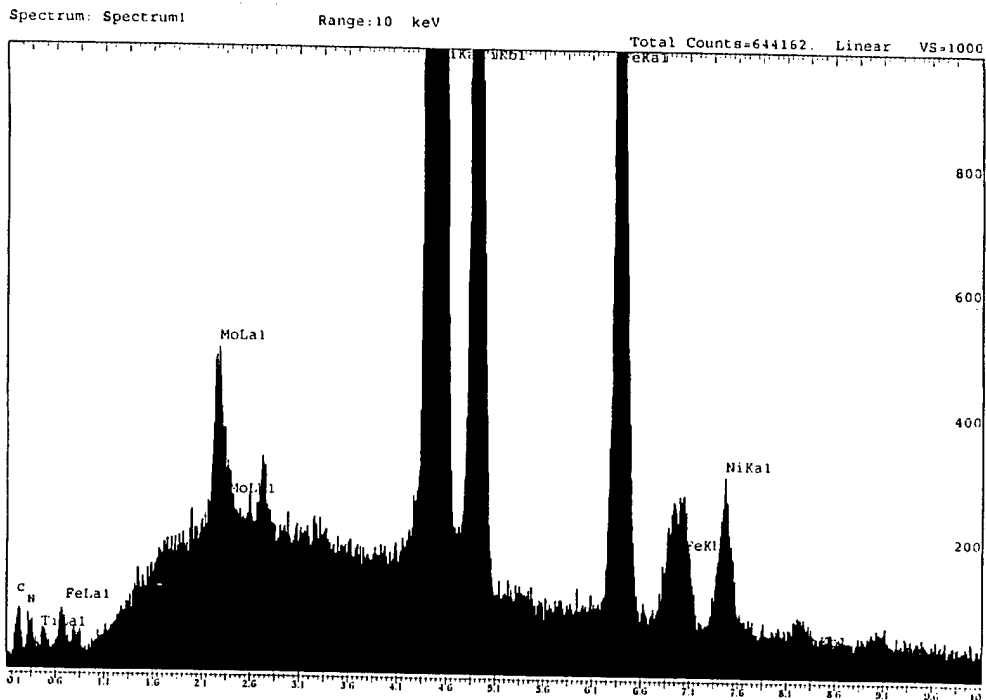
Figure 31. EDS spectra of the Ti (C, N) precipitate shown in Figure 30. Note the presence of titanium, carbon, and nitrogen, as well as the alloying elements.

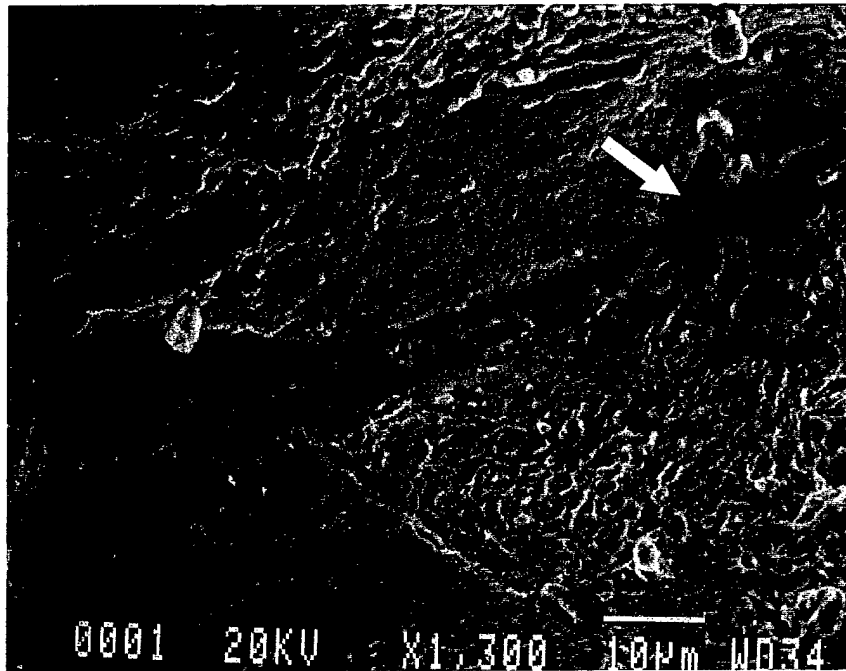
Figure 32. SEM micrograph of intergranular morphology of the primary fracture, showing another titanium-carbonitride precipitate (mag. 1300 \times).

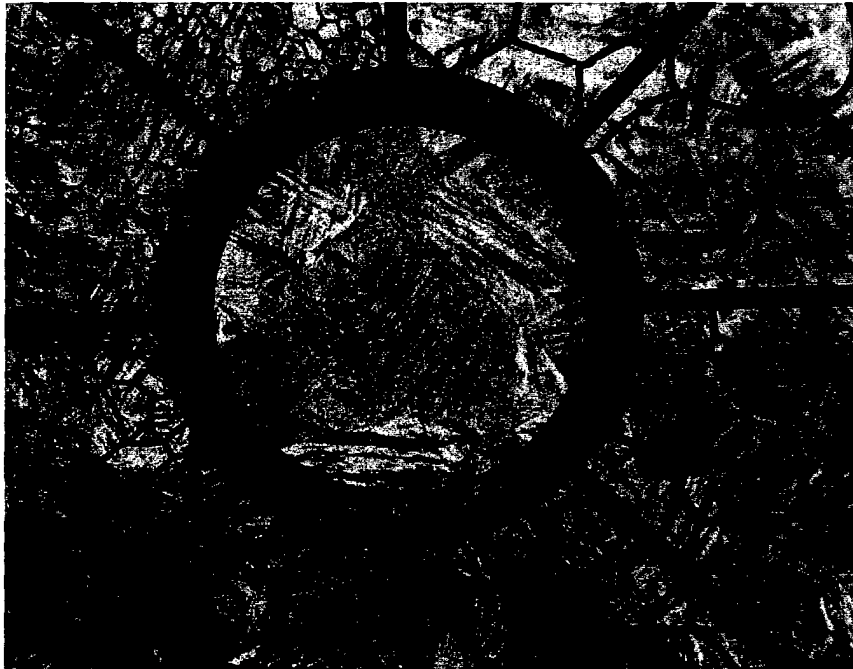
The grain size of failed Shock Strut Mount P/N 7-311113409, determined to be approximately double the required size (refer to section 2), was compared to the grain size of two scrap strut mounts. These strut mounts included one which had been sectioned into specimens that were cadmium brush plated at HAAF, Savannah, GA, and one that was sectioned for brush plating at Ft. Lewis, WA. The governing material specification, HMS 6-1081, *18% Nickel Maraging Steel - Bars and Forgings, 300,000 psi (2069 Mpa) Yield Strength Grade*, requires a grain size of no. 7 or finer with an occasional no. 5. It was determined that the grain size of the failed strut mount was between American Society for Testing and Materials (ASTM) nos. 2 and 3. Figure D-1 shows the grain size of the failed part, with a grain size reticle overlay at 100× magnification. Figure D-2 shows a scanning electron micrograph of the actual grain size observed within the intergranular fracture surface at 200× magnification.

Figure D-1. Grain size of the failed strut mount with reticle overlay (mag. 100×).

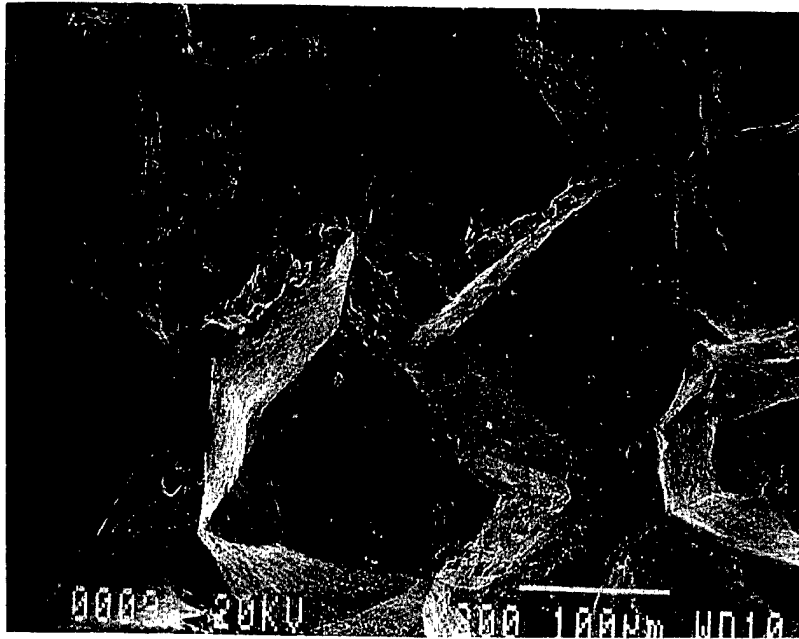
Figure D-2. Grains from the intergranular fracture surface of the failed strut mount (mag. 200 \times).
