NTSB/AAR-02/01  
PB2002-910401

**Aircraft Accident Report**

**Loss of Control and Impact with Pacific Ocean  
Alaska Airlines Flight 261  
McDonnell Douglas MD-83, N963AS  
About 2.7 Miles North of  
Anacapa Island, California  
January 31, 2000**

**NTSB/AAR-02/01  
PB2002-910401  
Notation 7263E  
Adopted December 30, 2002**

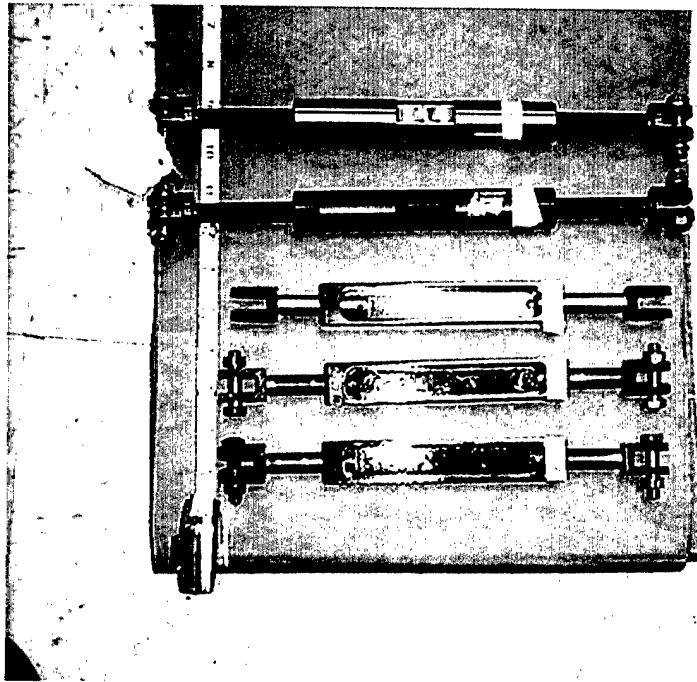
<sup>91</sup> Discrepancies up to a maximum of about 0.005 inch were recorded.

**Figure 10.** Two Alaska Airlines-fabricated restraining fixtures and three Boeing-manufactured fixtures.

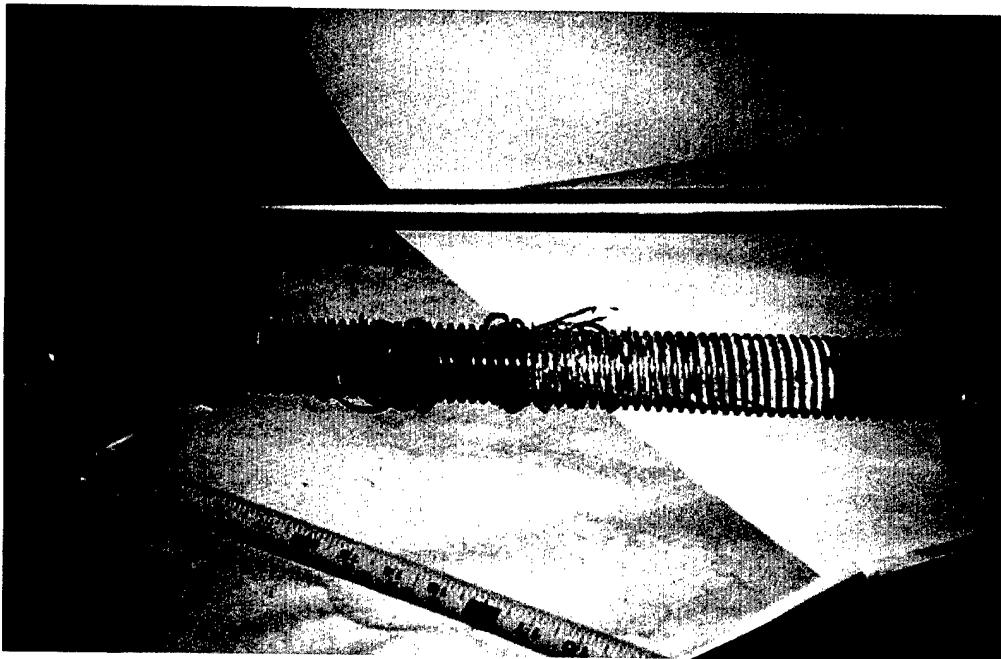
Corrosion pitting and red rust areas were found along most of the acme screw's length, with the heaviest areas of corrosion and rust along its lower half. Large areas of the acme screw were also found covered by white deposits, which chemical analysis determined were consistent with corrosion debris from the magnesium gearbox case attached to the top of the acme screw assembly. Figure 13 shows the acme screw thread remnants wrapped around the screw, the red rust areas, and the white deposits.

**Figure 13.** A photograph of the acme screw thread remnants wrapped around the screw, the red rust areas, and the white deposits.

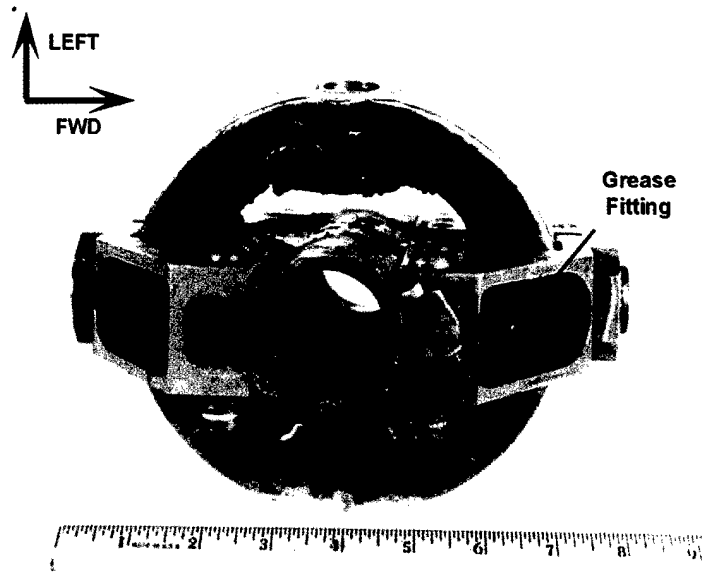
**Figure 15.** A photograph of an overall view of the recovered acme nut assembly.

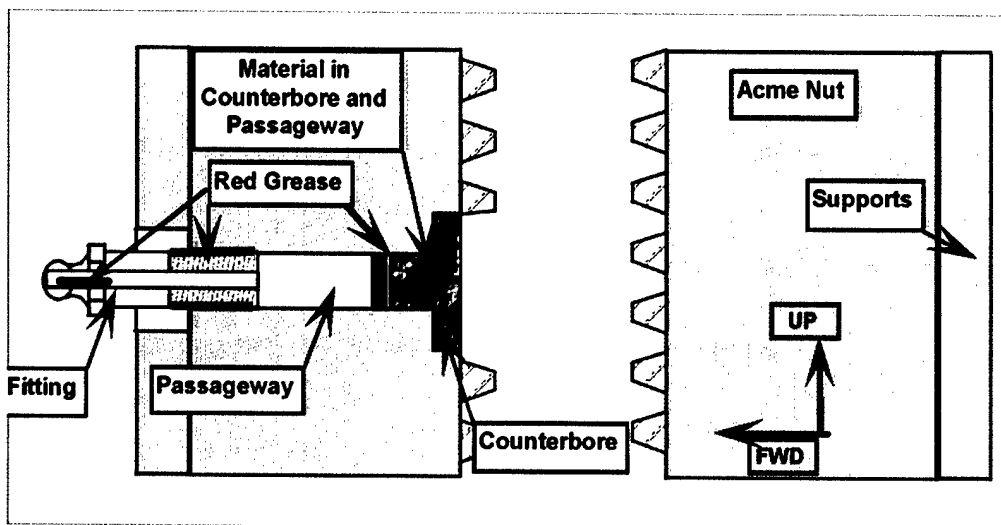
The acme nut has a grease fitting on the forward, upper side of the nut through which grease can be applied to the acme nut threads. A solid, black, claylike, dry residue coated with white, powdery material was found in the internal counterbore of the acme nut's grease passageway where it intersected the inside surface of the nut, as well as in the smaller diameter grease passageway behind the counterbore. When the grease fitting was

removed to allow collection of material samples from the grease passageway, translucent, reddish grease consistent with the appearance of Mobilgrease 28 was observed on the fitting's external threads. (Figure 17 shows a cross-section through the acme nut's grease passageway and fitting.) Traces of translucent, reddish grease were also found inside the grease passageway in the acme nut and in the bore of the grease fitting, a section distinct from the grease passageway. (Figure 18 shows the grease passageway and counterbore after the acme nut was sectioned.) Microscopic examination determined that the sample from the counterbore consisted mostly of black powdery material, larger chunks of black and white material, and particles of copper-colored metallic debris identified as acme nut material.

**Figure 17.** A diagram of a cross-section through the acme nut's grease passageway and fitting. Red areas denote the locations where red grease was found, and gray areas denote the location where the dry residue was found.

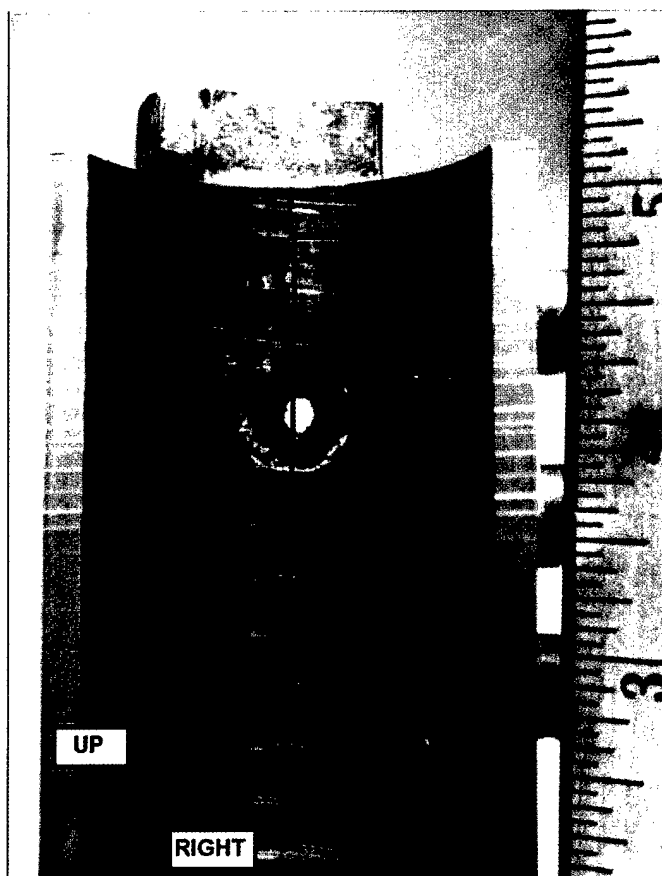
**Figure 18.** A photograph of the grease passageway and counterbore after the acme nut was sectioned.

Magnified visual inspections of the acme nut's interior after the nut was longitudinally sectioned confirmed the presence of the spiraling pattern consistent with the original location of the internal nut threads. For comparison with the accident acme nut interior, an exemplar nut was similarly sectioned.<sup>136</sup> The spiral patterns comprised a small raised ridge followed by a lustrous depression with spiral machining or wear marks transitioning into a dark band of surface deposits that rose to the next ridge. Under higher magnifications, longitudinal smearing and shear fractures were identified on the raised edges. The smearing and shearing directions were consistent with upward movement of the acme screw threads in relation to the nut body. Material was observed folded upward and smeared over adjacent surfaces along most of the ridges. Typical ridges were between 0.013 and 0.020 inch wide.

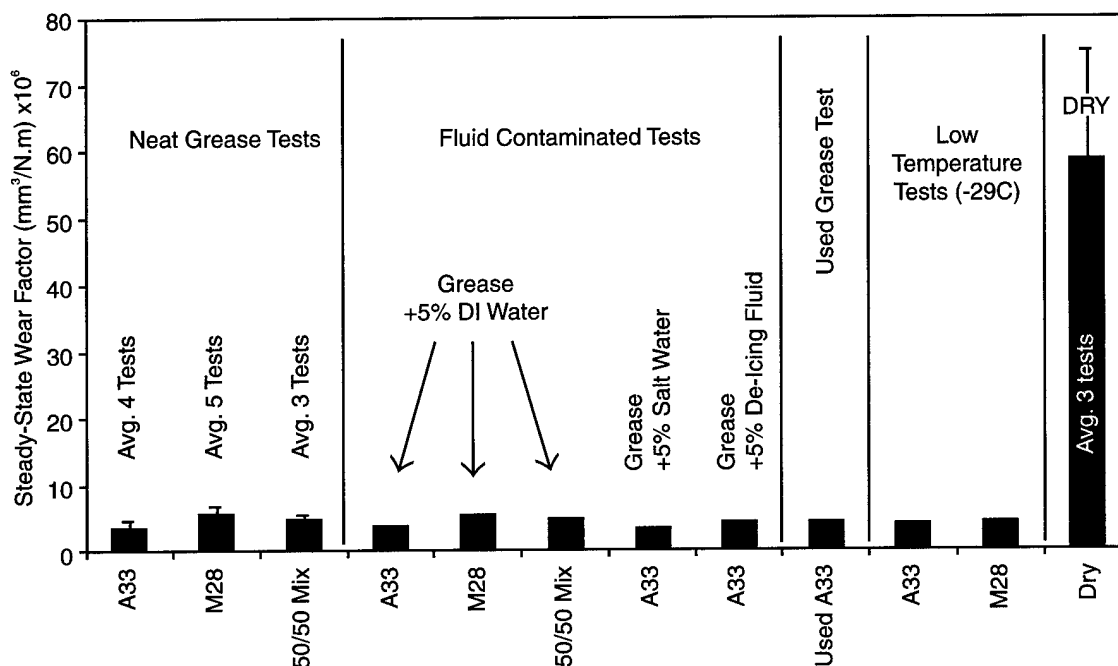
The results of the wear tests showed that, in all ranges of contact pressure, lower wear rates were generated when Aeroshell 33 was used than when Mobilgrease 28 was used. Additionally, the effects of contamination, aging, and subzero temperature exposure were determined to have little effect on the lubricating effectiveness of Aeroshell 33. Only the tests run without any lubrication generated wear rates significantly higher than those generated when Mobilgrease 28 was used. In these cases, wear rates were seen to transition up to 10 times higher than those with equivalent conditions lubricated with Mobilgrease 28. Figure 19 shows a summary of the results of the high-load wear tests, including the contamination and low-temperature tests.

**Figure 19.** A summary of the results of the high-load wear tests, including the contamination and low-temperature tests.

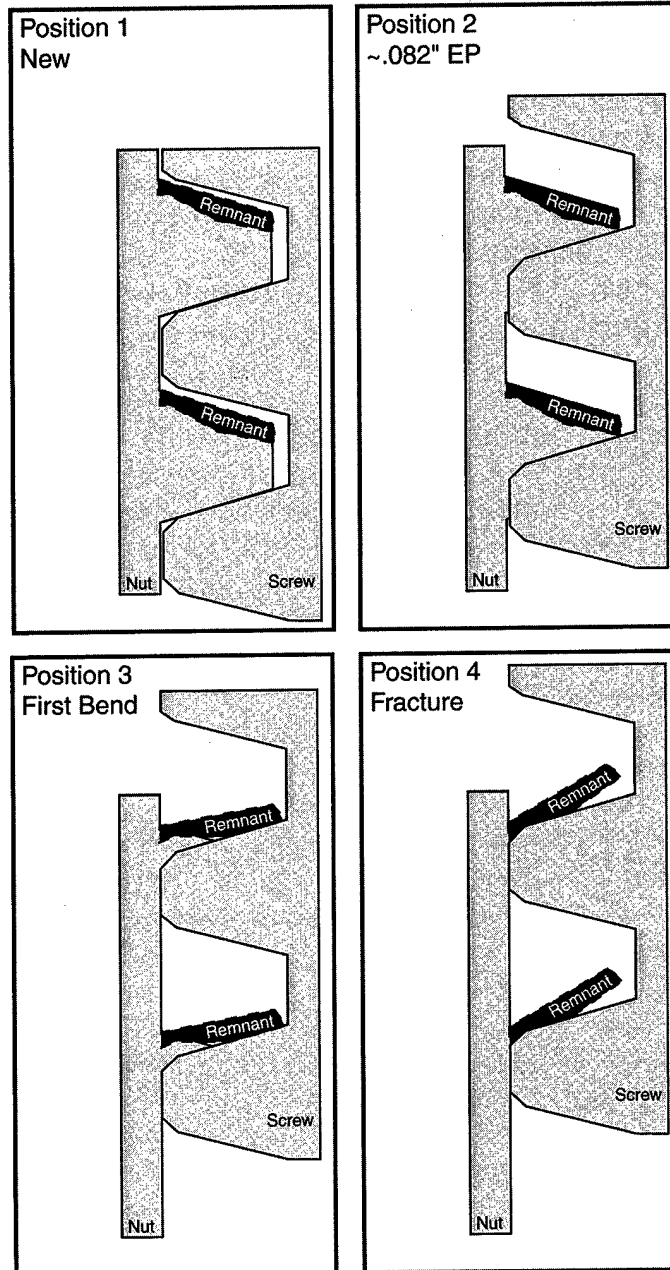
<sup>216</sup> It was theorized that, as the last of the acme nut thread remnants shear fractured and the screw threads tried to override the resulting ridges in the nut as the screw was pulled upward by aerodynamic loads and rotated circumferentially by the primary trim motor, the combined pinching and friction loads became greater than the combined aerodynamic and primary trim motor forces.

**Figure 20.** A graphical depiction of the stages of acme nut thread wear to the point of fracture.
