February 2001

Mill Creek

Flood Control Project
Radial Gate Investigations

HDR Engineering, Inc.

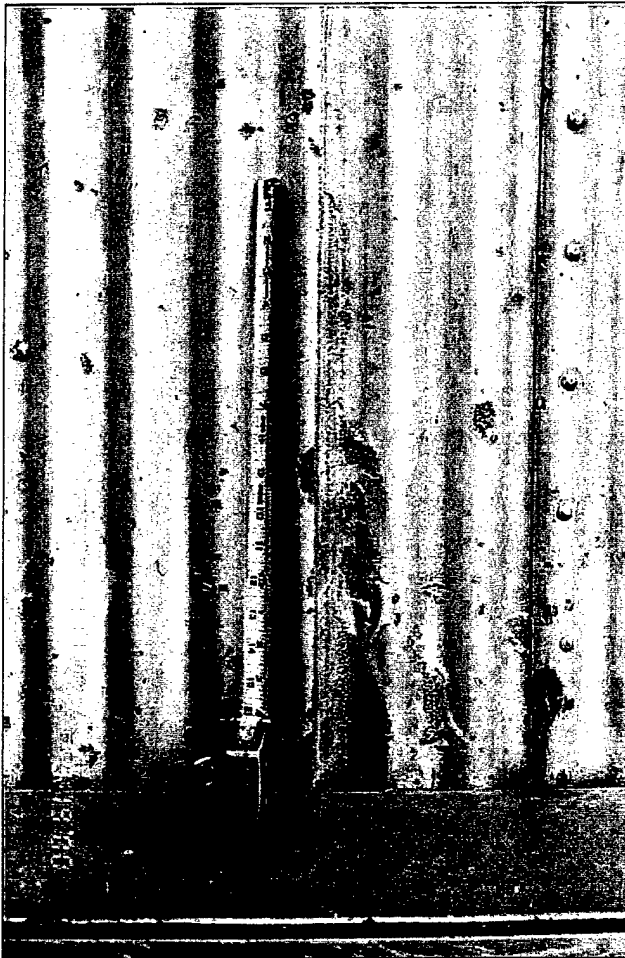
The skin plate is comprised of three sections of corrugated, galvanized steel with the corrugated ribs running in the vertical direction. The plate is 3/32 inch thick, with a span between corrugations of 2-3/4 inches and a section depth of 3/4". The skin plate is in very good condition. There are spots of delaminated paint, however, very little corrosion is visible through the galvanizing.

Photo 3 - Downstream surface of skin plate showing typical worst case delamination.

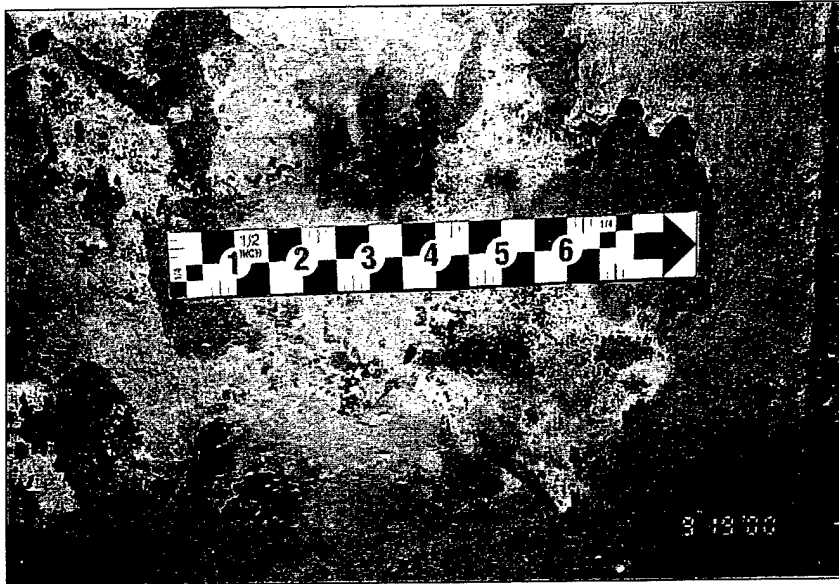
Photo 11 shows a close-up of the delaminated paint and moderate corrosion typical on the gate faces. Photo 12 shows a close-up of moderate corrosion near the bottom seal on Gate 2 (Note: good condition of rivets and bolts).

Photo 11 - Delaminated paint and light to moderate corrosion, typical on all gates.

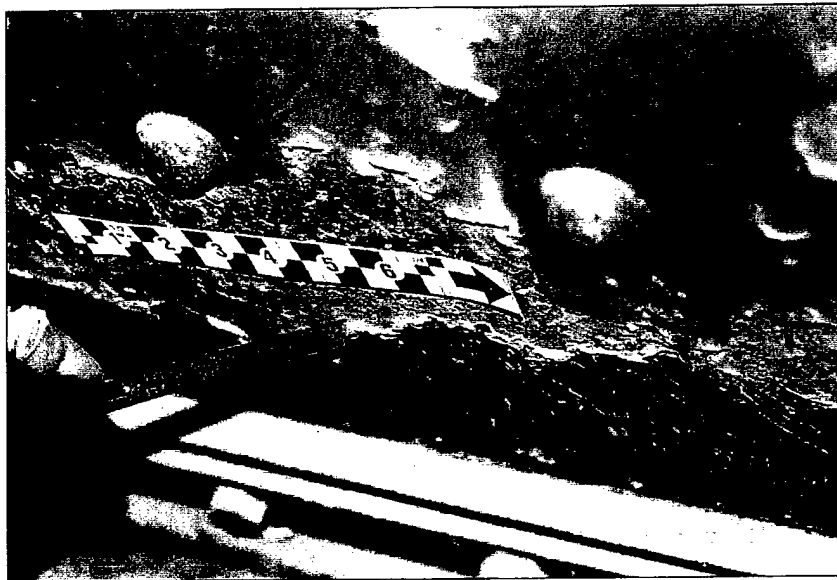
Photo 12 - Moderate corrosion on skin plate at bottom seal.

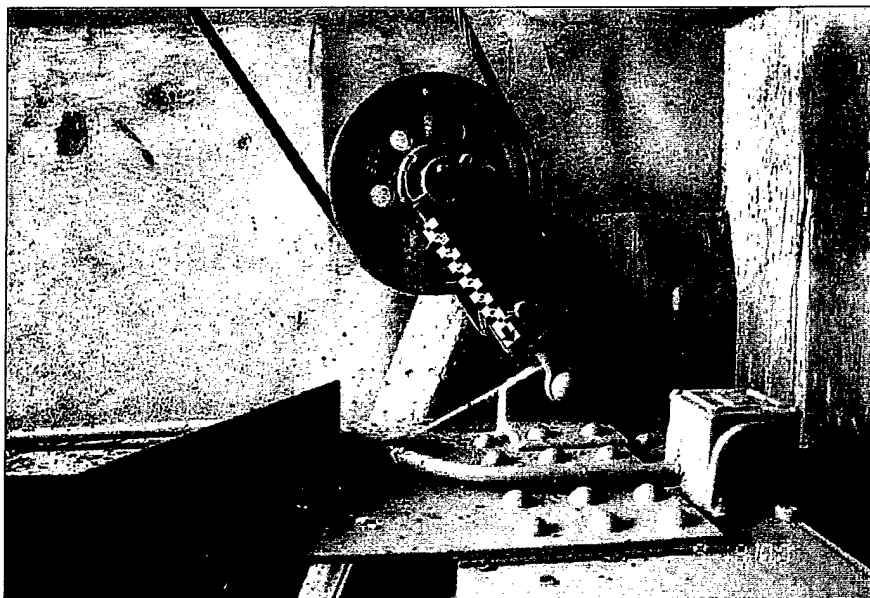
External portions of the hoist equipment, support platforms and gate connections were visually inspected for signs of excessive corrosion, wear or damage. The hoist and hoist machinery are in generally good condition. All of the gates were raised to approximately two feet open in order to check for racking and to allow access to the upstream side. Racking measurements were made at the left and right side of the gates, between the bottom corner of the bottom horizontal girder and the top of the spillway. There is no apparent racking occurring at any of the gates and all measurements were within 1/8-inch from one side to the other. Measurements for each of the gates are given in Table 1, below. The 2:1 reduction, lifting pulleys on the top of the gates were in good condition with only light corrosion on some of the wheels or linkages. See photo 17 below.

Photo 17 - Hoist reduction pulley at top of gate, typical.

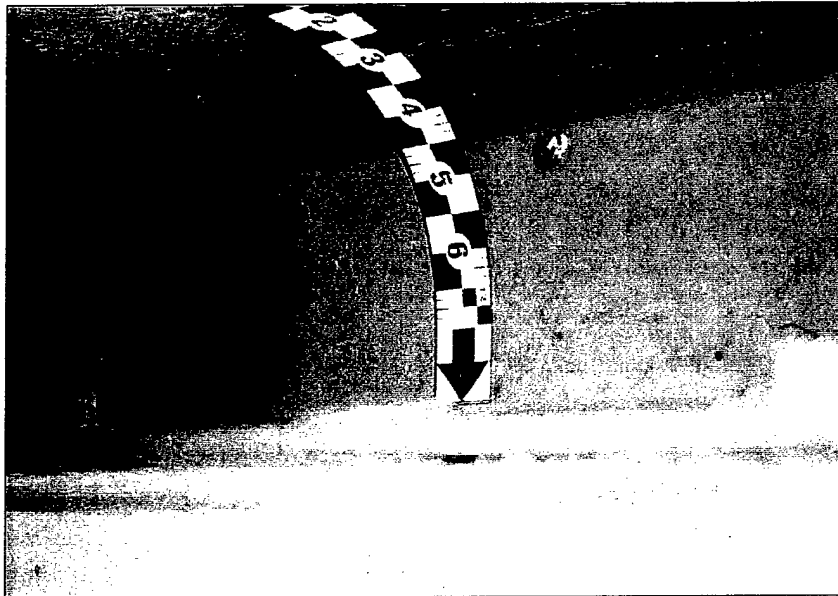
- There are five missing bolts at the top of the gate. The bolts attach the upstream top seal bracket to the skin plate and the web of the top horizontal channel. There is no apparent distress or evidence of leakage due to the missing bolts. See photo 22 below.

Photo 22 - Missing bolt at top seal bracket, typical of five locations. Note: presence of washer without bolt head.

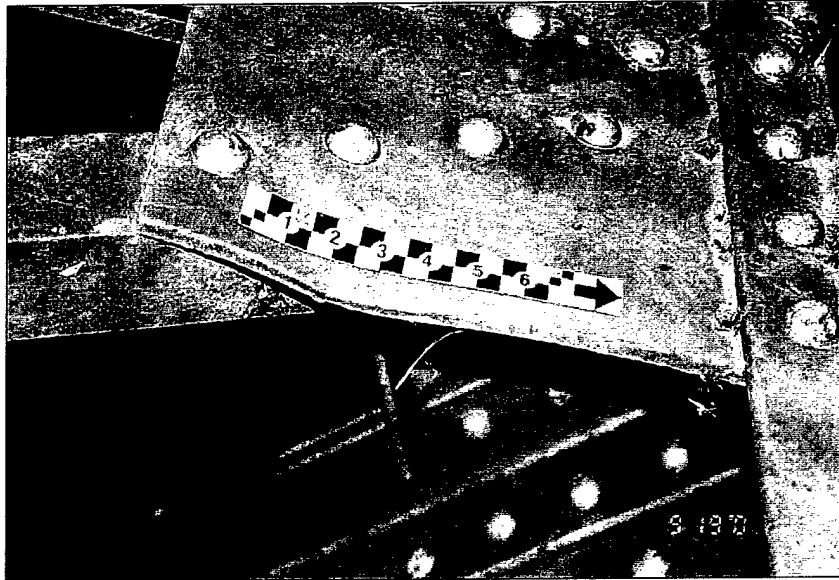
Riveted connections are in good condition with isolated spots of light corrosion. The gusset plate connecting the top left strut and top bracing to the top girder is deformed approximately $1/4$ -inch. See photo 25. It is unclear if this was caused by stress in the plate or something being dropped from above. The bolt holes at the connection of the top girder and the top seal have been flame cut to a slotted hole. This is typical across the top seal. See photo 26.

Photo 25 – Gusset plate at top strut connection to top girder.

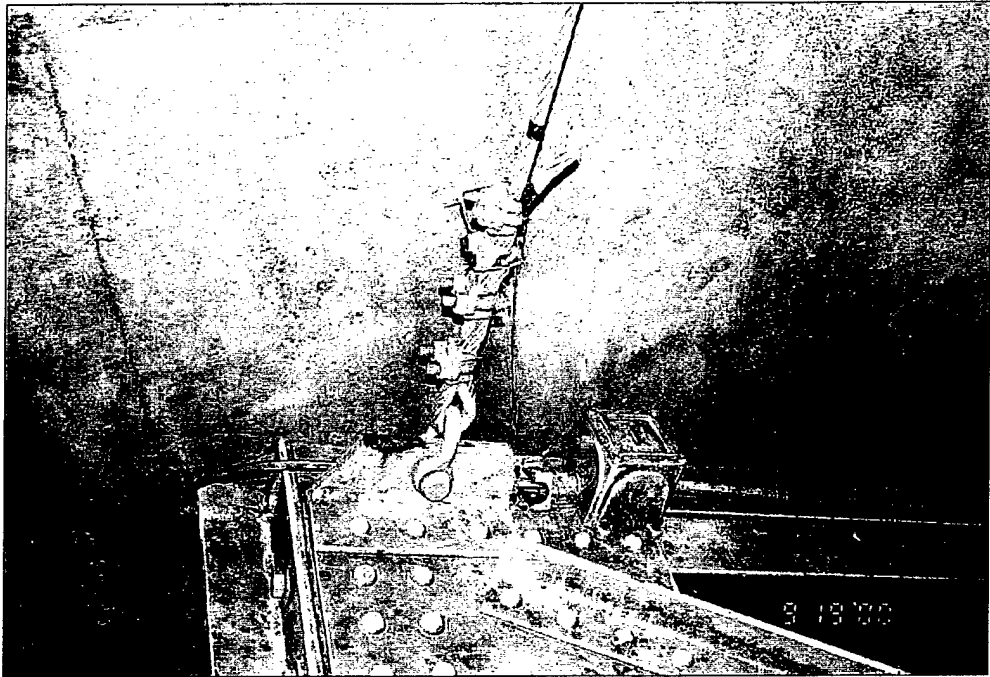
Electric side seal heaters have been installed on the gate at some time in the past. There is no indication of the heaters on the provided as-built plans. No determination as to the working condition of the heaters was made. See photo 28.

Photo 28 – Seal heater installed on gate.

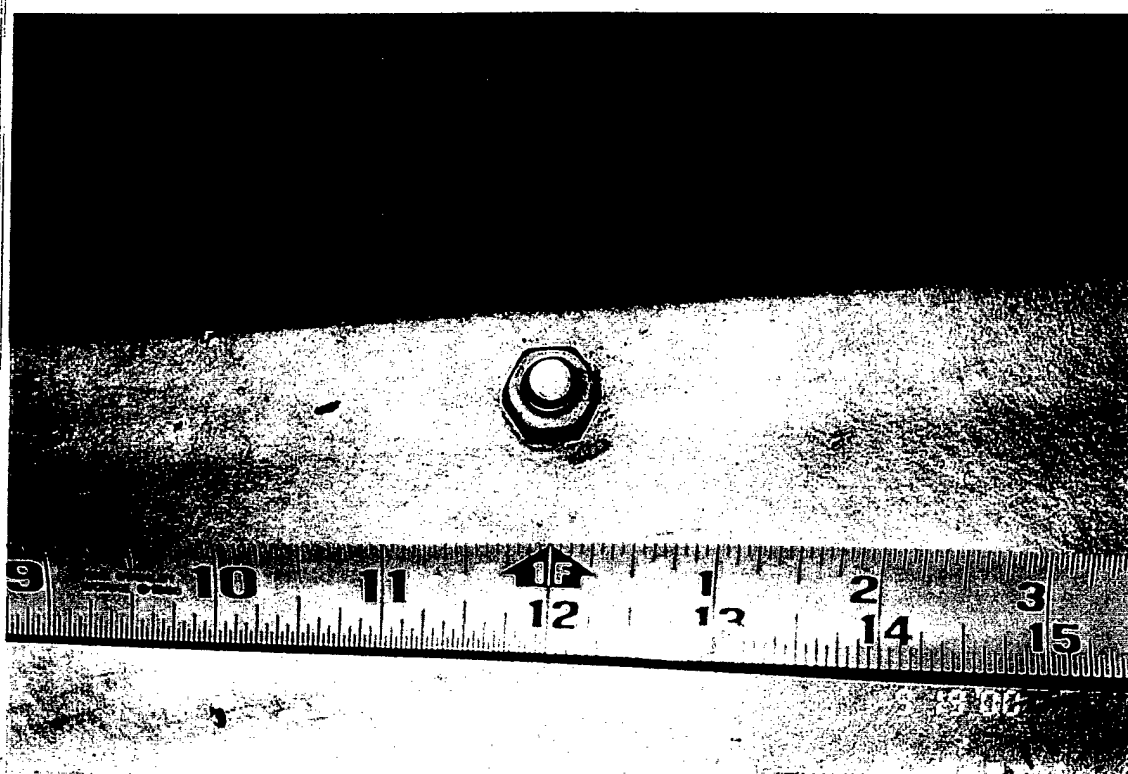
Mill
Creek
Dam
9/19/00
1-11

Armco 6'x14' Gate
Bottom upstream end Strut 1, left
side of gate. Light corrosion on
gusset plate and bolts.

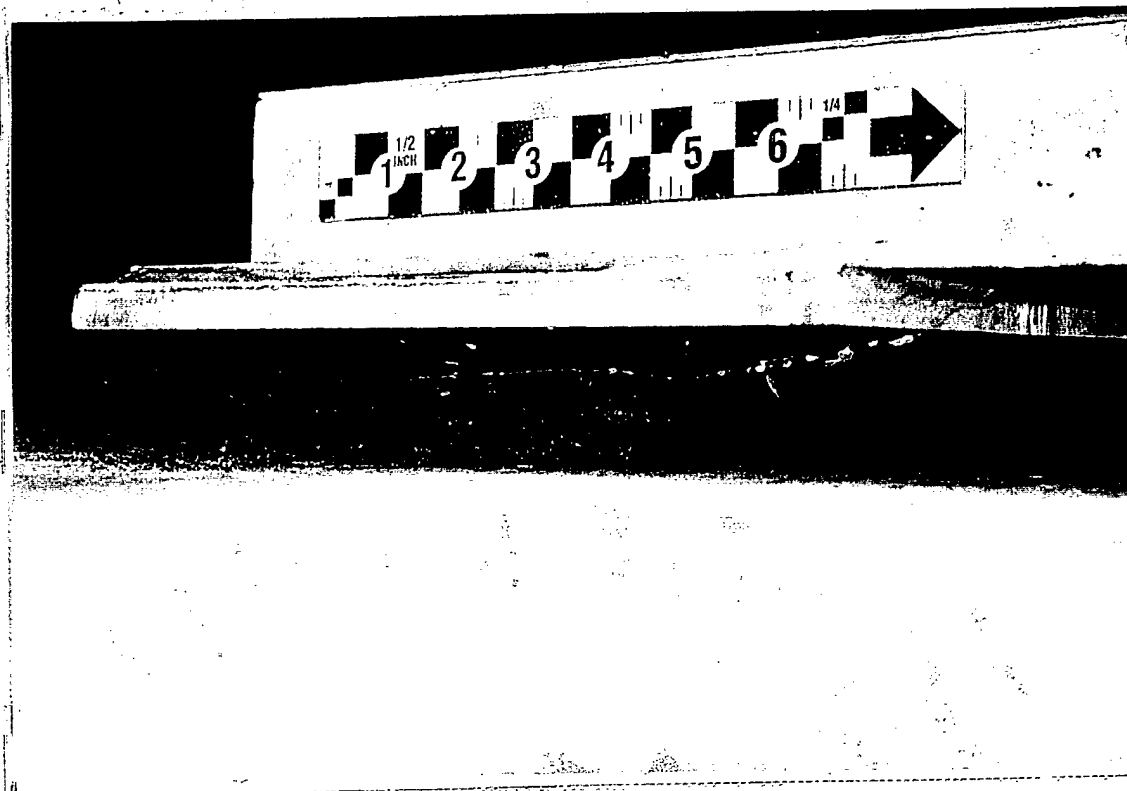
Mill
Creek
Dam
9/19/00
1-15

Armco 6'x14' Gate
Left trunnion looking downstream.
Light corrosion on embedded
trunnion assembly.

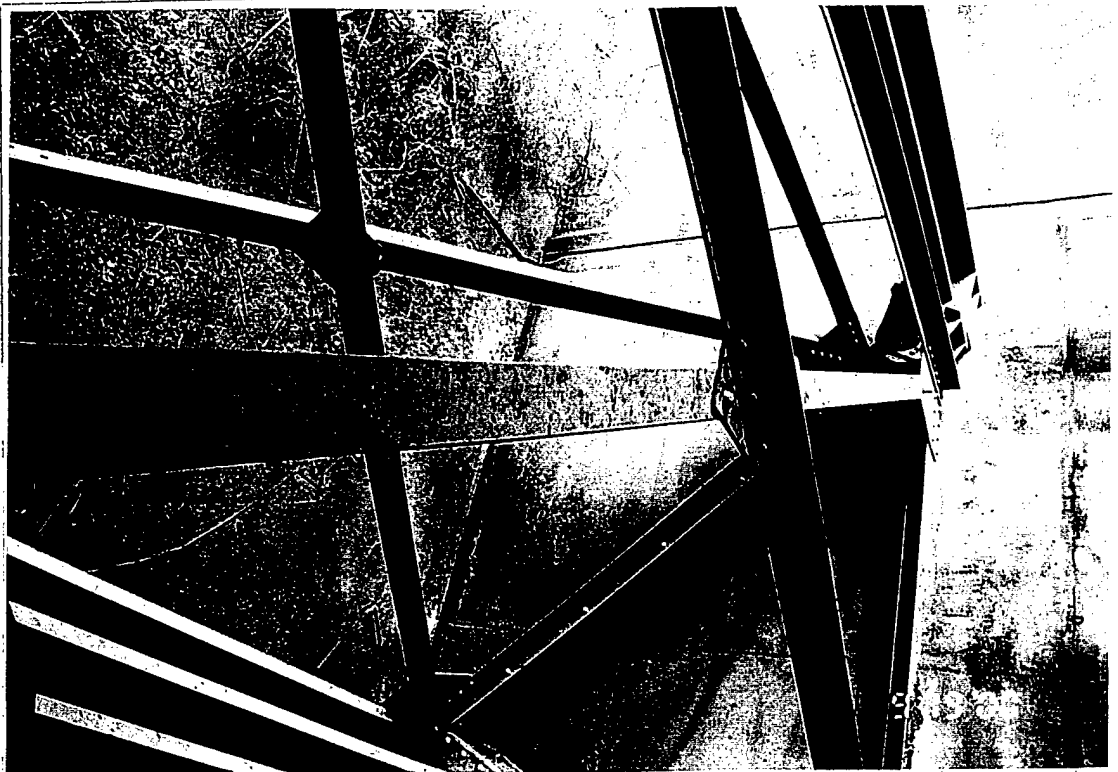
Mill
Creek
Dam
9/19/00
1-5

Gate 1 - 8'x18'
Top of top horizontal girder and right
hoist reduction pulley. Note: missing
paint on pulley at previous location of
hoist connection

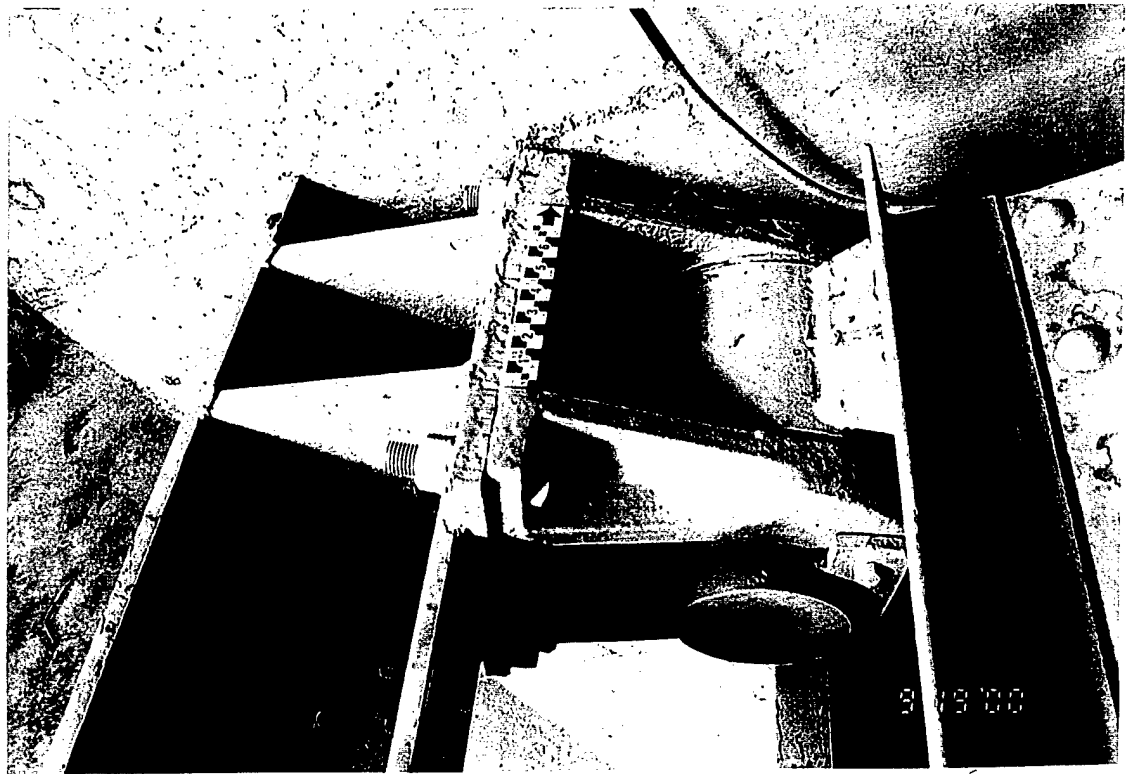
Gate 2 - 8'x18'
 Top of top seal and keeper angle,
 typical.

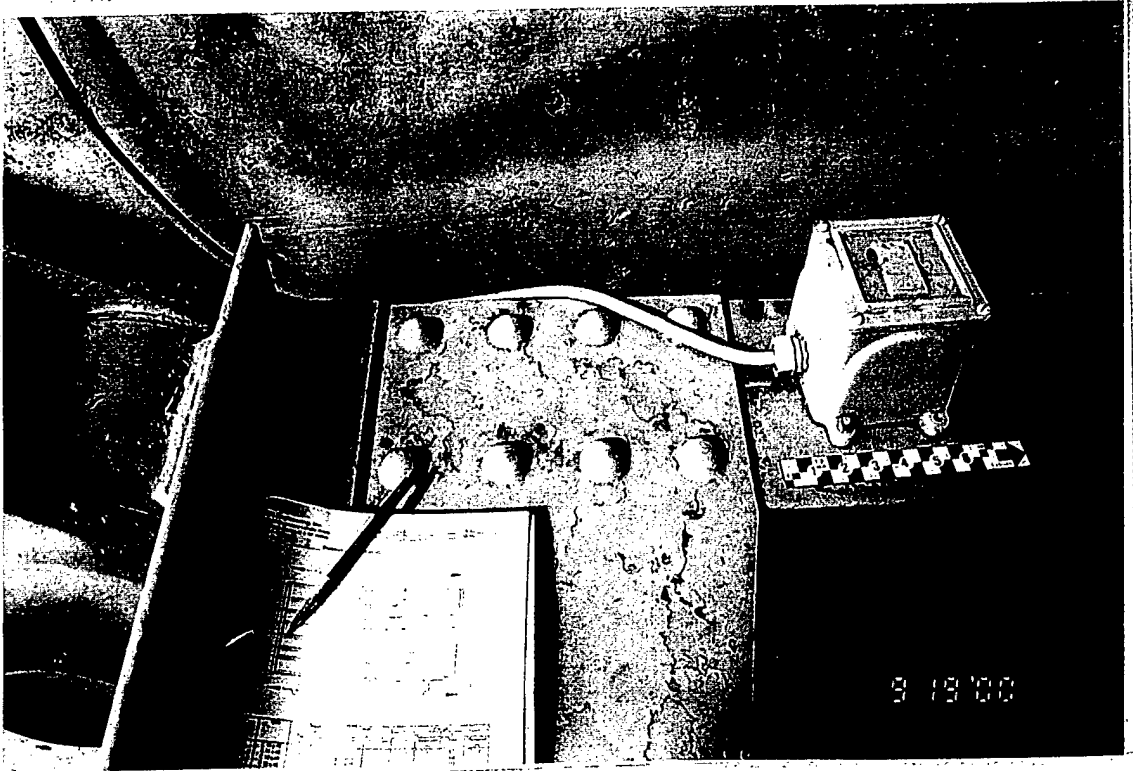
Mill
 Creek
 Dam
 9/19/00
 2-14

Gate 2 - 8'x18'
 Top of right trunnion and trunnion
 beam. Flaking paint and light
 isolated corrosion. Note: lubrication
 fitting on trunnion pin.

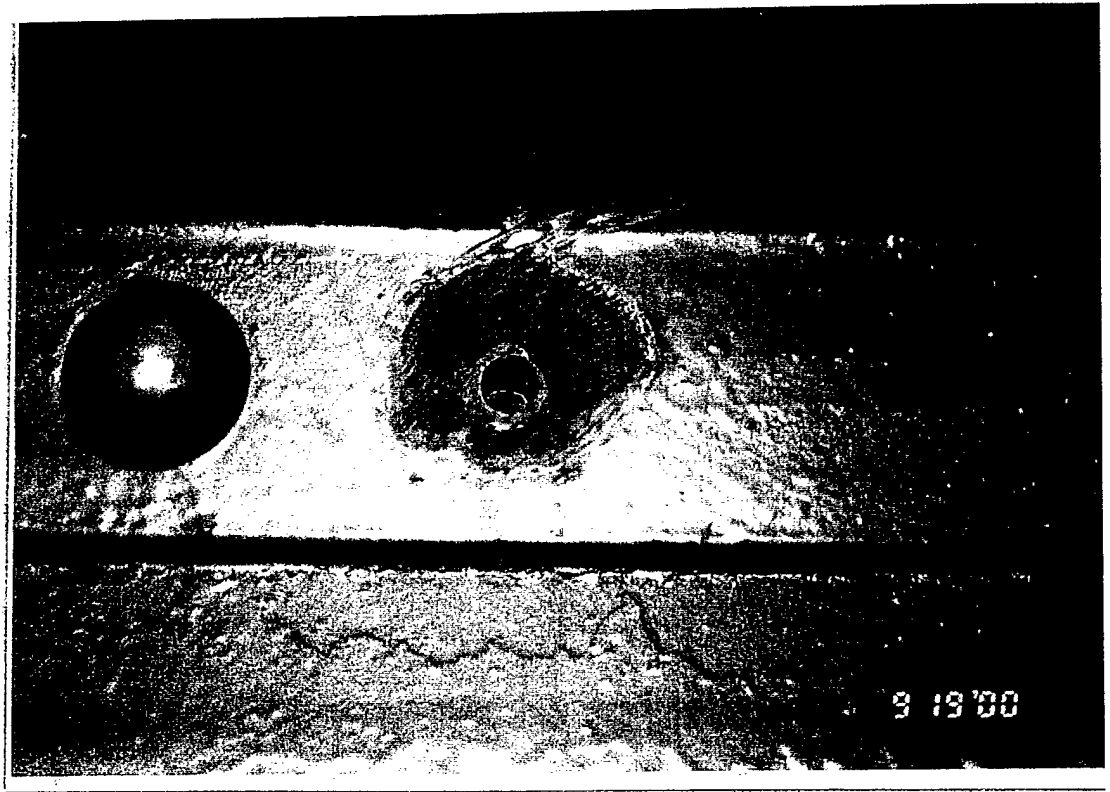
Mill
Creek
Dam
9/19/00
3-8

Gate 3 - 8'x18'
Top seal angle connection bolts,
approximately center of gate. Bolt is
loose and can be turned by hand.

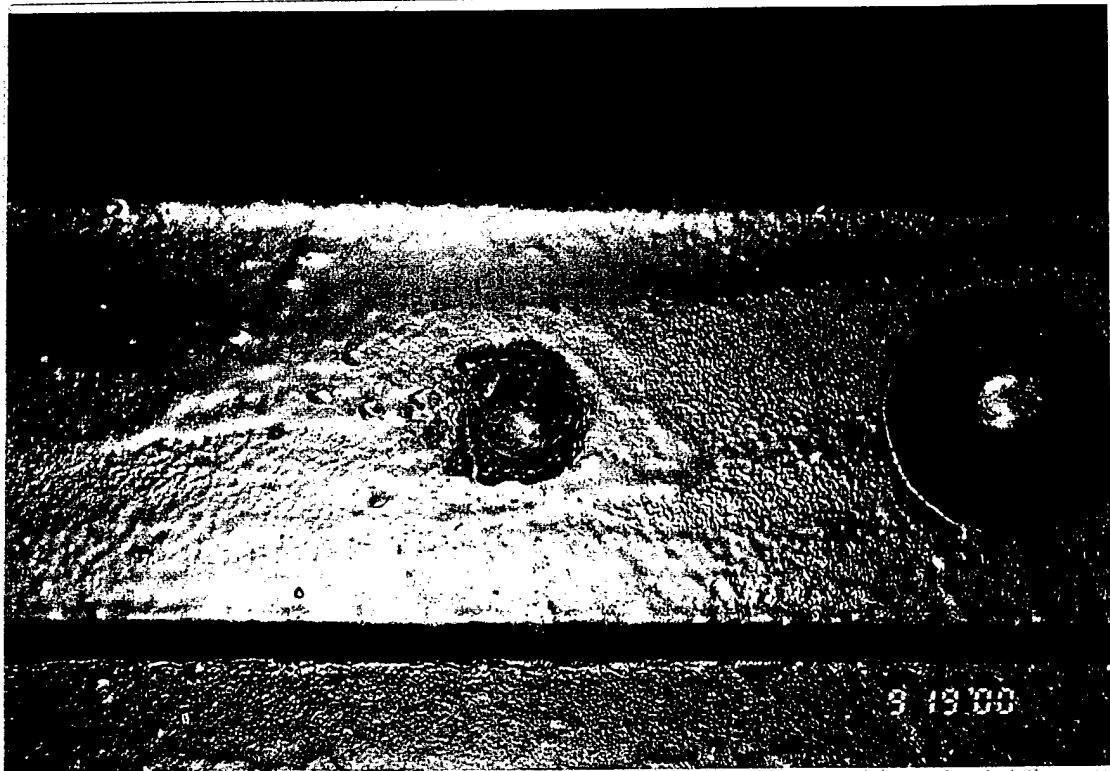
Mill
Creek
Dam
9/19/00
3-9

Gate 3 - 8'x18'
Top seal connection, missing bolt or
extra bolt hole.

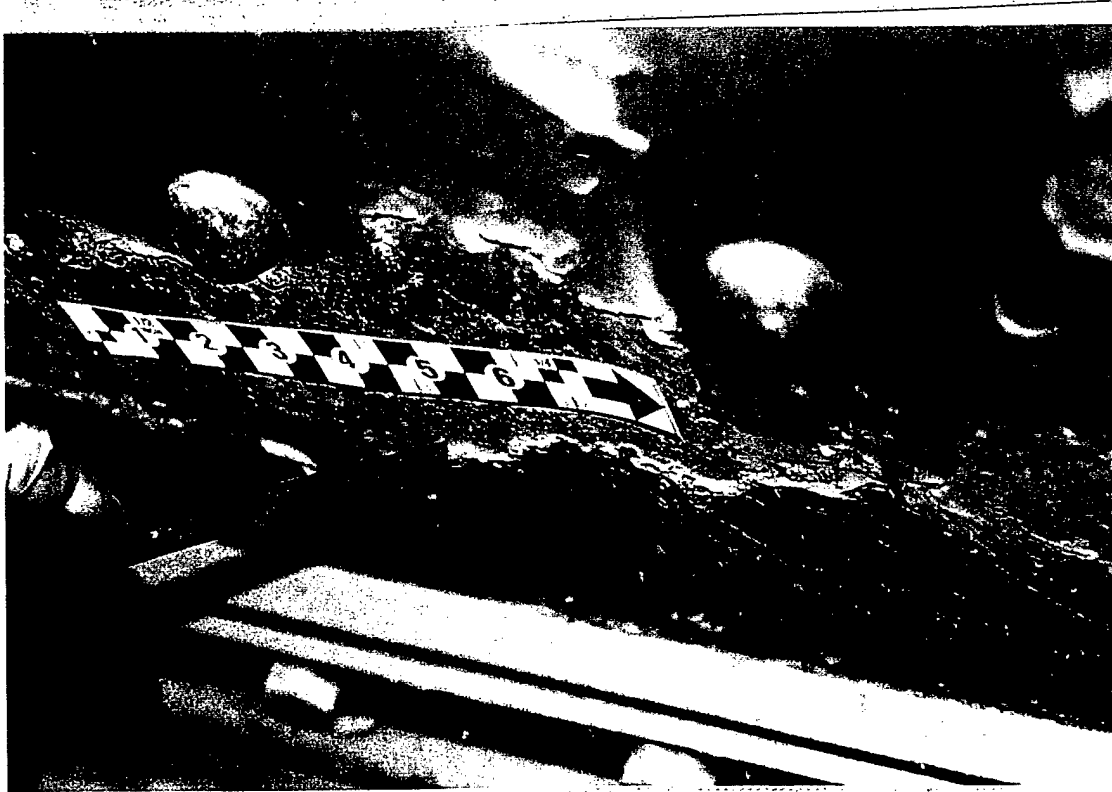
Gate 3 - 8'x18'
Close-up of skin plate at bottom seal.
Light to moderate corrosion.

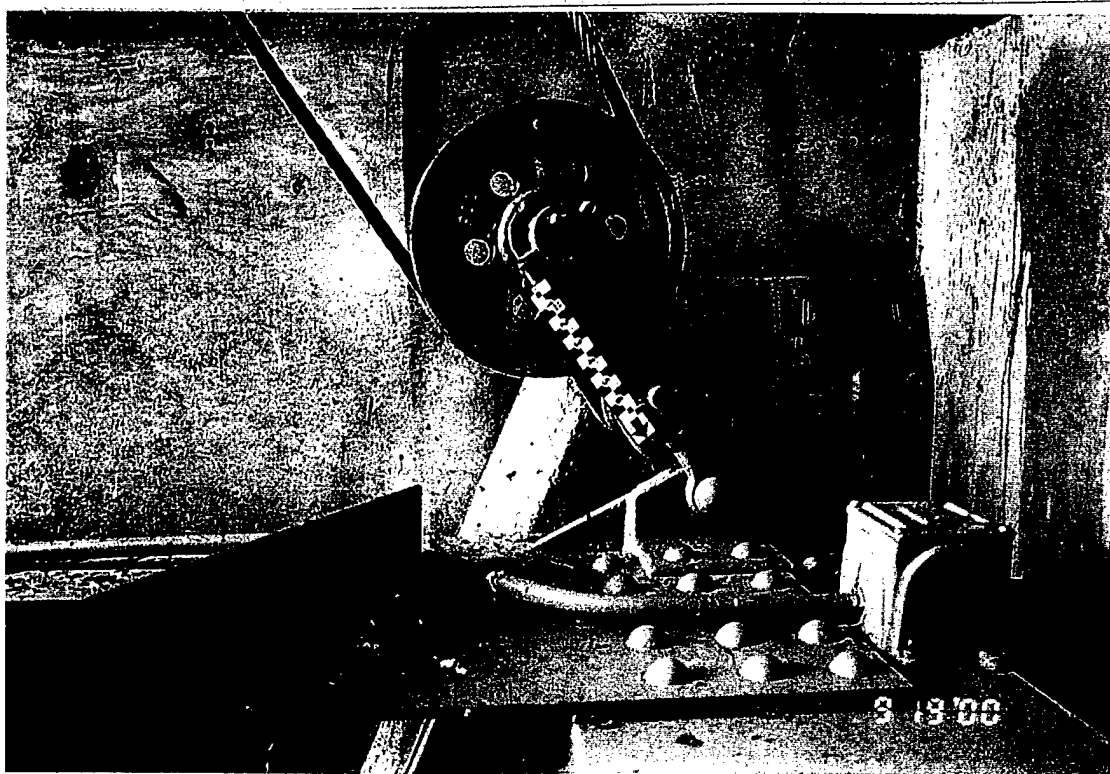
Mill
Creek
Dam
9/19/00
4-7

Gate 4 - 8'x18'
Left hoist reduction pulley. Note:
missing paint on pulley at previous
location of hoist connection.

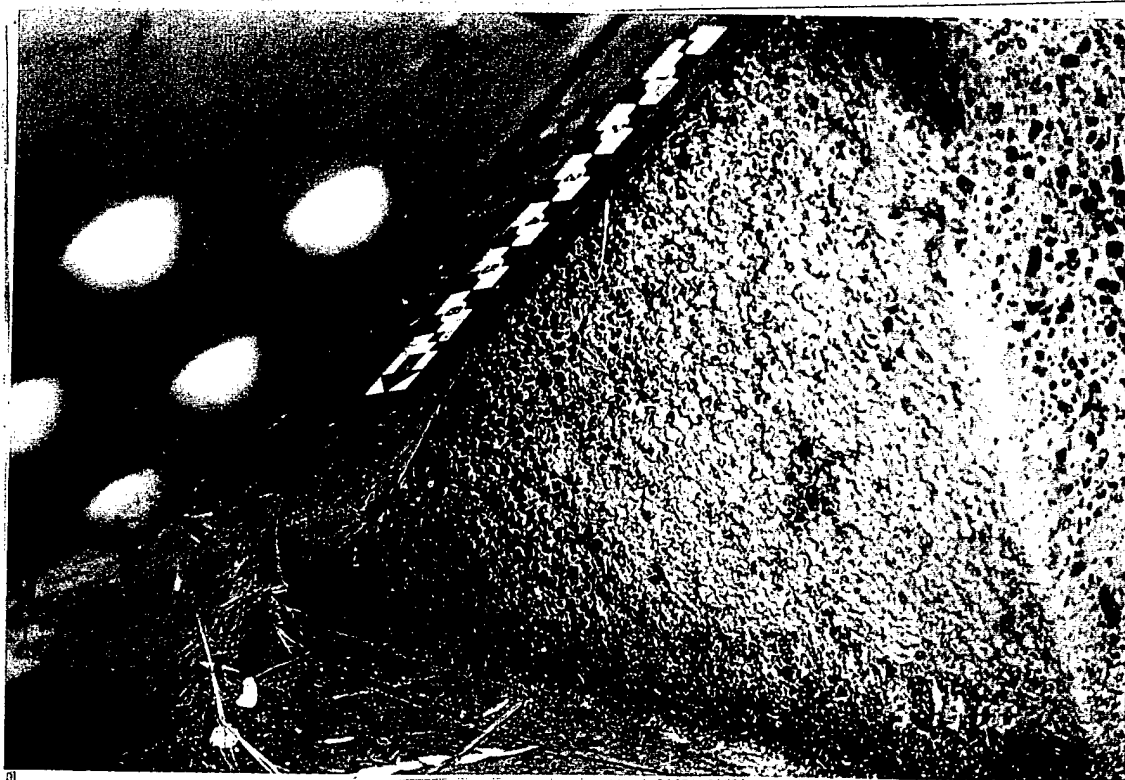
Bottom left corner, splintered timber
bumper, small deformation and light
corrosion in bottom strut.

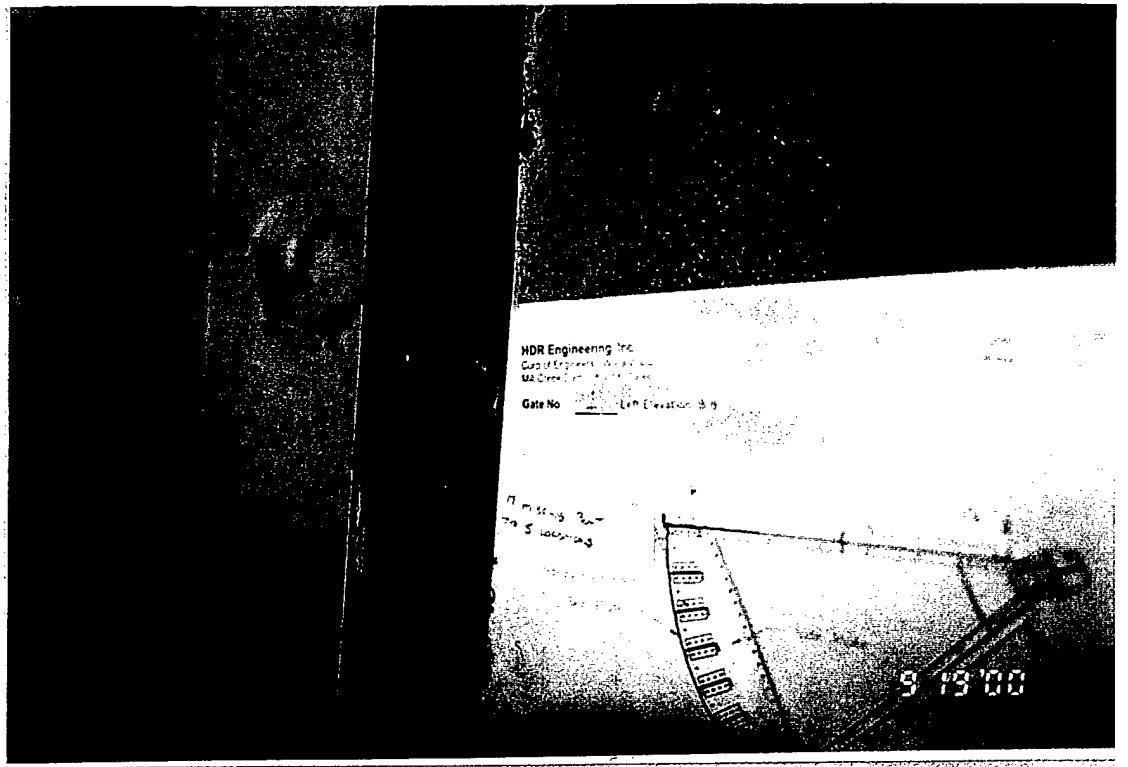
Bottom left corner, splintered timber
bumper, small deformation and light
corrosion in bottom strut.
