## **Periodic Inspections of Kahului and Laupahoehoe Breakwaters, Hawaii**

**Armor Unit Monitoring for Period 1992/93-2001**

Robert R. Bottin, Jr., and Daniel T. Meyers

August 2002

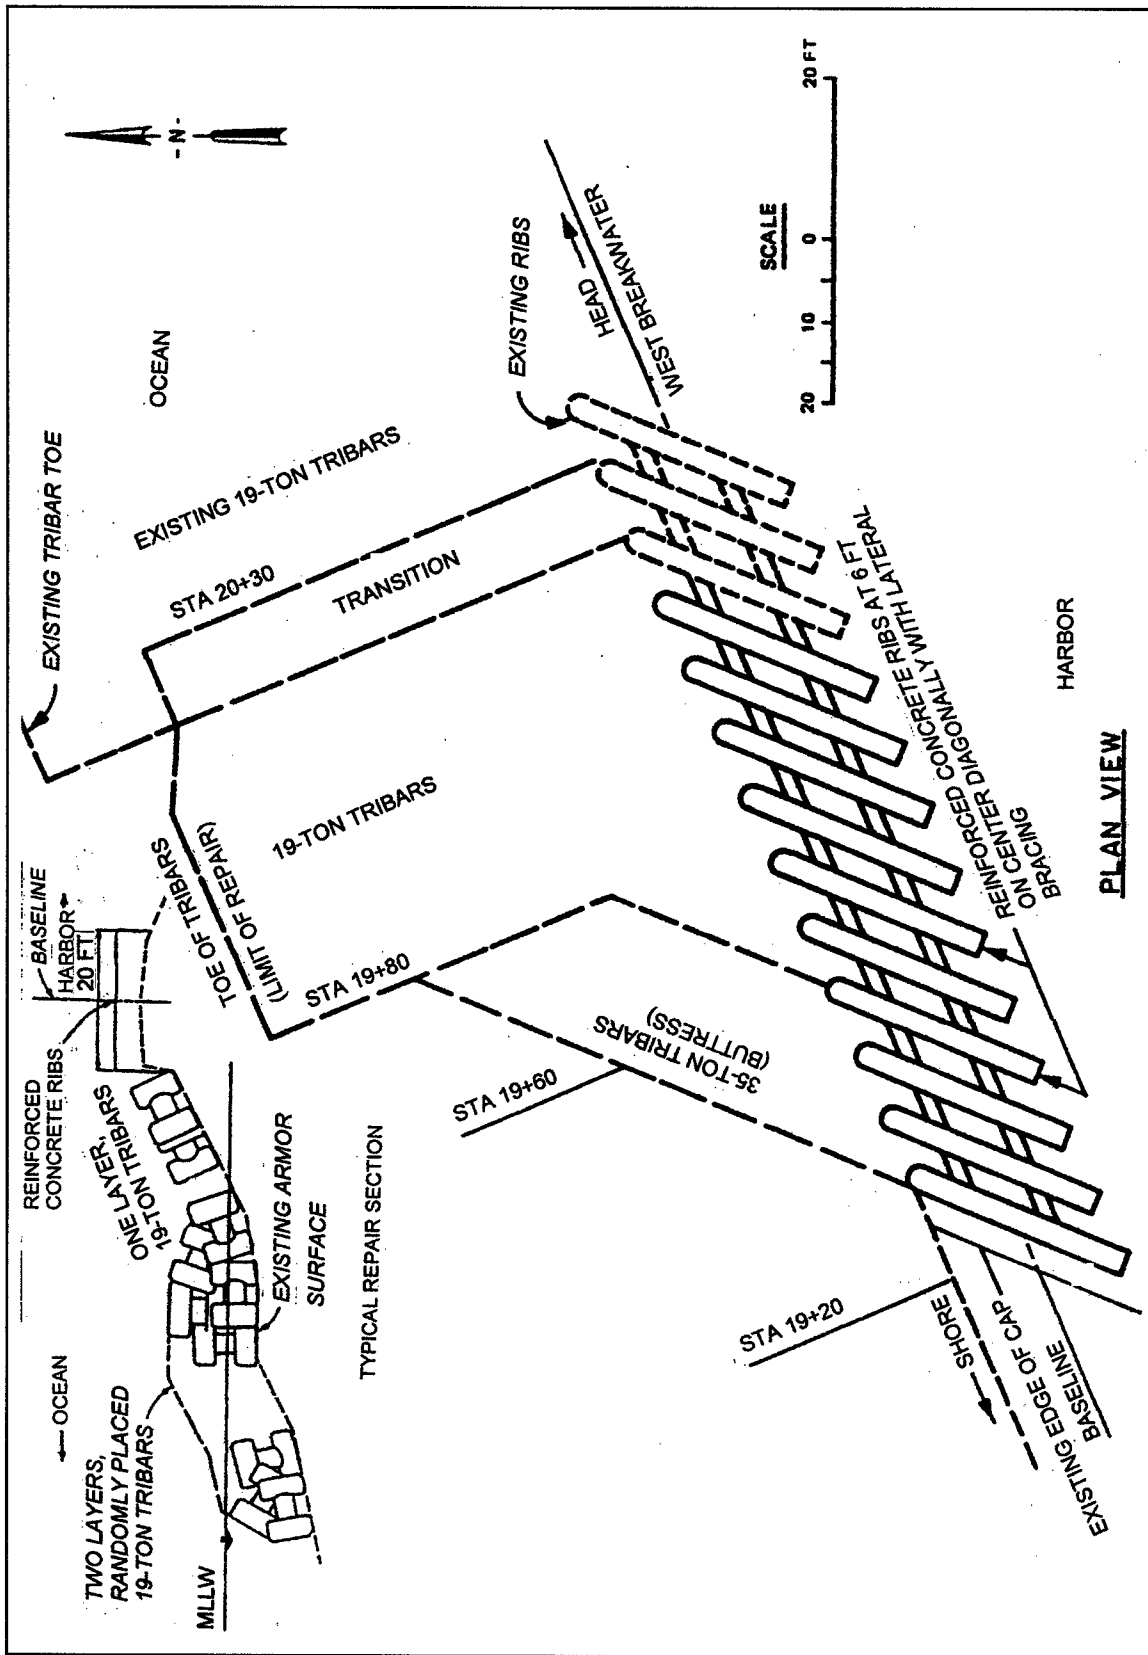
A storm in 1967 severely damaged the west breakwater trunk. This area was repaired in 1969 by construction of a concrete rib cap and placement of 260 reinforced tribars, weighing 17,235 kg (19 tons) each, on the sea-side slope. In November of the same year, the area adjacent to the 17,235-kg (19-ton) tribars at the shore end was damaged by 4.6- to 6.1-m (15- to 20-ft) breaking waves. This area was repaired in 1973 by a 24.4-m (80-ft) shoreward extension of the concrete rib cap and 17,235-kg (19-ton) tribars. The shoreward extent of the tribars was buttressed with 25 tribars, weighing 31,750 kg (35 tons) each (Figure 7).

Figure 7. Kahului west breakwater repairs of 1973

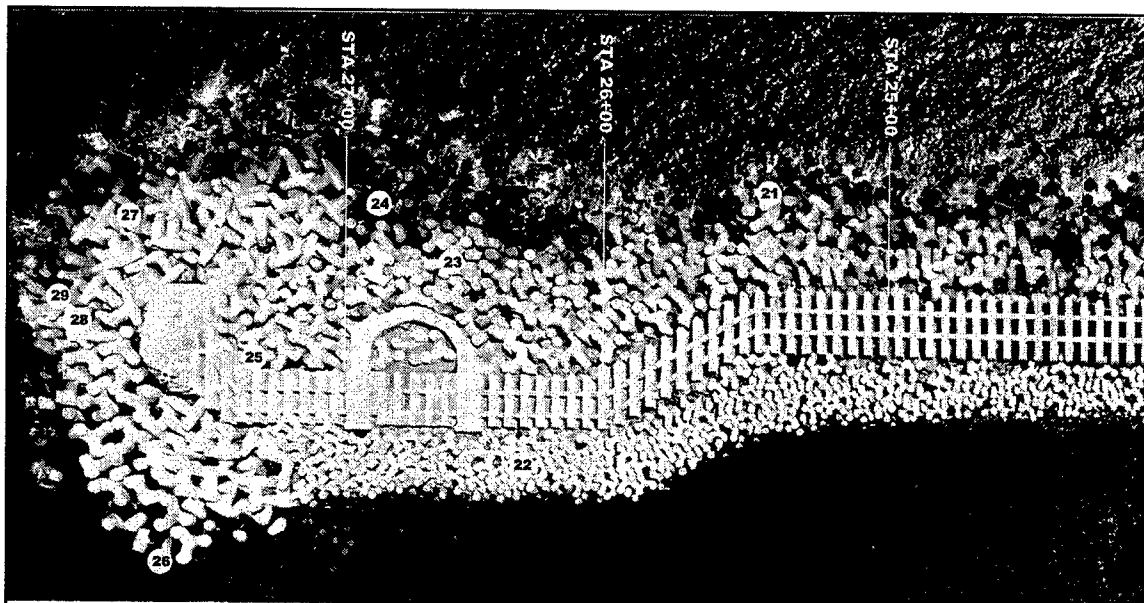
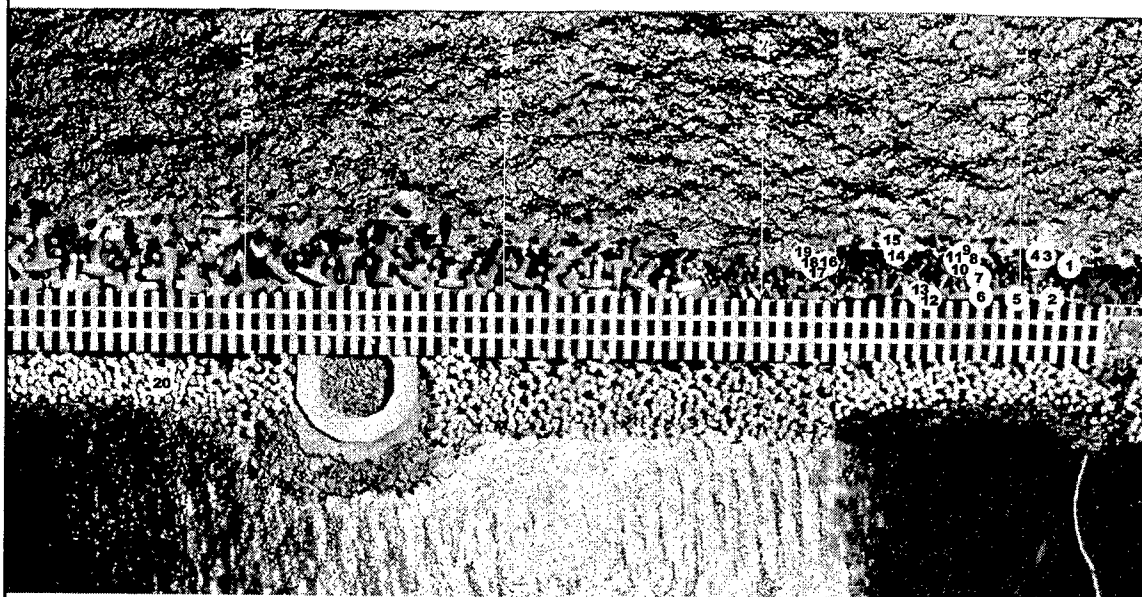
29 broken or cracked armor units were identified and 58 were observed on the Kahului west breakwater during the walking survey. No broken or cracked armor units were found on the Laupahoehoe breakwater .

The approximate locations of broken/cracked armor units along the Kahului east and west breakwaters are shown in Figures 26 and 27, respectively, and detailed data obtained during the broken armor unit inventory are shown in Table 11. Armor unit numbers identified in Figures 26 and 27 correspond to those listed in Table 11. Of the 29 broken armor units on the Kahului east breakwater, 19 were 5,445-kg (6-ton) dolosse; two were 8,165-kg (9-ton) tribars; four were 27,215-kg (30-ton) dolosse; and four were 31,750-kg (35-ton) tribars. The majority of the broken units (66 percent) were 5,445-kg (6-ton) dolosse located on the seaward side of the inner half of the concrete-armored portion of the structure. These broken units were concentrated between stas 19+60 and 20+84. Seventy-four percent of the broken 5,445-kg (6-ton) dolosse were located on the lower portion of the seaward slope in the active wave zone. Most the remaining broken units on the east breakwater were sporadically located around the head of the structure with no specific concentrations. Of the 58 broken armor units on the Kahului west breakwater, four were 5,900-kg (6.5-ton) tribars; one was a 9,980-kg (11-ton) tribar; 16 were 17,235-kg (19-ton) tribars; 18 were 18,145-kg (20-ton) dolosse; 11 were 27,215-kg (30-ton) dolosse; five were 29,940-kg (33-ton) tetrapods; and three were 31,750-kg (35-ton) tribars. On the west breakwater, 90 percent of the broken units were located on the seaward side of the outer half of the concrete-armored section of the breakwater. Concentrations of broken units occurred on the sea side of the breakwater between stas 20+50 and 21+50 and stas 22+50 and 23+50. Most broken units (66 percent) also were located on the lower portion of the seaward breakwater slope in the active wave zone.

Figure 26. Approximate locations of broken/cracked armor units along outer portion of Kahului east breakwater

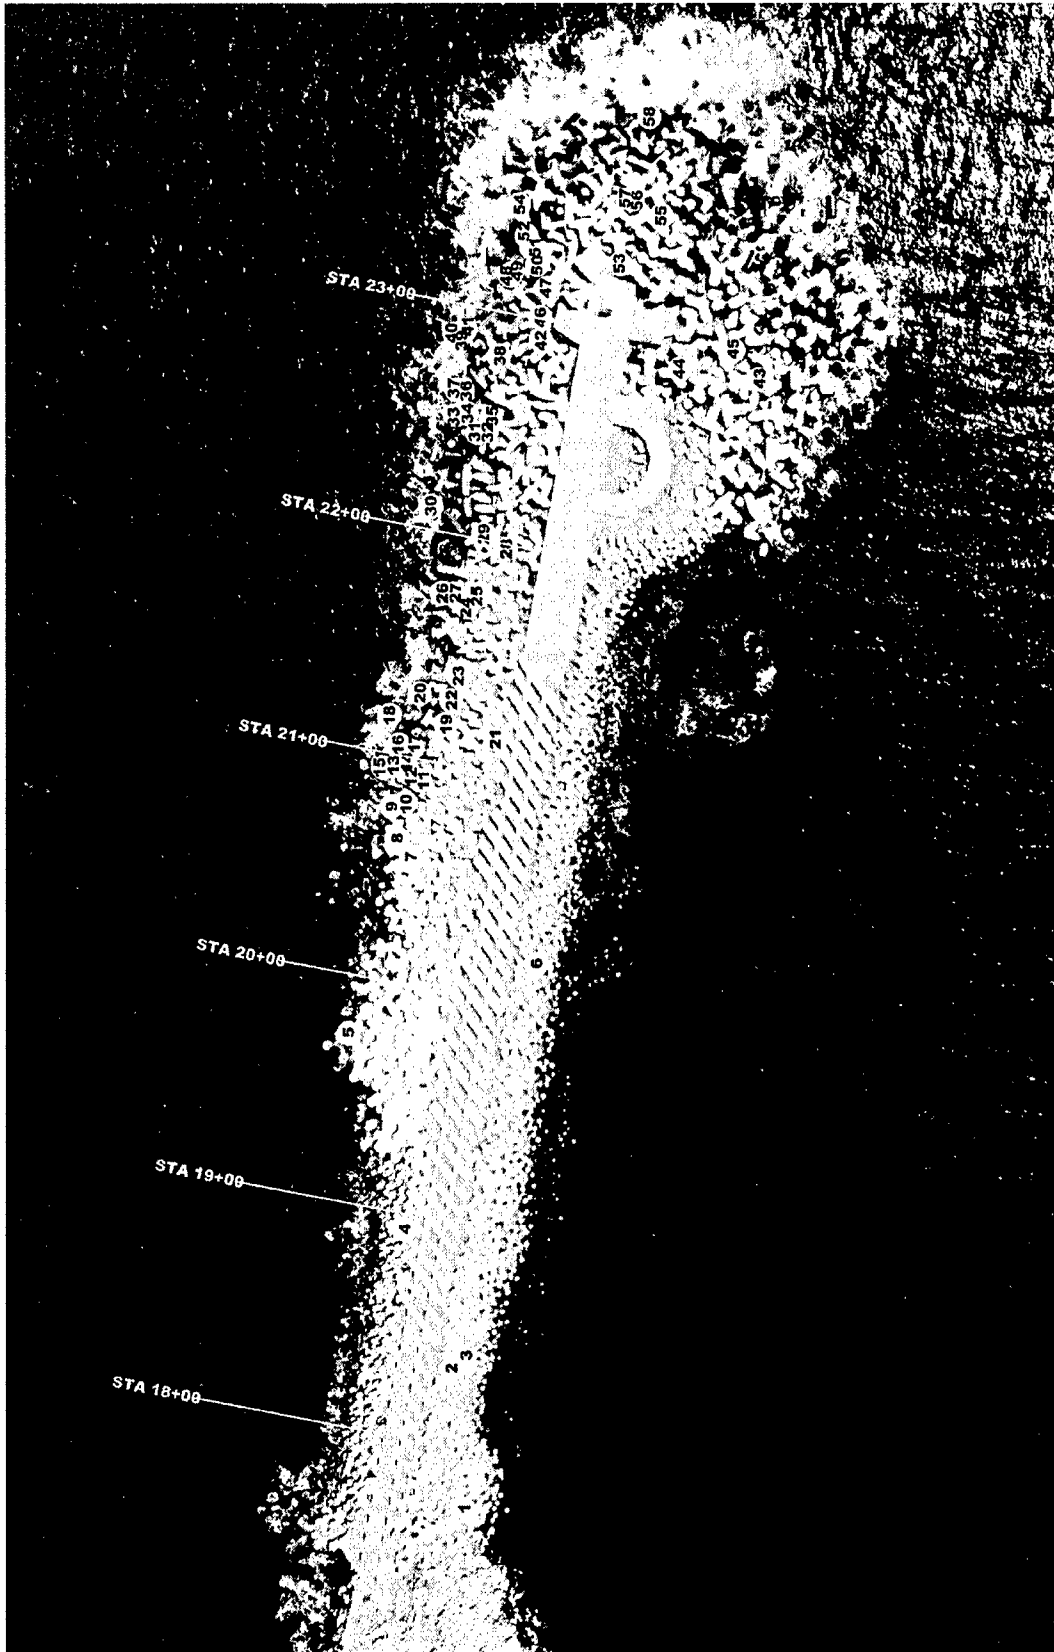
Figure 27. Approximate locations of broken/cracked armor units along outer portion of Kahului west breakwater

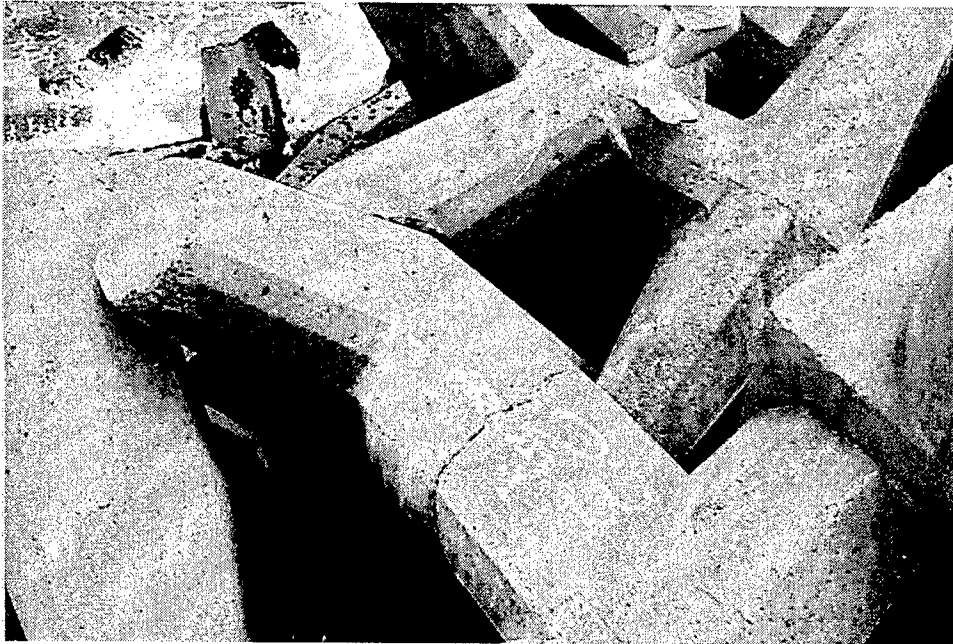
Types of breaks for the dolosse included shank and fluke breaks. These were characterized as mid-shank, shank-fluke (shank broken in vicinity of fluke), and fluke-shank (fluke broken off at junction with shank). Also recorded were straight breaks (broken straight across) and angled breaks (broken at some angle to the dolos limb). For the tribars and tetrapods, types of breaks included those through the center section of the unit where one or more legs were separated from the unit, and those in which just a portion of one of the legs was broken off.

Figure 28. Dolos with mid-shank crack

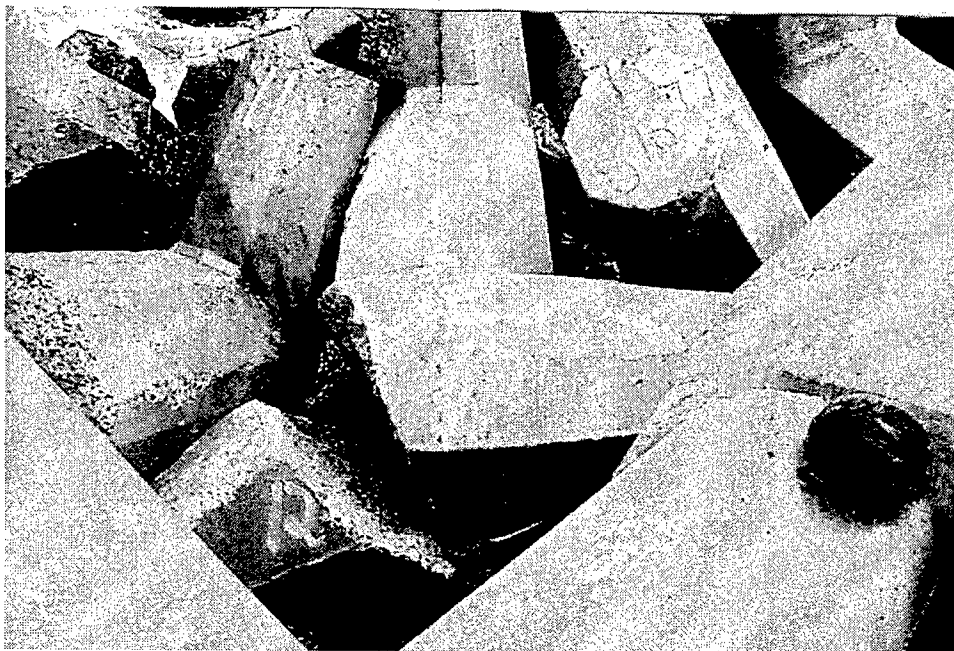
Figure 29. Dolos with fluke-shank break

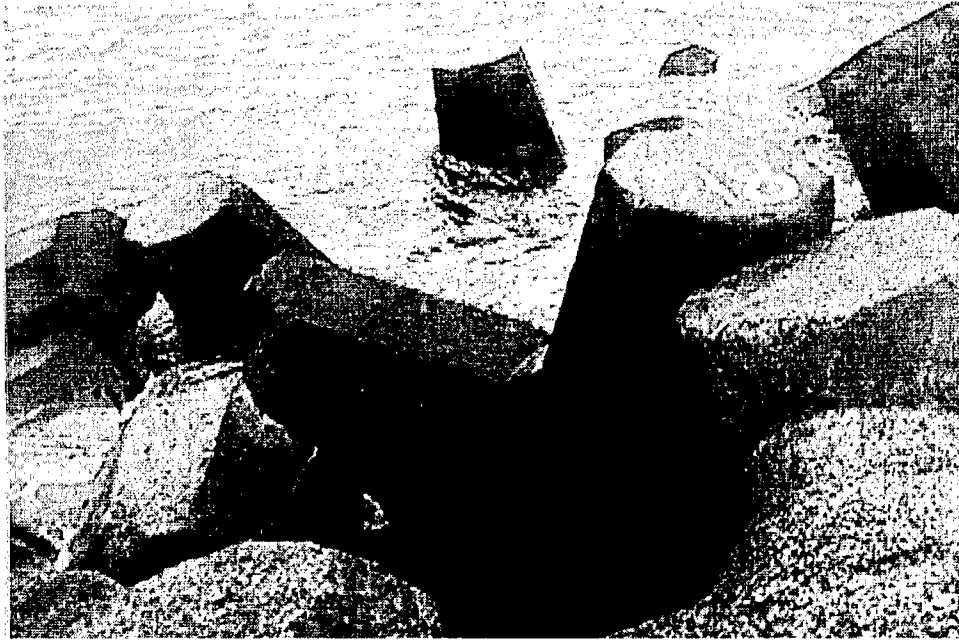
Considering the types of breaks for the 52 broken dolosse on both the Kahului structures, 75 percent had shank-fluke breaks, 16 percent had fluke-shank breaks, and 9 percent had mid-shank breaks. Of the dolosse breaks recorded, 78 percent were straight and 22 percent were angled. Considering the types of breaks for the 35 tribars and tetrapods on the Kahului breakwaters, 89 percent included units with breaks through the center sections where one or more legs had separated, and 11 percent had just portions of a leg broken off the unit.

Figure 30. Dolos with shank-fluke break
