ERDC/CERL TR-03-5

## Overcoating of Lead-Based Paint on Steel Structures

### Cost and Performance Report

March 2003

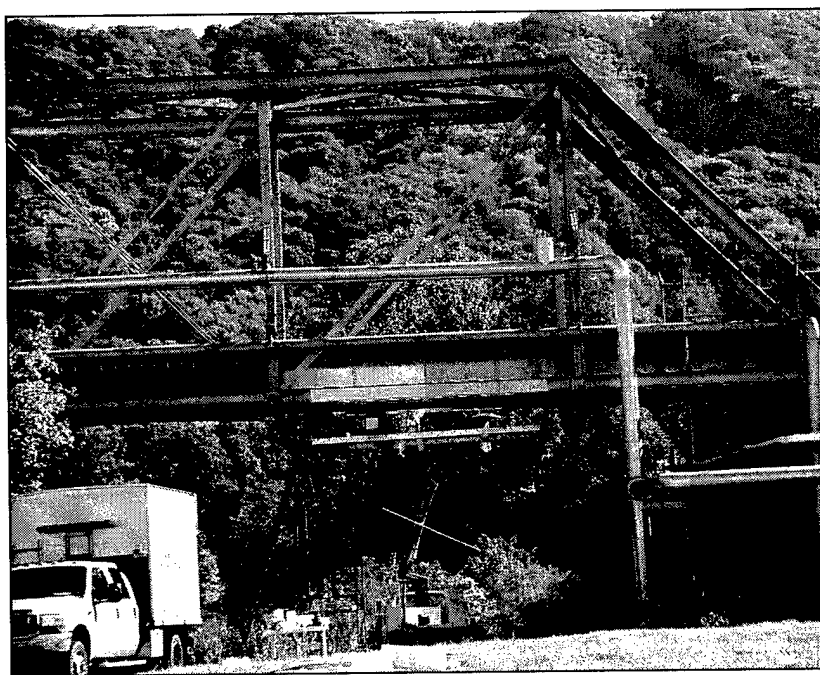
A visual inspection and physical tests were performed on the aged coating. The bridge appears to have been touched up and repainted on numerous occasions. It is doubtful that the bridge has been abrasive blasted and painted in at least the last 30 years and possibly not since it was erected at HAAP in 1943. The paint system is comprised of an orange primer and aluminum topcoat, which are probably TT-P-86, Type I, red lead in linseed oil and TT-P-38, aluminum phenolic finish coat. Most of the touchup painting was done with an aluminum finish coat. Paint film thicknesses are generally 8 to 15 mils on flat vertical surfaces and 20 to 25 mils on upward facing horizontal surfaces. The amount of visible rust is less than 1 percent of the total test area. Most of the rust was on the tops of flanges. Some rusted areas on the flanges were previously coated over and were lifting and curled. Adhesion tests were performed in accordance with ASTM D 3359 Method A X-cut tape test. Adhesion ranged from 4A to 5A. In some cases, a thin layer of aluminum pigment was lifted with the tape. This nonadherent material is the equivalent of chalk in a standard pigmented coating. A good deal of dirt had also accumulated on many of the bridge components.

Figure 2. Railroad bridge at HAAP, TN, with overcoated test areas.

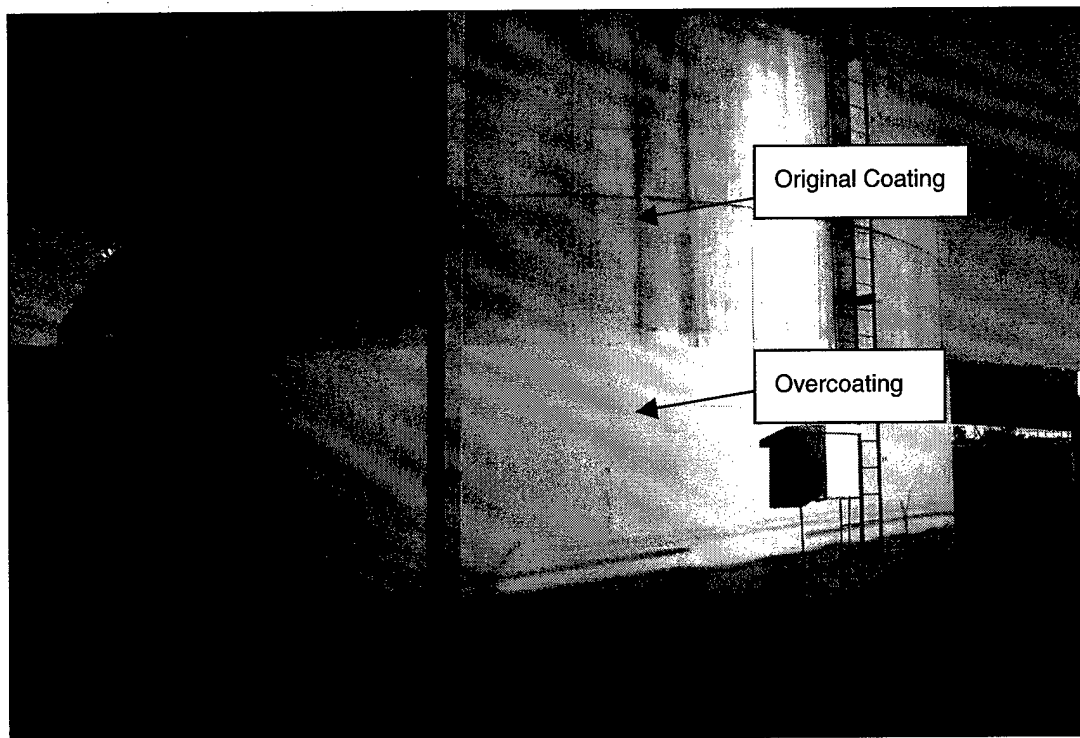
**Figure 3. Deluge tank at Fort Campbell Army Airfield. (Original coating with lead-based paint primer visible at top is deteriorated and steel underneath is rusted. The tank was overcoated with test patches of moisture cure polyurethane in October 2000.)**

Loose paint and rust were removed in accordance with SSPC-SP 3 Power Tool Cleaning using two rotary cleaning tools equipped with 3M brand Clean and Strip pads. Waste was collected in a High Efficiency Particulate Air (HEPA) filter vacuum canister. Solvent wiping with clean rags and varnish makers and paint (VM&P) naphtha was performed to remove residual dust and contaminants.

Wasser Mio Aluminum primer, Ferromastic intermediate, and FerroX A topcoat were applied by brush and roller to the first test area. Sherwin-Williams Corothane I Mastic primer, Corothane I Ironox A intermediate, and Corothane I Ironox A topcoat were applied by brush and roller to the second test area. Figure 3 shows the deluge tank after overcoating with test patches of moisture cure polyurethane.

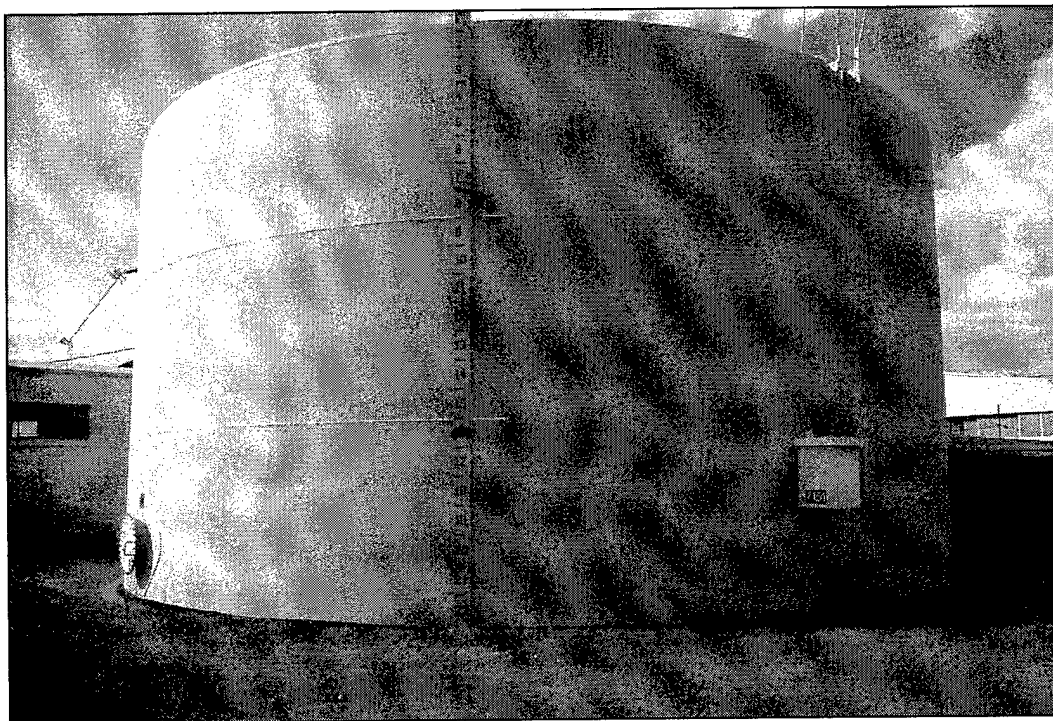
Both overcoat systems were performing well after 5 months of service. The winter months were relatively harsh with numerous freeze-thaw cycles. Intercoat adhesion between the overcoat systems and the original paint system was excellent. The adhesion of the original coating to the substrate was unaffected by either overcoat system. The risk that a catastrophic delamination failure will occur in the future is negligible. Both systems were devoid of any sign of early corrosion. Some rust staining of the overcoated areas had occurred as a result of wash down from corroded surfaces above the repaired areas.

Figure 4. Deluge tank at Fort Campbell Army Airfield after overcoating completed in August 2001.

After evaluation of the two coating systems, the coating system composed of Sherwin-Williams Corothane I Mastic primer, Corothane I Ironox A intermediate, and Corothane I Ironox A topcoat was chosen for completion of the tank coating job, as shown in Figure 4. The projected life of the overcoat repair on this tank is 15 to 25 years. This projection is based on the pre-overcoat condition of the original paint system, the durability of the overcoat materials, and the severity of the exposure environment. It should also be noted that the water tank can probably be overcoated two more times provided its condition is not allowed to deteriorate past that which is suitable for overcoating.
