4. TITLE AND SUBTITLE FINAL REPORT for Contract DAAE07-98-C-M012 (PART 1 OF 3) -Progress Report of LMTV Flywheel Housing & Driveline Failure Investigation	5a. CONTRACT NUMBER DAAE07-98-C-M012
	5b. GRANT NUMBER
	5c. PROGRAM ELEMENT NUMBER

**PROGRESS REPORT
OF
LMTV FLYWHEEL HOUSING
AND
DRIVELINE
FAILURE INVESTIGATION**

Contract No. DAAE07-98-C-M012

Hayes Hobolth
17 August 1998

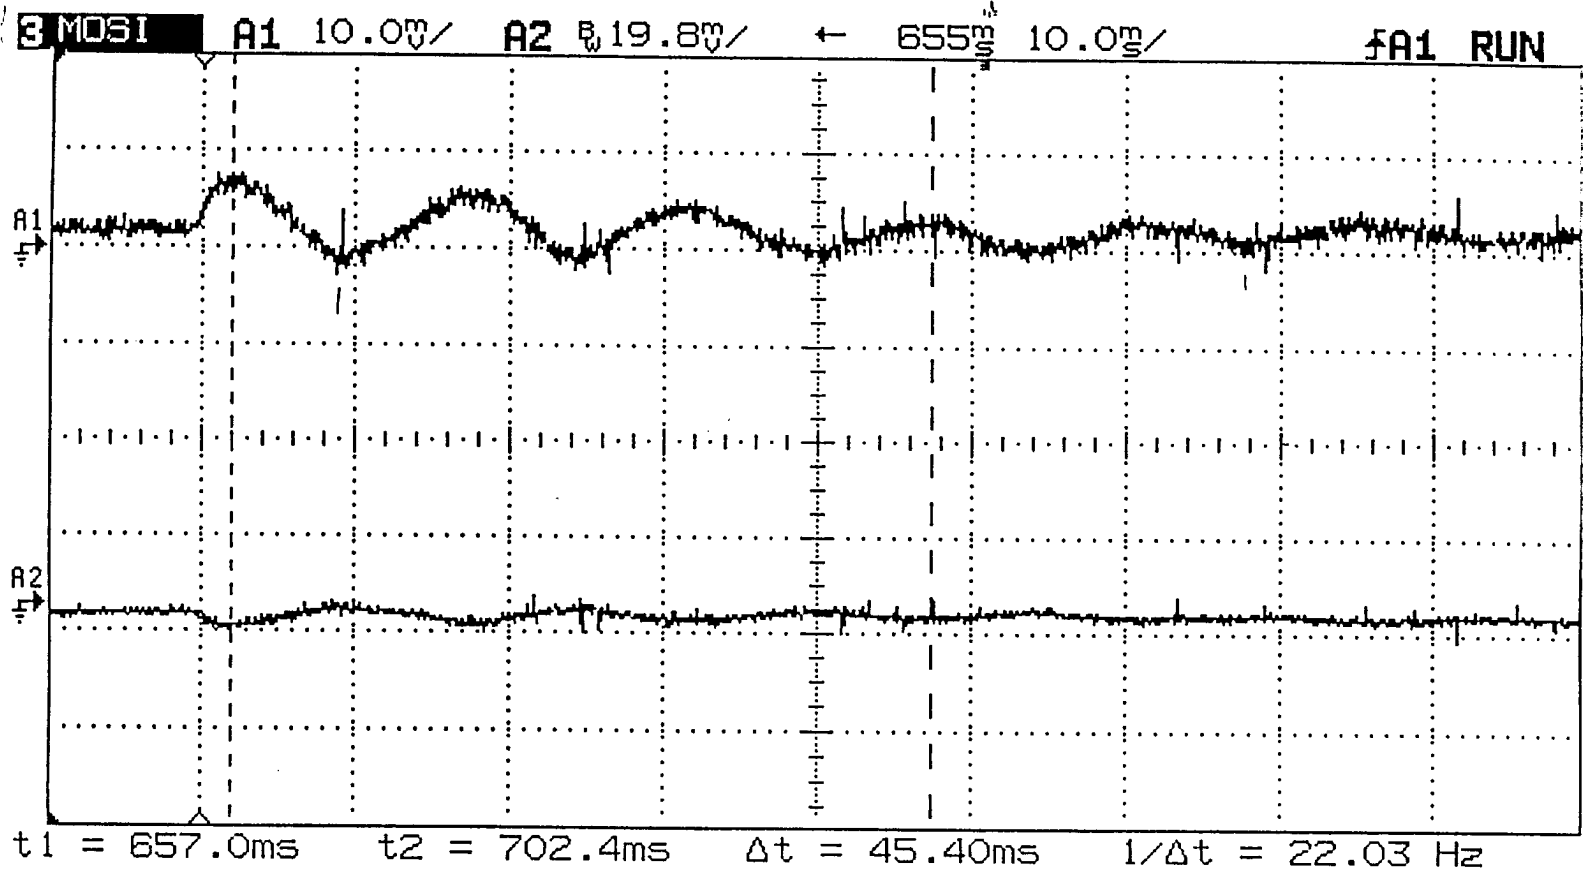
Impact Test of Natural Frequency 65-68 Hz (Original - 47.6 Hz)

- Impact test agrees with Caterpillar projection for ductile iron and increased section.
- Speed sweeps do not show a clearly defined resonance.
- Probing for the characteristic first mode vertical bending suggest that the new bending mode may be critically damped

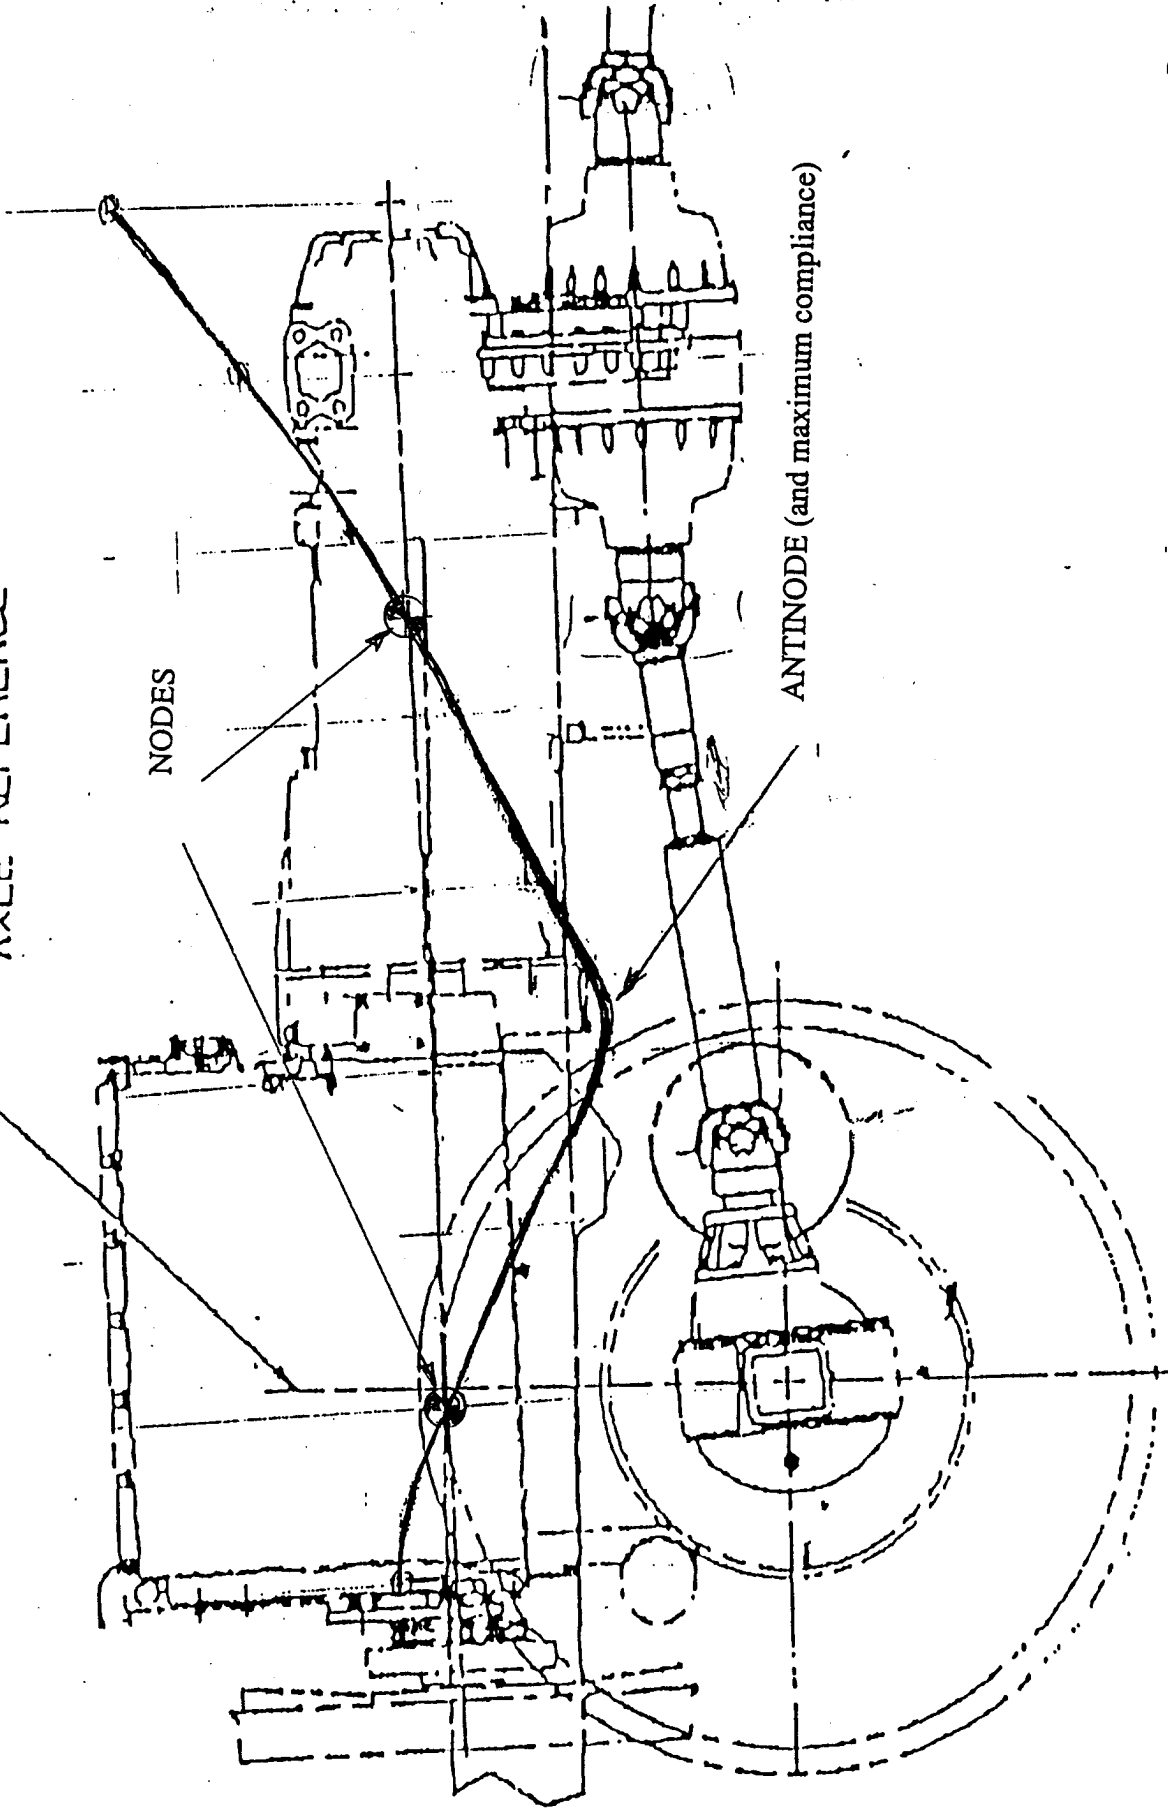
FIGURE 1.

An important relationship is shown in Figure 1, which is a mode shape of the vertical bending mode of the resonant response at its peak excited by the an unbalance at the transfer case output. The dynamic first order vertical velocity was probed at 10 inch increments along the length of the powertrain and is plotted on a side view. It clearly shows that the elastic energy is stored in the deformation of the flywheel housing.

FIRST MODE VERTICAL BENDING @ 47.6 HZ

PHASE II- Identify corrective actions: Diagnostic tests often point to corrective actions as is demonstrated above. A flywheel housing having stiffness and strength properties comparable to the experimental MSC flywheel housing would correct the flywheel housing failure problem.
